MARINE ACCIDENT REPORT

RAMONA
Collision with railway bridge 28 March 2012

This marine accident report is issued on 24 September 2012

Case number: 201204183

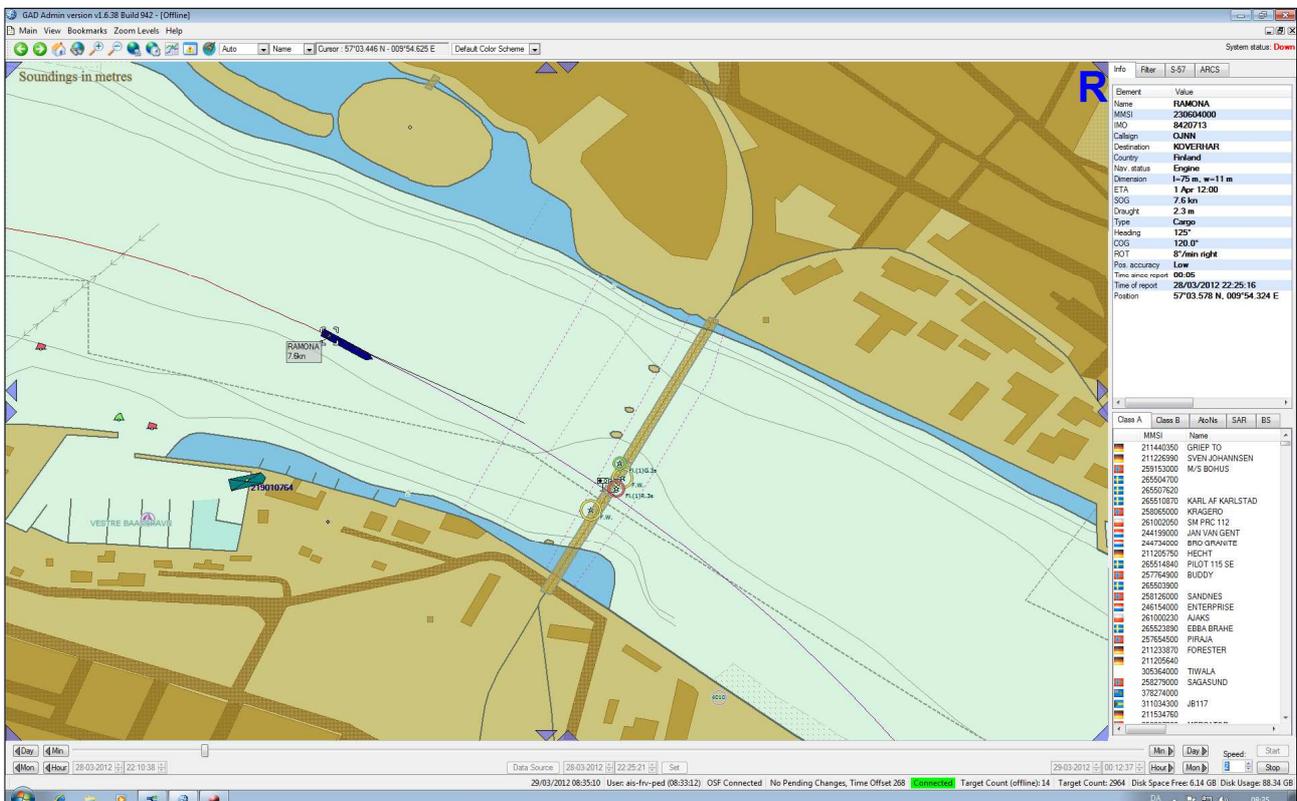
When RAMONA at 22:25:21 was 0.17 nm from the Railway Bridge, the ship's speed over the ground was 7.6 knots according to the AIS information, see figure 9.

Figure 9: AIS information, at 22:25:21
Source: Danish Maritime Authority

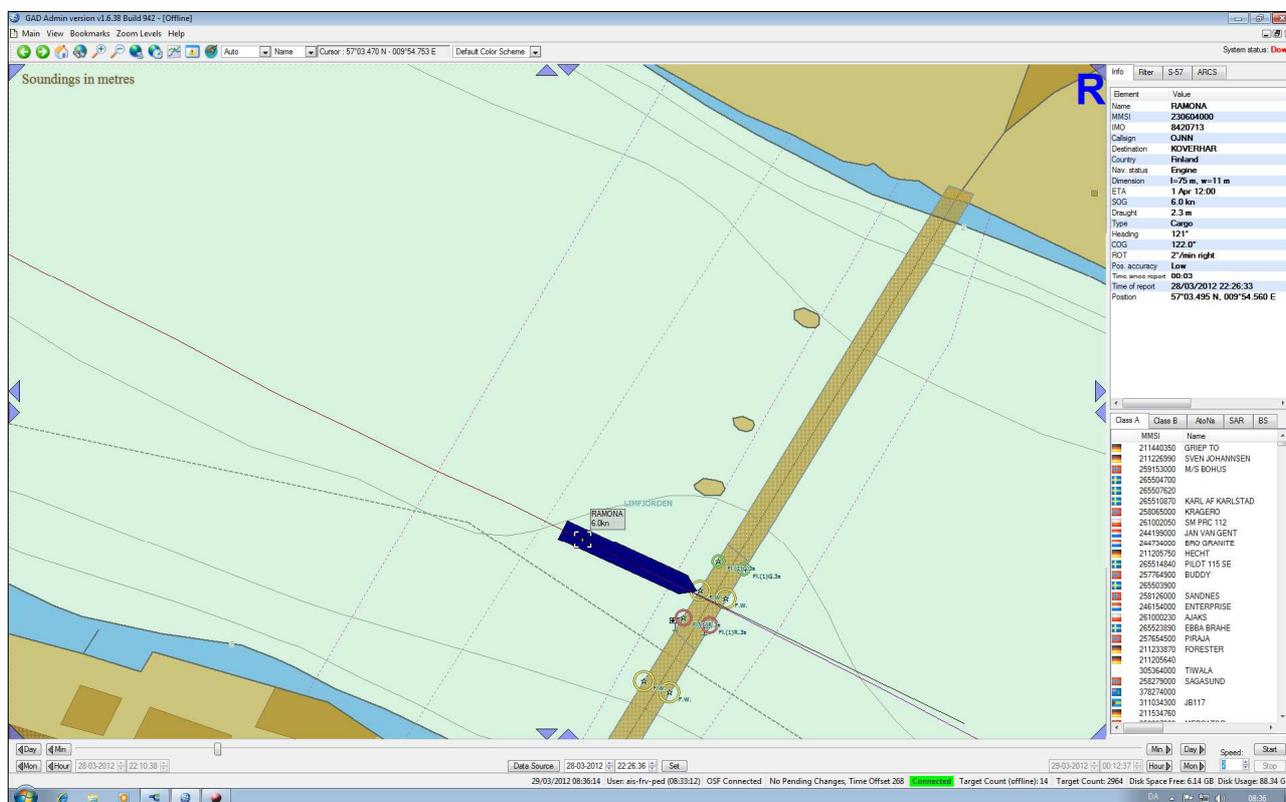
The chief officer replied that they could not stop the ship at such a short distance. The master had already manoeuvred full astern to stop the ship, but the ship could not stop immediately and hit the bridge at 22:26:36 at a speed of 6 knots over the ground (according to AIS information), see figure 10.

Figure 10: AIS information, at 22:26:36
Source: Danish Maritime Authority

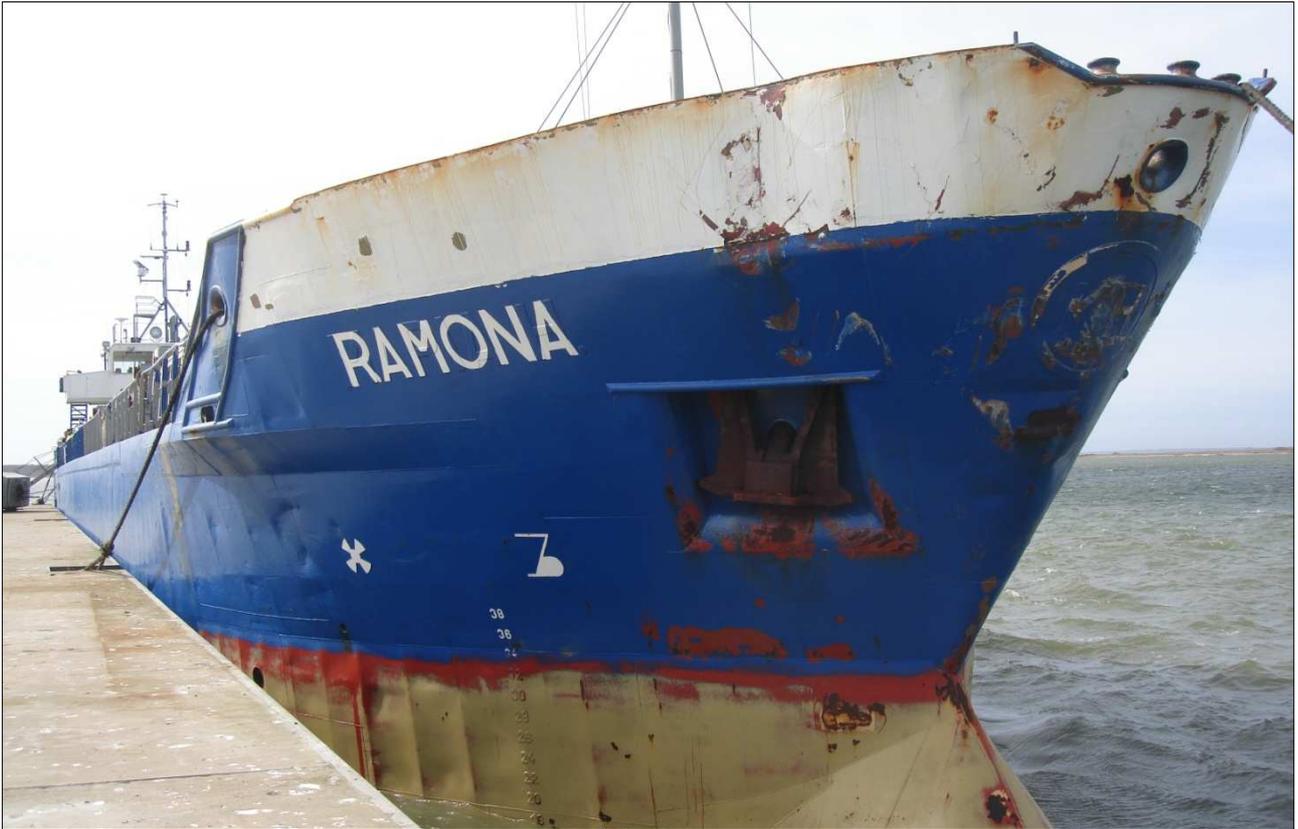
There was moderate damage to the ship's forecastle, and the structure under the forecastle (see figures 11 and 12) and severe damage to the Railway Bridge (see figures 13, 14 and 15).

Figure 11: Damage to RAMONA after collision with the Railway Bridge
Source: DMAIB

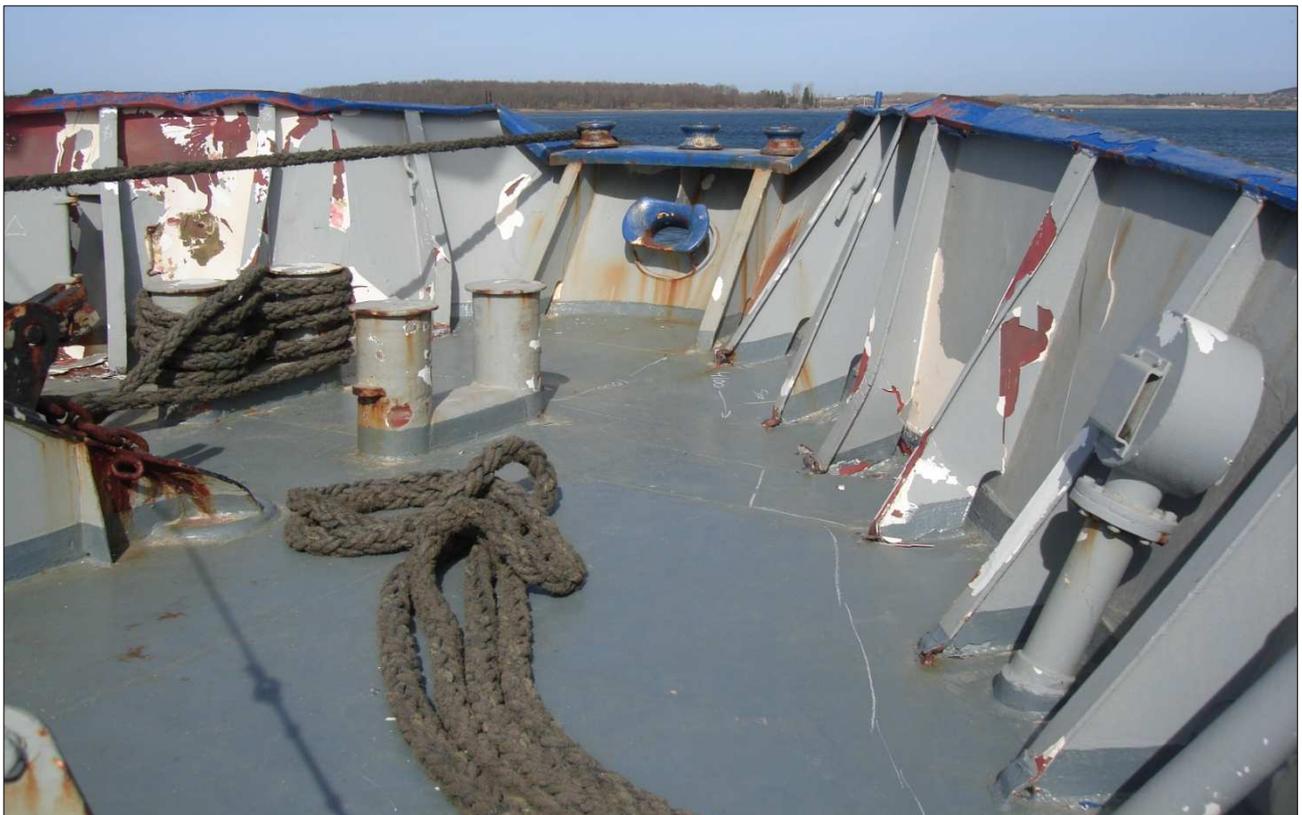
Figure 12: Damage to RAMONA after collision with the Railway Bridge
Source: DMAIB

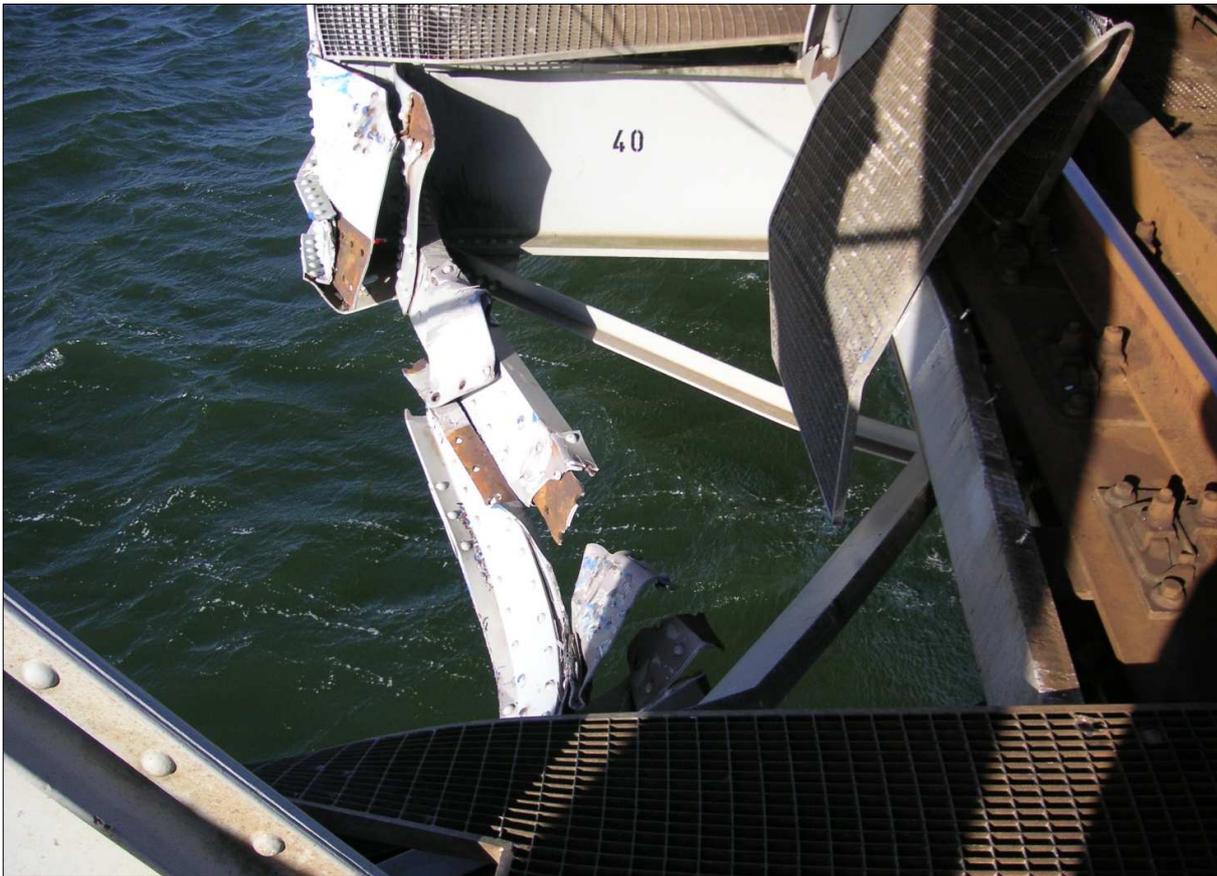
Figure 13: Collision damage to the Railway Bridge
Source: DMAIB

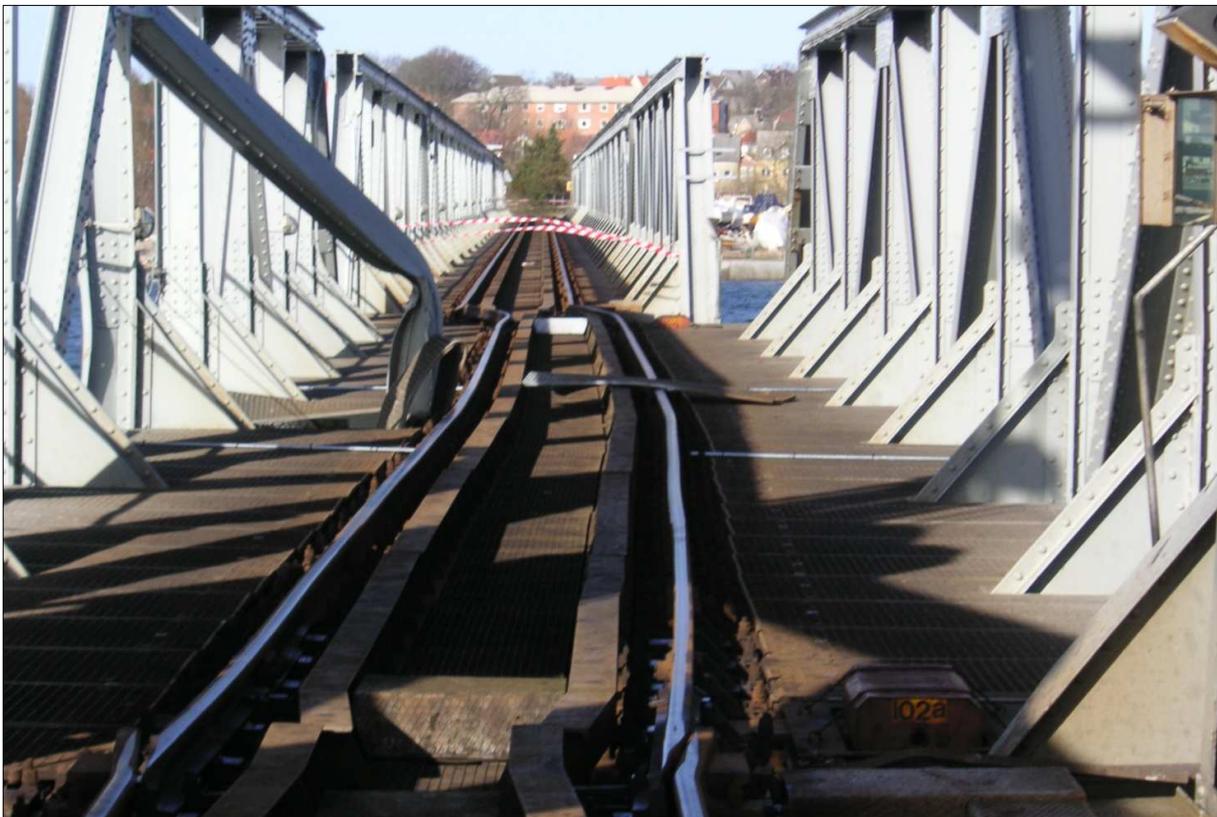
Figure 14: Collision Damage to the Railway Bridge
Source: DMAIB

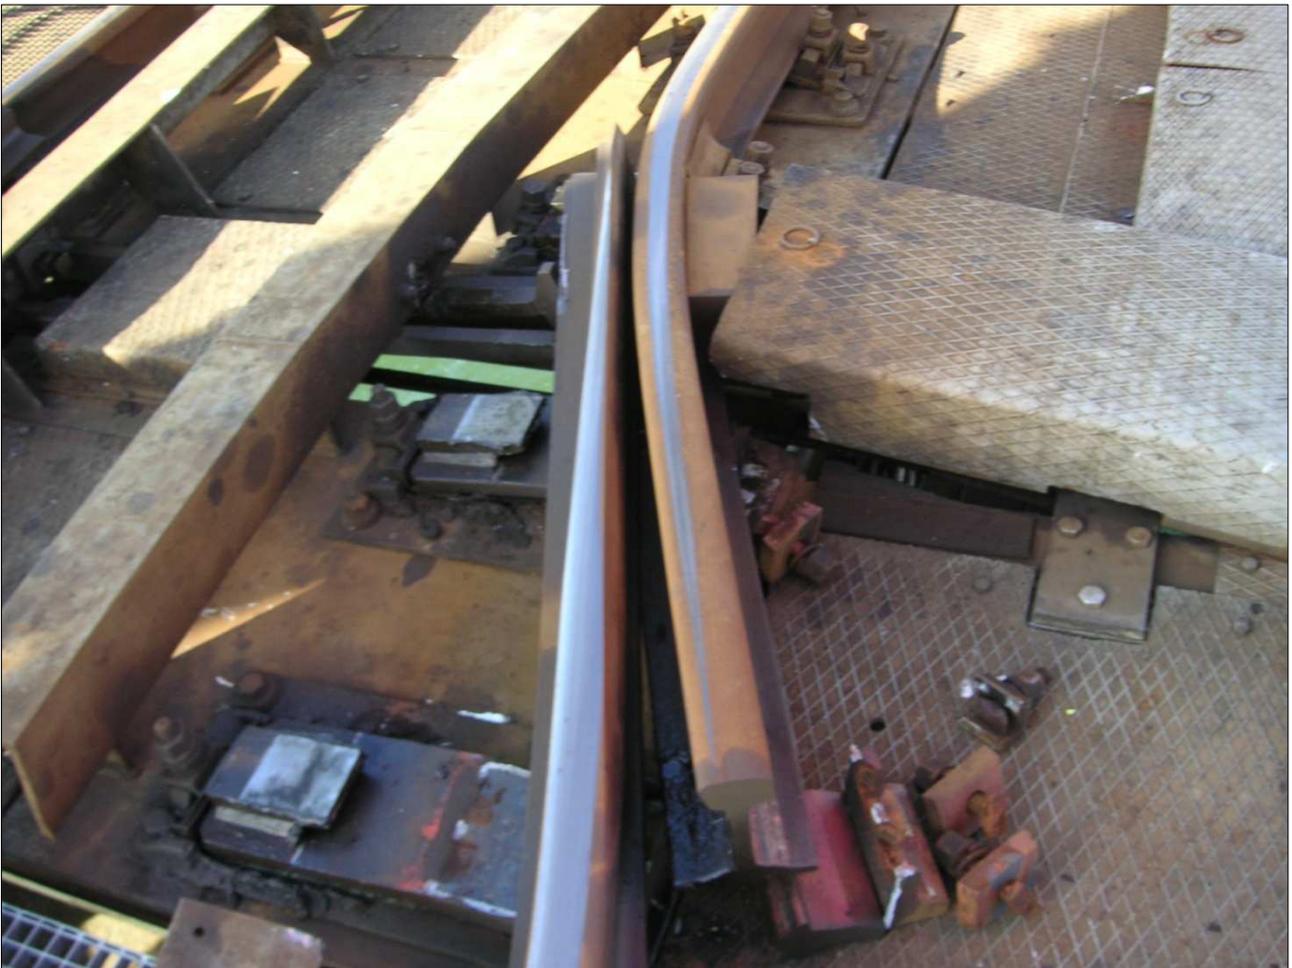
Figure 15: Collision Damage to the Railway Bridge
Source: DMAIB
