Investigation report

M2013-03

M/V EGON W, death of a seaman in consequence of falling into water in the Port of Vuoksi on 26 November 2013

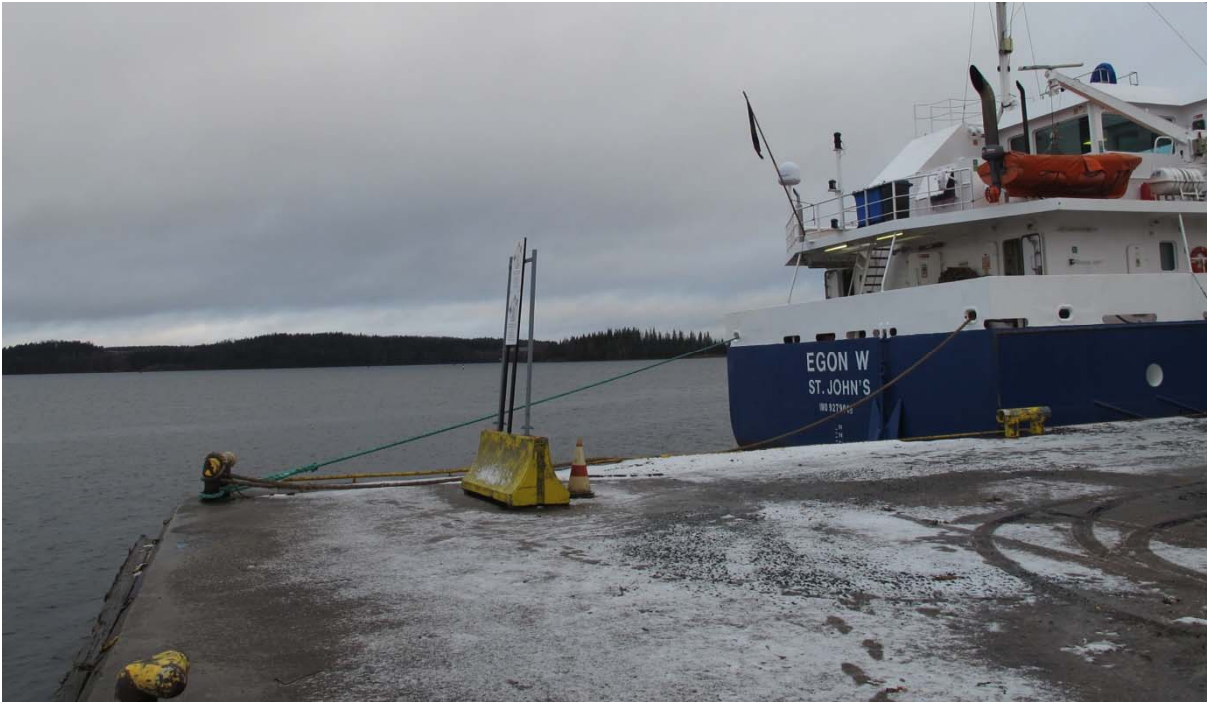
The seaman fell from the quay when he was letting go of the vessel's stern line. The photo was taken on the day after the accident, on 27.11.2013. It was dark when the accident took place. (photo: the police)

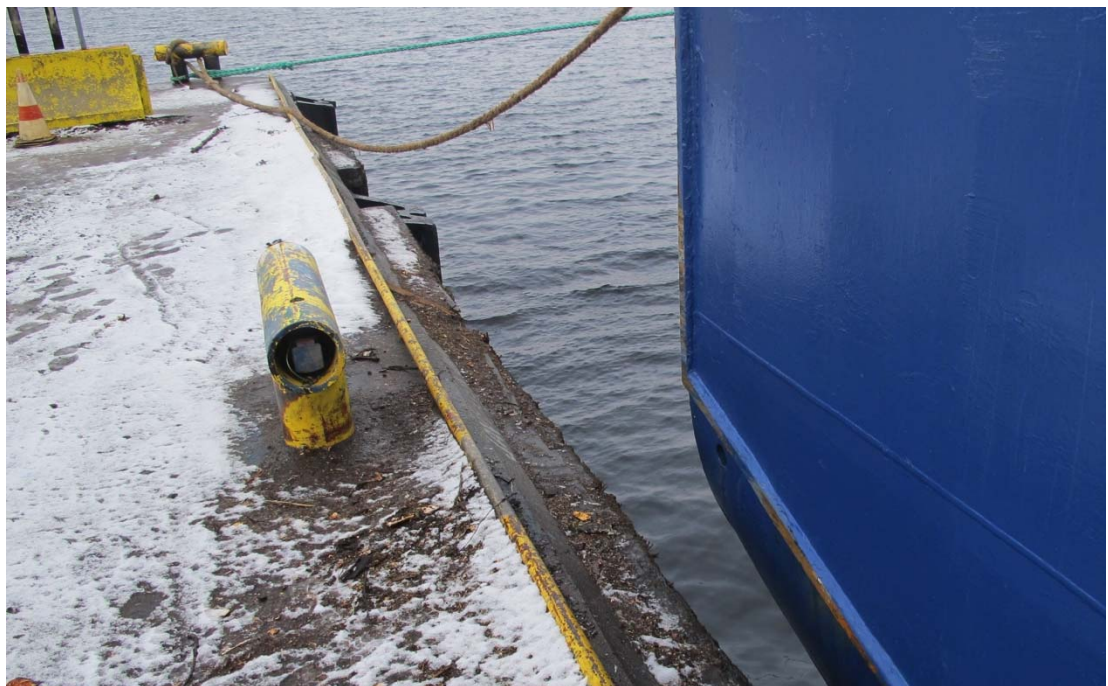
Figure 4. The concrete quay top at the scene of the accident, at the west end of quay B. An edge block made of yellow metal tube, the starboard side stern corner of the EGON W and the wooden protective beams on the edge of the quay can be seen in the photo. Photo taken on 27.11.2013. (photo: the police)

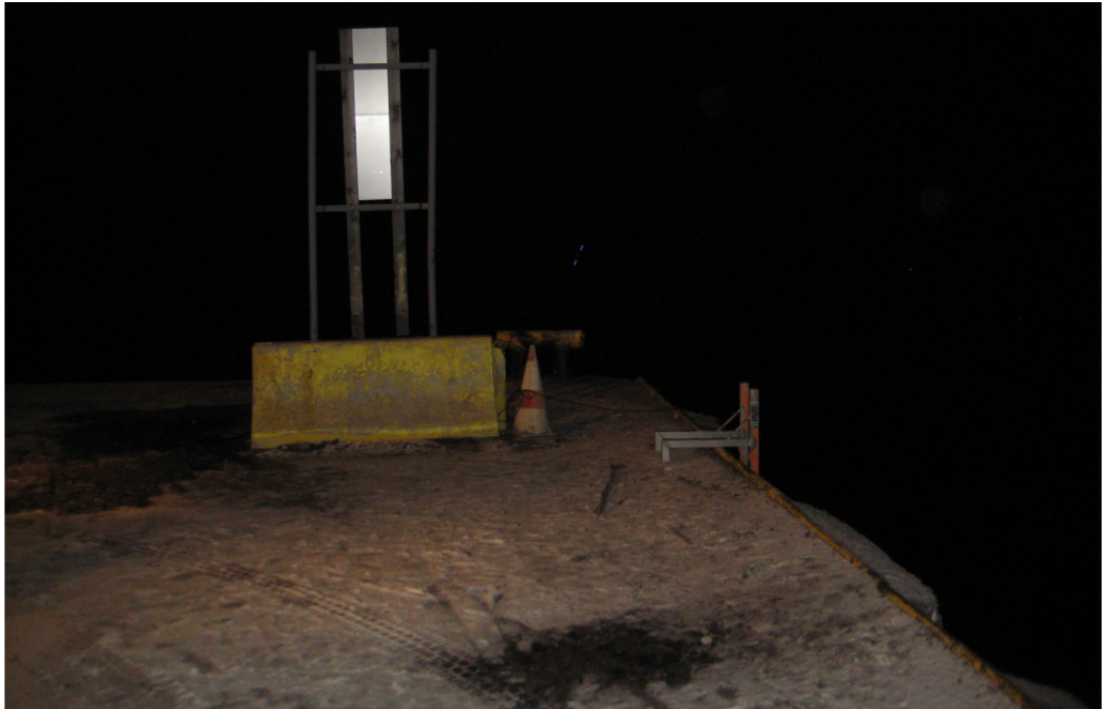
Figure 5. Photo of the scene of the accident 26.11.2013. The passageway on the edge of the quay was fairly narrow because of the concrete base of the information board and the attention cones stacked next to it. The ladder seen at the edge of the quay was brought there during the rescue operations. (photo: Stora Enso mill fire brigade)

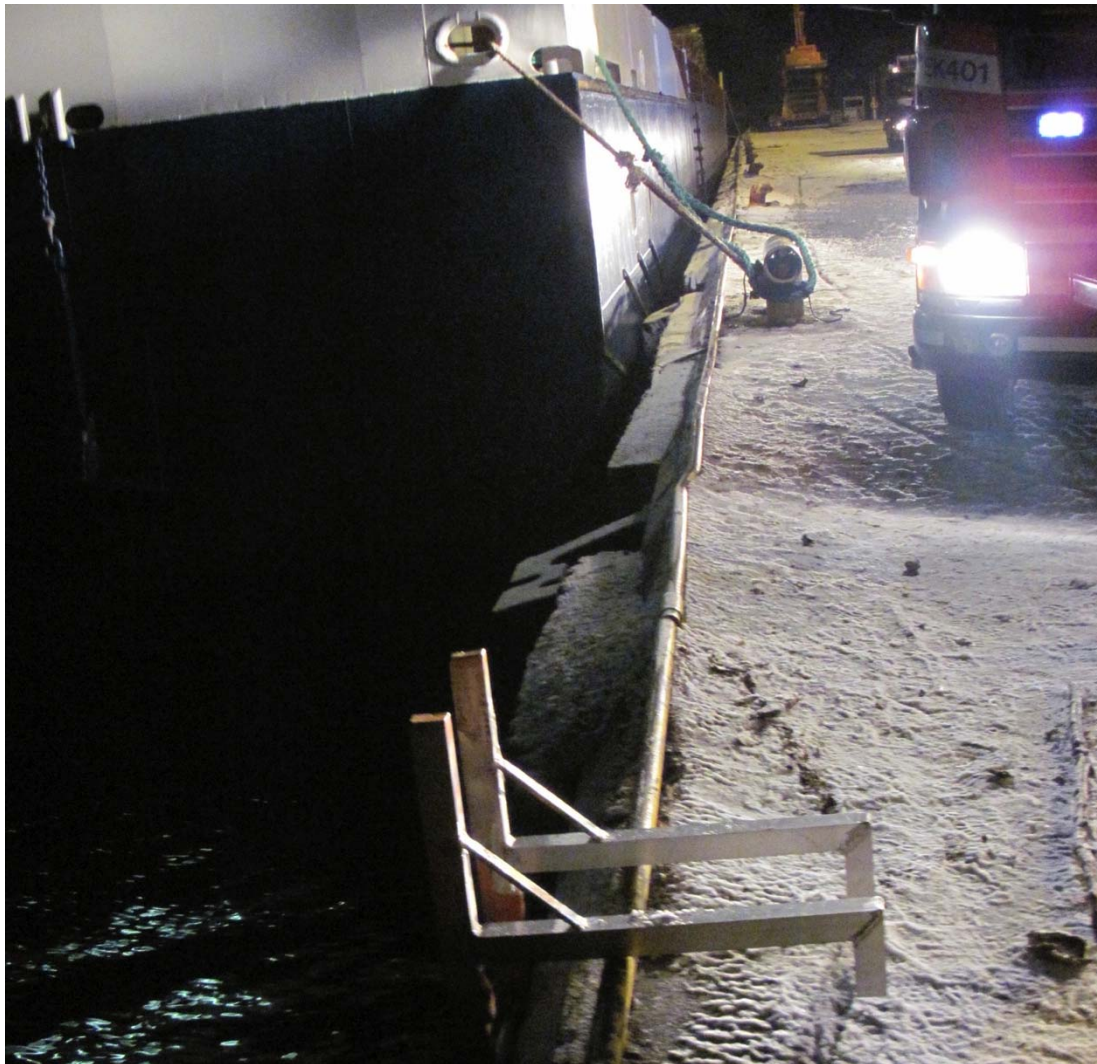
Figure 7. Photo on the estimated place of falling approx. one hour after the accident. There was a thin layer of powder snow on the quay and frost on the surfaces. The ladder seen in the foreground had been brought to the scene during the rescue operations. (photo: the police)

The weather conditions and darkness during the accident have probably contributed to the accident. The frost surface which develops on asphalt, concrete and trampled snow or ice is not necessarily slippery in itself, but wind, vehicles and walking on it may smooth the frost surface so that it becomes slippery. Metal or wooden surfaces covered with frost, e.g. the yellow tube going along the edge of the quay as well as slanted wooden surfaces, may also be very slippery.

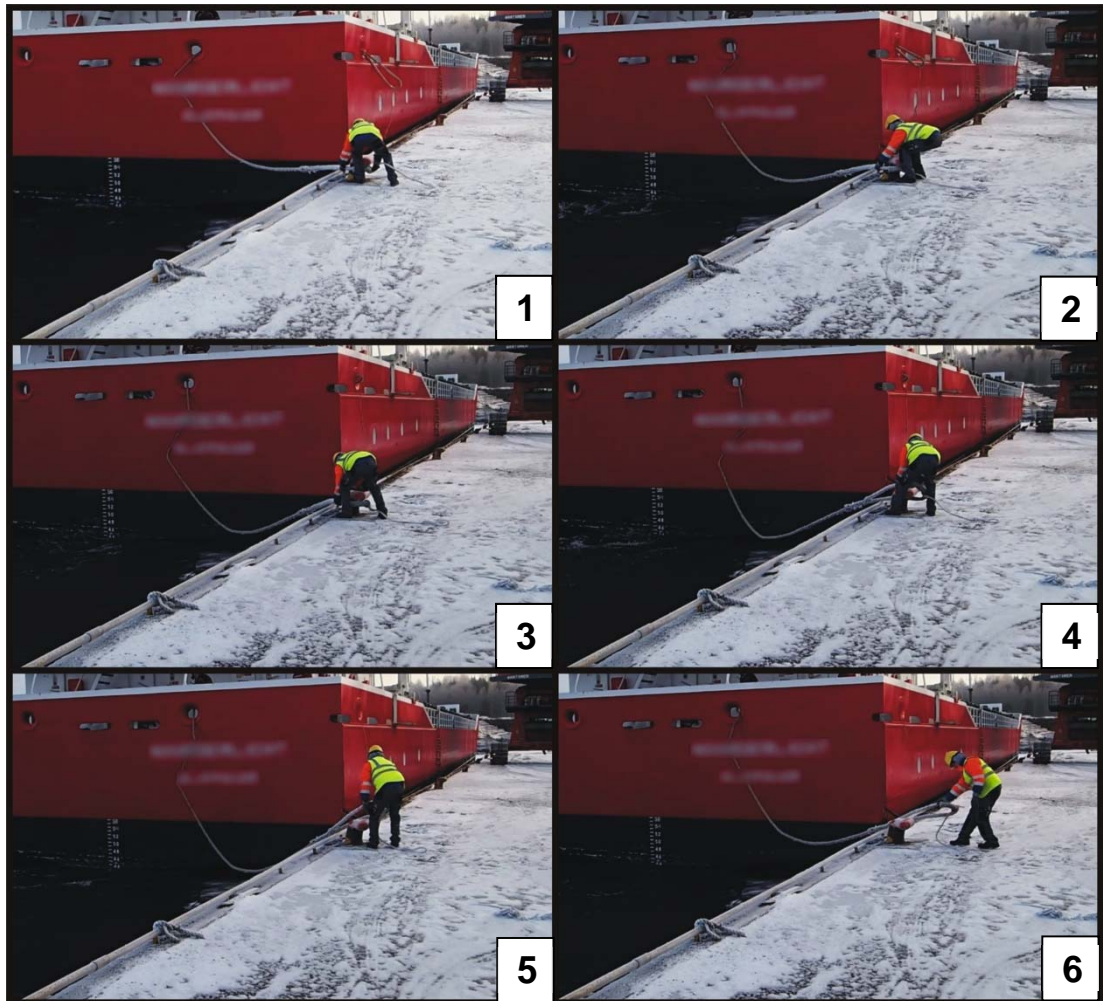
Figure 8. Series of photos portraying the actions of a line handler when letting go of a vessel similar to the accident vessel as to its size at berth number 2 in the Port of Vuoksi in winter conditions. The line handler shown in the photo had been ordered from a subcontractor, and he was not wearing a lifejacket. Photo taken on 14.1.2014. (Photos: the SIAF)

The line handler has to work very close to the edge of the quay at the same time both lifting and pulling at the rope, which means that there is a major risk of falling into water if he e.g. staggers or slips. The engines are running when the vessel is being let go as well as when it is moored. Therefore there can slipstream in the water at the stern, and bow thruster may cause flow in the bow. In winter conditions, the line is also stiffer and therefore more difficult to handle.

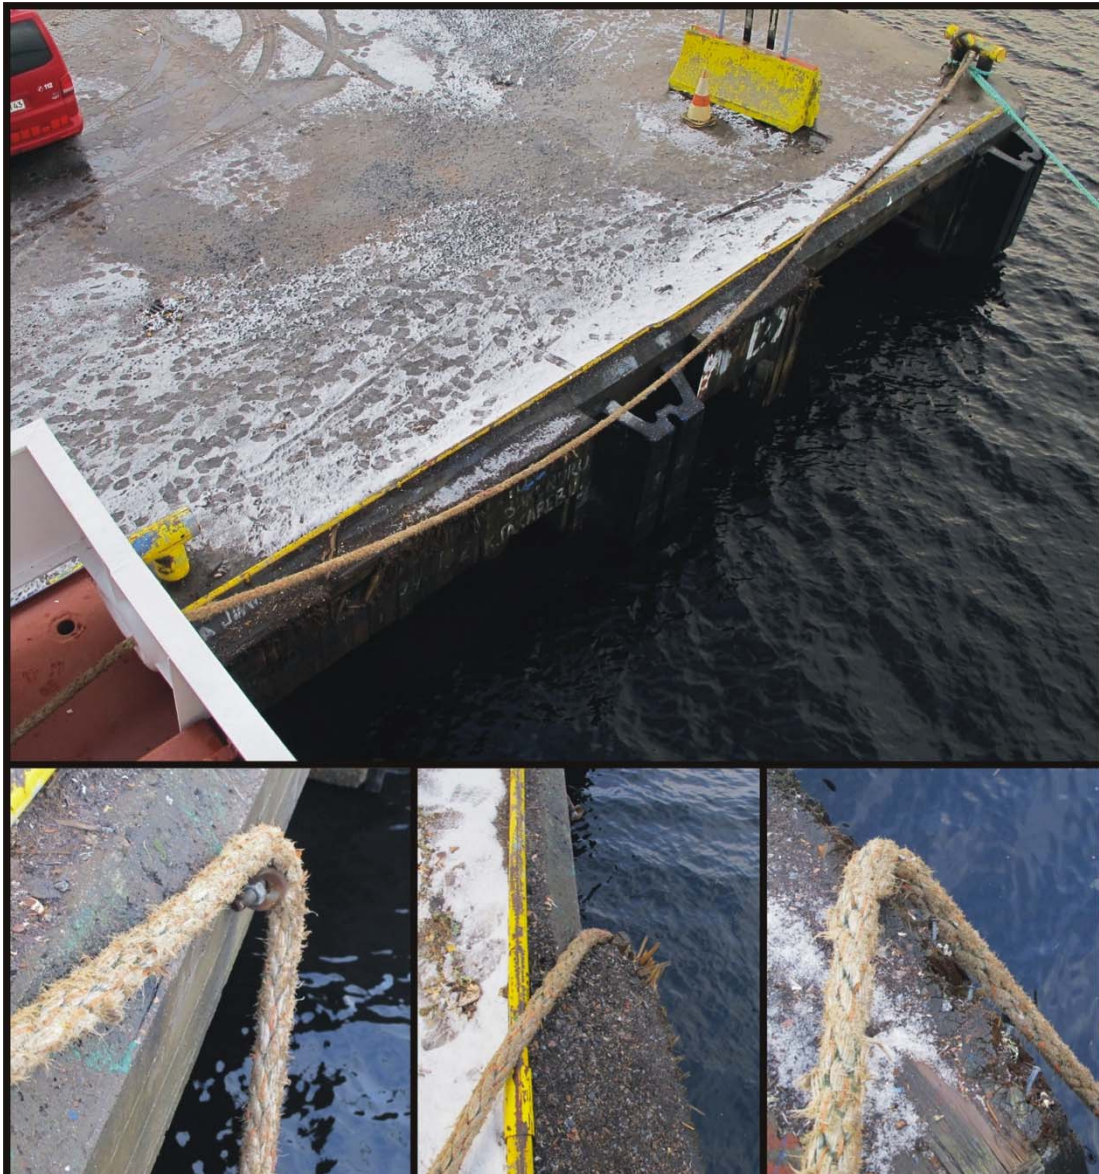
There were points in the port bollards and quay edges and its planking which could make it more difficult for the line handler to work if the line got stuck to them. Especially in the outer edge of the quay there were plenty of points to which the line could get stuck, protruding bolts, loosened nails, splinters of worn wooden beams, etc.

Figure 9. There were several points on the edge of the quay where the line could get stuck. Photo taken on 27.11.2013. (photos: the police)

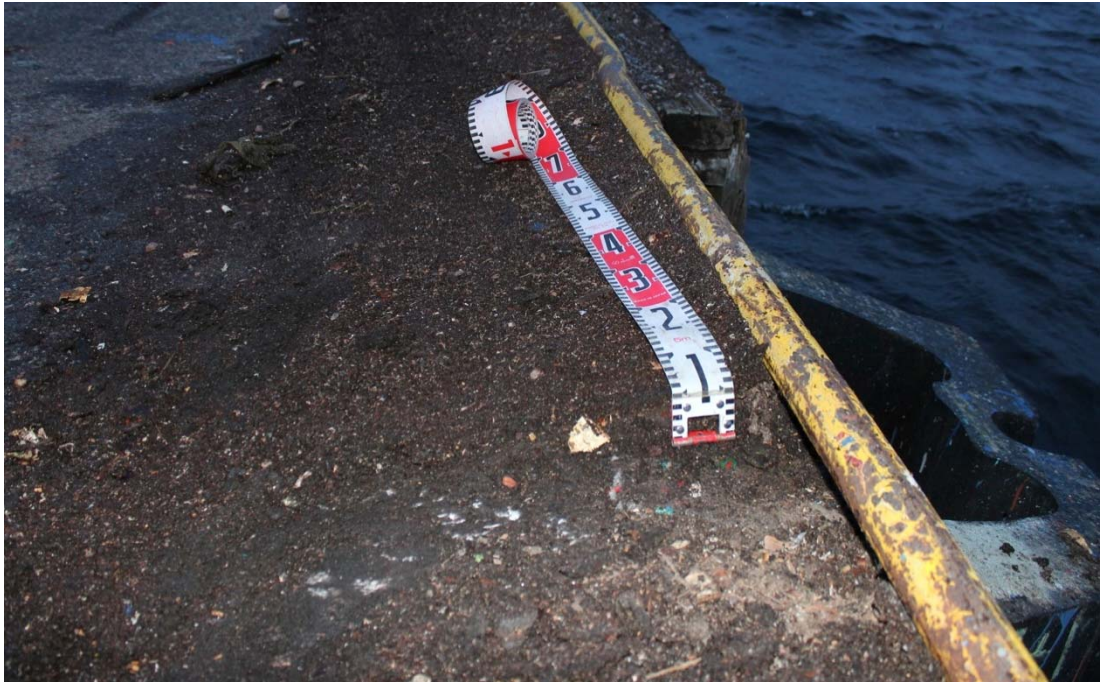
In places the interlayered crushed stone used for sanding and other matter piled on the quay reached the level of the metal tube on the edge of the quay. After the metal tube there was a steep bevel in the concrete quay top, and crushed stone used for sanding and other matter had piled on the top of the wooden covers fastened on the side of the quay.

Figure 10. Matter piled next to the edge tube of the quay where the falling has been estimated to have taken place. (photo: the police)

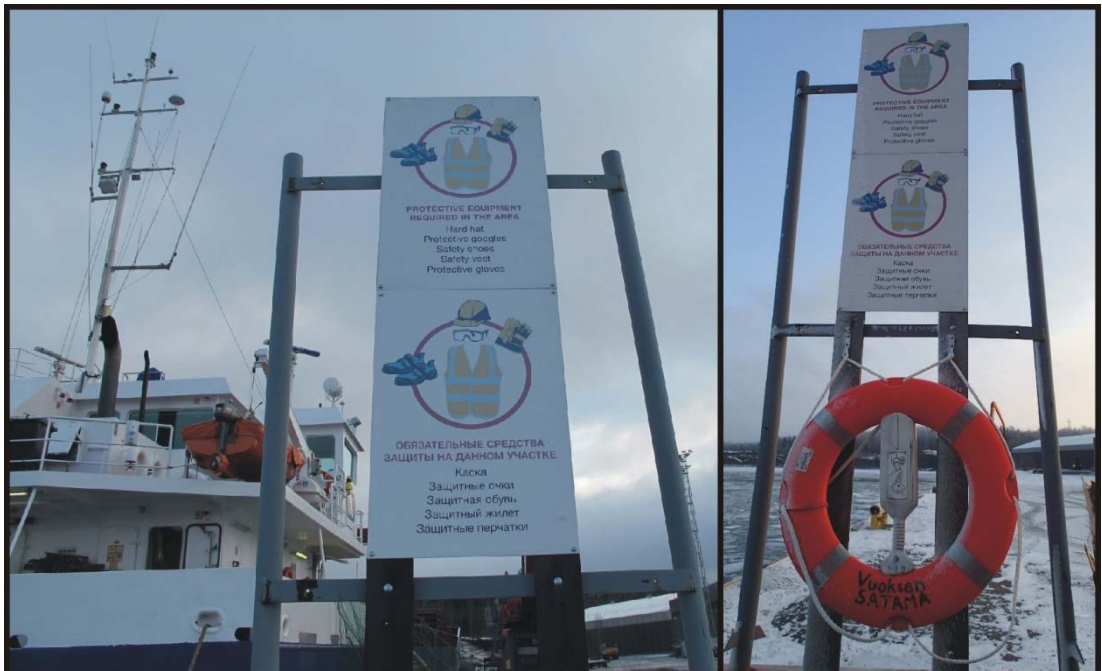
On quay A in the port there is an information board in English and Russian for seamen, and it gives instructions on safety equipment needed in the port. Lifejackets are not mentioned on the board, only safety vests.

Figure 11. The English language text in the information board: “Protective equipment required in the area: Hard hat, protective goggles, safety shoes, safety vest, protective gloves.” The photo to the left was taken on the morning following the accident, the one to the right on 14.1.2014. The lifebuoy seen in the photo to the right has been placed there after the accident. (photos: the police, the SIAF)

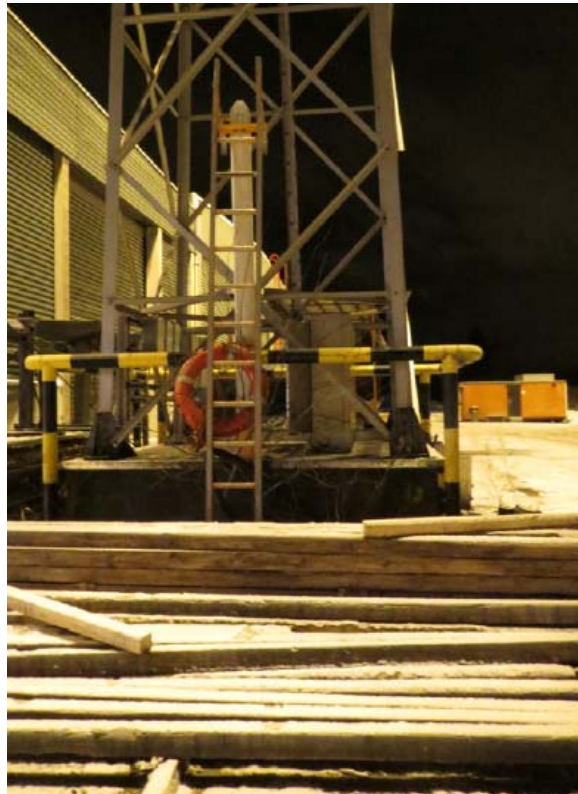
On the evening of the accident the statutory safety equipment in the port consisted of an orange lifebuoy equipped with a floating rope and a ladder equipped with a support bracket at its upper end (Decree 633/2004). They were placed approx. 60 metres from the scene (corner of the quay). There was some timber in front of them (Figure 12). An entry of *required cleaning in front of safety equipment in the Port of Vuoksi* was made to the Stora Enso Forest register of safety-related incidents and observations, and the timber in the area was removed.

Figure 12. The ladder and lifebuoy near to the accident scene, photo taken on the evening of the accident 26.11.2013. The Government Decree on the Occupational Safety in Loading and Unloading of Ships requires that there must also be a round-tipped boat hook available. (photo: Stora Enso mill fire brigade)

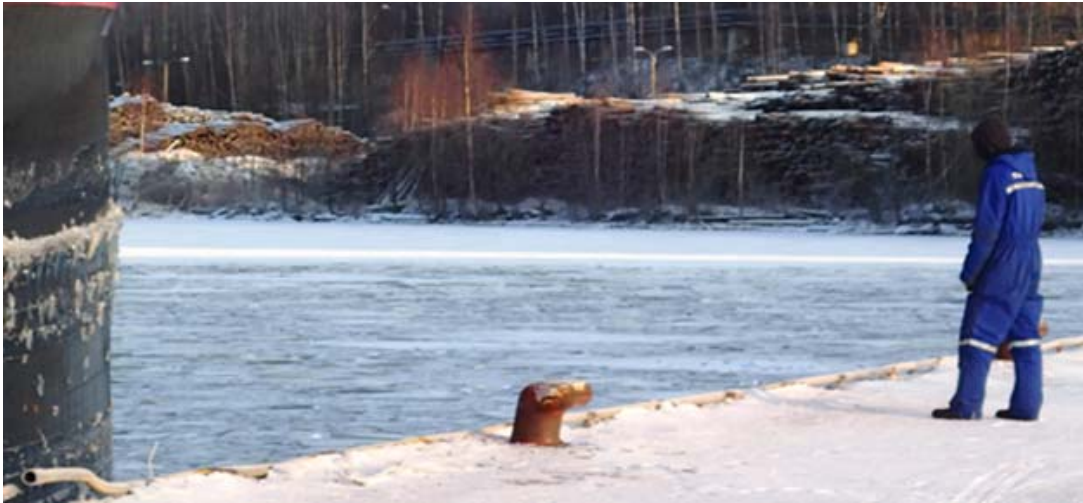
When the Investigation Team visited the Port of Vuoksi, the transfer of another dry cargo vessel from quay A to quay B was observed: the transfer was realised without outside line handlers by the vessel's own crew, and the seaman working on the quay did not wear appropriate safety equipment.

Figure 13. Quay transfer of a cargo vessel in the Port of Vuoksi 14.1.2014. The seaman waiting for the bowline does not have safety equipment required in port and necessary for the safe execution of the task. The vessel and person in the photo are not related to the accident. (photo: the SIAF)

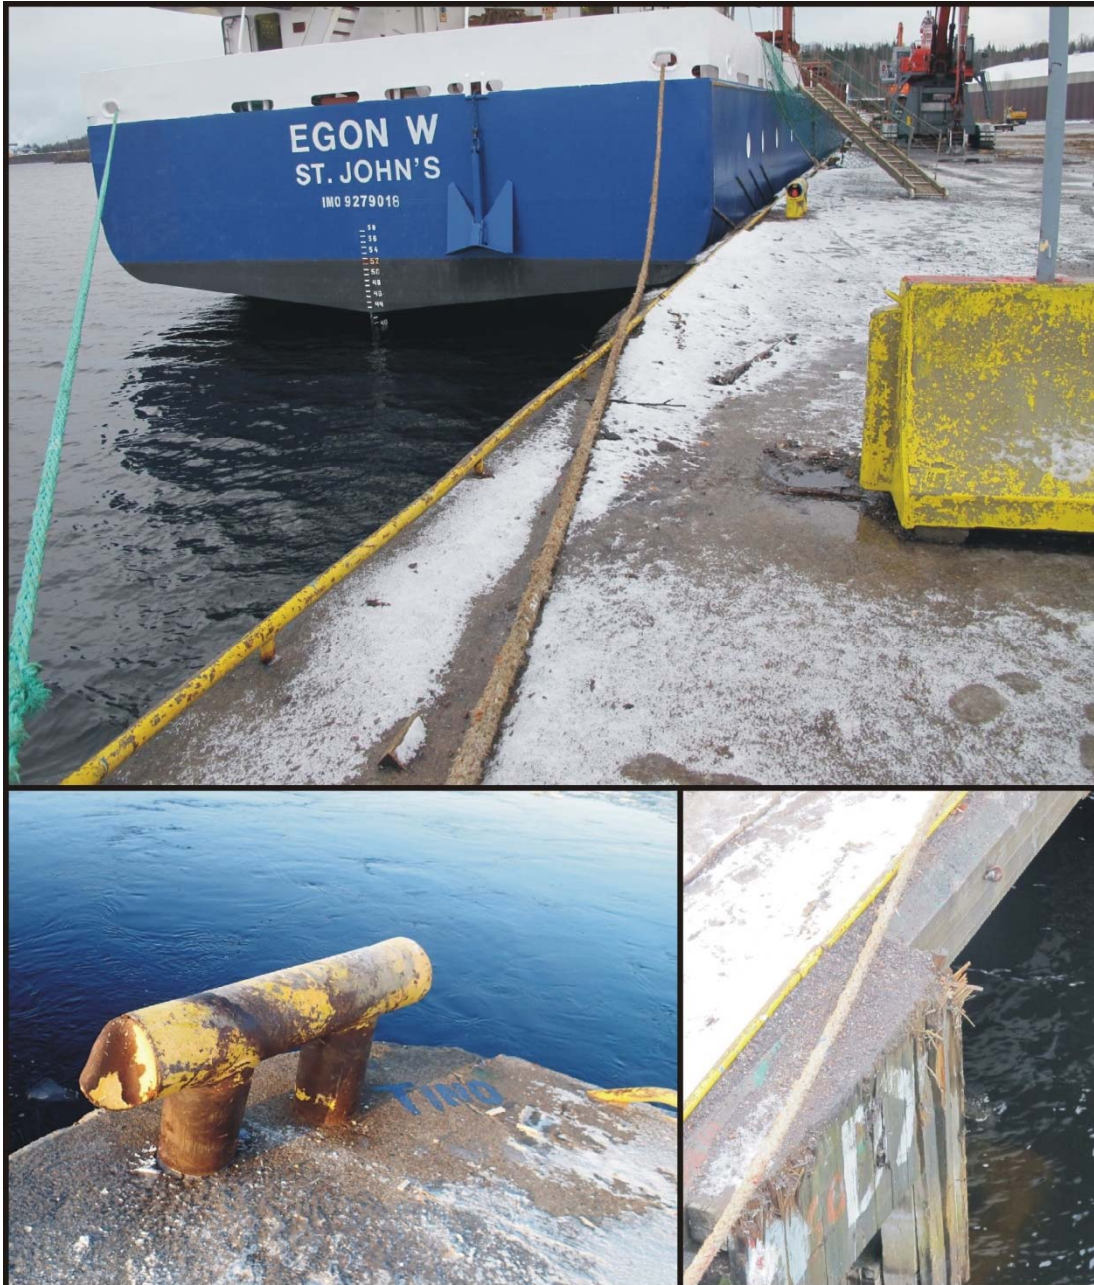
The uneven structures on the edge of the quay made it possible for the mooring rope to get stuck. During the technical investigation carried out by the police, the tendency of the line to get stuck was tested by taking the line from the bollard and pulling it along the quay towards the vessel. When this was done, the line got stuck at several points to the bolts, nails and an end of a plank jutting out on the edge of the quay. When investigating the scene, several observations were made on details related to the condition of the

quay structures or to keeping them clean. Some of them are presented in the photo series below (Figure 15) and in the bottom left-hand corner of Figure 13 (broken and twisted edge block).

Figure 15. On the day following the accident, wooden waste increasing risks related to moving and working on the quay could be observed on edge parts of the quay top (topmost photo). There was also an end flange which was torn from the joint and twisted at the mooring bollard at the corner of the quay as well as splinters of wood in the protective balks on the quay. Both these factors may have made line handling more difficult. (photos: the police, the SIAF)
