M2014-01

M/V SYLT (AG), ground touching off Rauma on 11 October 2014

Investigation report 5/2015

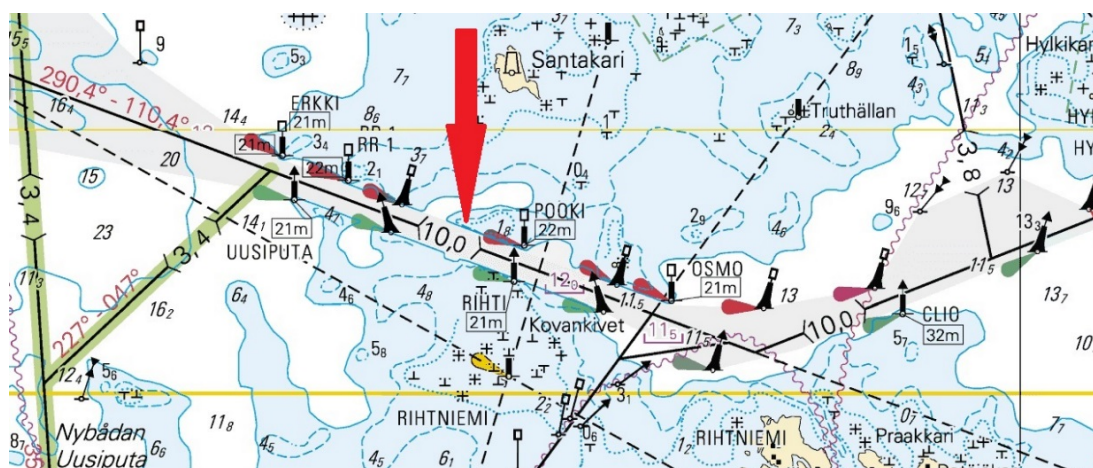
Figure 7. The excavated section of the Rihtniemi channel. The location of the ground touching marked with a red arrow. The heading of the channel section between Rihtniemi (on the right-hand side of the figure) and the port is 248 degrees when outbound. (Photo: Nautics Sailmate)

When the SYLT was drifting to the south side of the fairway centre line, the pilot switched over to manual steering and turned the vessel to starboard. According to those on the bridge the manoeuvre made the vessel turn more strongly to starboard. The rudder angle used for the turn is not known because there are no VDR recordings. The pilot tried to stop the turn by giving counter-rudder hard-a-port. Regardless of this the starboard turn did not stop. The pilot asked the master to take over the manoeuvring. The master took over the manual steering, made sure that the rudder was hard-a-port and increased the main engine power in order to improve the effect of the rudder. The vessel started to turn to port, but drifted with a speed of 12.8 knots and with her starboard side first into the north side rocky edge of the channel on 11 October 2014 at 02:14.

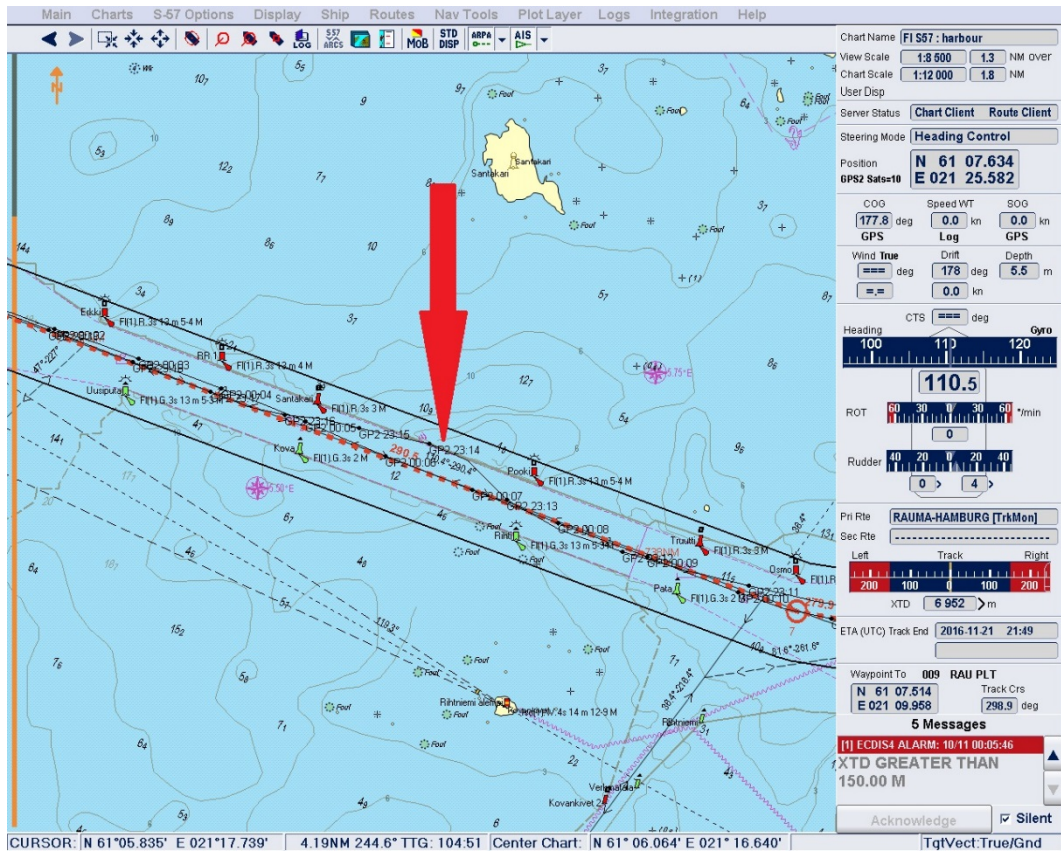
Figure 8. The recording of the SYLT's ECDIS device. The vessel's track and the location for the ground touching (the red arrow) can be seen in the figure. (Photo: M/V SYLT)

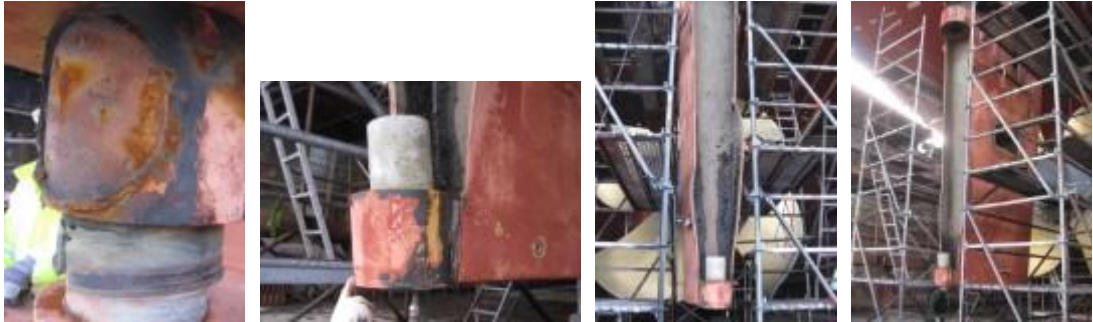
The rudder flap was missing altogether. During the dive it was noticed that the metallic surfaces of the tears caused by the flap falling off were shiny. According to the divers' assessment, the damages were not older than a couple of days at the most.

Figures 9, 10, 11 and 12. Damages to the rudder (photographed at the repair yard).
(Photos: DNV GL)

The swinging arm of the upper part of the rudder flap had been torn off from its bearings (Figure 9), and the bearing journal of the lower part was twisted backwards (Figure 10). The side plates of the rudder blade, which protected the shaft of the flap, were bent outwards from their lower parts (Figures 11 and 12).

When the vessel was at the repair yard, it was possible to get a clear picture of the damages to the rudder. It can be concluded that the flap had first come off from its upper part, because the hinge pin of the lower edge of the flap had been bent backwards (Figure 9). The swinging arm of the upper part of the flap, i.e. the mechanism which makes the flap turn when the rudder turns had been torn off from its weld (Figure 8). The fastening of the swinging arm to the bearing frame was designed without any strengthening around the bearing frame. The hinging of the flap was realised only between the hinge pins at the lower and upper ends without any hinge in the middle of the flap. The breaking of the upper hinge caused the flap to fall off.

The leading edge of the flap has been designed to be inlaid in the channel at the rear edge of the rudder blade. The sides of the channel in the rear edge of the rudder blade were also bent. This leads to the conclusion that the flap had turned from side to side before coming loose, thus damaging the rear edge of the rudder blade. However, this can have happened only after the bearings at the upper part of the flap and the swinging arm have yielded, because otherwise the upper part of the flap could not have turned to the side. The damage has stopped the steering of the flap through geometric rudder angles. Damages to the rear part of the rudder blade have been caused by the turning of the flap, which was due to the flow of water (Figures 11 and 12).

The swinging arm of the flap could also have been damaged much before the upper hinge was damaged. The damaging of the rudder can be divided into three different phases: a) damages on the swinging arm b) the flap turning with the flow of the water after the upper hinge had come loose, and c) finally coming loose of the lower hinge, i.e. the flap falling off. Since there were no abrasions to be seen at the base of the lower hinge, the coming off of the flap must have happened fairly quickly after the upper hinge has yielded. The lower edge of the flap would have caused abrasions, had it been there for long. Another alternative is that the flap, being bent backwards after the upper hinge had come off, has partly risen upwards on the pin of the lower bearing due to the flow of water. If this was the case, there has been a gap between the lower edge of the flap and the base of the lower bearing pin.

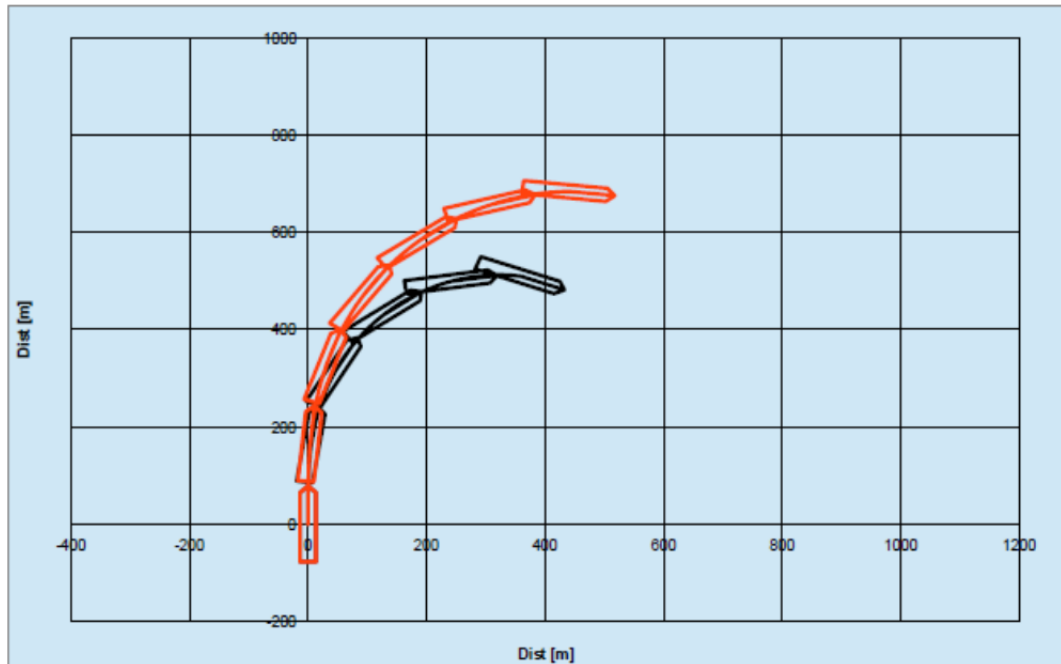
Figure 13. A simulated turn of 90 degrees with a 35-degree rudder angle. The effect of the damaged rudder has been illustrated by using the red trajectory. (Photo: Simulco Oy)

The vessel's simulated trajectory with an intact flap rudder (black) and with a damaged rudder without a flap (red) can be seen in Figures 13 and 14. For example in the turn circle test the difference is clear, but during the first minute of the test (vessel symbol drawn with the interval of 30 seconds) the difference has not developed. In a similar way, the differences were minor in the initial stage of the yawing test, even though the damaged vessel used much more fairway space for manoeuvring. On the basis of the simulation results it can be concluded that in normal channel navigation the effect of the damaged rudder on the manoeuvring may go unnoticed, especially if weather conditions, wind and current have an effect on the behaviour of the vessel.

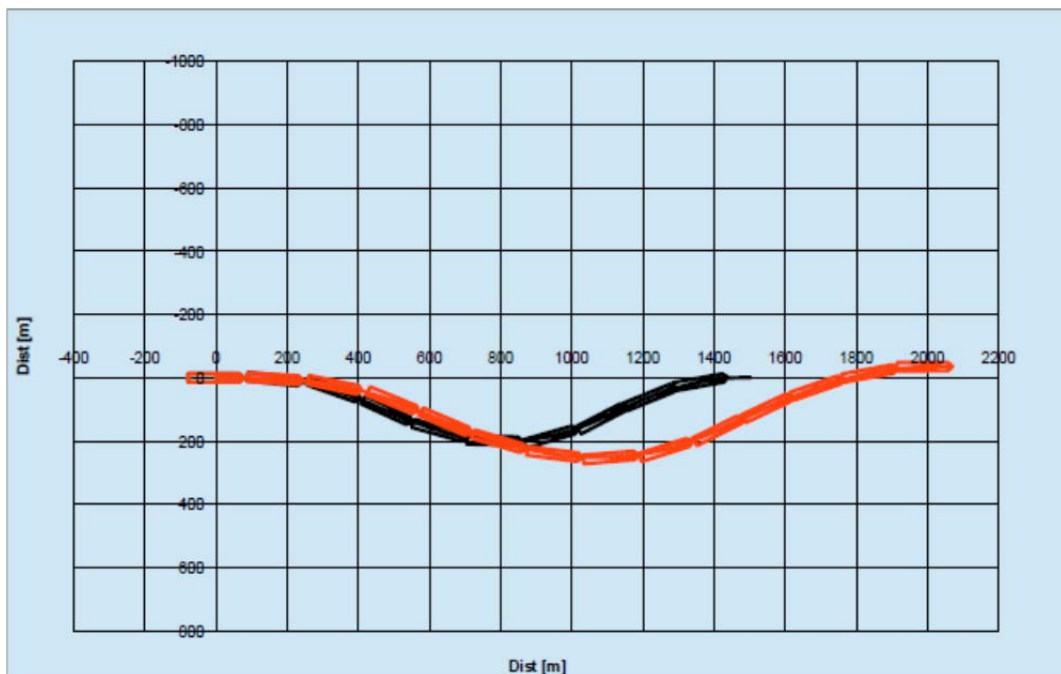
Figure 14. A simulated yawing test using a 20-degree rudder angle. The effect of the damaged rudder has been illustrated by using the red trajectory. (Photo: Simulco Oy)
