M2014-E1

Report on preliminary investigation

M/V Lady Hester (NL), ground touching and grounding in Ruotsinsalmi channel off Kotka on 5 December 2014

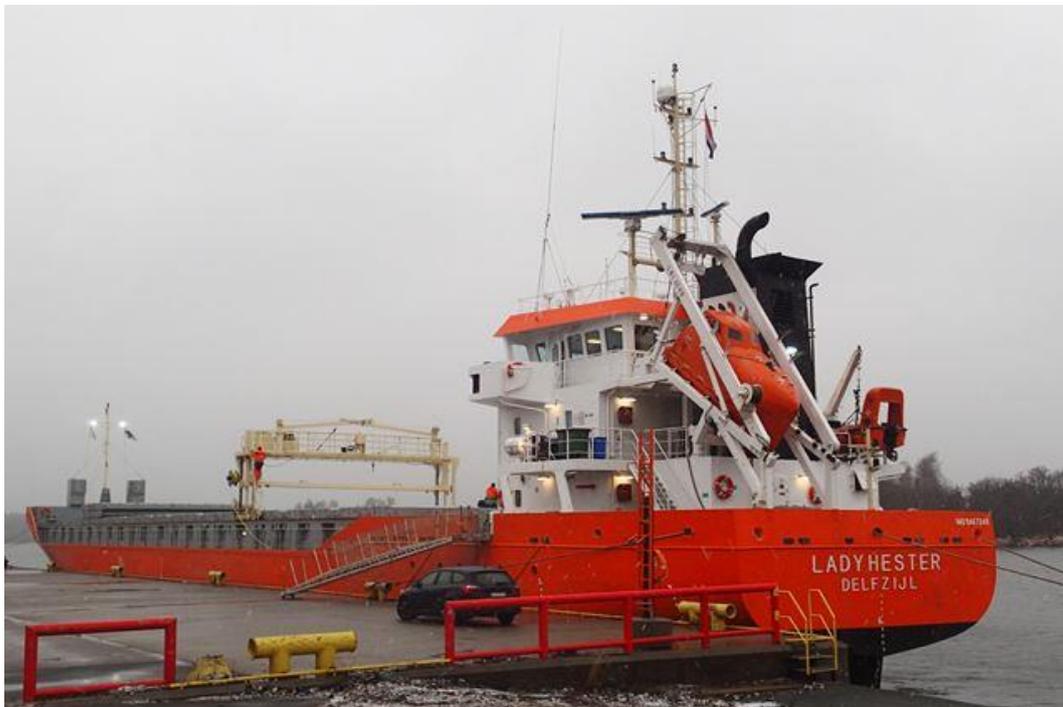
Figure 1. M/V Lady Hester (The Safety Investigation Authority, Finland)

Damages to the vessel	Damages in propeller blades, dents and scratches in the bottom of the vessel and on the starboard side of the bilge keel for the length of the entire vessel, bends in the frames of the double-bottom tanks.
Other damages	No damages to persons or the environment

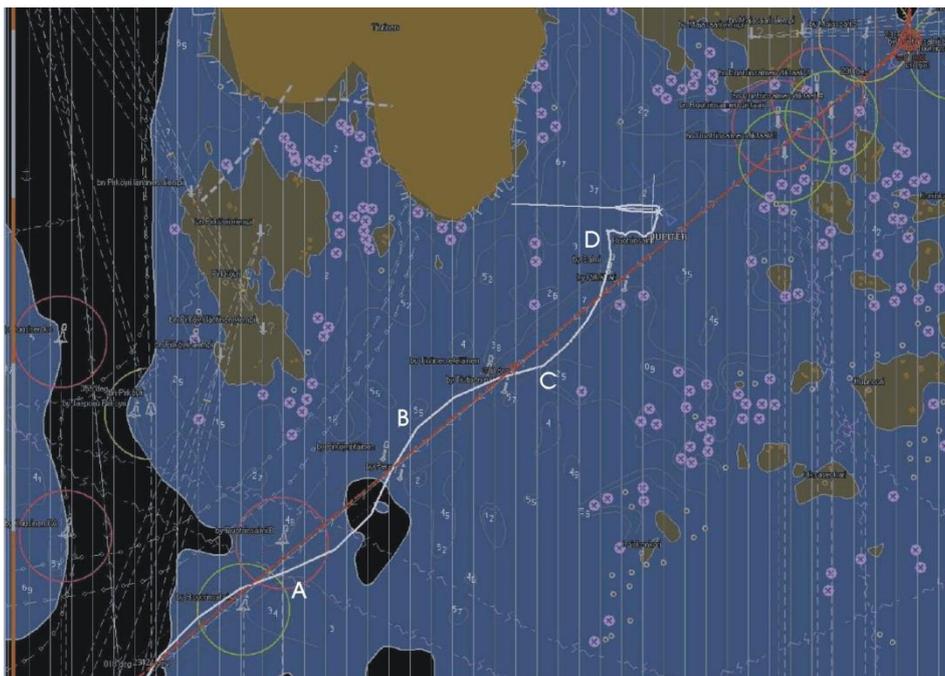
Figure 2. Screenshot of M/V Lady Hester's route from vessel's Ecdis. The stages of the incident have been marked on the picture with letters.

It was difficult for the Master to understand the pilot's manoeuvring order on how to steer between the first two buoys, which made the vessel drift south of the channel after she had passed the first green buoy (Figure 2: A). Because of these difficulties, the Master asked the pilot to give the manoeuvring orders as compass courses. By using the given course the vessel was able to pass the following red buoy and steer between the first pair of spar buoys. The correcting manoeuvre had, however, been so large with regard to the channel alignment and breadth that after the first pair of spar buoys the vessel drifted to the north side of the channel (Figure 2: B).

The visibility was so poor at the first pair of spar buoys that the unlit green spar buoy only became visible at midships when the vessel was passing it. The buoys and spar buoys further off could be seen on the radar, but the closest ones disappeared in the adjacent shadow zone and sea clutter, which meant that navigation was mainly based on the vessel's Ecdis display and the pilot's portable electronic chart device. The vessel was still able to navigate through the next buoy and spar buoy pair after which she suffered from ground touching on the south side of the channel at 06.40 (Figure 2: C). The speed of the vessel was approx. seven knots when she touched the ground.

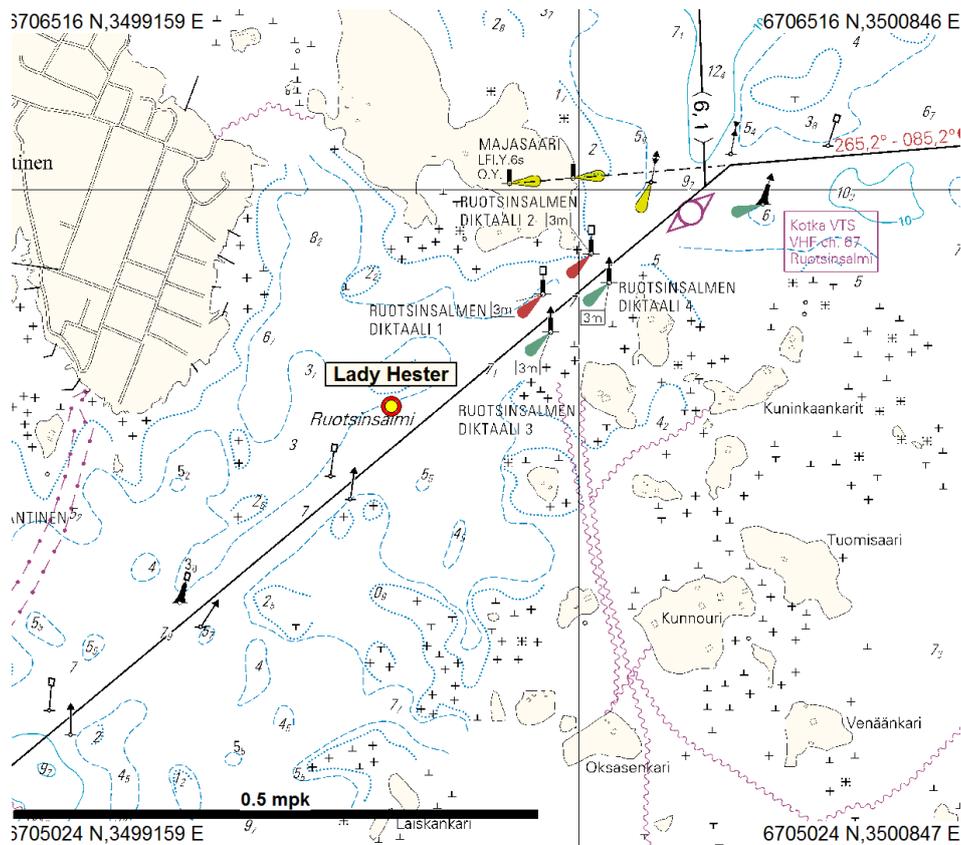
Figure 3. The Ruotsinsalmi 6.1 metre channel (The Finnish Border Guard)

The Ruotsinsalmi channel is a merchant shipping channel of class 2, and only some of the navigational aids are lit in the channel. The breadth of the narrowest parts of the channel is approx. 50 metres, and the distance between the spar buoys is a few hundred metres. According to the pilot's opinion, safe navigation in the channel requires a visibility of at least one nautical mile, optical observation and precise rudder work with only minor course alterations. The pilot was of the opinion that the maximum vessel length suitable for the channel would be 120 metres.
