Drifting of container ship MV Priamos (AG) into shallows off Kotka on 12 September 2018

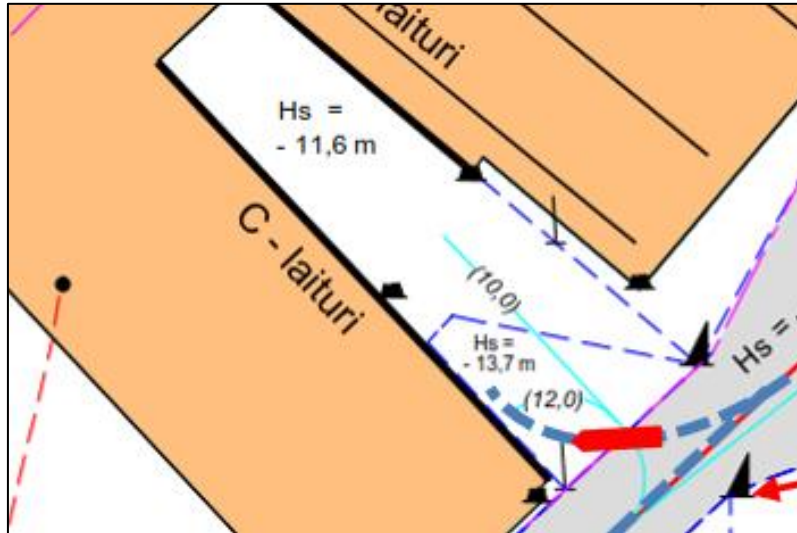
Picture 1. The planned turn of MV Priamos to the fairway. The red arrow indicates the ice buoy to which the vessel collided. The violet line shows the outer border of the boundary of the port water area. (Picture template: The Finnish Transport Infrastructure Agency, additions: SIA)

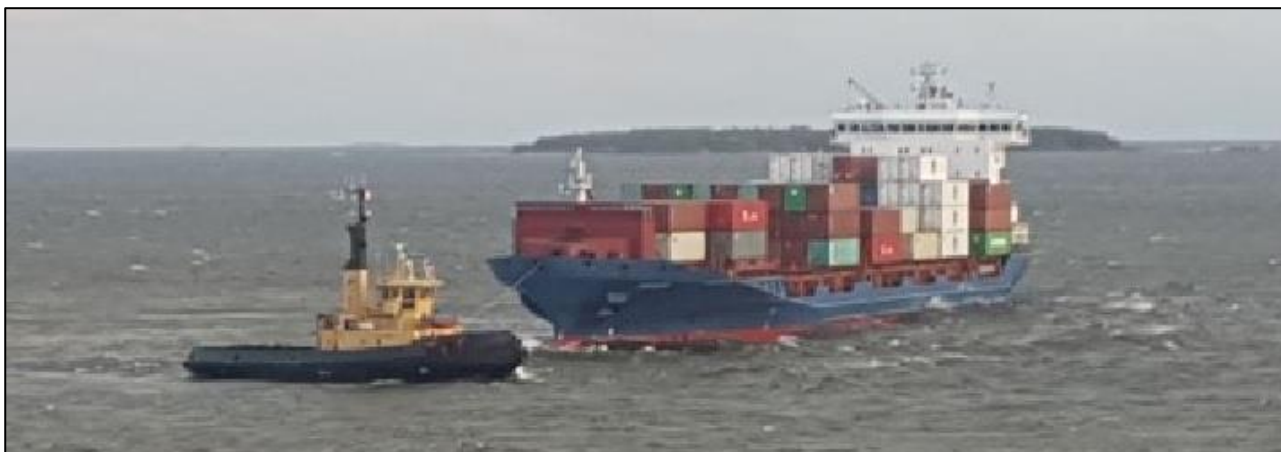
Picture 2. MV Priamos being towed by the tugboat Viikari on 12 September at 19:13hrs. (Photo: MS Seagard, Bore Oy)

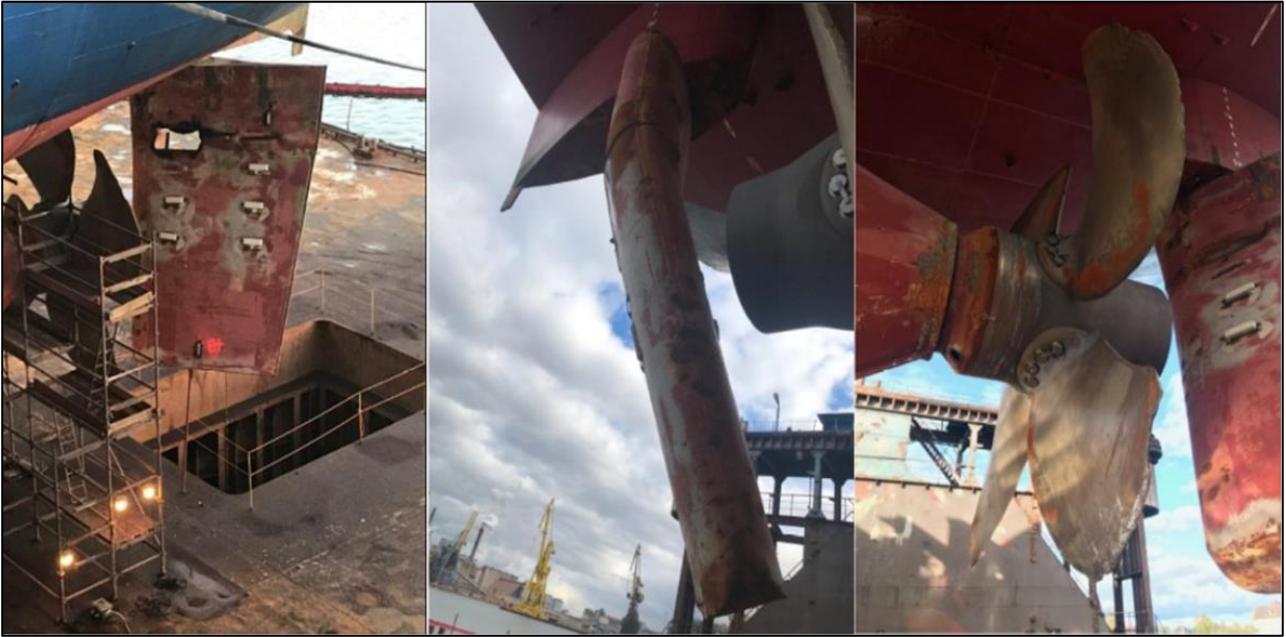
MV Priamos's rudder blade, rudder stock and propeller were damaged (Figure 4). The vessel's shell plating and bottom were dented. The vessel sprung leaks in its aft section and at midships in the ballast tank. After unloading, the vessel was towed to a dockyard in Gdańsk for repairs on 23 September.

Picture 4. The vessel's damaged rudder on the left, the bent rudder stock in the middle, and the damaged propeller on the right. (Photos: Leonhardt & Blumberg, Shipmanagement GmbH & Co. KG)

The Finnish Transport and Communications Agency⁹ conducted a Port State Control on MV Priamos on 13 September 2018 due to the incident, ordering the vessel to be towed to a repair dock for repairs. The vessel was unloaded before towing. Following the repairs, the vessel was taken back into service in mid-December 2018.

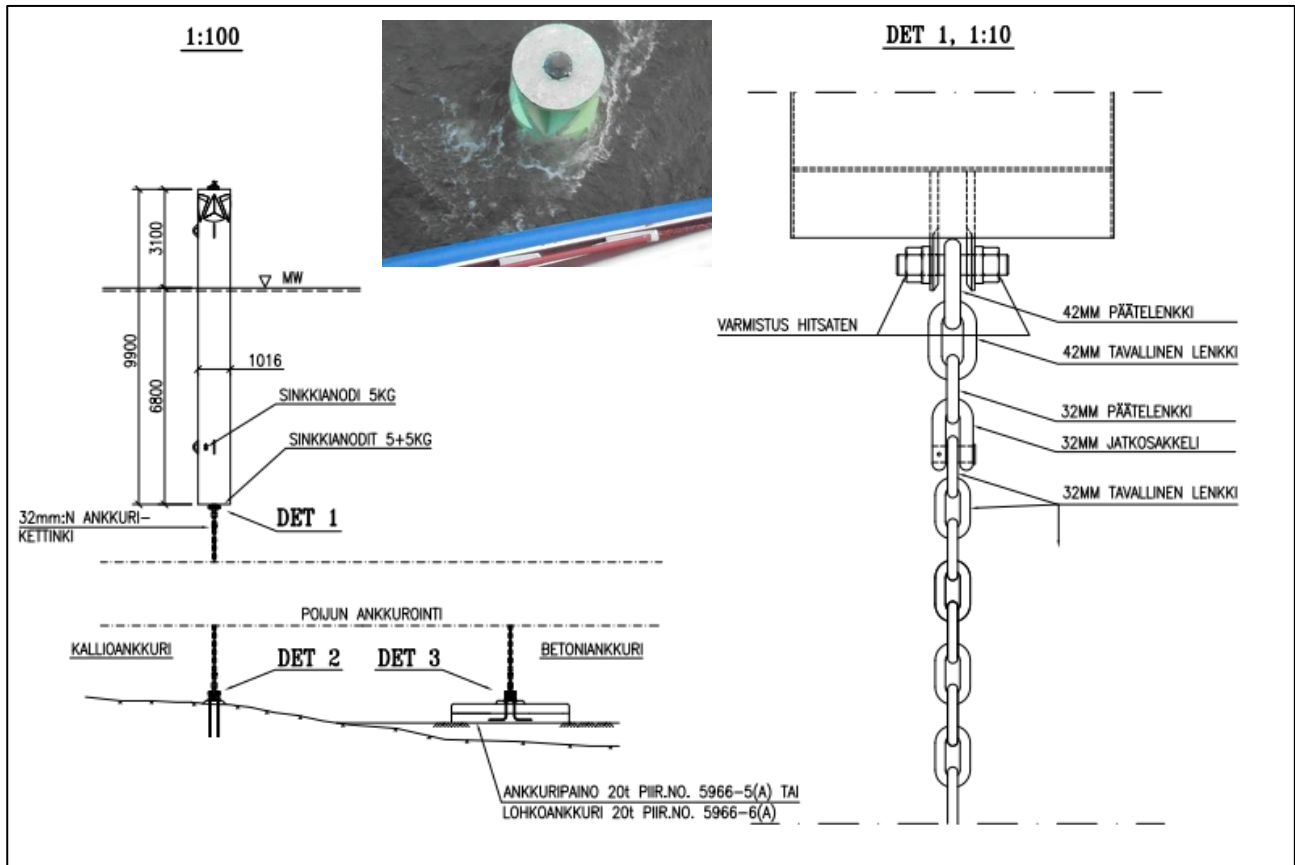
The green ice buoy was damaged beyond repair. It was flattened, it received a large hole to its side and its bottom part was torn open. The buoy's chain was cut (Figure 9). The buoy's anchor weight was dragged nine metres outside the navigation line. The weight's attachment to the buoy had become loose, so the old weight could no longer be used and it was left in place on the bottom of the sea.

Picture 9. The green ice buoy. Small picture is a photo taken by the second mate of MV Priamos. (Drawing: Finnish Transport Infrastructure Agency, photo: MV Priamos).

On 14 September, Meritaito Oy installed a light spar buoy in place of the damaged buoy. A new weight and buoy were installed on 18 September.

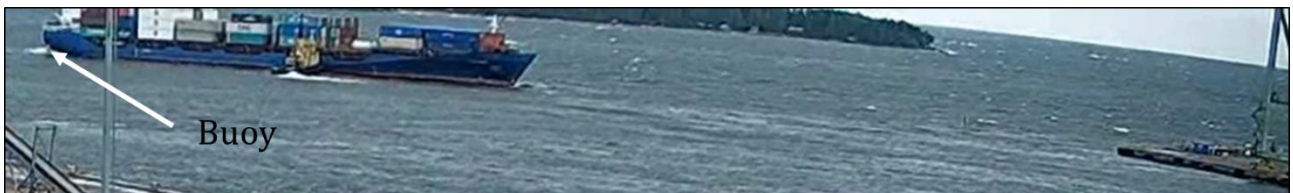
Picture 14. MV Priamos about to collide with the buoy at 18:42.25hrs. Quay C is on the right in the picture. The location of the green buoy restricts the turning space of vessels. (Screen capture from a video: HaminaKotka Port)

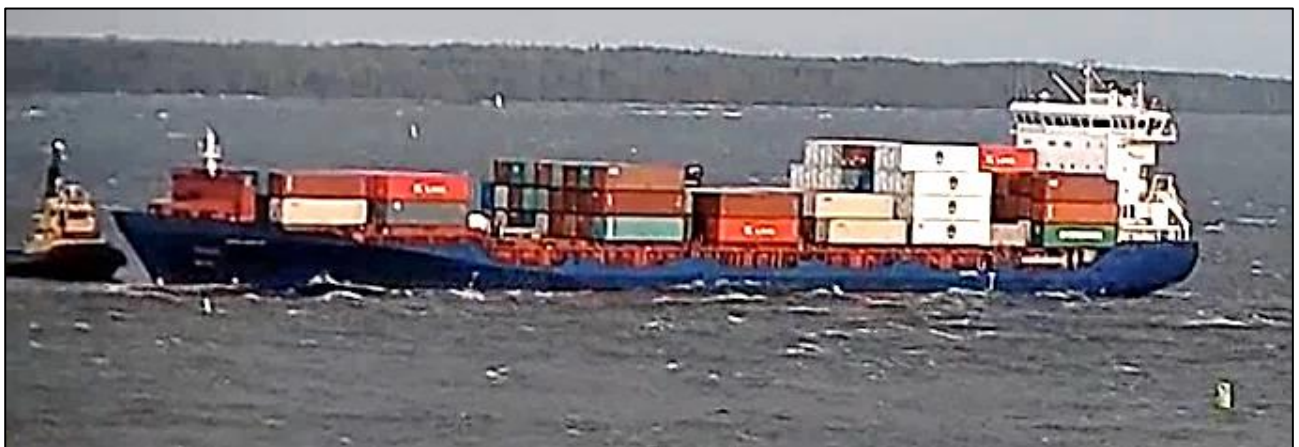
Picture 15. MV Priamos after drifting to the shallows. Tugboat Viikari can be seen on the left. (Screen capture from a video: HaminaKotka Satama Oy)

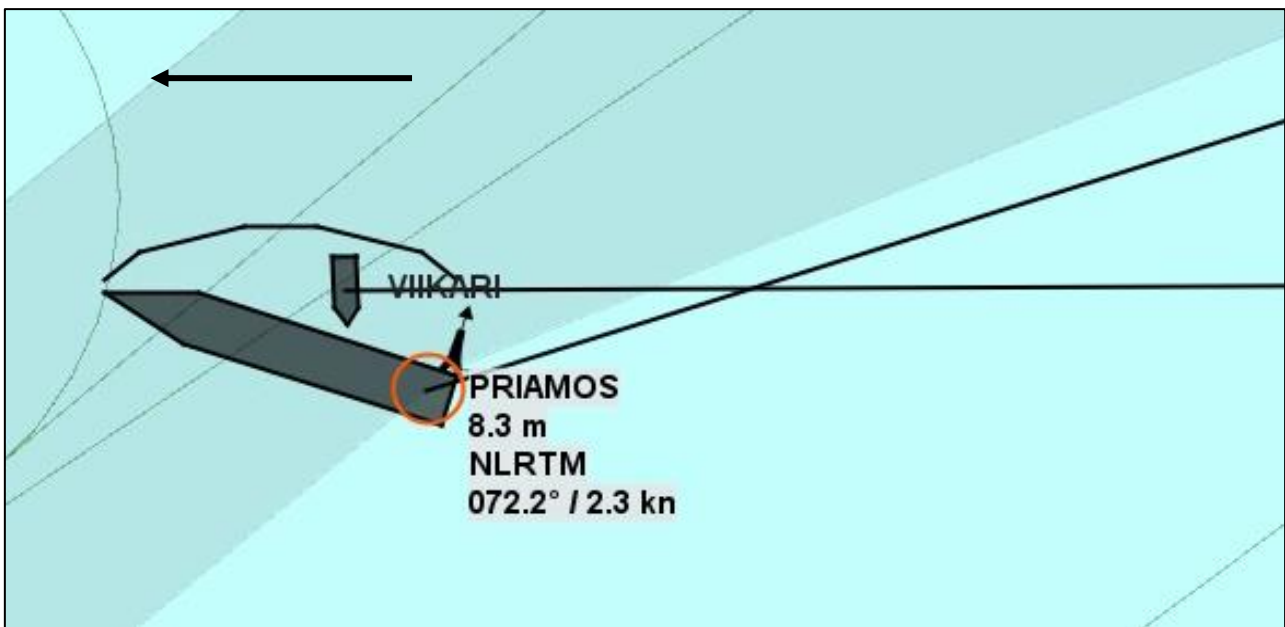
Picture 19. MV Priamos having overrun the buoy at 18:42.30hrs. Viikari's location in the image is only indicative. The pile shows the outer border of the area administered by the port. (Screen capture from a video: Finnish Transport Infrastructure Agency/VTS)

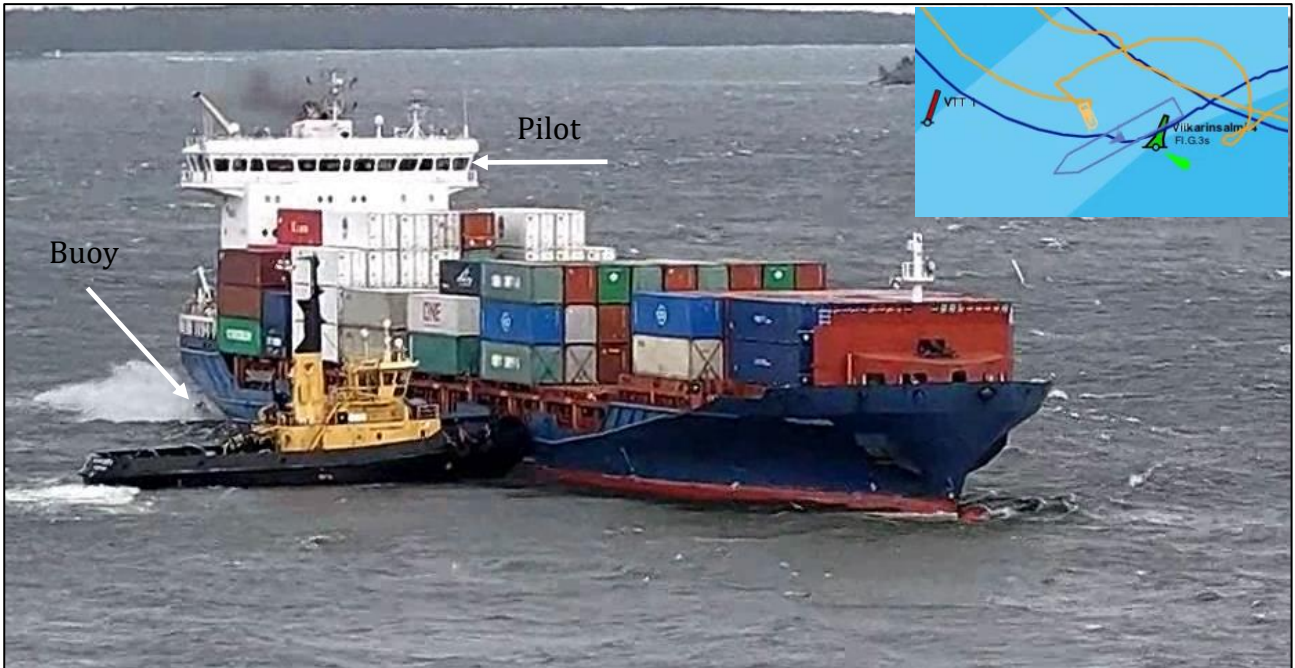
- 18:42.25hrs The right side of MV Priamos's stern hits the buoy, which goes under the vessel. Viikari's position starts to be more slanted towards the stern of MV Priamos.
- 18:43.30hrs The buoy that has come back to the surface hits the stern of MV Priamos again and goes under the vessel.
- 18:44.20hrs Viikari has disengaged from MV Priamos and moves to its other side.

Picture 23. MV Priamos having collided with the buoy at 18:42.36hrs. (Screen capture from a video: HaminaKotka Port). In the small image, Viikari is disengaging from the side of MV Priamos at 18:44.12hrs. (Screen capture from a video: Finnpilot AISLap)
