Landing gear failure during landing run at Oulu Airport on 3 October 2016

Investigation number: L2016-02

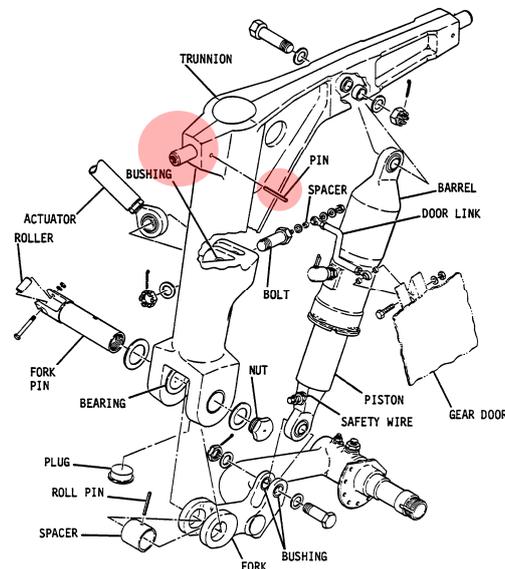
Kuva 2. Main landing gear, with the separated pivot pin and the securing pin used to lock it in place marked with a circle. The actuator rod attached to the landing gear is shown under the pivot pin. Picture: ASI Aviation

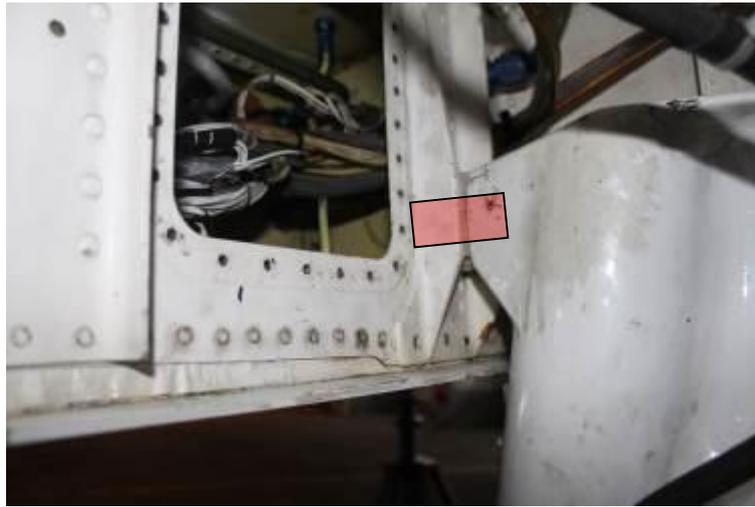
Kuva 3. Forward attachment point of the right main landing gear in place. The location of the pivot pin is shown by a red rectangle. The pivot pin is removed and fitted through an open access panel. Picture: Lapin Tilauslento Oy

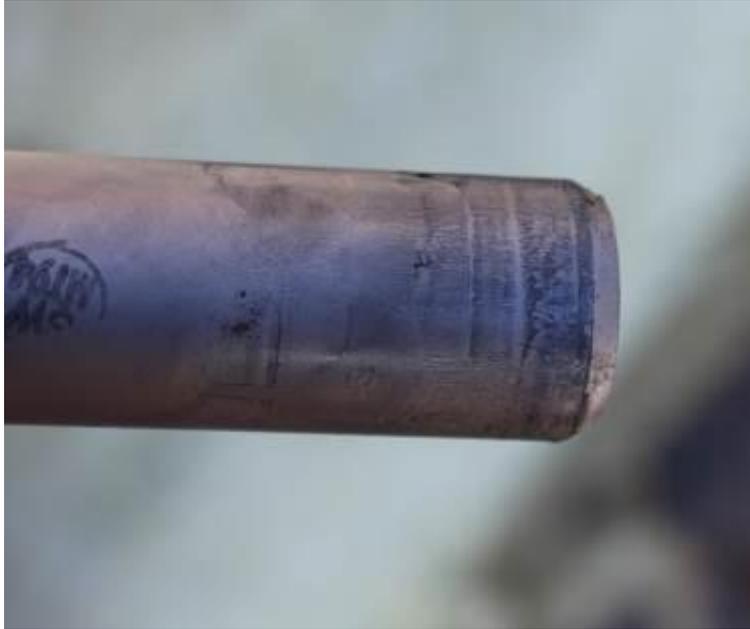
When the right landing gear was installed, the forward pivot pin was left too far forward so that the securing pin supposed to go through it was eventually behind the whole pivot pin. As a result of the incorrect installation, nothing prevented the pivot pin from moving forward and out of the gear trunnion. The securing pin was put in place and a safety wire was installed through it. According to the mechanic that made the installation, he used a punch tool to make sure that the securing hole for the pivot pin was in the right place. When positioning the pivot pin, he first noticed that the punch did not go through the pivot pin, and repositioned the pin by supporting the trunnion with the other hand and moving the pivot pin with a puller tool at the same time. The punch then went through the hole in the trunnion, from which the mechanic assumed that the hole was correctly positioned and fitted the securing pin. When removing the puller tool from the pivot pin, he did not support the gear trunnion, and because of greater friction it seemed that the pivot pin was locked in place.

In the aircraft inspection after the accident, it was found that the pivot pin in the forward attachment point of the right main landing gear had partly slid off its place. The landing gear was pivoted back during the landing run, held only by the aft attachment and actuator.

Kuva 4. The aft end of the right main landing gear forward pivot pin, photographed after the accident. This end is attached to the landing gear trunnion. Photo: Lapin Tilauslento Oy

The European Aviation Safety Agency (EASA) require the aircraft type certificate holder to review and update the maintenance instructions for Reims F406 aircraft, so that any deficiencies in main landing gear installation instructions are rectified. The landing gear installation instructions do not cover all necessary phases of work, and the order of phases is impractical in some places. The instructions provide no warning of the possibility of incorrect pivot pin installation. [2017-S26]

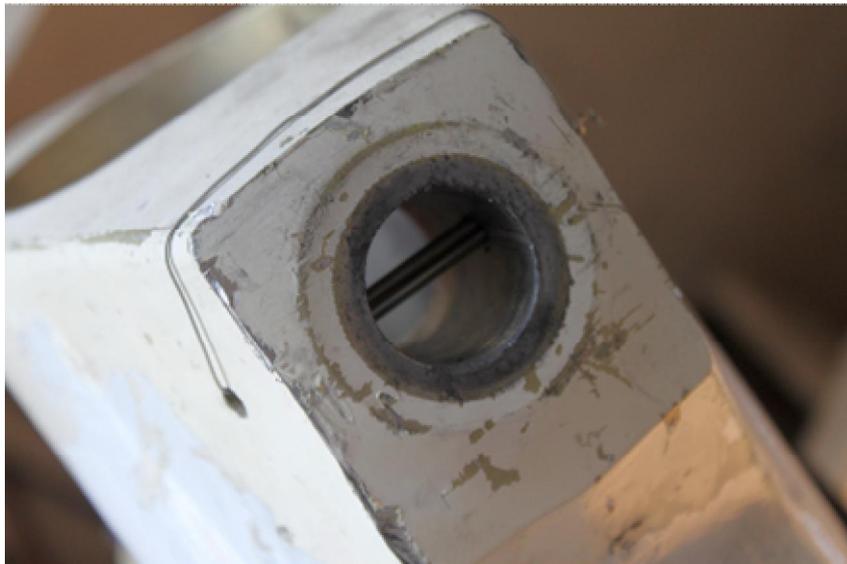
Kuva 5. The securing pin of the right main landing gear forward pivot pin in place after the accident. Photo: Lapin Tilauslento Oy
