Loss of Directional Control during Landing Roll at Turku Airport on October 25, 2017

SYNOPSIS

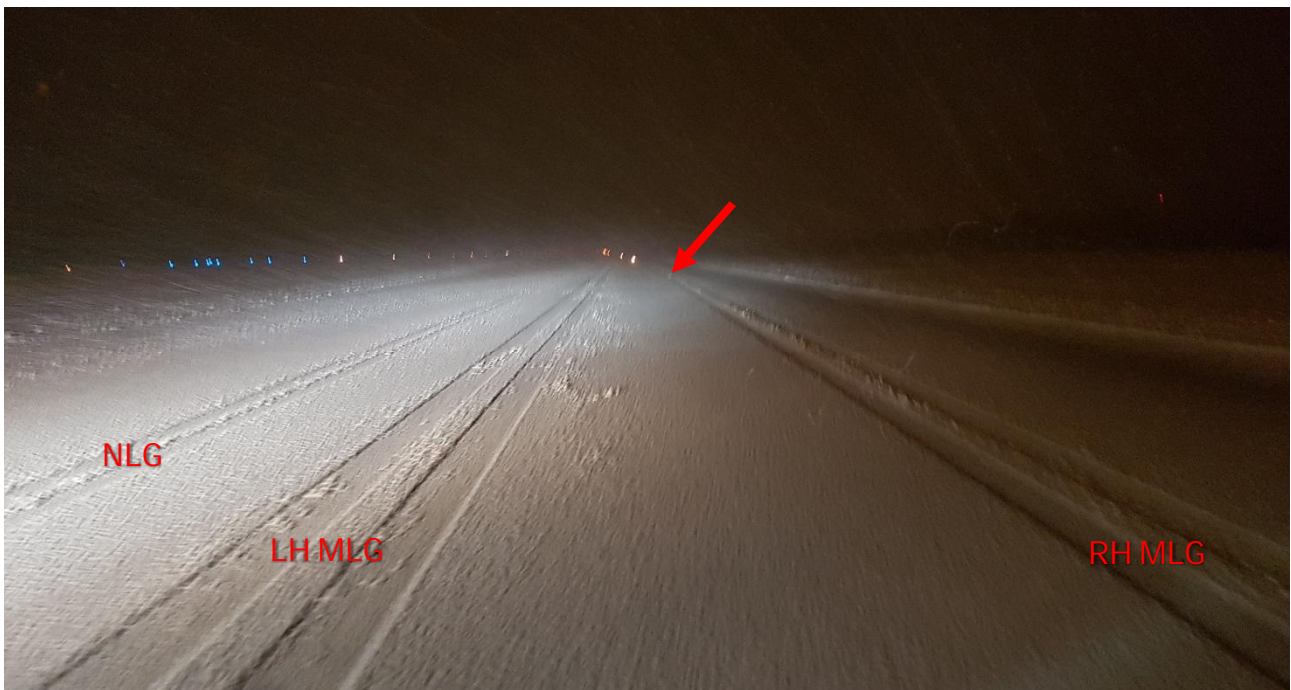
Figure 2. The tracks left by the left main (LH MLG), right main (RH MLG), and nose (NLG) landing gear as the skidding airplane was veering towards the runway edge lights, as seen approximately 35 min after landing. The red arrow shows the location of the first broken light. Intact lights are visible further down the runway in the center of the photo. (Photo: Finavia, annotations: SIAF)

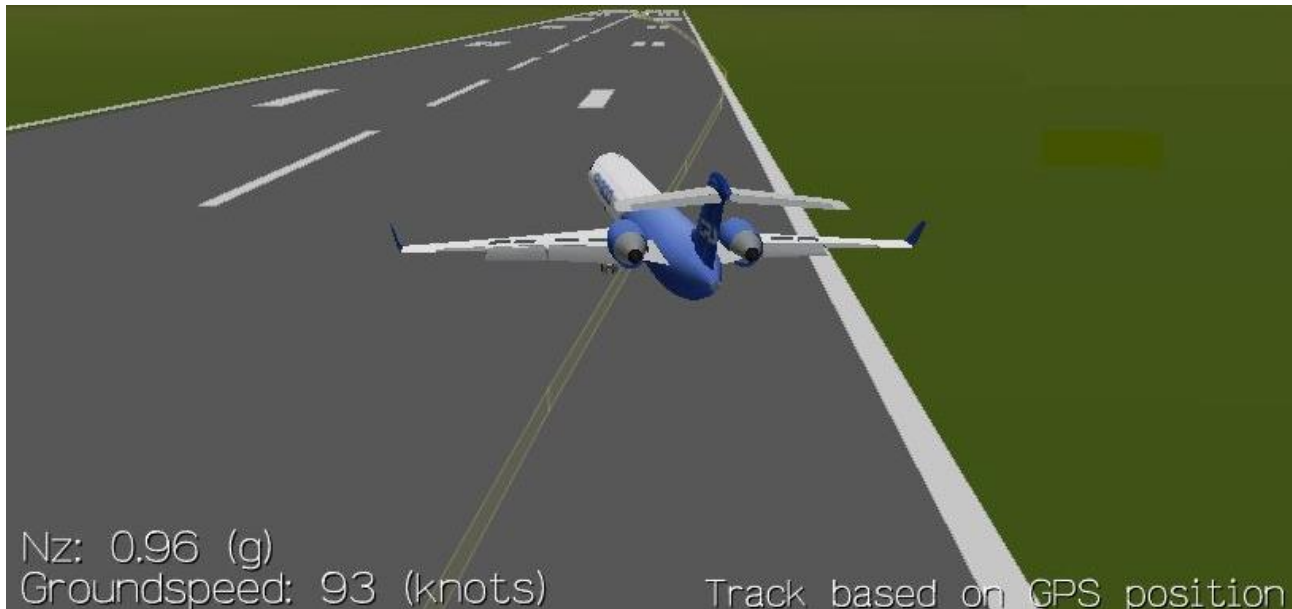
Approximately 1,200 m from touchdown, the skidding airplane began to veer to the right towards the edge of the paved area. It impacted and broke five runway edge lights. The minimum distance between the right mainwheel tires and the unpaved area was less than 0.5 m. The airplane then started to rotate to the left. When it was at right angles to the runway heading it was moving at 42 kt (78 km/h) groundspeed. It came to a halt next to the runway centerline 2,050 m from the initial touchdown point, having rotated 196° counter-clockwise from the initial direction of travel. The distance from the final position to the runway end was approximately 160 m.

Figure 3. A snapshot from the flight data recorder -derived animation shows the skidding airplane veering off the runway. At this point, groundspeed is approximately 170 km/h, and the airplane tracks as indicated by the yellow line that is based on the locations of GPS points obtained from the recording. The actual paved area extends beyond the white runway edge line, but this is not shown in the picture. The tires did not leave the paved area. (Photo: Insight™ ProView)

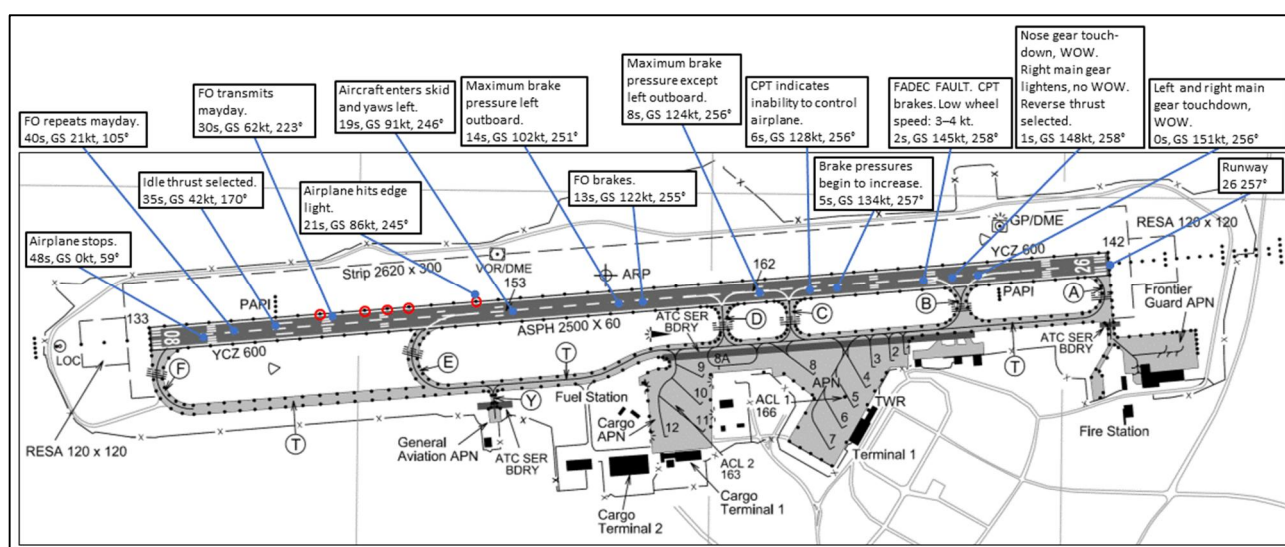
Figure 4. Significant events during the landing roll. The red circles indicate the broken runway edge lights. The bottom line(s) in each box indicates time from touchdown, groundspeed, and heading (WOW = weight on wheels, GS = groundspeed, CAPT = captain, FO = first officer). (Base map: ©ANS Finland Oy, overlays: SIAF)

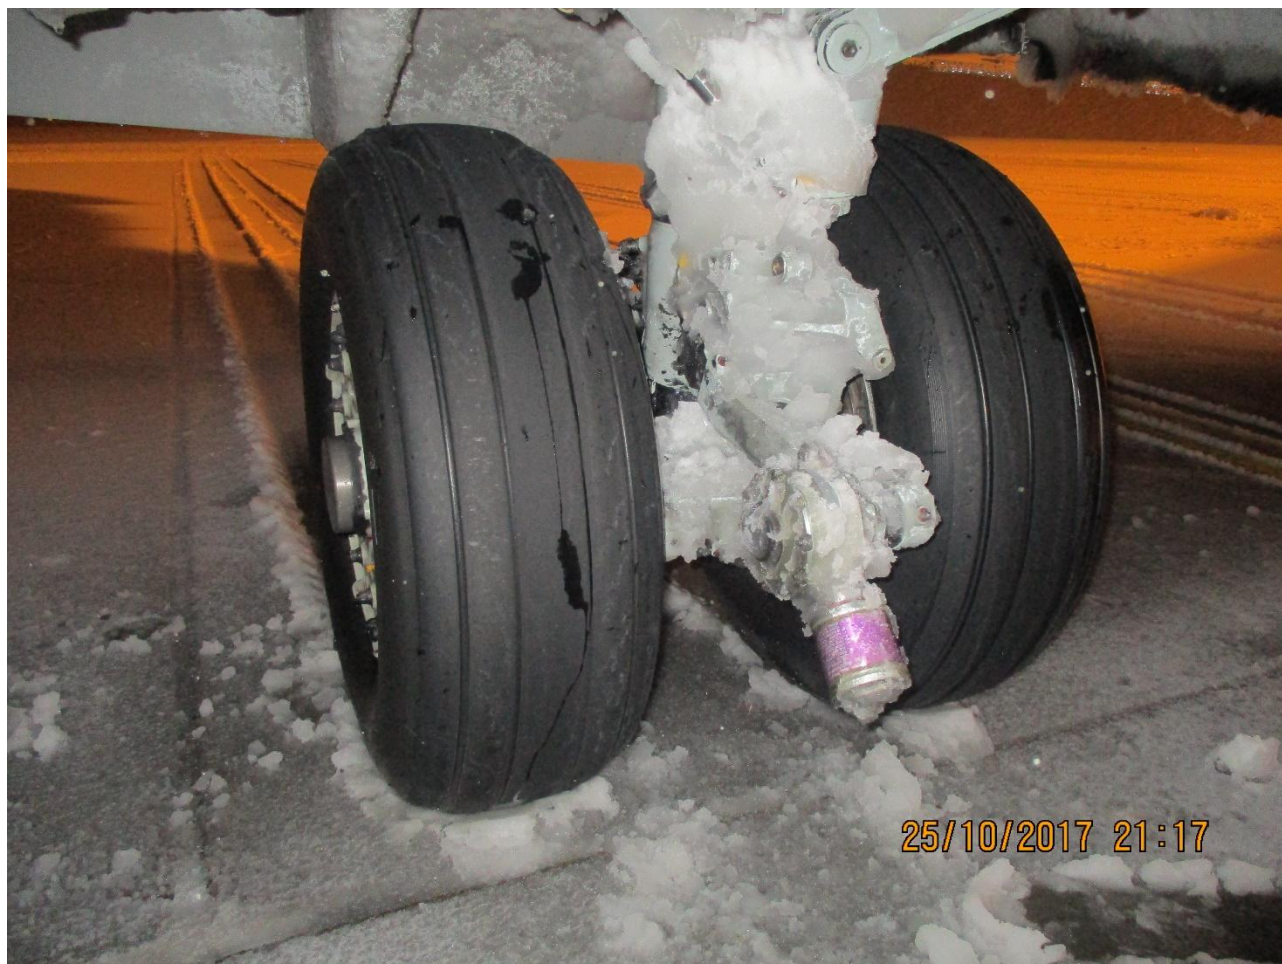
Figure 5. This close-up was taken on the apron approximately 50 min after landing. The airplane taxied into this position and stopped approximately 15 min after landing. No significant amount of fresh snow has fallen on the underwing areas, and by examining the track depth it can be estimated that the slush was over 10 mm deep at the time of the landing. Ground temperature expedited the transformation of snow into slush. (Photo: Police)

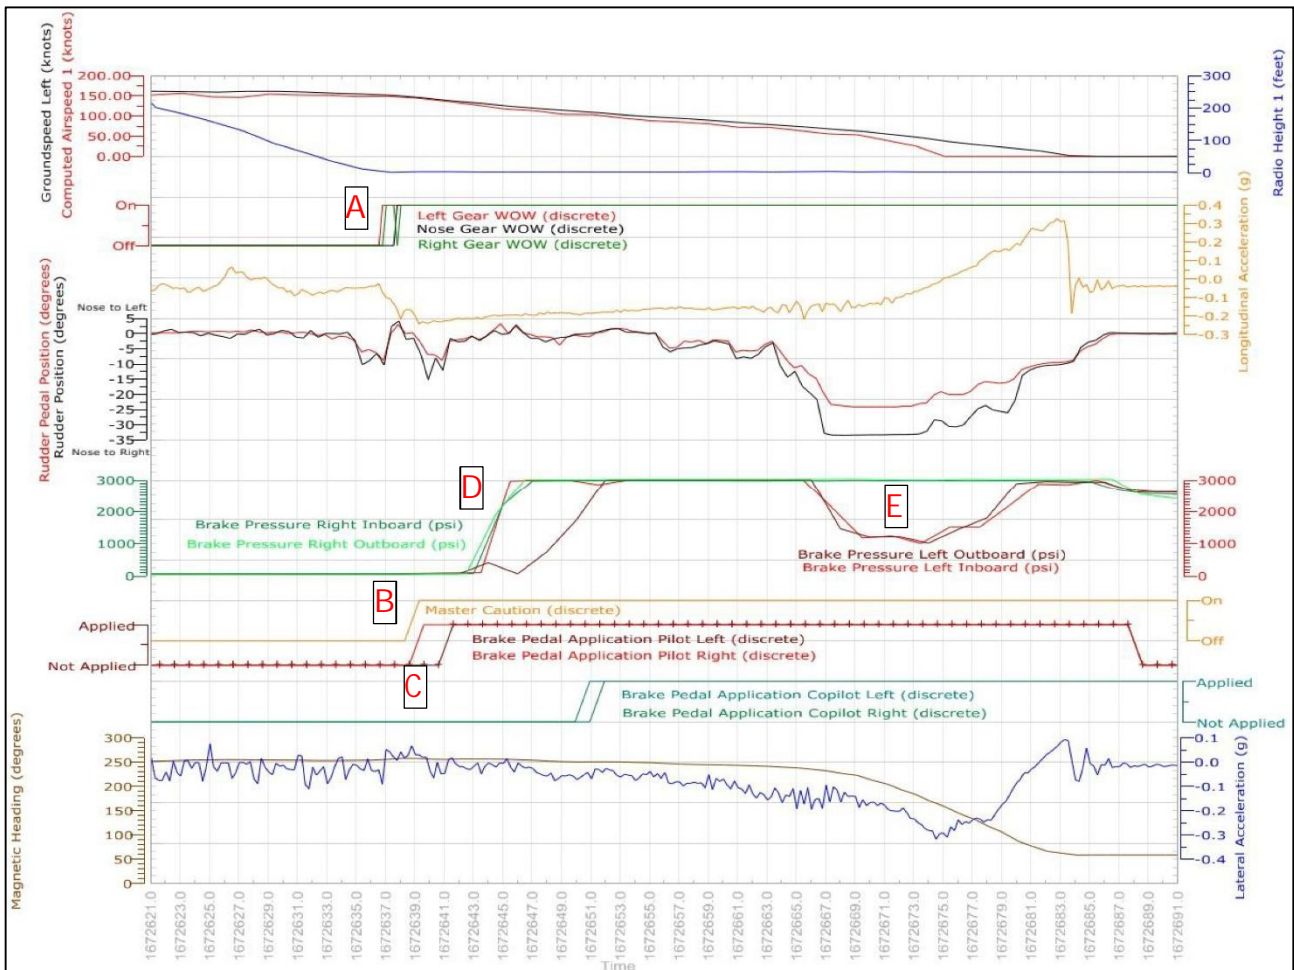
Approximately 1 s later, load on the right main gear lightened sufficiently for the logic to record "air." This condition lasted for 0.25 s (Figure 8, A). The tire did not necessarily rise off the runway, but the oleo extension (0.47 g) that followed the firm (1.95 g) landing may have reduced the load on the tire to such an extent that "air" was recorded. Nose gear touchdown occurred at the same time.

Manual brake pedal application (Figure 8, C) was recorded simultaneously with the master caution. Brake application is not shown in FDR graphs until brake pressure increases to 500–800 psi so light braking and even many normal brake applications remain unregistered. However, pressure in the brake units did not increase despite brake application (Figure 8, D) due to the operation of the touchdown protection logic that is designed to guard against wheel locking on touchdown. The logic prevents pressure increase in the brake units until wheel speed is over 35 kt or the WOW sensors record "ground" for more than 5 s. Brake pressure started to rise (Figure 8, D) after approximately 5 s from the first "ground" signal from the WOW sensors.

Figure 8. Flight data recorder parameters (Photo: FDR time history trace / Bombardier, overlays SIAF)

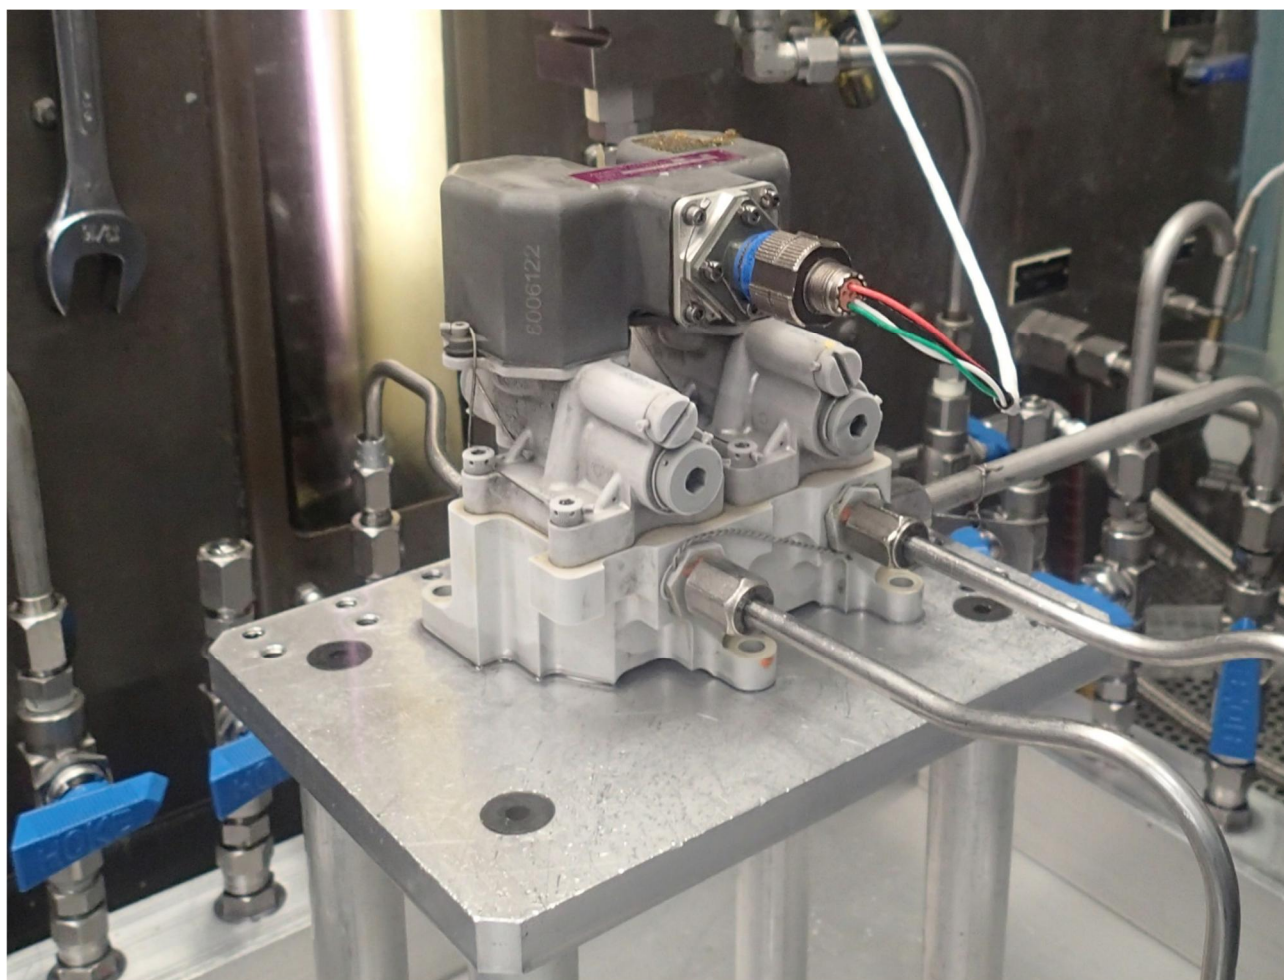
Figure 12. A cooled-down anti-skid control valve unit on the test stand (Photo: SIAF)

A total of 56 parameters were measured during testing on the two ASCV units and their two brake ports. Five parameters showed deviations from the limits set for a respective new production component. The deviations were related to hysteresis between the input signal current and the brake pressure gain at 500 psi and to the elapsed time between the input signal activation and the transient brake pressure response. The deviations were not significant and are commonly found during the testing of returned components. One deviation was observed during testing on the brake port for the left outboard wheel since it showed an anomaly in pressure gain on brake application during the landing roll. The elapsed time from the input signal activation to the start of the pressure drop at this port was 0.0118 s, while the maximum requirement is 0.010 s.

The ASCV tests showed no anomalies that could have contributed to the observed inconsistent performance of the brake unit on the left outboard wheel.

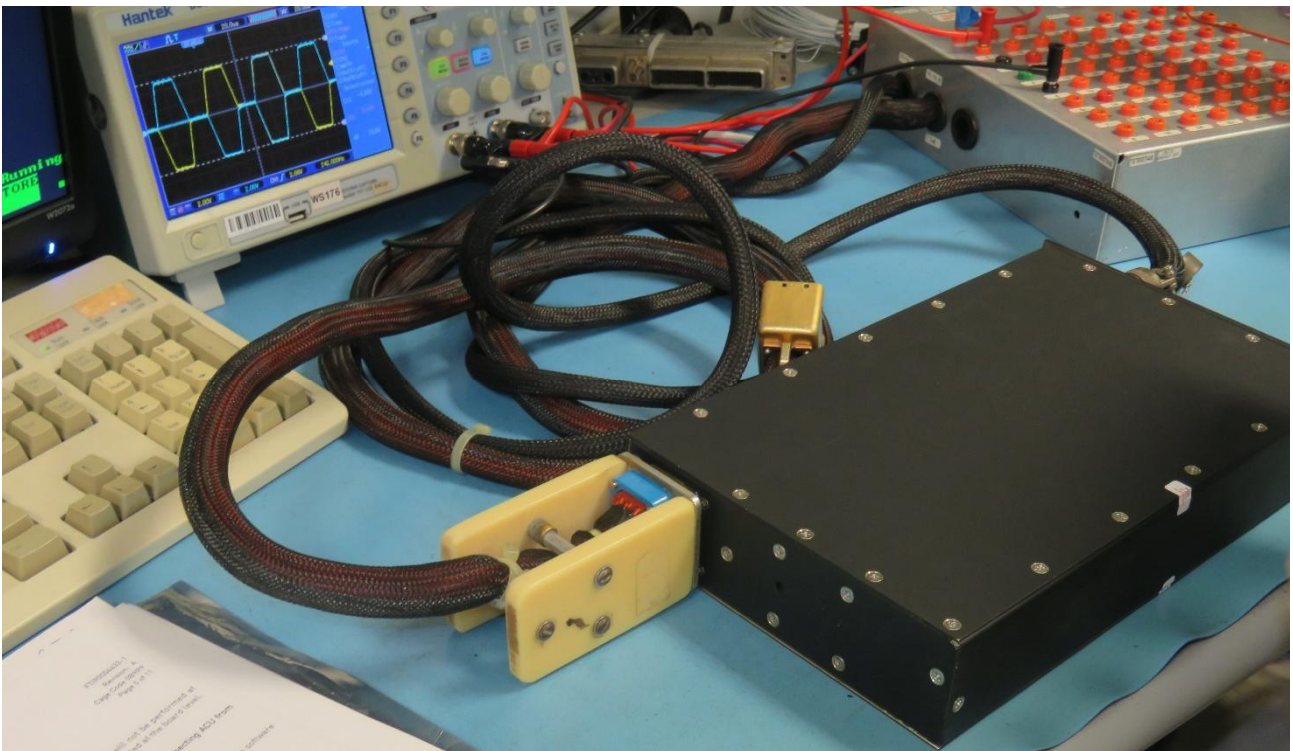
Figure 13. The anti-skid control unit under testing (Photo: Projects Unlimited Inc.)

The ASCU was subjected to functional validation that is done on returned or overhauled units. The validation plan calls for the sequential testing of the ASCU functions. These tests were repeated after temperature soaks at -40 °C and +70 °C. One failure occurred during the testing after the heat soak and was related to the test signal for the left outboard wheel brake. The anomaly was traced to a pin in the test connector that is only for ASCU test purposes and software uploads and updates and is not used on in-service aircraft. After cleaning the connector, the ASCU passed functional testing.

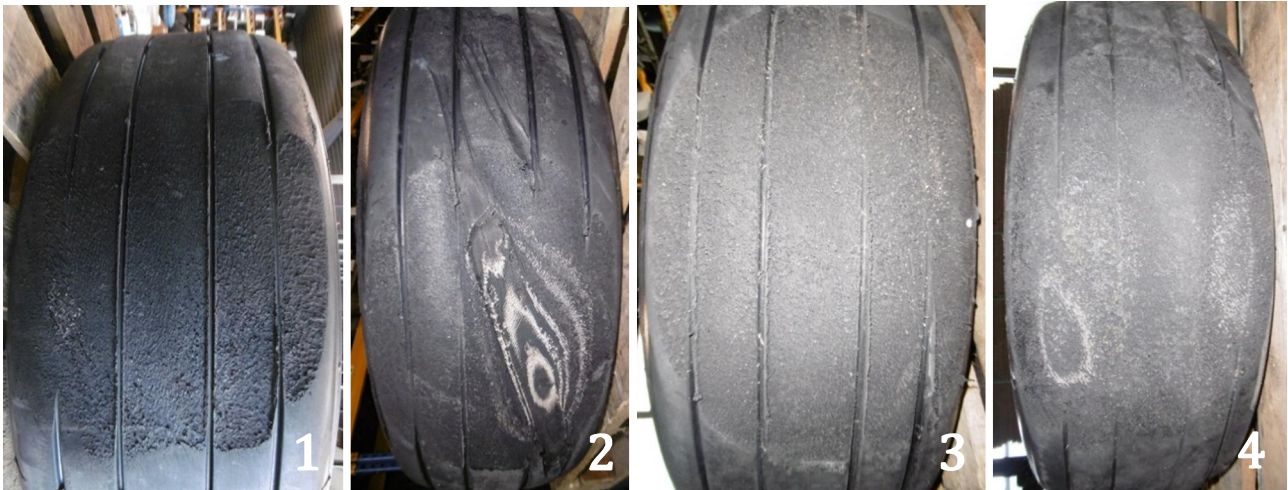
The occurrence did not result in injuries. The mainwheel tires of the airplane exhibited wear due to wheel locking and hydroplaning and were rendered unserviceable. They also sustained damage by impact with the runway edge lights. The airplane remained at Turku for five days for damage assessment, inspections, and component replacement and departed on October 30, 2018. Indirect costs were incurred due to the airplane's removal from revenue service and because some components had to be replaced with leased spares during inspection and investigation. Five runway edge lights were broken and had to be replaced.

Figure 14. Damage to the mainwheel tires. The tires are arranged to correspond to their position on the airplane as seen from the rear. (Photos: CityJet)

Tracks on the runway and snow were used to determine the sequence in which the tires struck the runway lights. Tire #3 broke the first light, tire #2 struck the three next lights, and tire #4 contacted the fifth light.

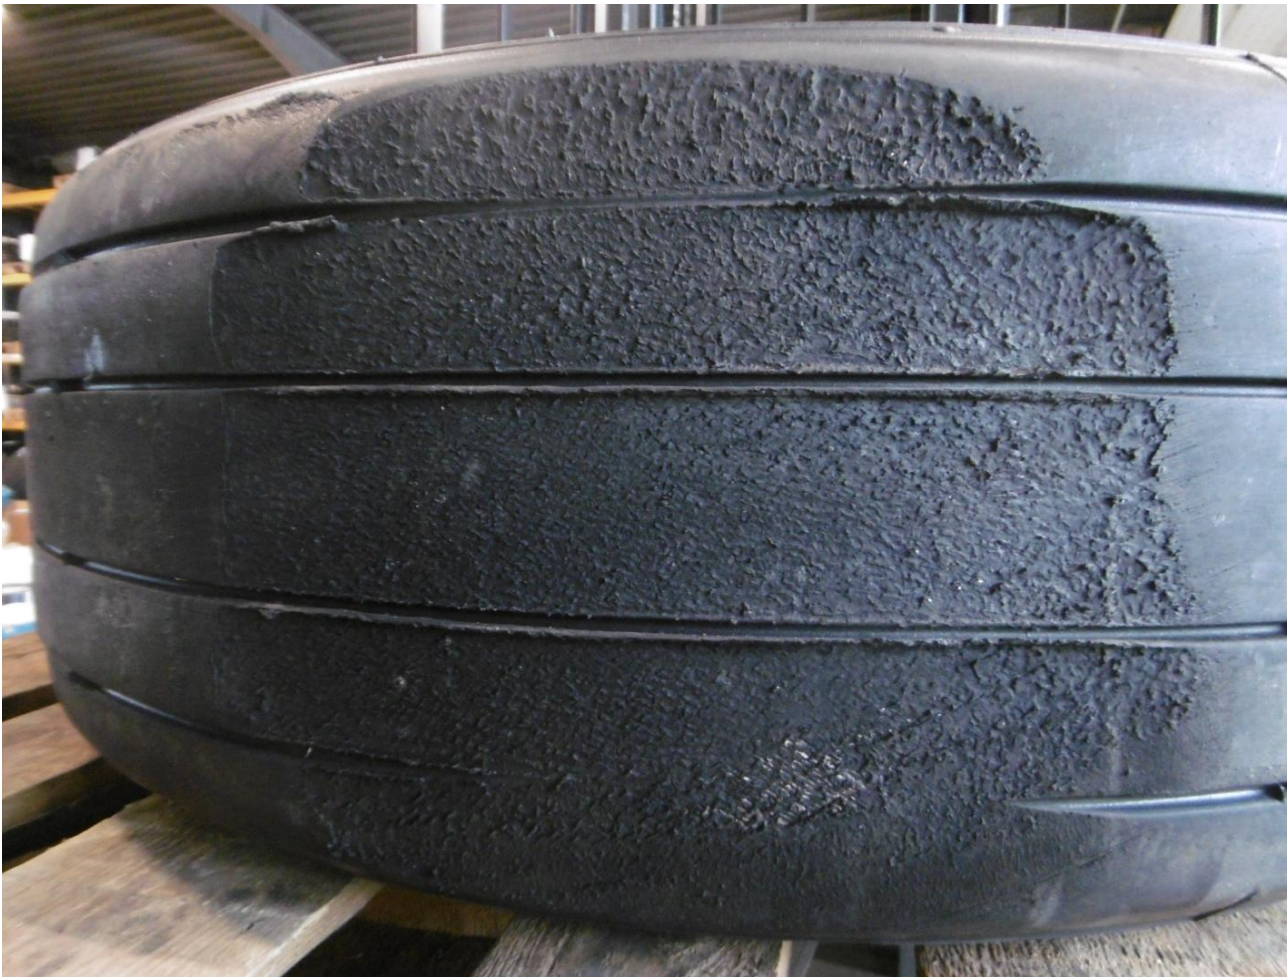
FDR and FADEC data show that the wheels barely started to rotate on touchdown. Wheel speed after approximately 2 s from touchdown was 0–3.4 kt, while the airplane was at that point traveling at approximately 150 kt groundspeed. After approximately 5 s from touchdown, the brake pressures started to increase, and the wheels locked. They subsequently remained locked over approximately 2,050 m, or for almost the entire length of the landing roll. Since none of the tires deflated, friction between the tires and the runway remained extremely low throughout the landing roll.

Figure 15. Mainwheel tire #1. Evidence of reverted rubber hydroplaning is apparent on the tread. The tire did not contact the runway edge lights. (Photo: CityJet)
