REPORT

SL 2019/08

REPORT ON AIR ACCIDENT 10 KM NORTH-WEST OF GRIMSTAD, AUST-AGDER COUNTY, NORWAY ON 21 JUNE 2018 INVOLVING HUGHES HU 369 D, OH-HNX, OPERATED BY HELIWEST OY

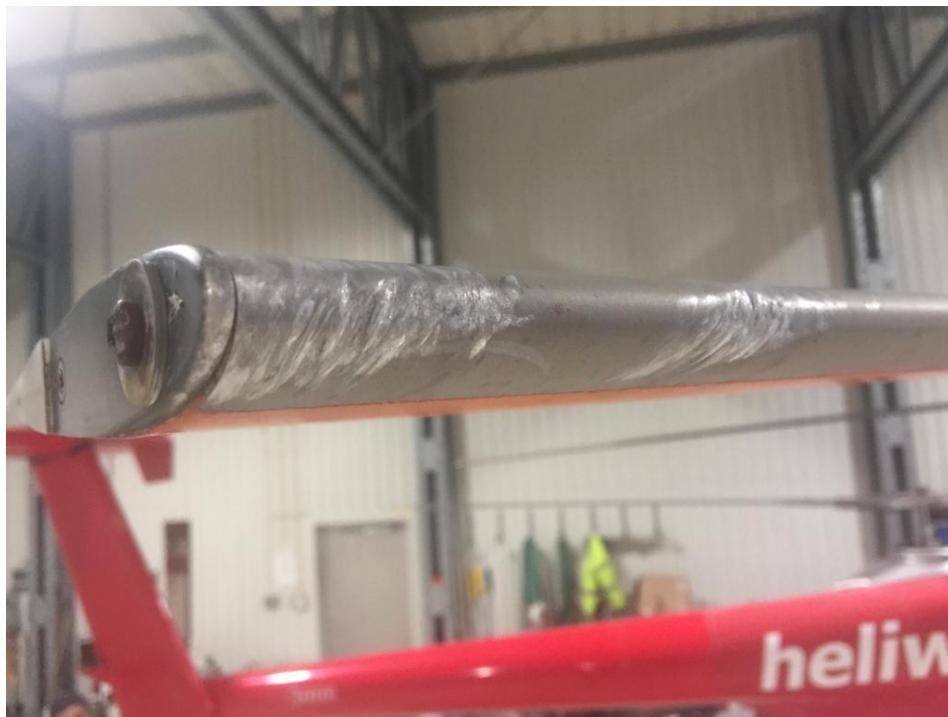
- 1.1.8 Closer investigations of the helicopter revealed damage to the tips of three rotor blades. It became clear that the helicopter had cut all three conductors in a 132-kV power line belonging to Agder Energi Nett.

Damage to the tips of three main rotor blades meant that all five main rotor blades had to be replaced. The damage to the main rotor also resulted in extensive replacements and overhauls of components in the main rotor, the main rotor transmission and the engine.

Figure 1: The damage to the tip of one of the rotor blades. Photo: Heliwest

- 2.2.2 The power line consisted of three thick conductors. At a speed of 80 – 100 km/h, any contact between the conductors and the helicopter will normally entail significant damage to the helicopter and loss of control. The fact that the helicopter did not crash in this instance was due to the conductors being struck by the very tips of the main rotor blades. Rotation speed at the tips is approx. 743 km/h. When the rotor hit the conductors, the relative speed between the blade tips and conductors was 823 – 843 km/h. This meant

that the rotor blades had enough kinetic energy to cut the conductors without the rotor system sustaining immediate critical damage.

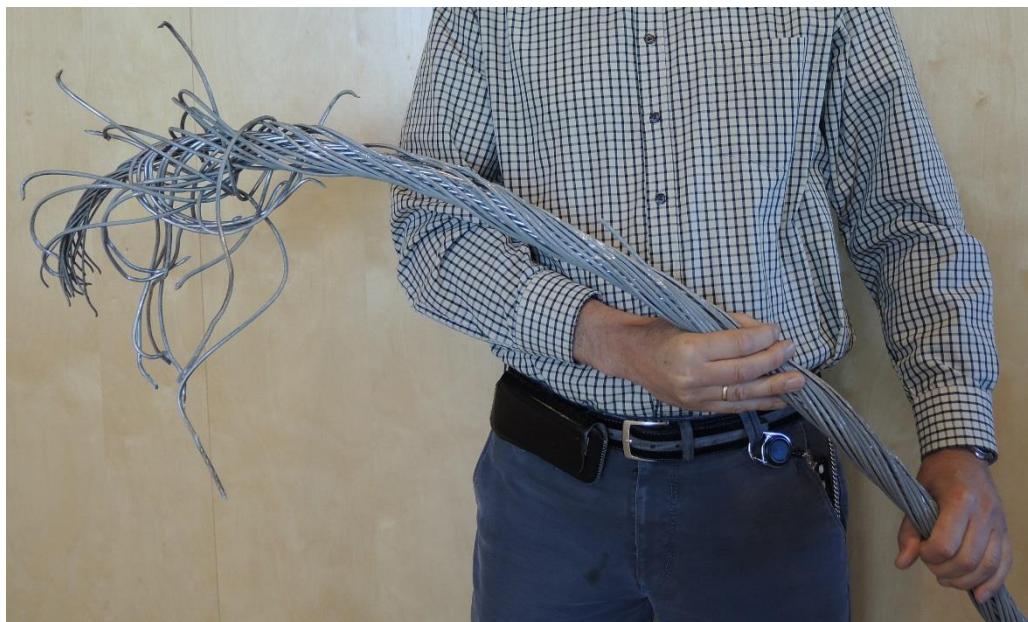
- 1.4.1 All three conductors in the 132-kV line belonging to Agder Energi Nett were cut. Each line was 30 mm thick and consisted of a 10 mm thick spun steel core wrapped in aluminium strands.

Figure 2: The end of one of the live conductors that was cut. Photo: AIBN

- 1.4.2 The line was part of a "ring structure", which is why no customers lost power. According to Agder Energi Nett, splicing of the just over 500 m long air span was resource-intensive and complicated.

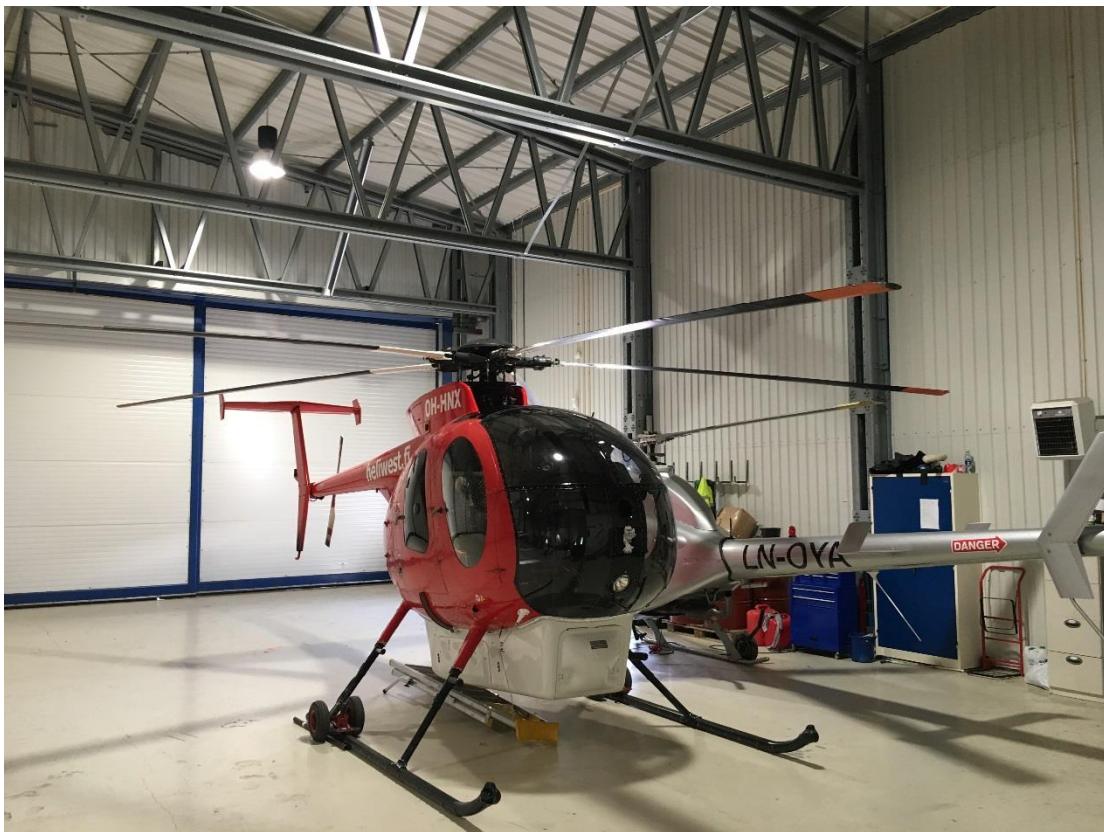
Figure 3: The helicopter photographed in the hangar at Gullknapp the day after the accident. The inspection equipment is mounted in the white pod under the belly of the helicopter. Photo: Agder Energi Nett

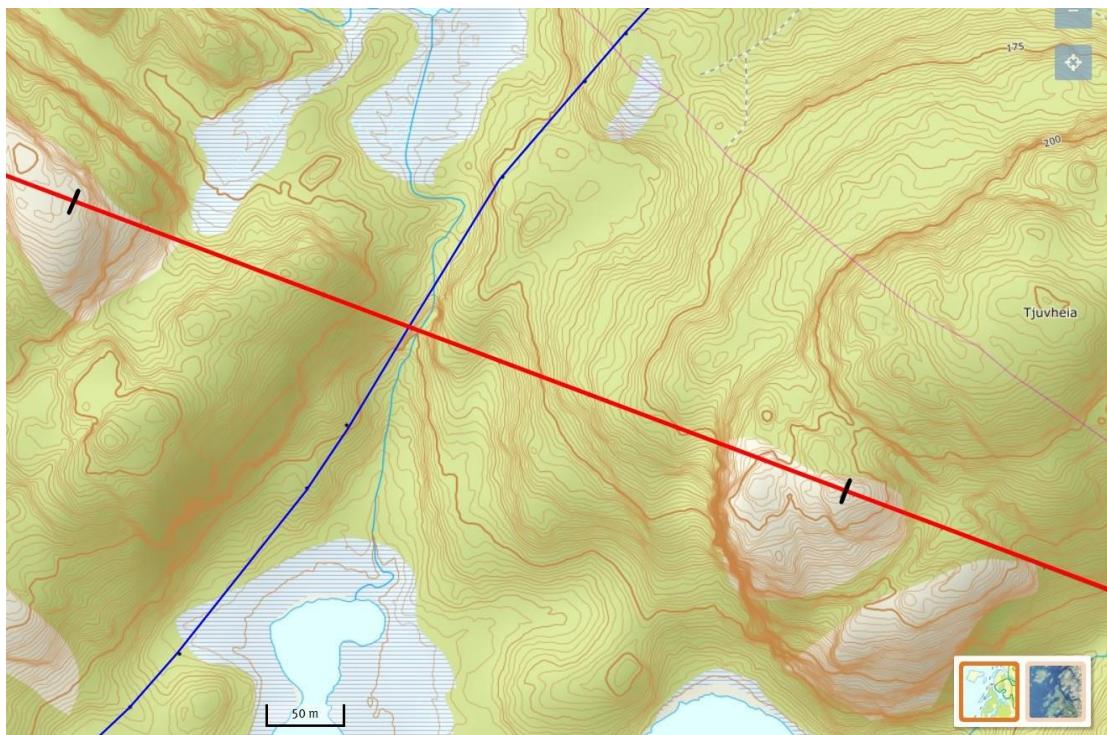
discovered a crossing power line at the same altitude as the helicopter and immediately effected an evasive manoeuvre to the left (see Figure 4). At this time, the systems operator was looking at the *main screen* and heard the commander yell *crossing line*. When he looked up, he saw the power line pass above.

- 1.12.2 The 132-kV power line was not visually marked. Neither was it subject to a marking requirement because less than 100 metres of the line was more than 60 metres above the terrain³. The 22-kV power line was not marked with signage to inform about the crossing overhead line running above the power line, which is also not a requirement in Norway.

Figure 4: Area where the power lines crossed. The 132-kV line is indicated in red and the 22-kV line is indicated in blue. The northern part of Austertjenn lake is visible at the bottom of the image. Map: © Norwegian Mapping Authority

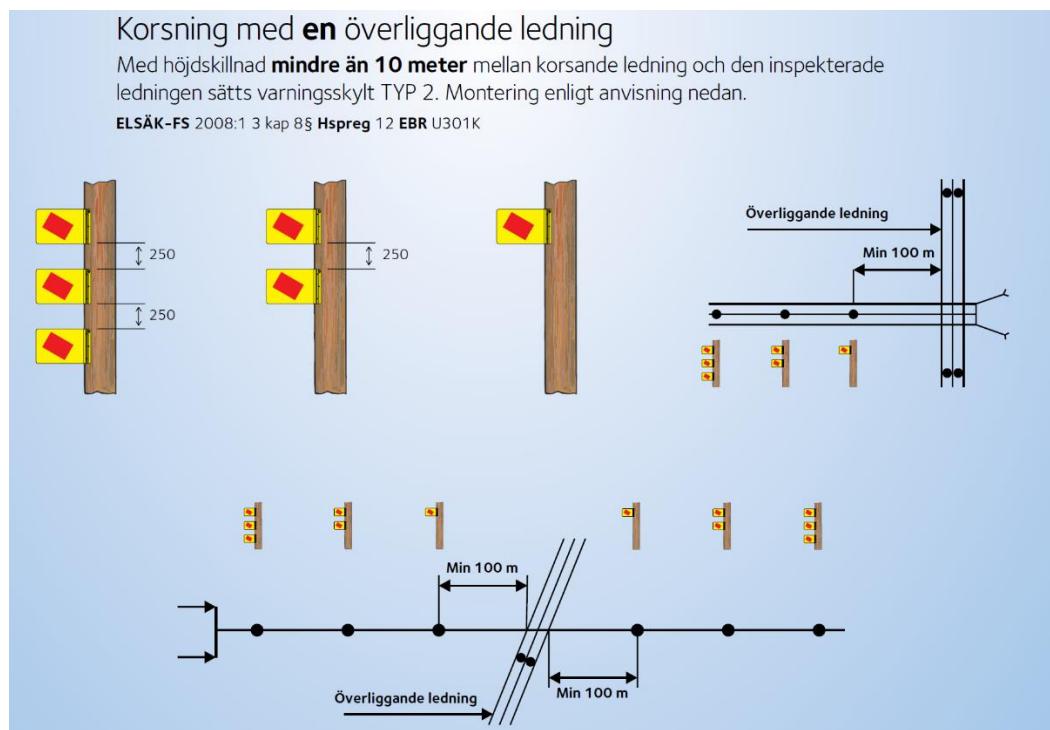
- 1.18.1.1 Owners of power lines in Sweden and Finland have been required to mark power line pylons before crossing lines. In Sweden, the last three pylons before the crossing must bear signage. There is also extra signage if more than one line is crossing, if the crossing line is more than 10 metres above the line to be inspected, or if lines run close to each other. Heliwest has stated that they had good experiences with such signage.

Figure 5: Example of signage in Sweden. Source: Sales catalogue from the company Hammarprodukter

The Accident Investigations Board Norway recommends that the Civil Aviation Authority introduce requirements for physical marking of crossing lines in Norway.

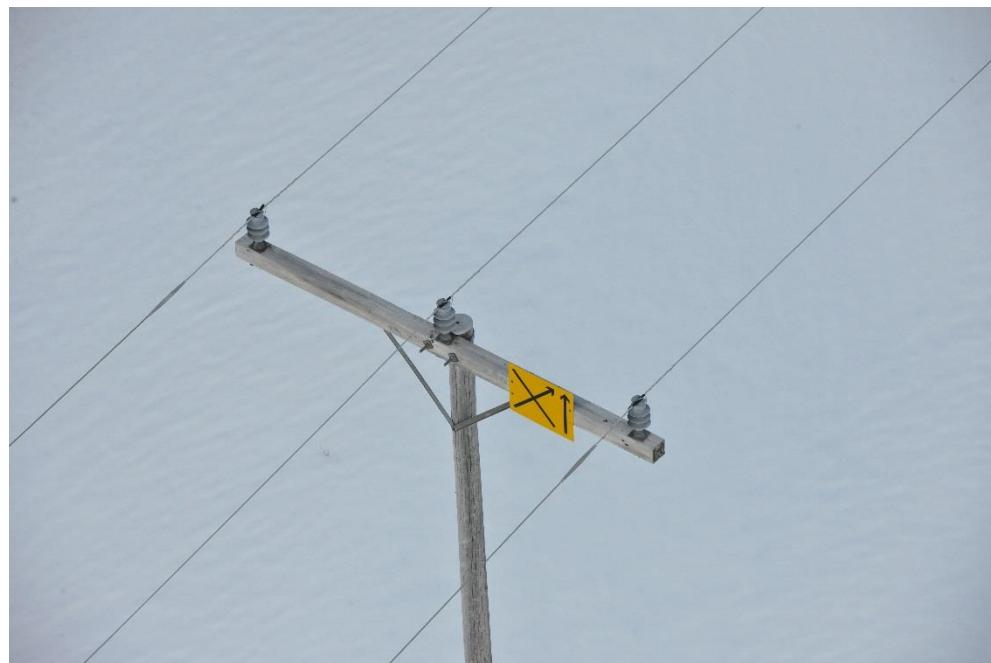
- 1.18.1.2 In Norway, Helgeland Kraft has already marked all their lines. This signage is simpler than that in Sweden.

Figure 6: Signs on Helgeland Kraft's power distribution network notifying of an upcoming crossing line ahead. Photo: Pegasus AS
