Report

A-004/2020

Accident involving a DIAMOND D-40 aircraft, registration OH-DTF, at the Cordoba Airport on 23 January 2020

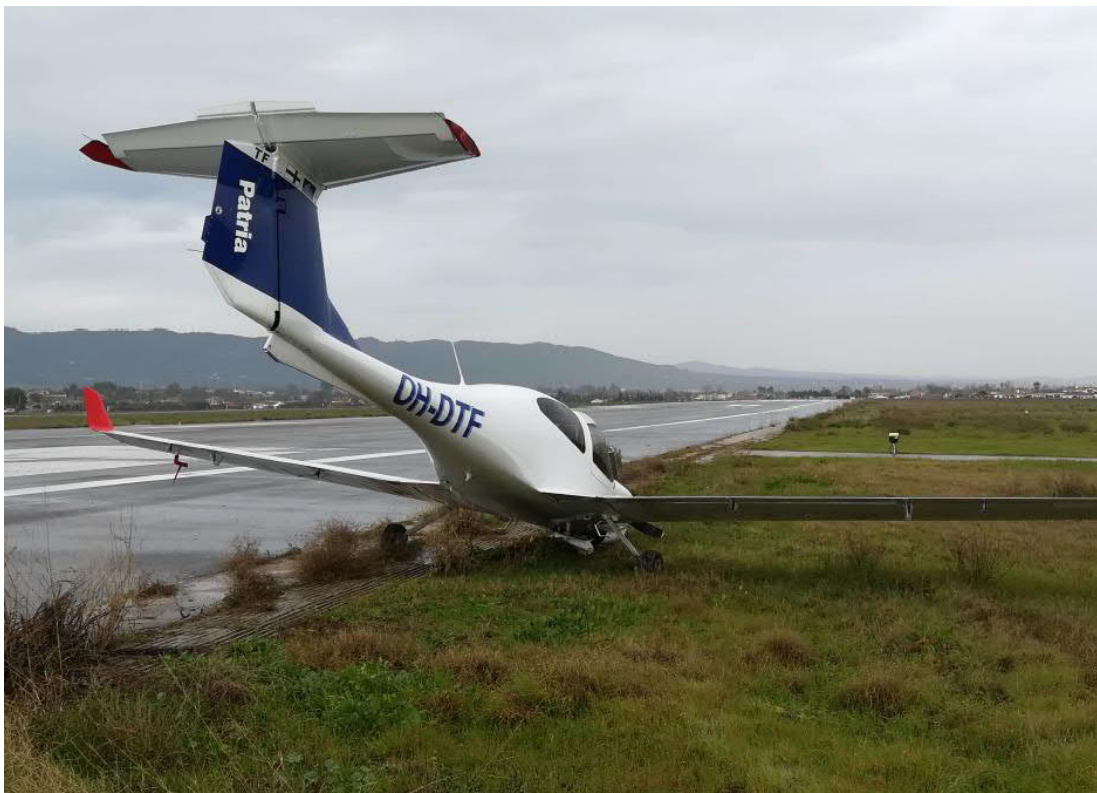
The aircraft came to a stop off the right edge of the runway.

Upon contacting the runway, the airplane rose again before finally touching down, falling on its main gear wheels. It then continued traveling to the runway 21 threshold, where it veered off the right side of the runway and came to a stop next to the runway.

Figure 1. Final position of the aircraft

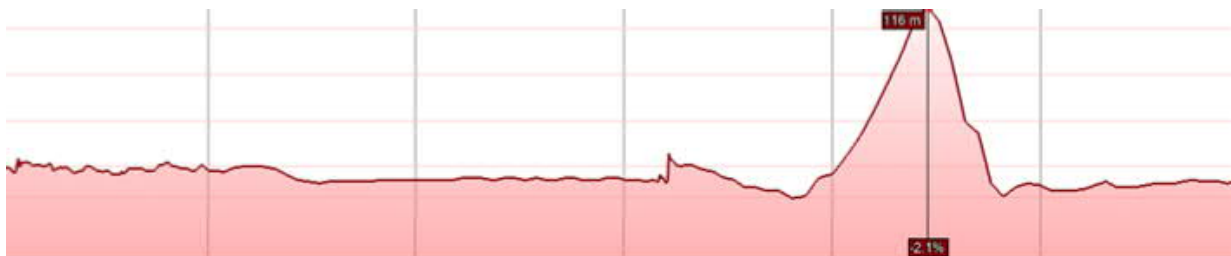
revealed that the takeoff began at 11:55:44 and that at 11:56:04, the aircraft reached a maximum altitude of 380 ft, with an indicated airspeed of 71 kt. At that point its altitude over the runway was 73 ft (22 m), since the airport's elevation is 307 ft.

From that moment on, it began to descend and it stopped 32 s later.

Figure 3. Flight profile recorded in the GPS

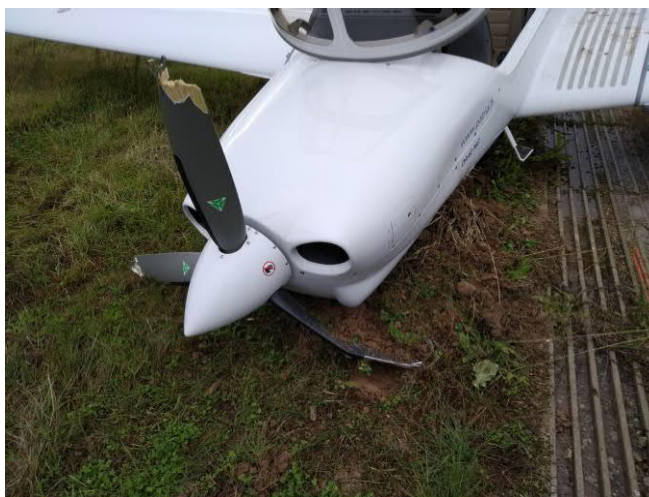
As a result of the initial impact and subsequent runway excursion, all three propeller blades broke and there were varying degrees of damage to the lower engine fairing, to the front gear wheel in the area where it attaches to the fork, to the fairing of said wheel, to the right main gear wheel, affecting the brake disk and caliper, and to the left wing, which had a mark on its lower surface.

Figure 4. Damage to the propeller blades

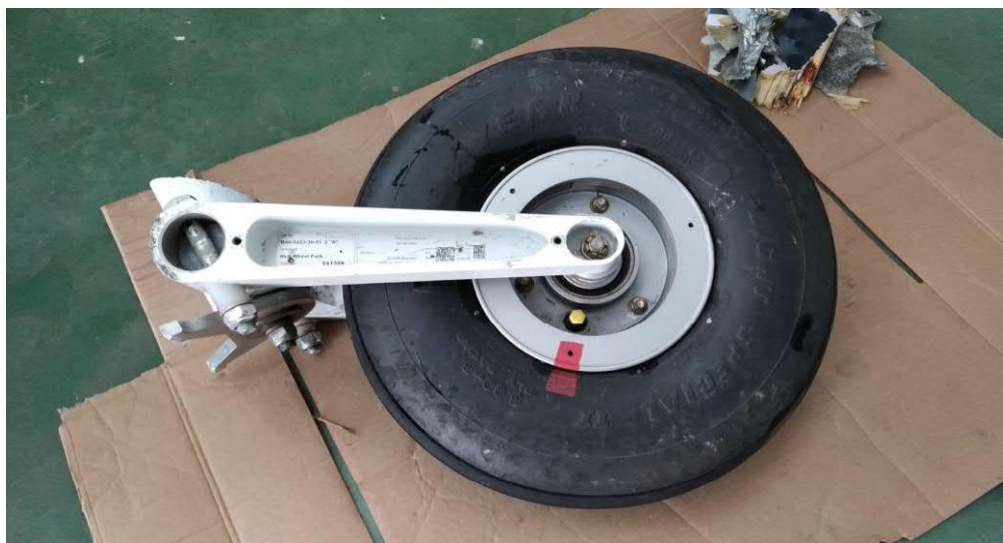
Figure 5. Damage to the nose wheel gear

The nose wheel gear collapsed on the first impact, and it was also when the propeller broke.
