MV Estonia Accident Investigation. Stability calculations.

Technical Report VALC177.

VTT Manufacturing Technology. Espoo 1996.

Espoo, May 1996

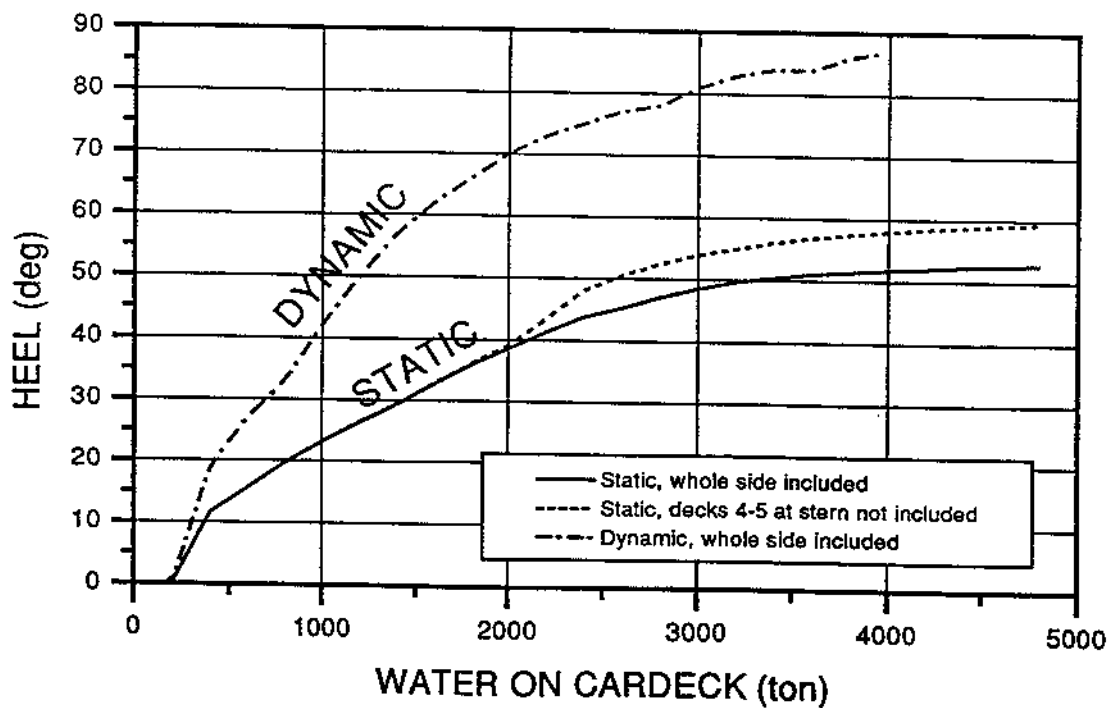
Both the static and dynamic heel angles for the case of side included are larger than those for the case of sides not included when there is less than 2000 tons of water on the cardeck. This ambiguous result is a consequence of the fact that the actual transverse metacentric height used in the case of side included was smaller than the preliminary assumption used in the calculations for the other case. When the amount of water on the cardeck increases and the heel angle grows over 40 degrees, the effect of intact hull side is emphasised. The static righting arm increases when the ship heels to the maximum calculation angle of 90 degrees. The dynamic heel angle remains under 90 degrees even in the worst calculation case when there is 4000 tons of water on the cardeck. If the effect of side is not included, the ship capsizes when the amount of water on the cardeck is more than 2000 tons.

In the case of side not included the static righting arm starts to decrease right after the heel angle of 40 degrees and becomes rapidly negative. The dynamic heel angle cannot even be calculated when the amount of water on the cardeck is more than about 1350 tons.

Figure 4.4 Static and dynamic heel angles.

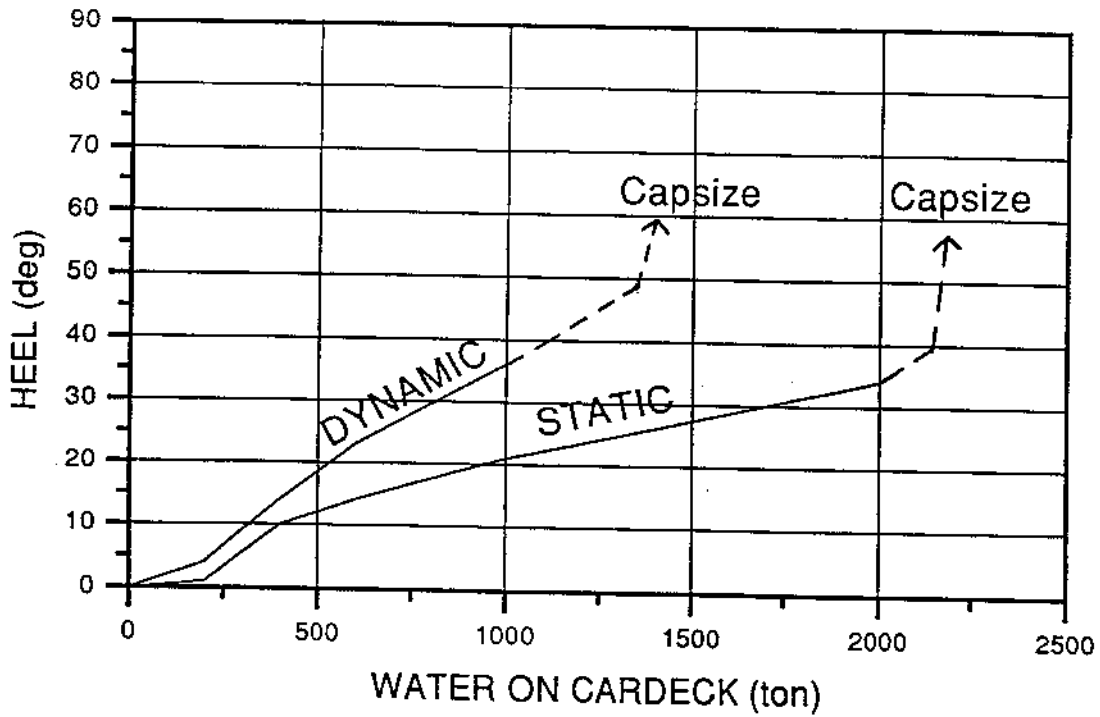
The stability for the case with side above the 4th deck not included was calculated with 0, 200, 400, 600, 1000, 1400 and 2000 tons of water on cardeck. The h_ϕ and e_ϕ values as functions of heel angle are presented in Figures 4.8 and 4.9, respectively. The static and dynamic heel angles as functions of water amount on cardeck are shown in Figure 4.10 where the last dynamic heel angle corresponding to 1350 ton water is interpolated using the adjacent values. The preliminary values of ship main particulars were used.

Figure 4.10 Static and dynamic heel angles. Side above 4th deck not included, preliminary load condition.

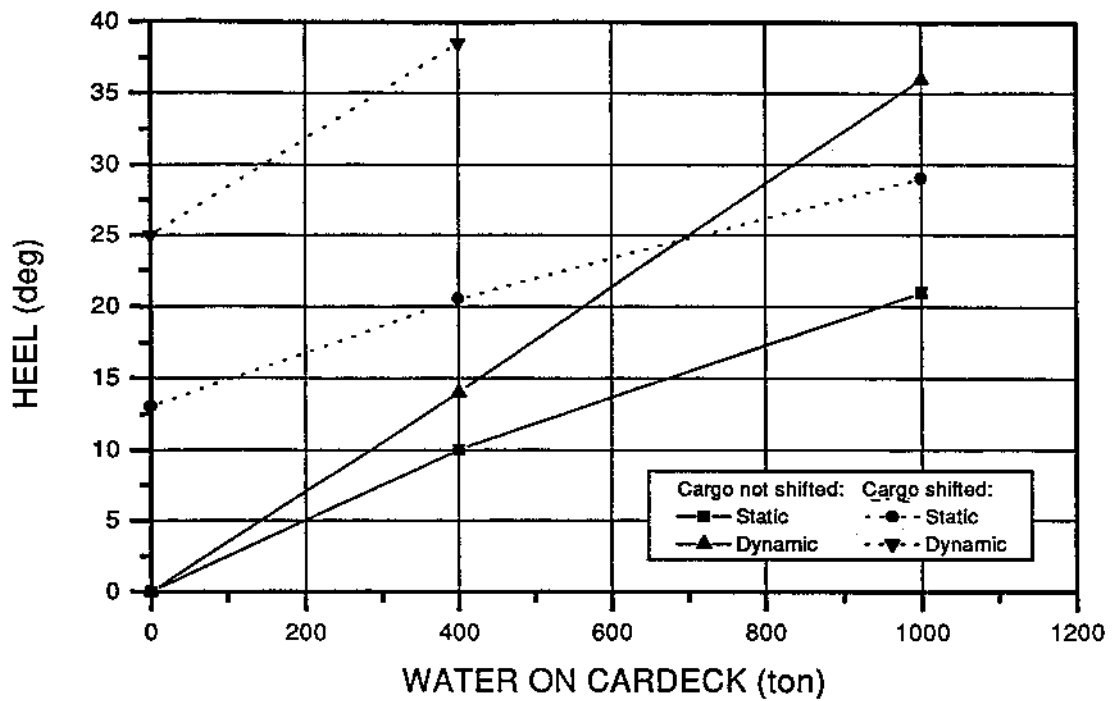
The static heel angles in the case of cargo not shifted were about 0, 10 and 20 degrees when there was 0, 400 and 1000 tons of water on the cardeck. In the case of cargo shifted, the corresponding heel angles were about 10, 20 and 30 degrees. The cargo shifting reduces the static righting arm about 0.4 m in the heel angle range of 0 - 40 degrees. The distance of cargo shifting was, however, unrealistically large in the calculations.

Figure 4.12 Static and dynamic heel angles, effect of cargo shift, side above 4th deck not included.

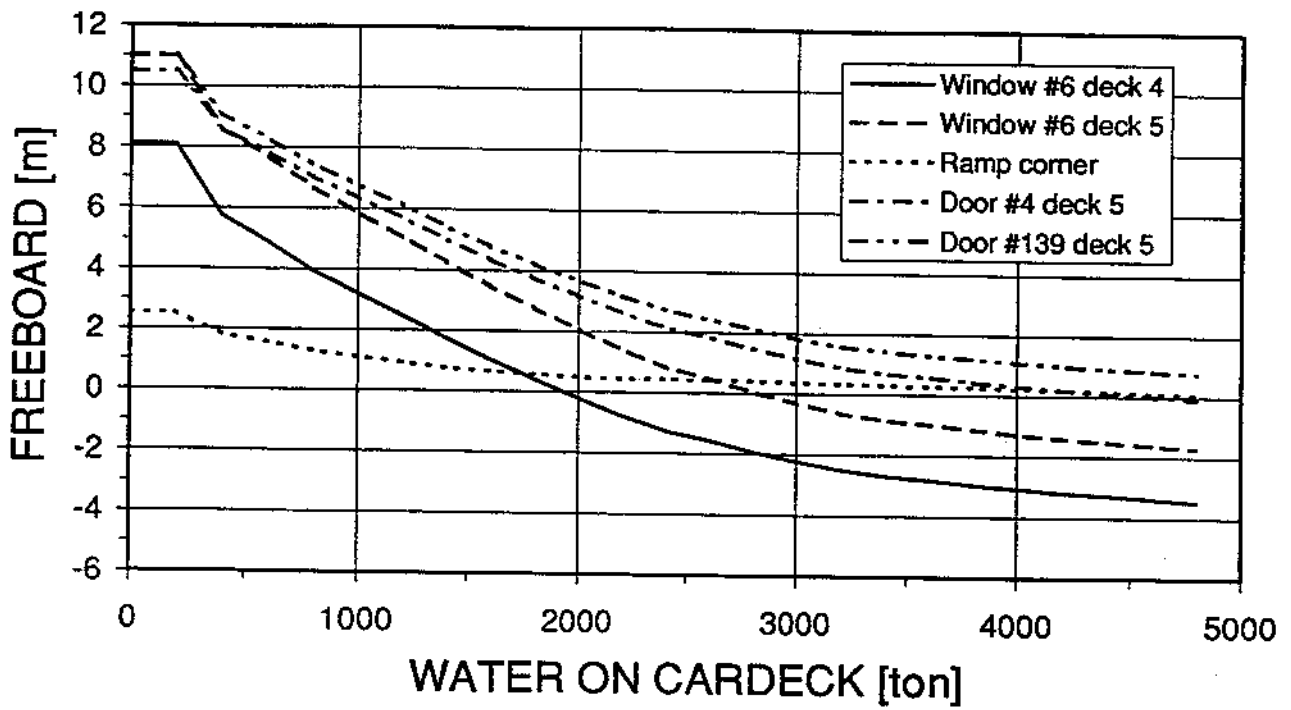
The calculated freeboard values at the first five openings as functions of water on cardeck are drawn in Figure 4.15. It shows that the first openings which go under the calm water level are the side windows on the 4th deck. This occurs when there is about 2000 tons of water on the cardeck and the heel angle is about 40 degrees. At this stage, the lowest corner of the ramp opening is about 0.4 m above the calm water surface and it remains slightly above the water level until there is over 5000 tons of water on the cardeck.

Figure 4.15 Freeboard to some critical openings.

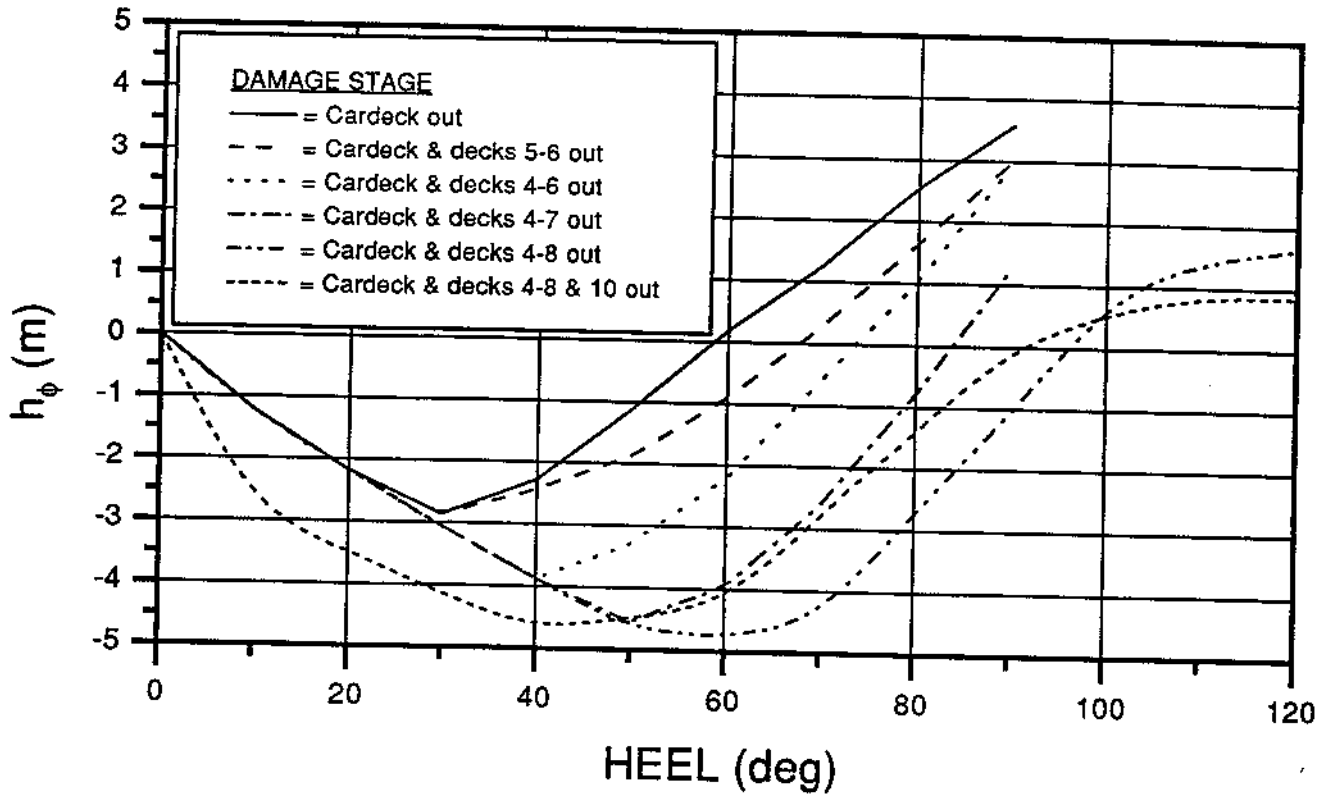
Though it is impossible to predict how the flooding of the vessel hull and the superstructure developed, some simplified flooding cases have been analysed. The h_{ϕ} and e_{ϕ} values as functions of heel angle for different damage stages are presented in Figures 4.16 and 4.17, respectively. The static stability was calculated for cases where watertight hull volume above the cardeck gradually decreases as the ship heels and more water flows inside through openings. The notation of first damage stage 'cardeck out' in the figures means that water can flood in to the cardeck through the lower corner of the opened bow

ramp. The second stage 'cardeck & decks 5-6 out' means that water can flow in also to the 5th deck through the openings on that deck with the result that the hull volume between decks 5 and 6 does not contribute any more to the righting moment. In the next stage 'cardeck & decks 4-6 out' water has flowed down also between decks 4 and 5. After this stage openings on the upper decks gradually remain under the water level representing the last three damage stages. The actual values of ship main particulars including the visor have been used.

Figure 4.16 Static stability curves, effect of damage stage, 3200 ton water on cardeck.

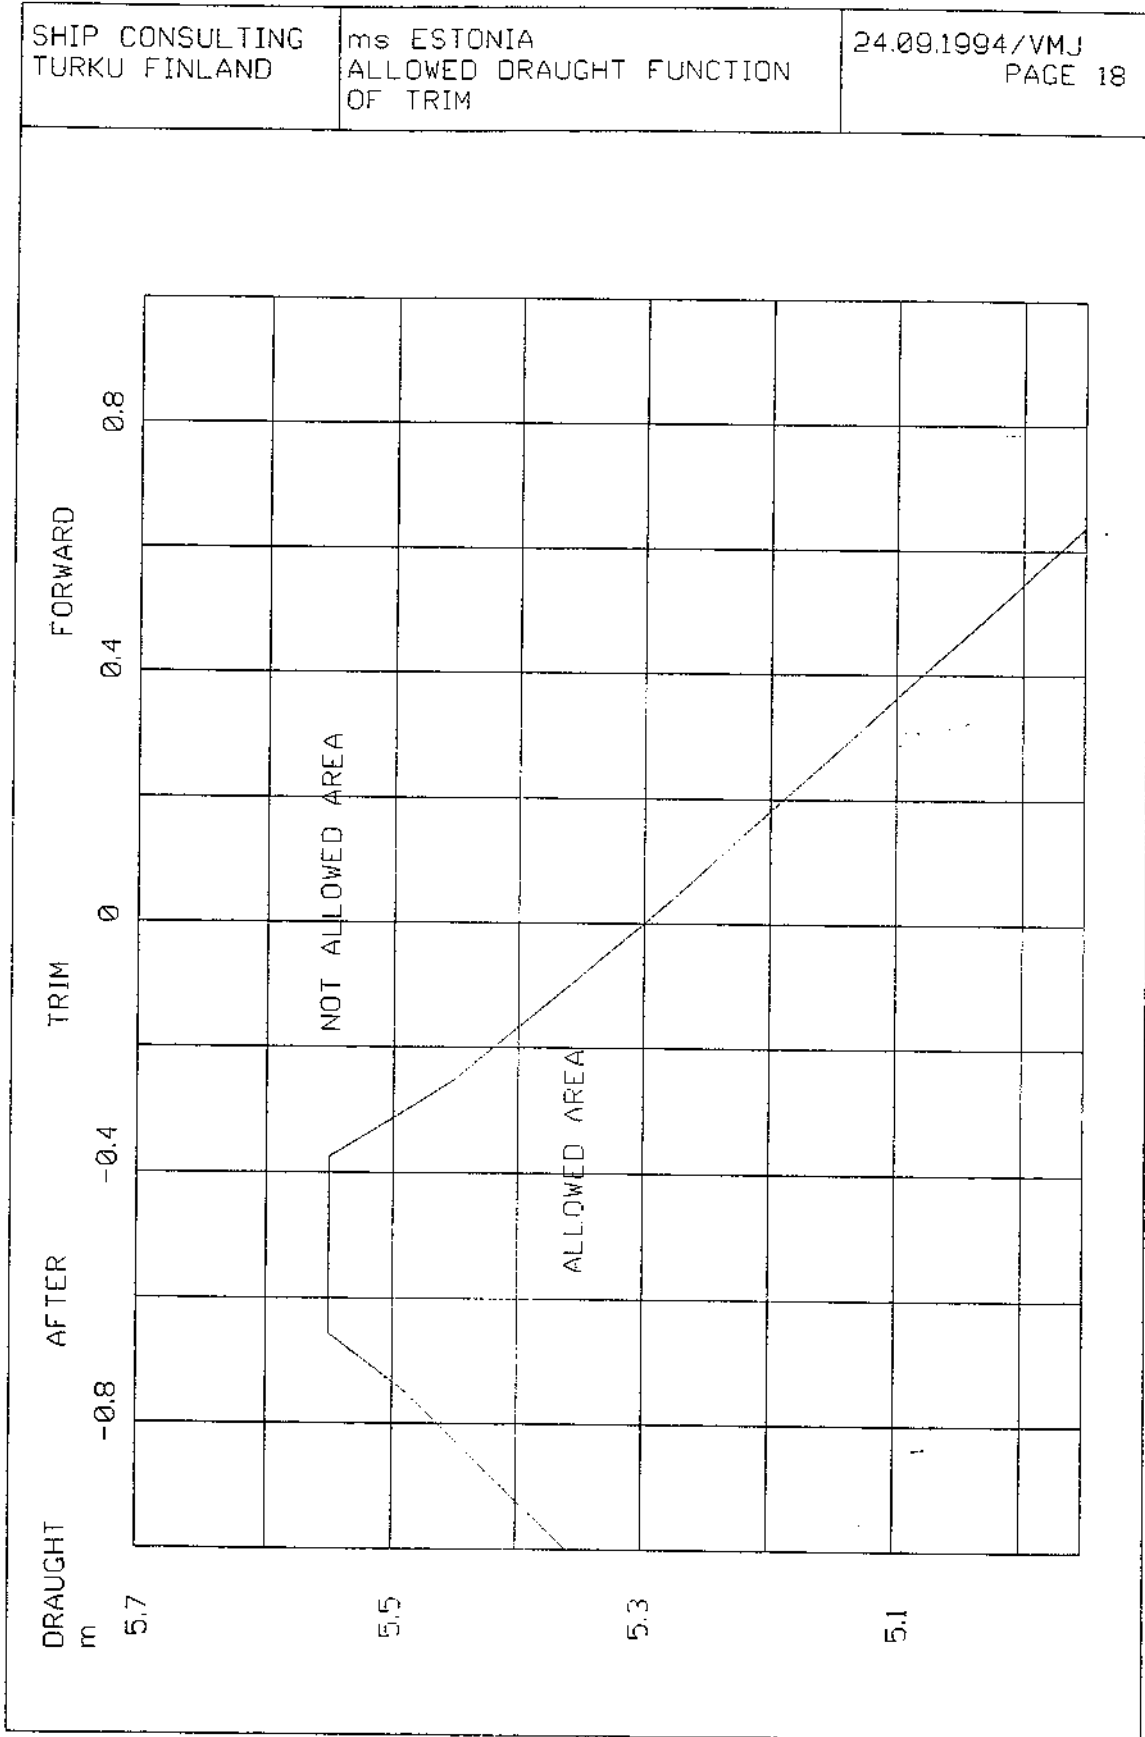
The allowed and not allowed trim/draught combinations for MV Estonia are shown in Figure 4.18. In Figure 4.19 the equilibrium floating position of the ship is shown for the case when the cardeck and decks between 4-6 are out. The cross-section is at the longitudinal coordinate $x=79.4$ m from the after perpendicular.

Figure 4.18 The allowed and not allowed trim/draught combinations for MV Estonia.

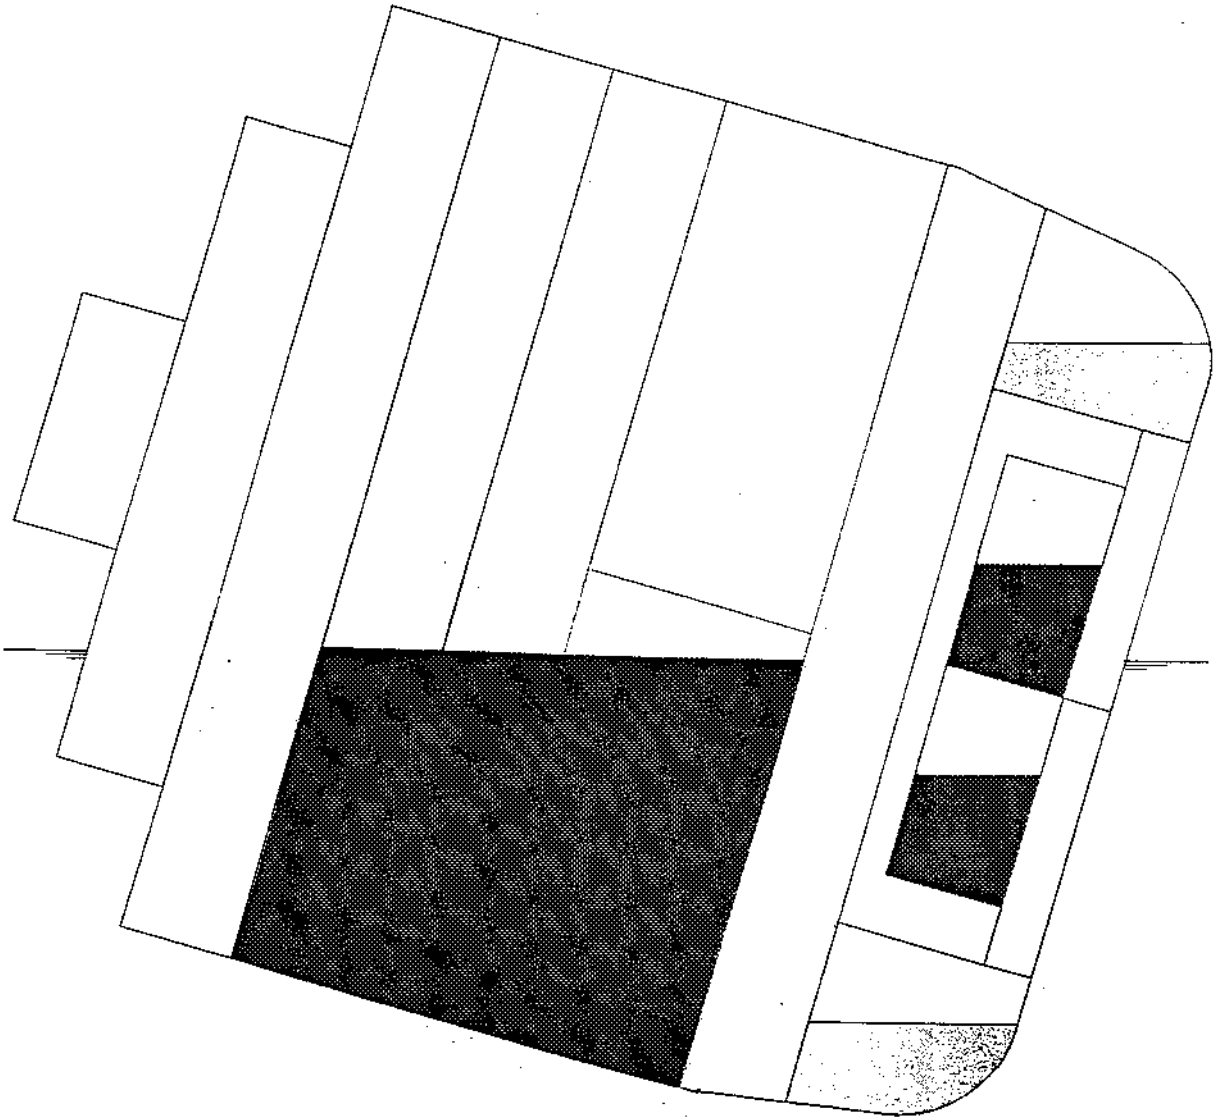
Figure 4.19 The equilibrium floating position of the ship for the case when the cardeck and decks between 4-6 are out. The cross-section is at the longitudinal coordinate $x=79.4$ m from the after perpendicular.
