SUPPLEMENT No. 509

Investigation of paint systems from MV Estonia Visor Bottom Lock.

Research Report No. RTE57243/96.

VTT Building Technology.

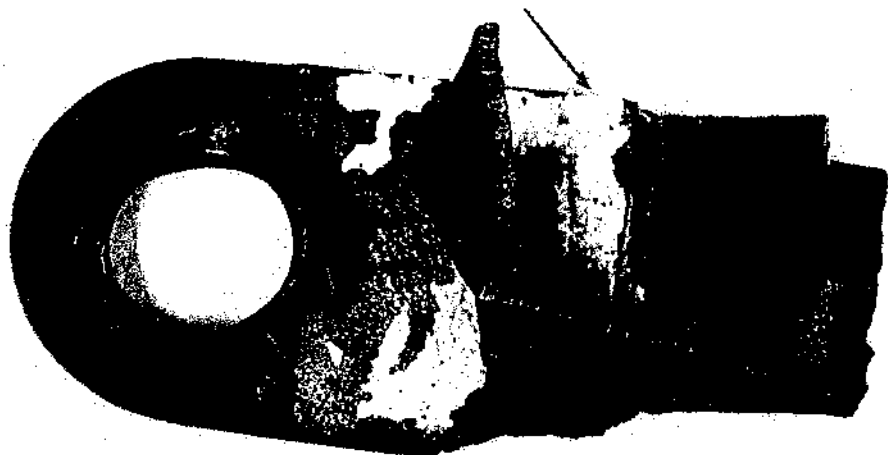
Figure 1. Visor lug, KTH sample nr 4511, view from starboard.

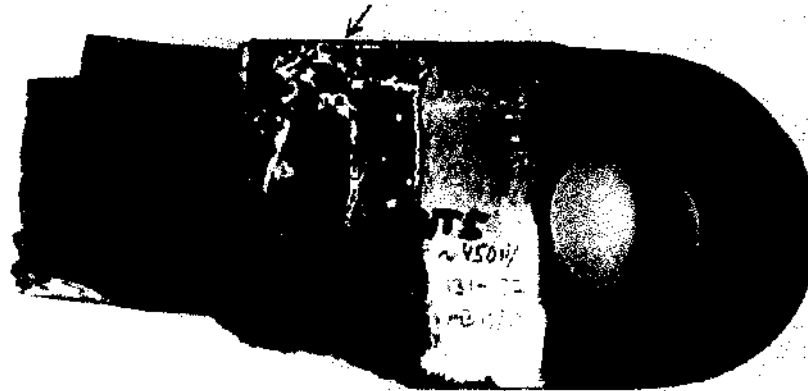
Figure 3. Visor lug, KTH sample nr 4511, view from port.

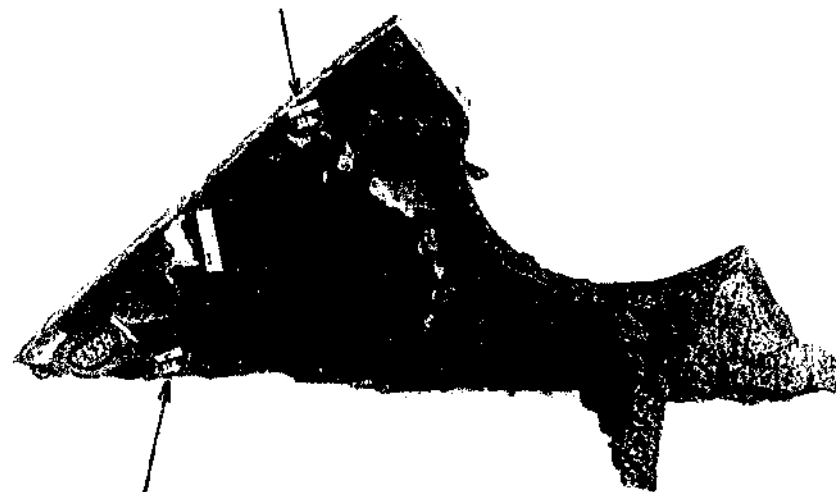
Figure 4. Forepeak deck starboard lug, KTH sample nr 4543, view from starboard.

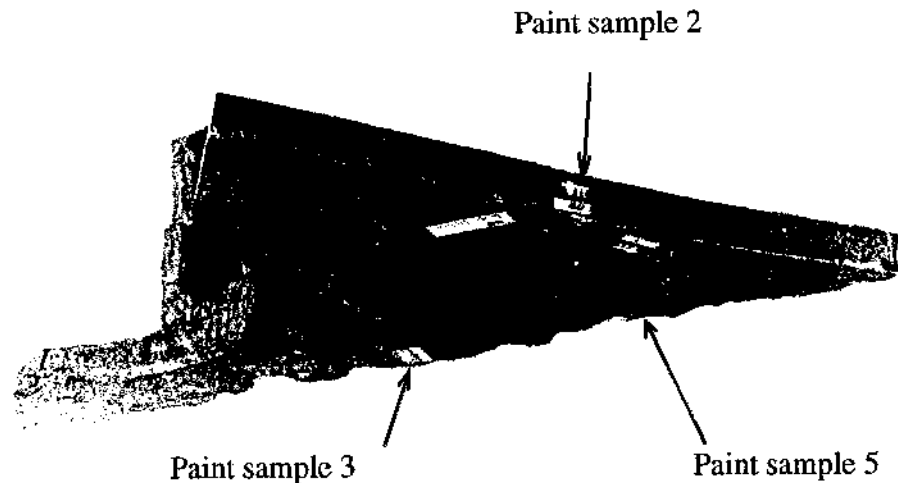
Figure 5. Forepeak deck starboard lug, KTH sample nr 4543, view from above aft port.

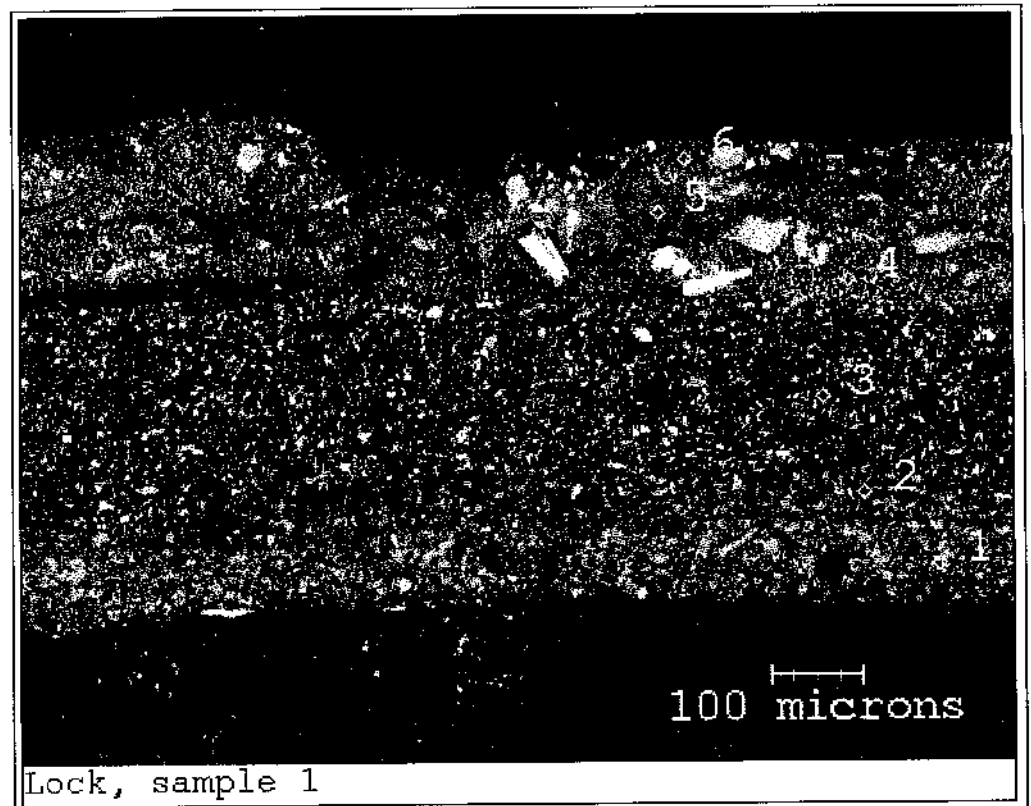
Six paint layers were found. The BSE-image of the cross section of the sample is given in figure 6 and the corresponding EDS-analyses of the paint layers are given in Appendix 1 in figures A1-1 to A1-6.

Figure 6. Forepeak deck starboard lug, paint sample 1, cross section. The paint layers and the analysis spots are numbered from 1 to 6.

Shades of the layers: 1-white; 2-grey; 3-blue; 4-red; 5-white; 6-blue

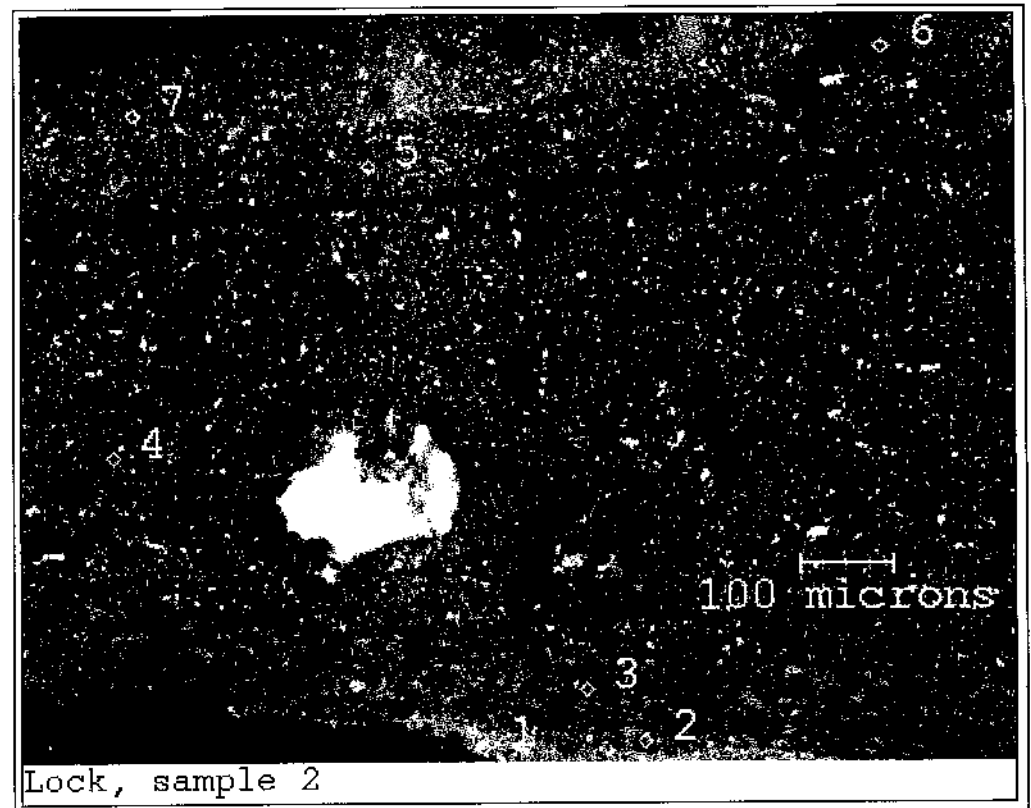
Seven paint layers were found. The BSE-image of the cross section of the sample is given in figure 7 and the corresponding EDS-analyses of the paint layers are given in Appendix 2 in figures A2-1 to A2-7. According to the appearance and the results of the EDS-analysis the layers 4 and 5 seem to be identical.

Figure 7. Forepeak deck starboard lug, paint sample 2, cross section. The layers and the analysis spots are numbered from 1 to 7. Shades of the layers: 1-light brown; 2-white (discontinuous), 3-grey; 4- blue; 5-blue; 6-white (discontinuous); 7-blue. Black crevice between layers 4 and 5.

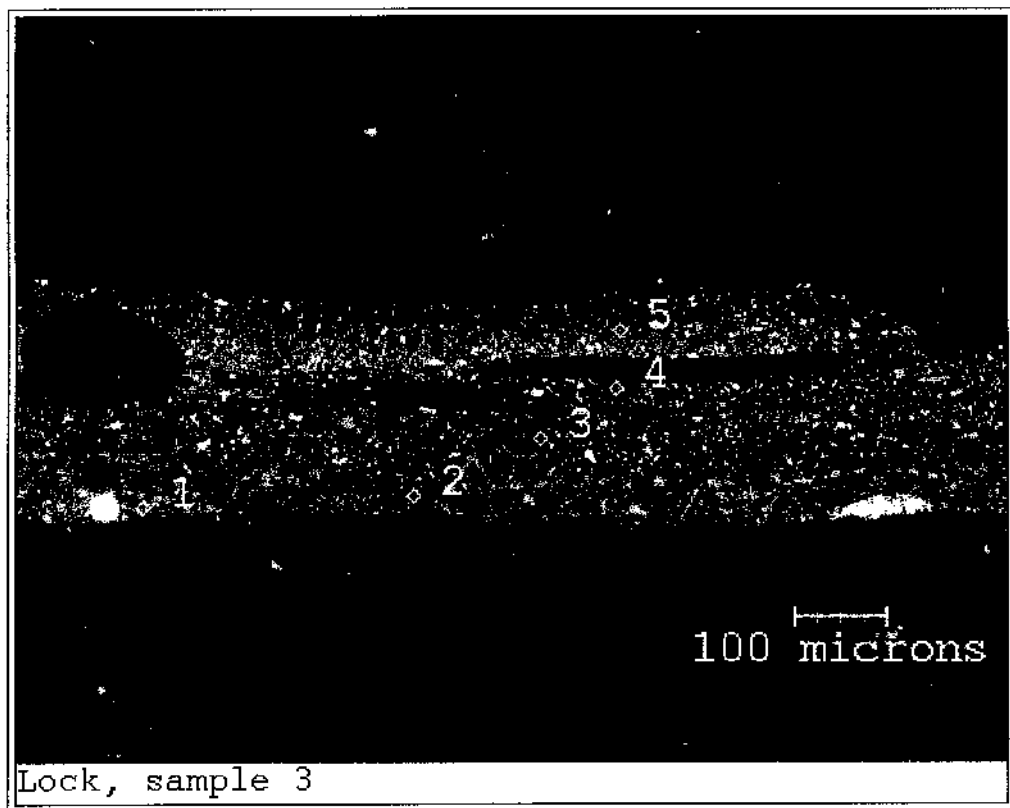
Five paint layers were found. The BSE-image of the cross section of the sample is given in figure 8 and the corresponding EDS-analyses of the paint layers are given in Appendix 3.

Figure 8. Forepeak deck starboard lug, paint sample 3, cross section. The layers and the analysis spots are numbered from 1 to 5. Shades of the layers: 1-white (discontinuous), 2-grey; 3- blue; 4-blue; 5- blue. Black crevice between the layers 3 and 4 as well as between layers 4 and 5.

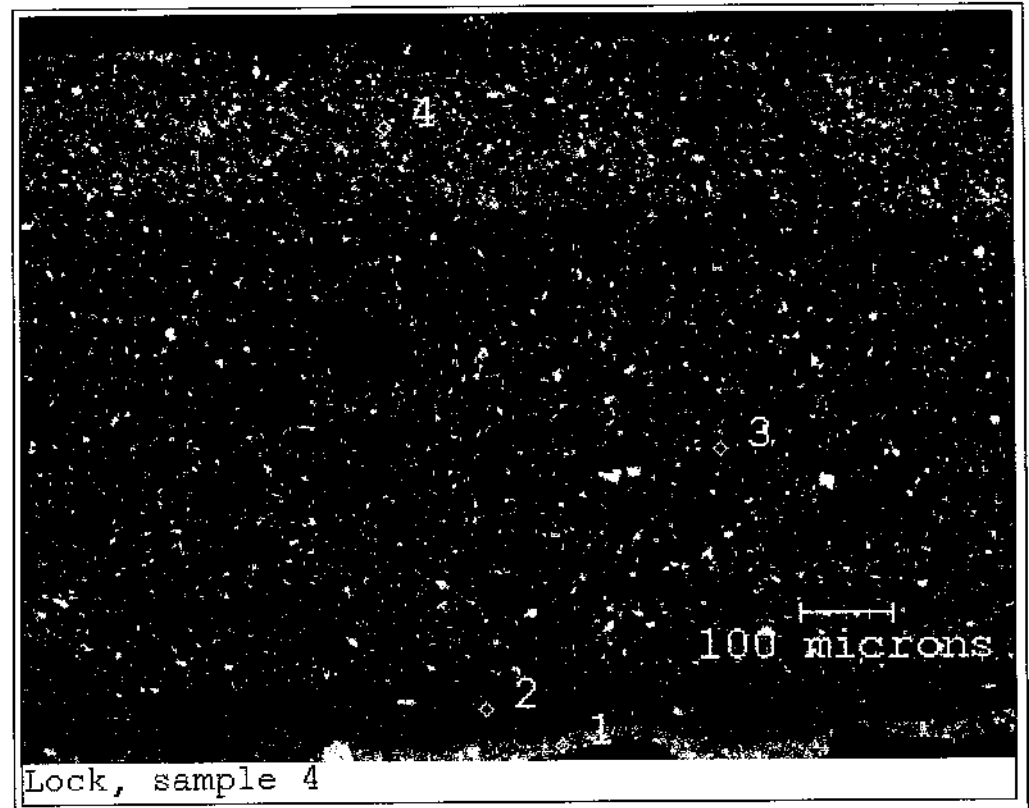
Four paint layers were found. The BSE-image of the cross section of the sample is given in figure 9 and the corresponding EDS-analyses of the paint layers are given in Appendix 4.

Figure 9. Forepeak deck starboard lug, paint sample 4, cross section. The layers and the analysis spots are numbered from 1 to 4. Shades of the layers: 1-light brown, 2-grey; 3-medium blue; 4-blue. Black crevice between layers 3 and 4.

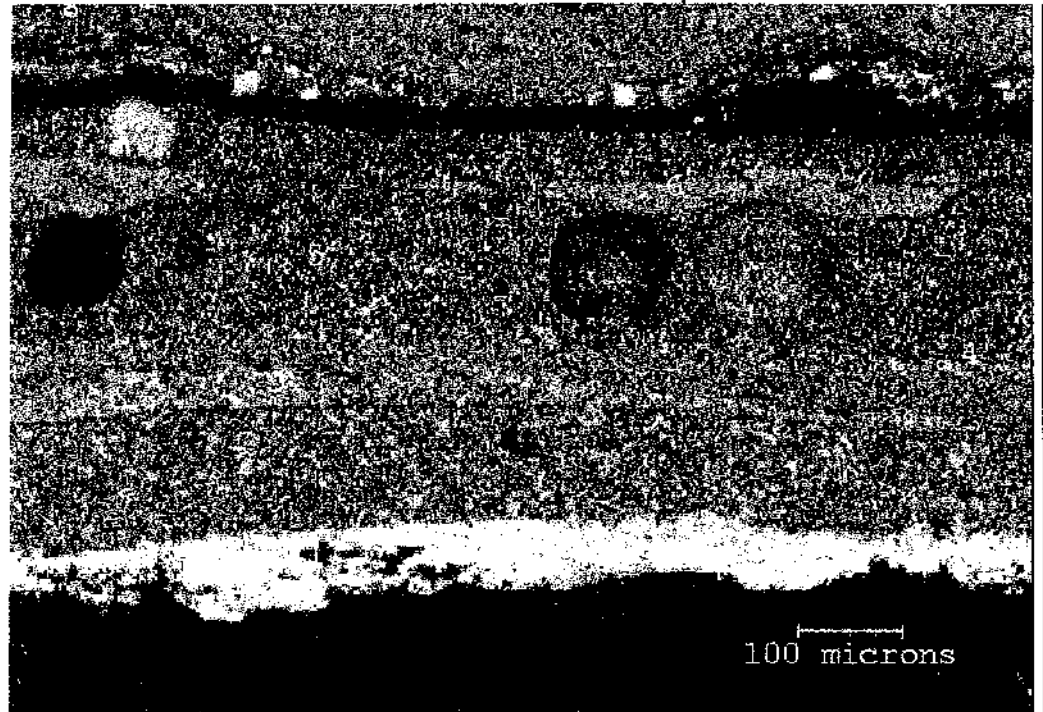
The BSE-image of the cross section of the paint system is given in figure 10. The layers found are marked from 1 to 9. Number 1 is the rust layer.

The paint system consisted of a multilayer coating with a very poorly adherent white top coat consisting of two layers (7 and 8 in Fig. 10).

The coating system under this loose paint layer had a red top coat (5 in Fig. 10). This red coating was built of two layers, some white paint (6 in Fig. 10) was seen here and there between these two red layers.

Some of the underlying layers were seen only here and there, for instance layer nr 9 was found only sporadically.

Figure 10 . Visor lug, paint system sample, cross section. Layer 1-rust; layer 2-yellowish; layer 3-white; layer 4-grey; layer 5-red; layer 6-white; layer 7-white; layer 8-grey; layer 9-light brown. Layers 8 and 7 were poorly adherent to the previous paint surface and rust was found underneath these layers.
