Strength and failure assessments of parts from MV ESTONIA. Royal
Institute of Technology.

STRENGTH AND FAILURE ASSESSMENTS OF PARTS FROM MV ESTONIA

Fred Nilsson and Hans Öberg

1. BACKGROUND

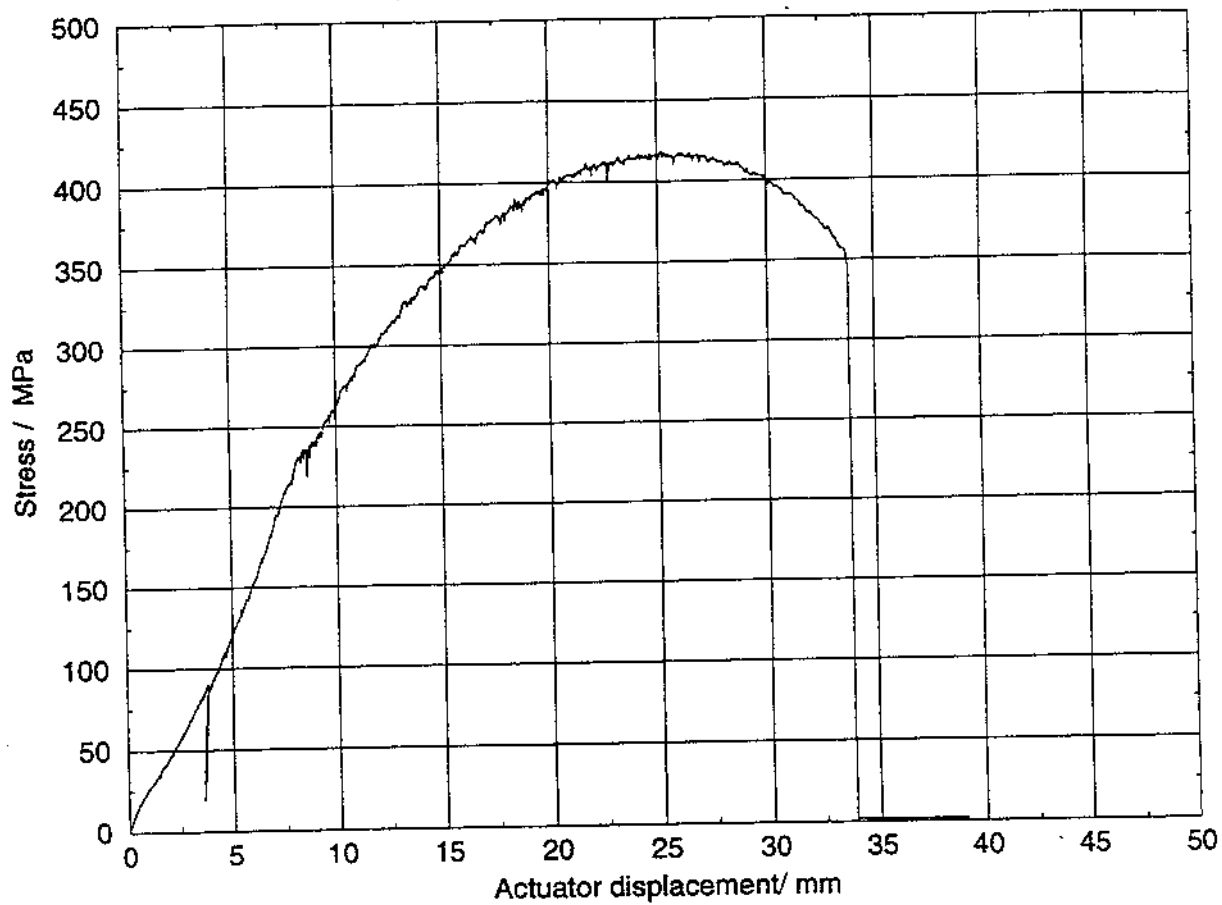
Fig. 1. Tensile testing of bottom lock material, rectangular specimen.

The failure load was 177 kN which is proportional to a stress of 417 MPa which is then taken as the ultimate tensile strength σ_u . This value is in reasonable accordance with the expected behaviour of the material. A stress-displacement diagram is enclosed (Fig. 1). The displacement shown in the diagrams is the sum of the elongation of the specimen and of the fixtures and the testing rig. From Fig. 1 the yield stress can be estimated to 230 MPa.

The cross section after break was 9,3 mm x 22,5 mm. A 50 mm long gage length elongated to 68,3 mm during the test. This corresponds to an average strain of 36,6%.

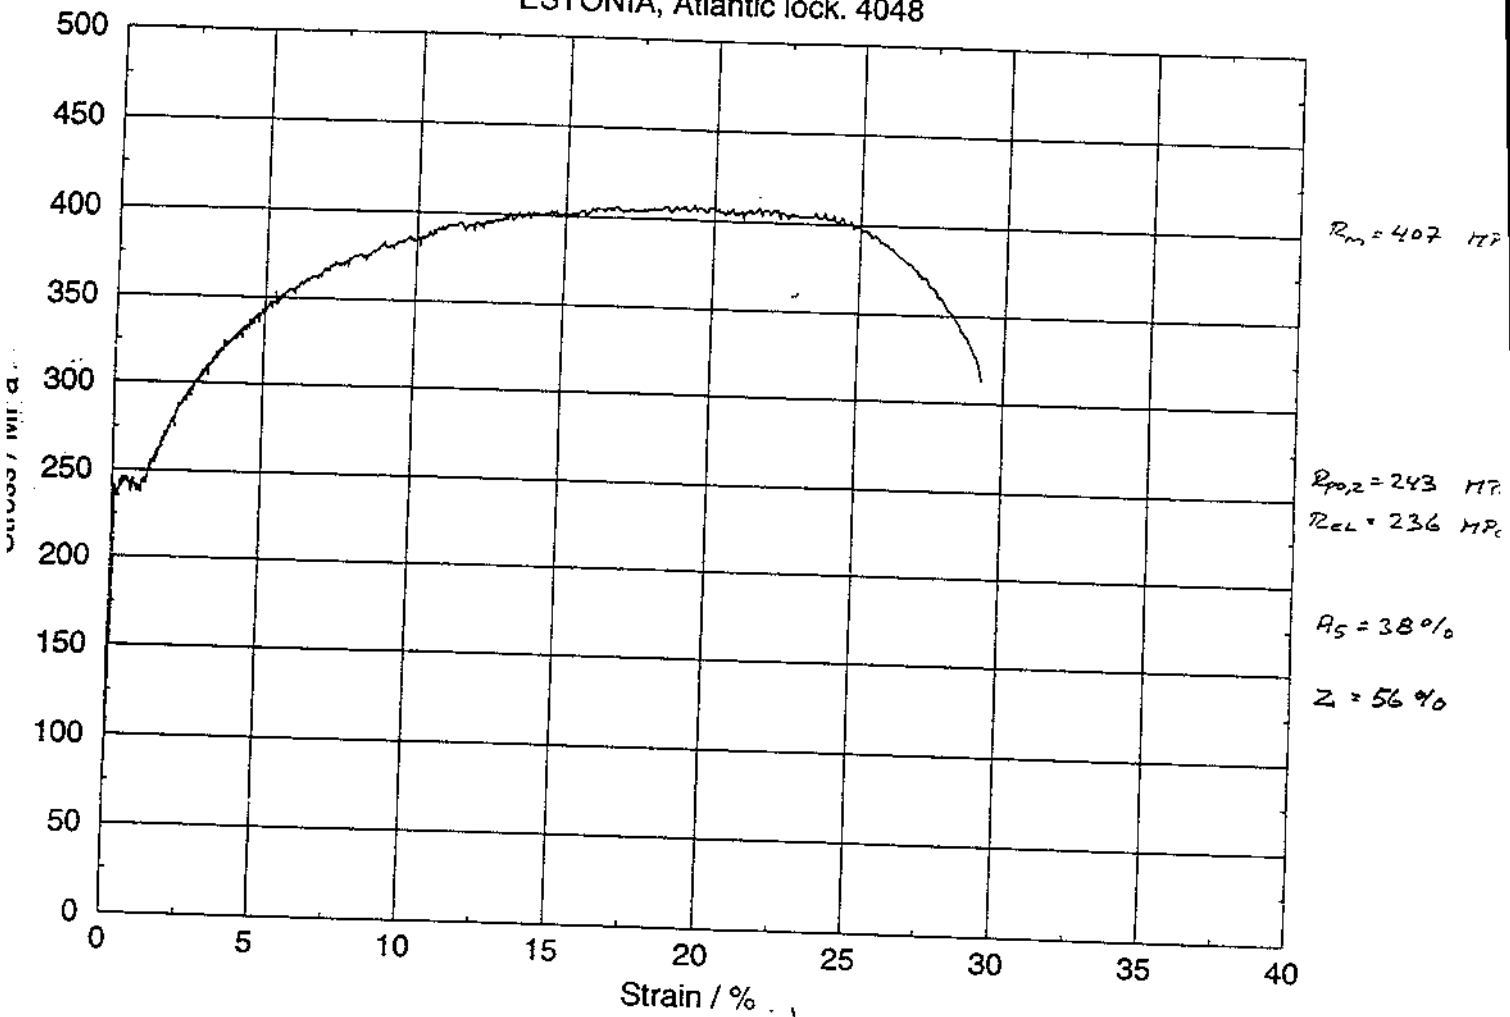
Fig. 2. Tensile testing of bottom lock material, standard cylindrical specimen.

Two standard tensile specimens with a circular cross section were also cut out from the lug and tested. The object of this part of the testing was to determine the yield and the ultimate strength of the material according to standard procedures. The two tests yielded virtually identical information and the stress versus strain behaviour is shown in Fig. 3. The yield strength was determined to 243 MPa and the ultimate tensile strength to 407 MPa. This is in reasonable accordance with the previously described testing on rectangular specimens.

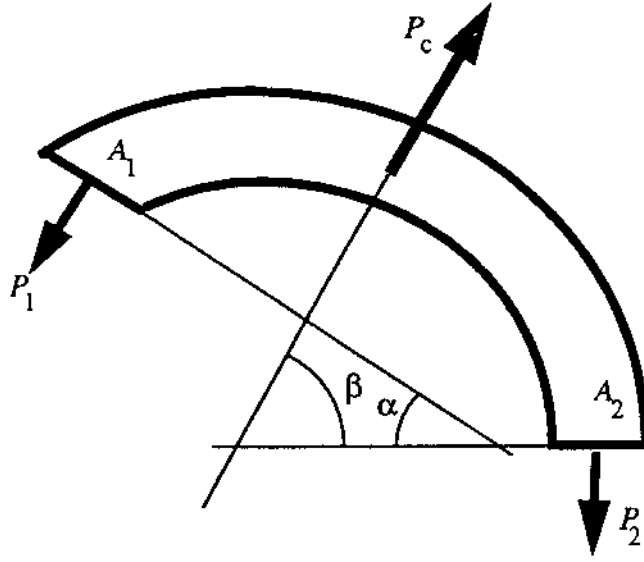
Fig. 3. Assumptions for calculation of the collapse load

The areas A_1 and A_2 and the angle α between the fracture surfaces are measured from the fractured parts. The loading angle β is assumed unknown and is determined by equilibrium considerations. Expressing equilibrium in the horizontal and vertical directions, respectively, we obtain

The different measured quantities and the calculated results are given in Table 1. Two different values of the tensile strength have been used. The lower and more realistic one is formed by taking the average of the yield and the ultimate tensile strength, respectively, while the upper bound value in the table is obtained by using the ultimate tensile strength. In the last row the contribution from the different plates has been summed. The total load bearing capacity of the lock is not, however, necessarily equal to the sum of the limit loads in Table 1. This sum is rather an upper bound to the total capacity. The problem is statically indeterminate and if there is sufficient clearance for deformation, one of the plates may have failed before the others.

In these calculations no account has been taken of the welds between the plates and the bushing. The load bearing capacity of these welds is very uncertain. The visual impression is that the welds were of poor quality and unfortunately no direct measurement of their load bearing capacity is possible. An estimate was, however, made in the following way. Assuming that these welds had the same strength properties as corresponding parts tested from the visor pivoting point as described in section 4 below. The load bearing thickness of the welds at the bottom lock plates was on average 4 mm (measured along the fusion line) in comparison with the 12 mm thickness of the welds from the visor pivoting point. A simple proportioning then gives that the load bearing capacity of the bottom lock welds should be 4/12 of the load bearing capacity per unit length of the welds subjected to testing. Calculating the total force on an area projected from a semi circle gives a force of 36 tons per plate. This contribution has been added in the right-most column of Table 1. It should be kept in mind that this is a very uncertain figure in view of the uneven quality of the welds.

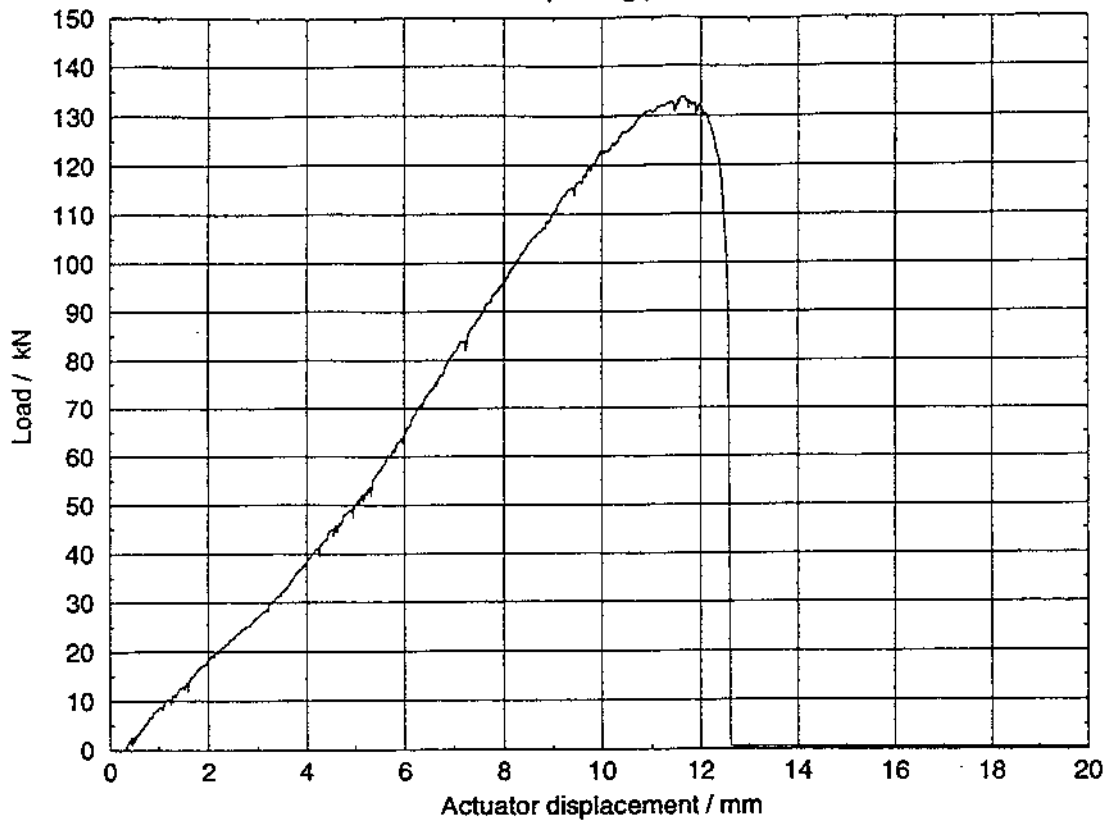
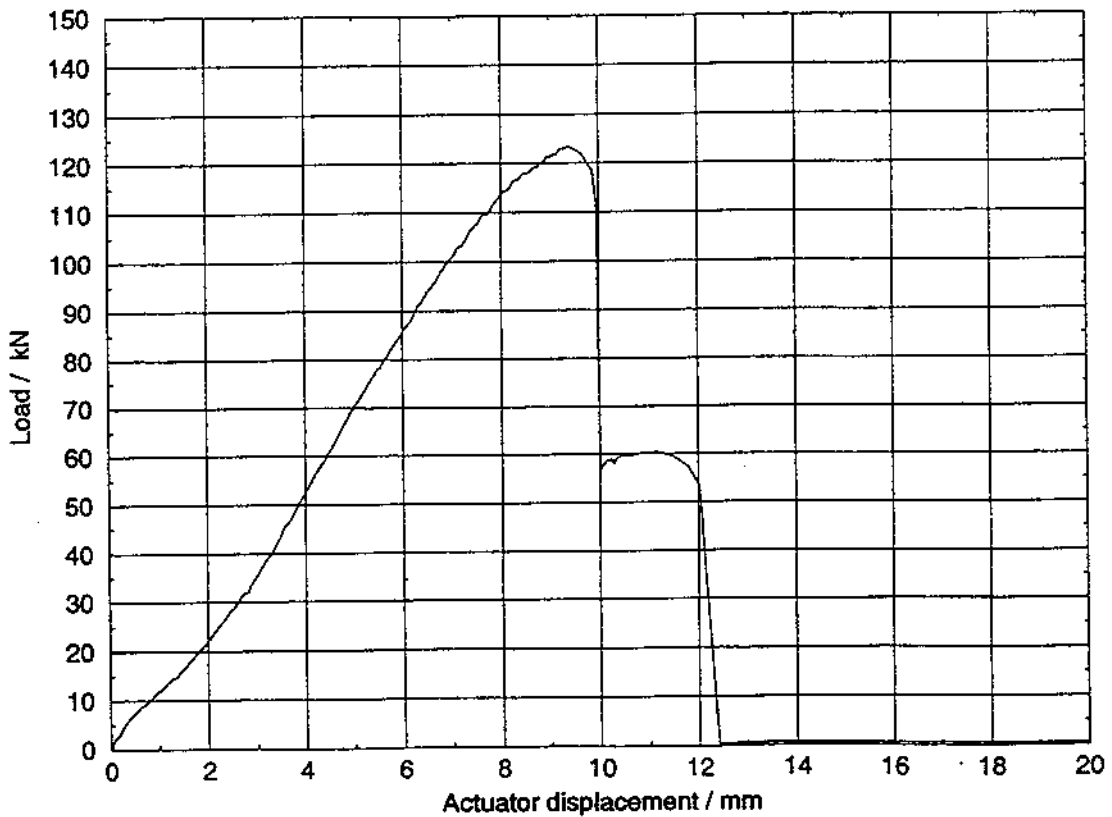
Fig. 4. Load vs displacement from testing of welds from visor pivoting point.

Two slices, numbered 3042 and 3043, were cut from the *visor pivoting point*. The thicknesses of the slices were 14,0 mm and 13,9 (3043). The welded joints were loaded using equipment mentioned above. The results are shown in two diagrams enclosed (Fig. 4).

Welding defects could be seen in the broken welds. In spite of that, the load carrying capacity of the welds was good compared to that of the net section.

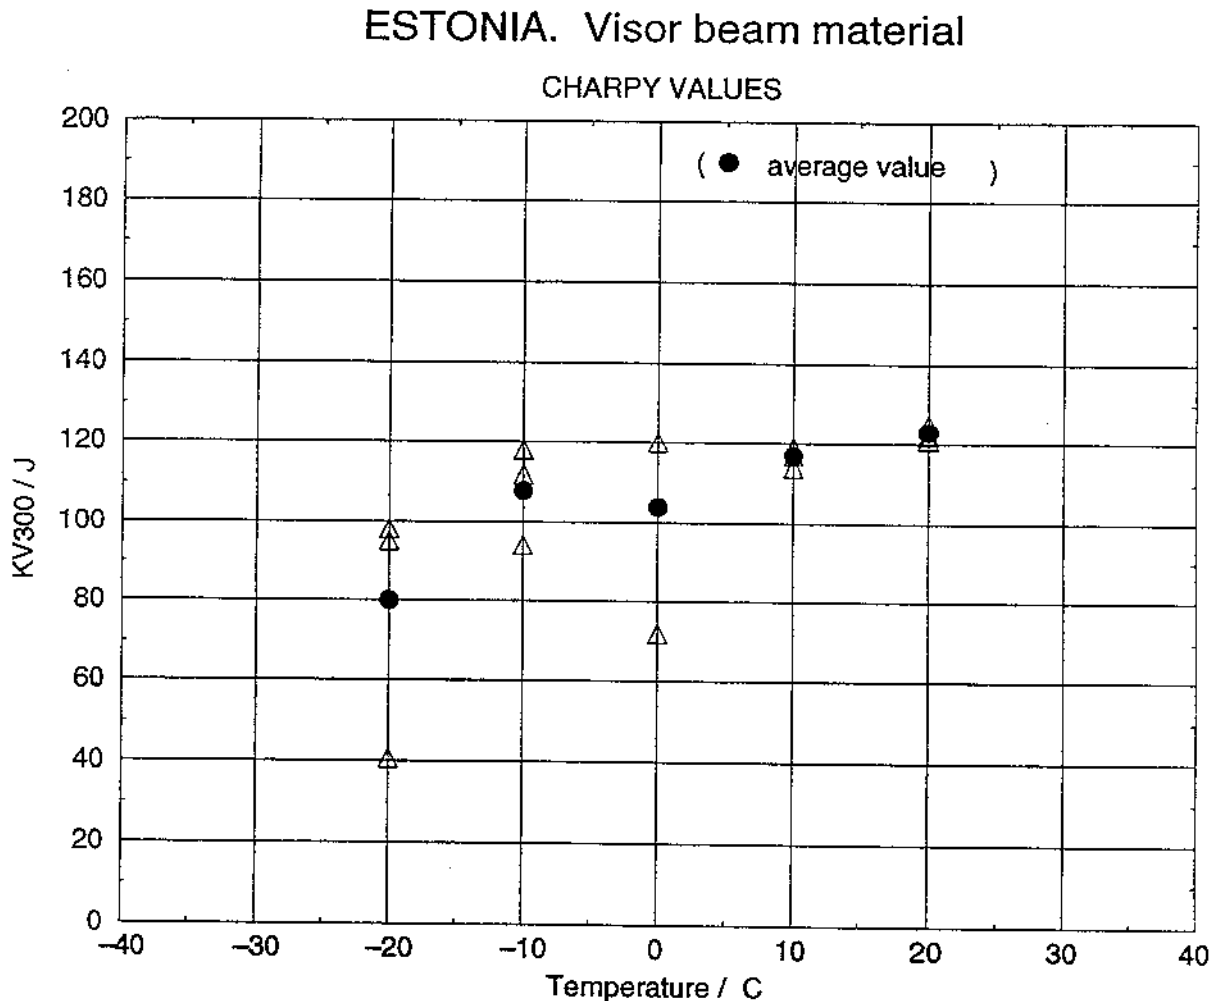
Fig. 5. Charpy impact toughness.

Impact testing using standard Charpy specimens machined from the visor beam was carried out in order to establish the toughness properties. The results from testing at different temperatures are shown in. The main conclusion is that the material possesses adequate toughness properties in the temperature interval considered.
