SUPPLEMENT No. 517

Metallographic and fractographic examinations of samples
from MV Estonia.

Royal Institute of Technology.

Pettersson Kjell - Söderholm P-O: Notes from metallographic and fractographic examinations of samples from MV Estonia.

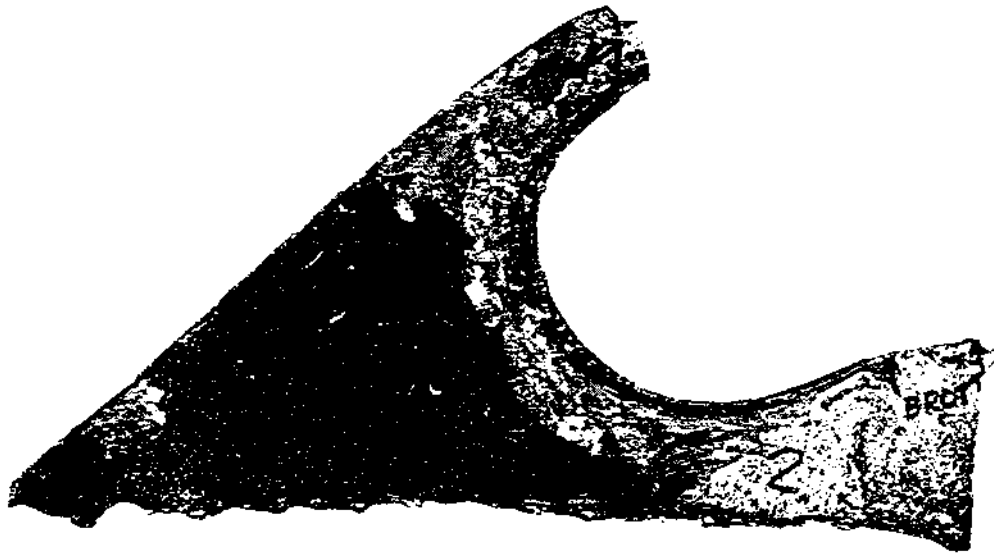
Figure 1 shows one of the lugs. The slightly undulated lower edge is a result of the cutting under water. The edge to the right and the sloping edge are parts of the original shape of the lug. The lug has failed in the ligaments between the hole and the external edges. Around the hole there is the remains of a fillet weld which has served to keep a housing insert in place. The weld is apparently of low quality and has not had any significant load carrying capacity. The weld has a triangular cross section with a leg size of 4 – 6 mm. The superficial impression of the weld is that in parts of it there is insufficient penetration and lack of fusion. A cross section of the weld is shown in Figure 2. In figure 3 is illustrated the lamellar microstructure of the plate material used for the lugs. It is characterized by elongated slag inclusion with a typical interlamellar distance of 0.06 – 0.09 mm. In some of the specimens examined slag inclusions with a length of over 1 mm have been observed, the largest one being over 6 mm in length..

Figure 1. One of the lugs

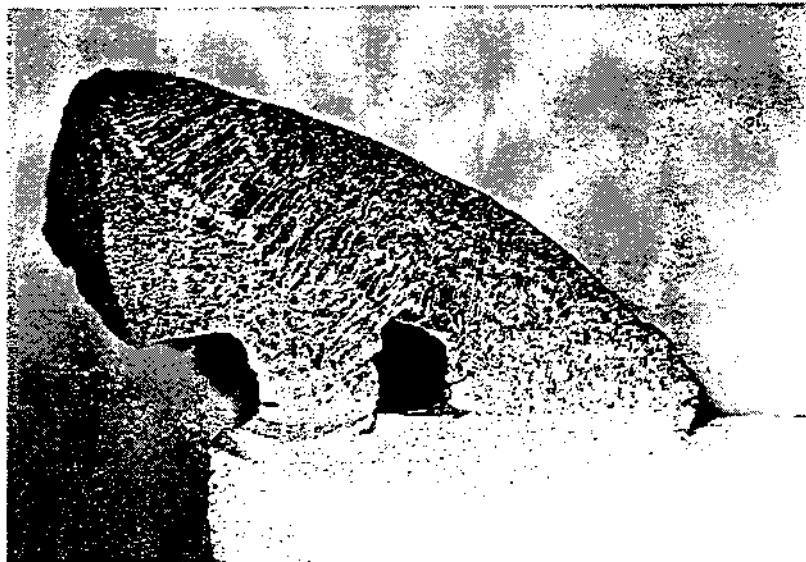
Figure 2. Cross section of fillet weld. Note the large pore, the undercut and poor penetration. 10x.

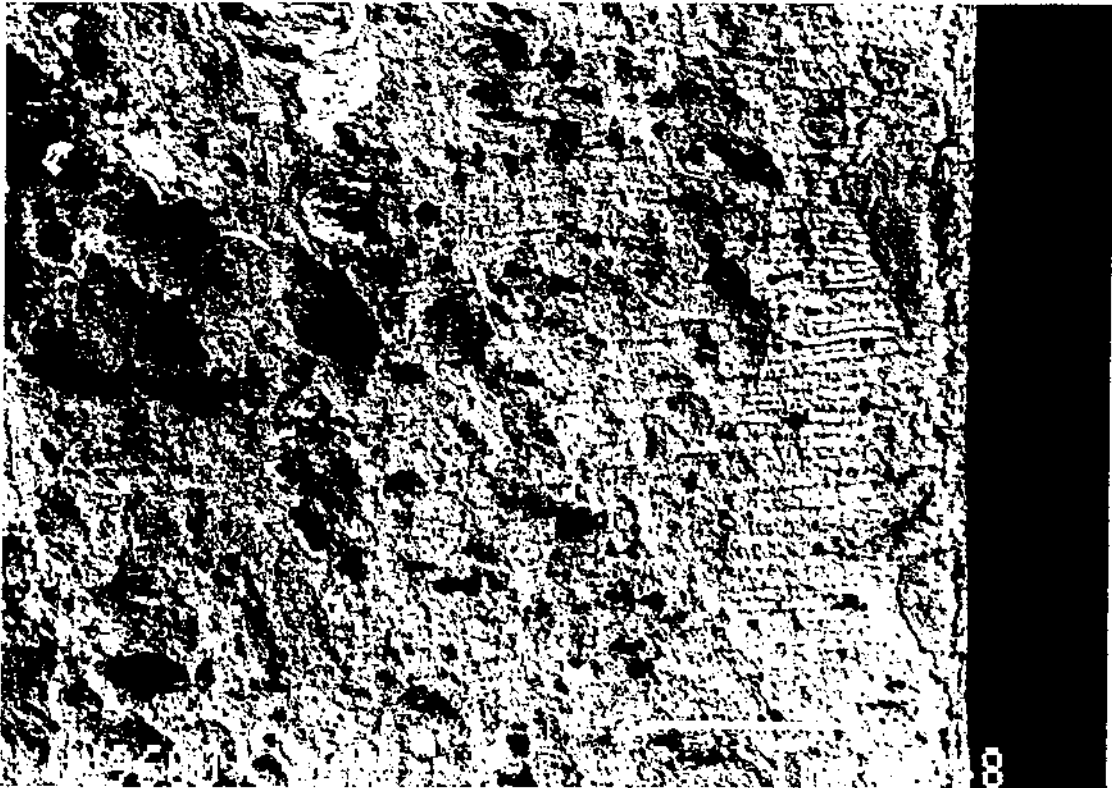
The fracture surface of the plate material welded to the housing insert piece was cleaned with the organic rust remover which in this case removed almost all of the rust. Examination in an optical stereo microscope showed a striation pattern which can also be seen in the SEM picture shown as Figure 9. We again believe that this striation pattern is related to the microstructure of the material which contains elongated inclusions oriented in the same direction as the striation pattern. The material also has a banded perlite-ferrite structure where the perlite and ferrite bands may corrode at different rates and thus give a striated appearance on the cleaned fracture surface. The spacing of the striations, 0.05 mm, matches almost exactly the spacing of the ferrite-perlite bands. Apart from the striations the general character of the fracture surface was of a ductile dimpled type as can be seen in Figure 10. It also gives the impression that the features of the dimples are not as sharp as on the fracture surfaces on the lock lugs which again suggests that this surface has corroded more than the surfaces of the lugs. However this could have been caused by a difference in corrosion properties between the plates used for the different parts.

Figure 9. Fracture surface of hinge. SEM 29x.

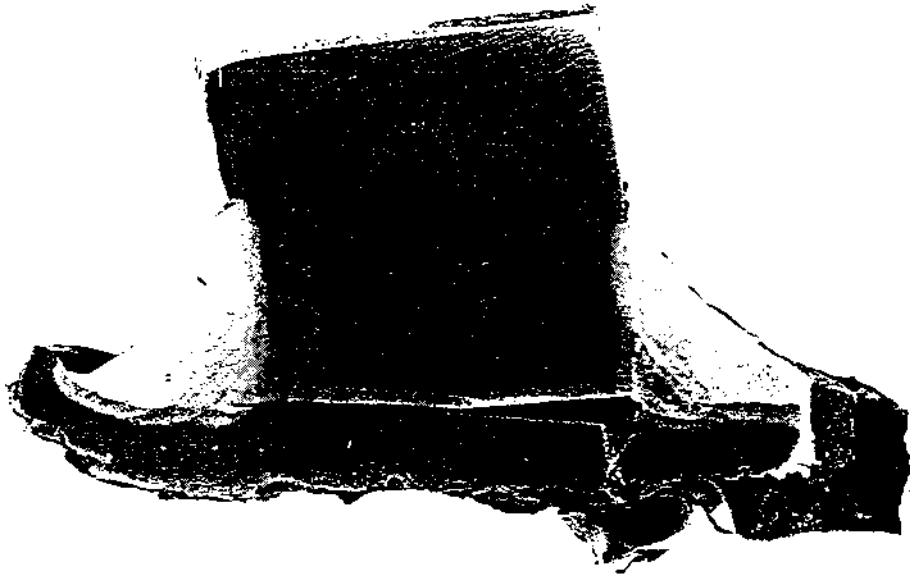
The lugs of the side locks were attached to the 8 mm thick plate. On the other side of the plate was a 20 mm thick support plate. According to the information given to us the support plate was not attached directly under the lug plate but rather a few cm to the side. Sections were made through the 8 mm plate and the two support plates in order to see if these had ever been repaired. One of the sections, from a piece marked SL1, can be seen in Figure 11. It is obvious from the Figure that there has been some deformation of the weld but there is no indication of any repair work having been done to the weld. Apart from a few minor defects the weld looks perfectly sound. There is also some indication of corrosive attack in the crevice between the two weld beads but not so much that there has been any significant threat to the integrity of the weld. It can be that the thickness of the 8 mm plate in this section is only about 4–5 mm. We interpret this as a result of a delamination failure of the plate when the lug was pulled away, a failure mode not unlikely for a plate with an abundance of elongated slag inclusions in the plane of the plate. The triangular gap between the 20 mm plate and 8 mm plate may have been caused by a slight bending of the 20 mm plate relative to the 8 mm plate.

Figure 11 Cross section of side lock specimen marked SL1 (ca 2.5x)

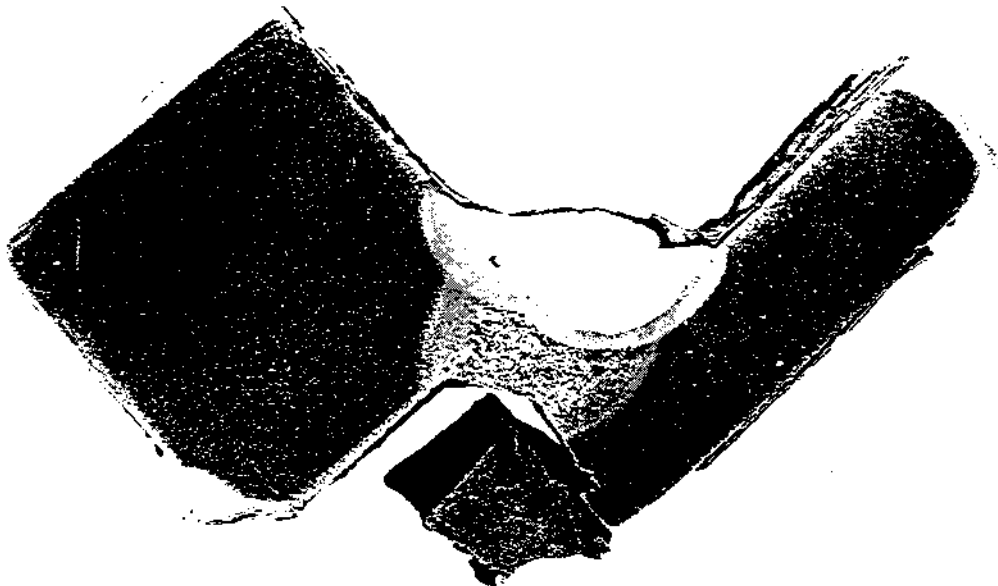
The other cross section, from a piece marked SL2, is shown in Figure 12. Here we note that the etchant has attacked the weld material differently, a difference which suggests that two different electrode materials have been used. The weld is however perfectly sound and there is no indication of any repair work, at least not any work which has impaired the integrity of the weld. The odd feature in Figure 12 is the small apparently loose piece of material just under the support plate. On inspection of the whole piece of 8 mm plate with attached support plate it became clear that the apparently loose piece of material is part of a tongue of material from the 8 mm plate just under the support plate which appears to have been hammered away from the rest of the plate by one or several severe blows to the plate. Such a conclusion is supported by several markings on the 8 mm plate. From the appearance of these markings it seems reasonable to conclude that the markings come from the lug plate which first have been pulled loose from the 8 mm plate and then as a result of movement of the bow visor has struck and slid against the 8 mm plate several times.

Figure 12 Cross section of side lock specimen marked SL2 (ca 2.5x)

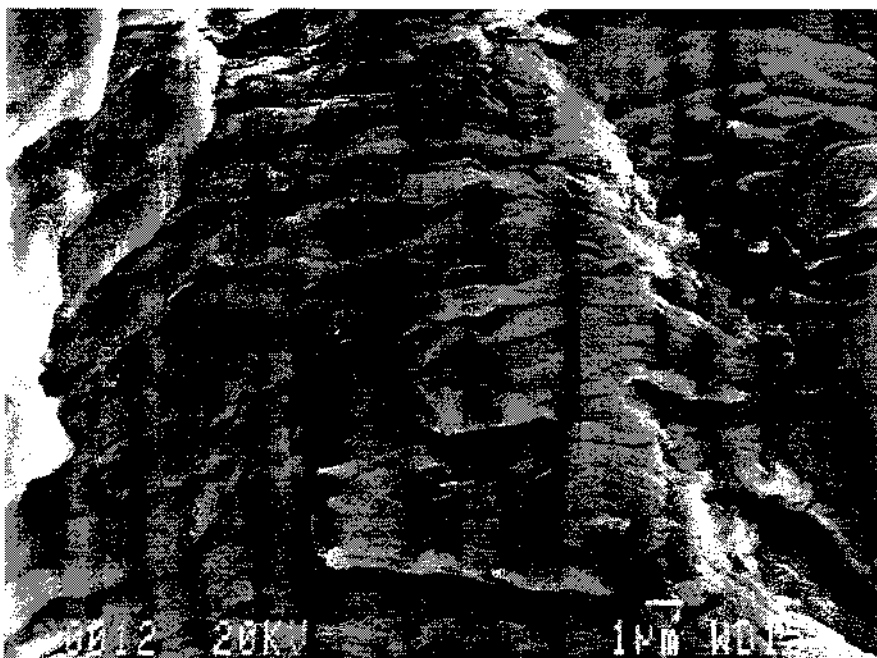
Figure 2. Fatigue fracture surface on laboratory specimen from visor hinge plate. 5000x.

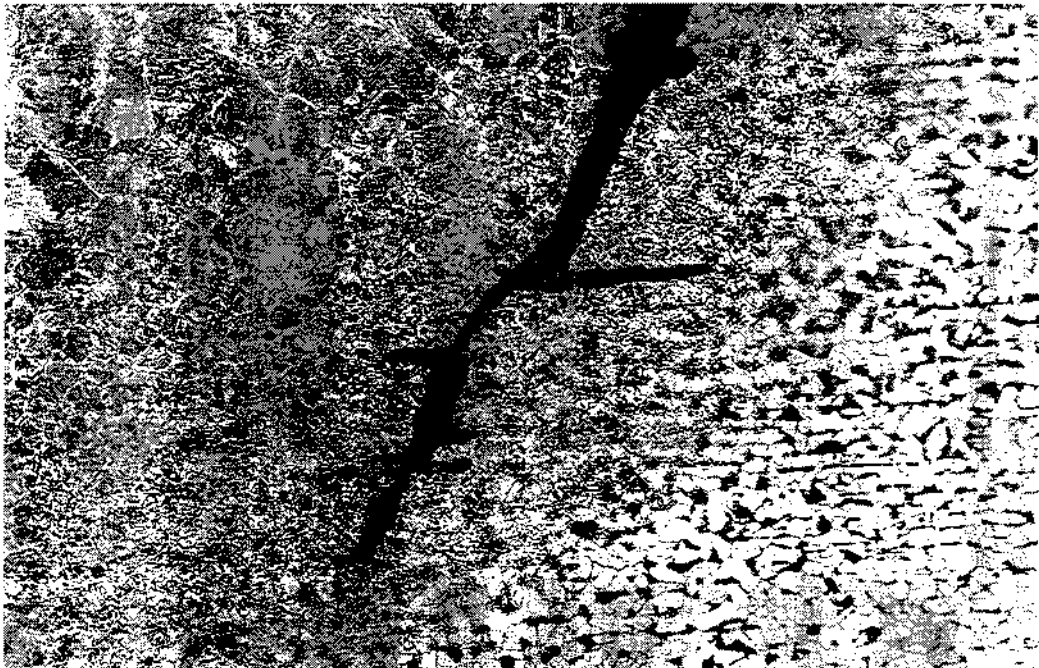
Figure 4. Metallographic cross section of crack in bottom lock weld. 100x.

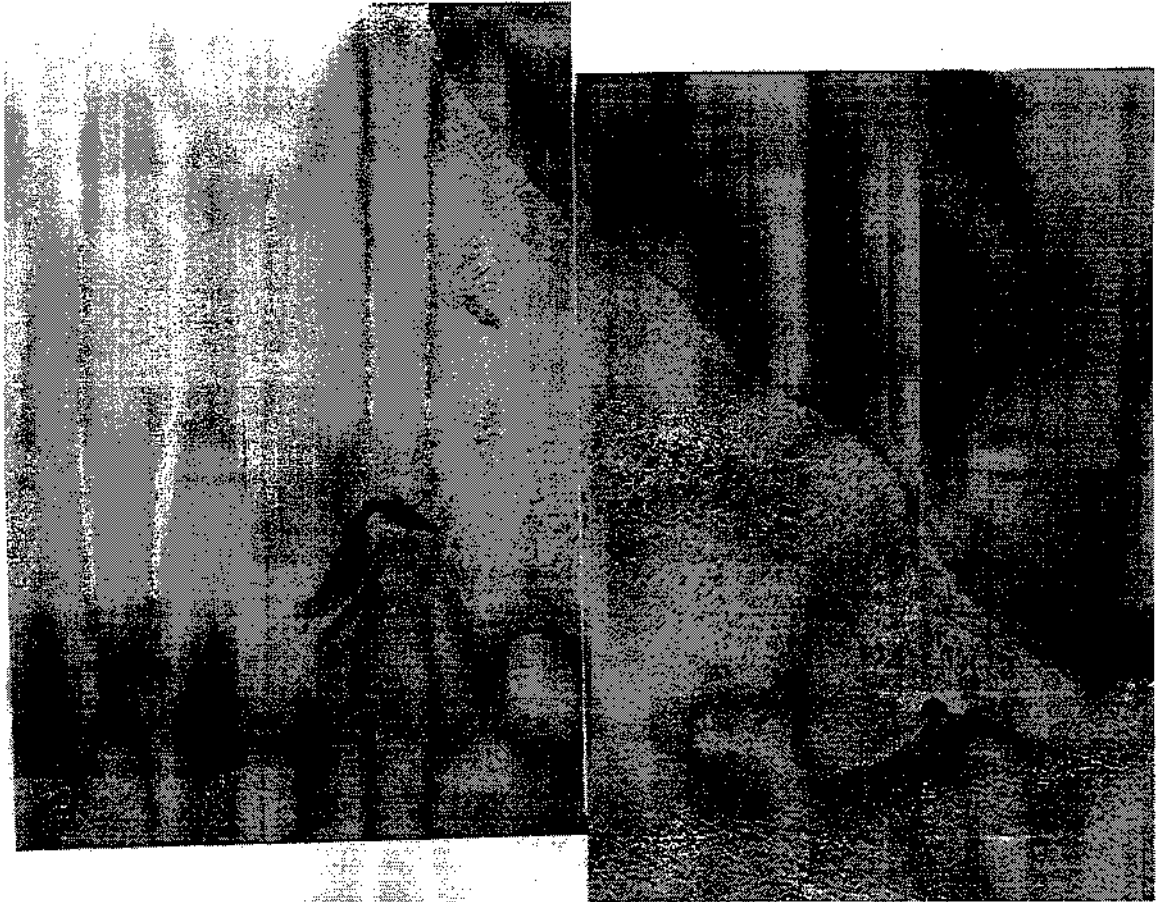
bushing is a bronze cylinder functioning as a bearing. A piece of a hinge on Mare Balticum was cut out in order to provide a comparison with the Estonia hinges. Figure 5 shows a metallographic cross section of the weld between hinge plate and bushing of Mare Balticum. To the left in the figure it is possible to see the heat affected zone after flame cutting of the hole in the hinge plate. Several cavities and a crack can be seen in the weld. In connection with the crack there was a grey-black deposit which we believe is magnetite because it looks like magnetite and is magnetic. This indicates that somewhere along the weld there must be a penetrating defect.

Figure 5. Cross section of weld between hinge plate and bushing on Mare Balticum.
7x.

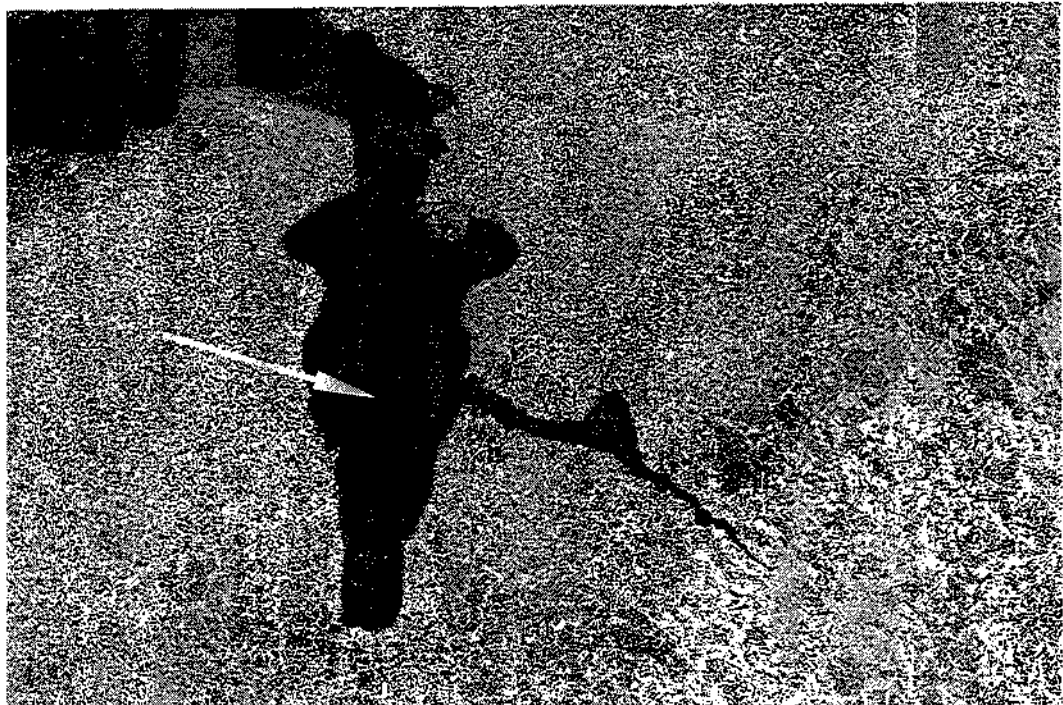
The crack is shown in higher magnification in Figure 6. The wide part marked with an arrow is not actually part of the crack but a cavity formed during welding which just happened to be located in the cross section. The main part of the crack is the branch extending to the right in the figure. It is interesting to note however that a very fine crack has initiated in the bottom of the cavity as shown in Figure 7. This indicates that the hinge is subjected to fatigue loadings which can initiate and grow cracks.

Figure 6. Cross section of weld in higher magnification. The wide part of the crack is actually a pre-existing cavity formed during welding. 50x

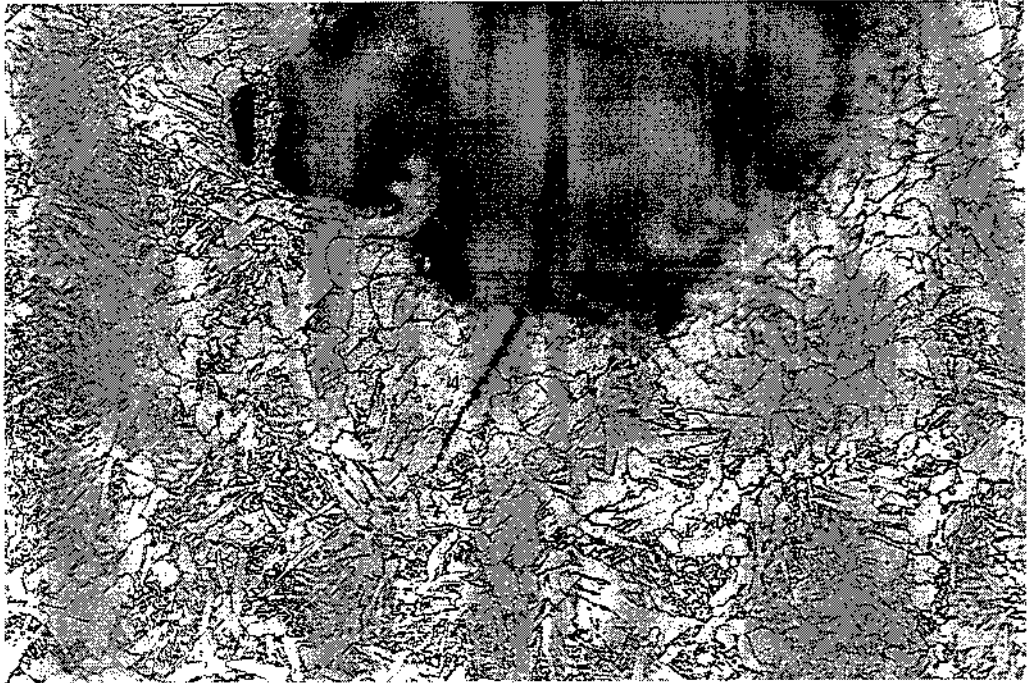
Figure 7. A sharp crack initiated in bottom of cavity, presumably by fatigue. 500x.
