SUPPLEMENT No. 519

Investigation of deformations and related loads, applied to the lug of the visor bottom lock of MV ESTONIA.

MS ESTONIA Bow Visor. Inspection Report of PS-side Hydr. Lifting  
Cylinder.

#### INSPECTION REPORT OF PS-SIDE HYDR. LIFTING CYLINDER

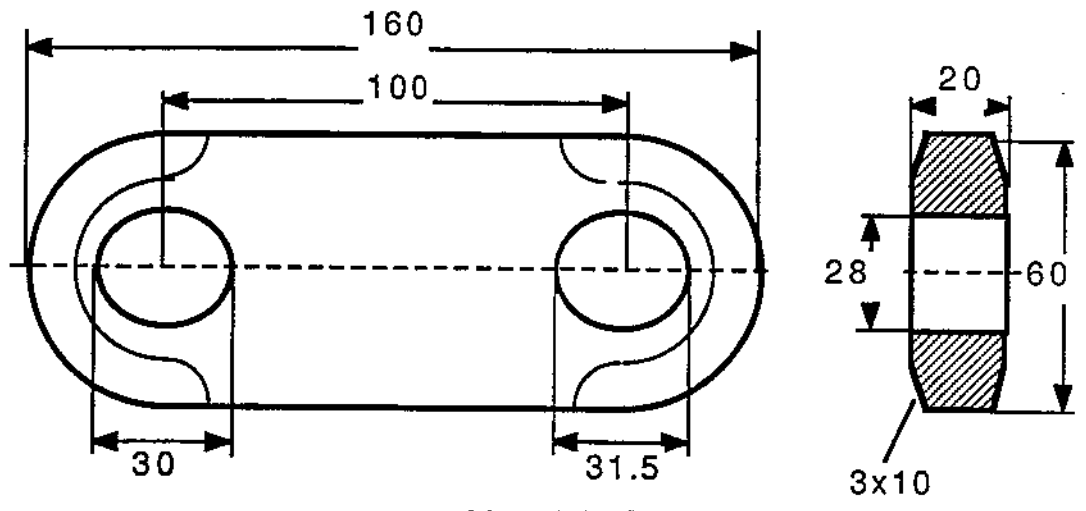
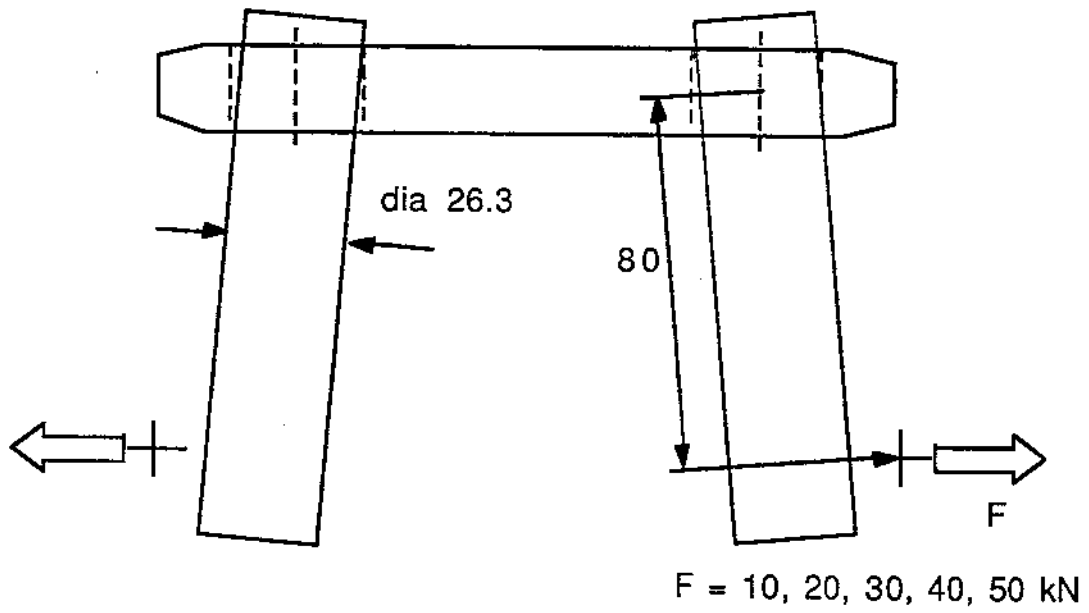
FIGURE 1 TEST SPECIMEN AND TEST ARRANGEMENT

A test specimen was made in one third scale compared to the original. See **Figure 1**. It was manufactured in steel to the Swedish specification SS 2172, being approximately equivalent to the earlier St52. The specimen contained two test sections, arranged back to back. The holes for the locking bolt of diameter 28,0 mm was elongated in the longitudinal direction of the lug by machining to the length of 31.5 mm in one hole (1.) and 30.0 mm in the other (2.) in order to illustrate two different conditions of original wear of the hole. The elongations were located symmetrically around the centre of the original hole.

The loading of the specimen was made at the ends of two bolts of diameter 26.3 mm with dimensions to give an arm of momentum of 80 mm to the centre of the lug. It should however be observed that the arm of momentum decreased substantially during the test due to deformation of the holes and bending of the bolts.

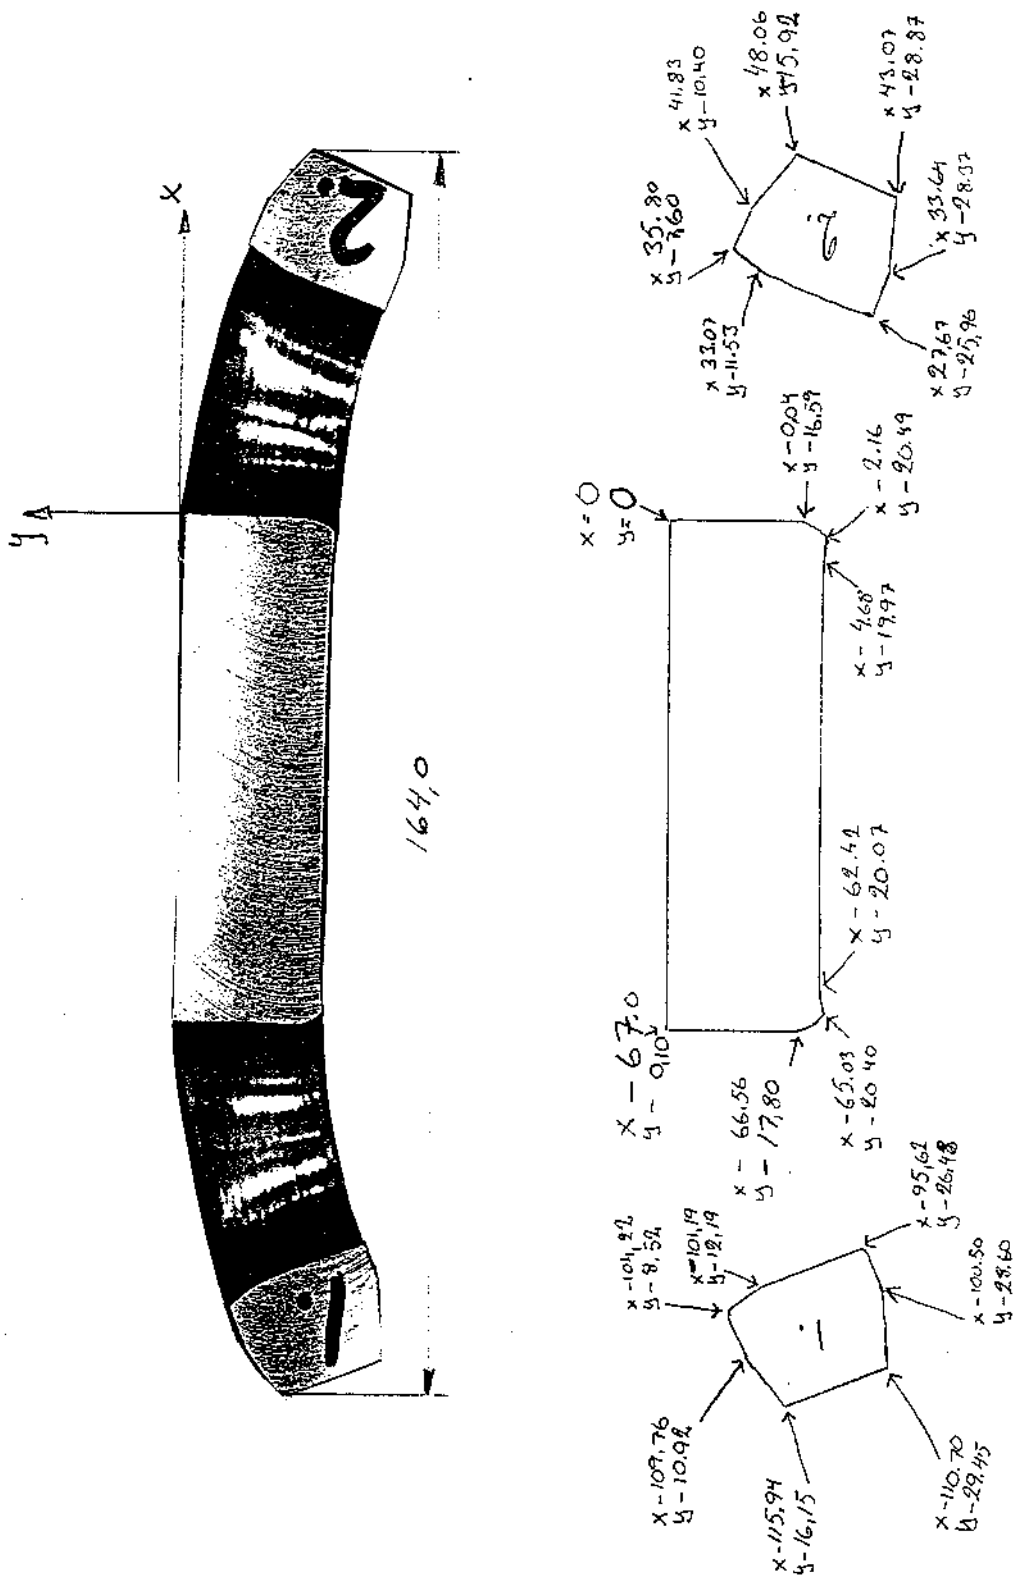
FIGURE 2 SYMMETRY SECTION AFTER TEST

The test specimen was cut apart along its centre line in order to better show the deformation and the contours of the holes. The section of the deformed specimen is shown in **Figure 2**.

It was observed that considerable elongation had taken place in the bolt holes, being close to 1.5 mm in the test scale at mid thickness of the lug. Detailed dimensions are shown in **Figure 2**. Considerable plastic deformation had taken place at the contacting points between the bolts and the edges of the holes. Some plastic deformation was also noted on the bolts, resulting in a smoothening of the contact pressure distribution. The elongation was not accompanied by any increase of the length of the entire specimen in the bent condition.

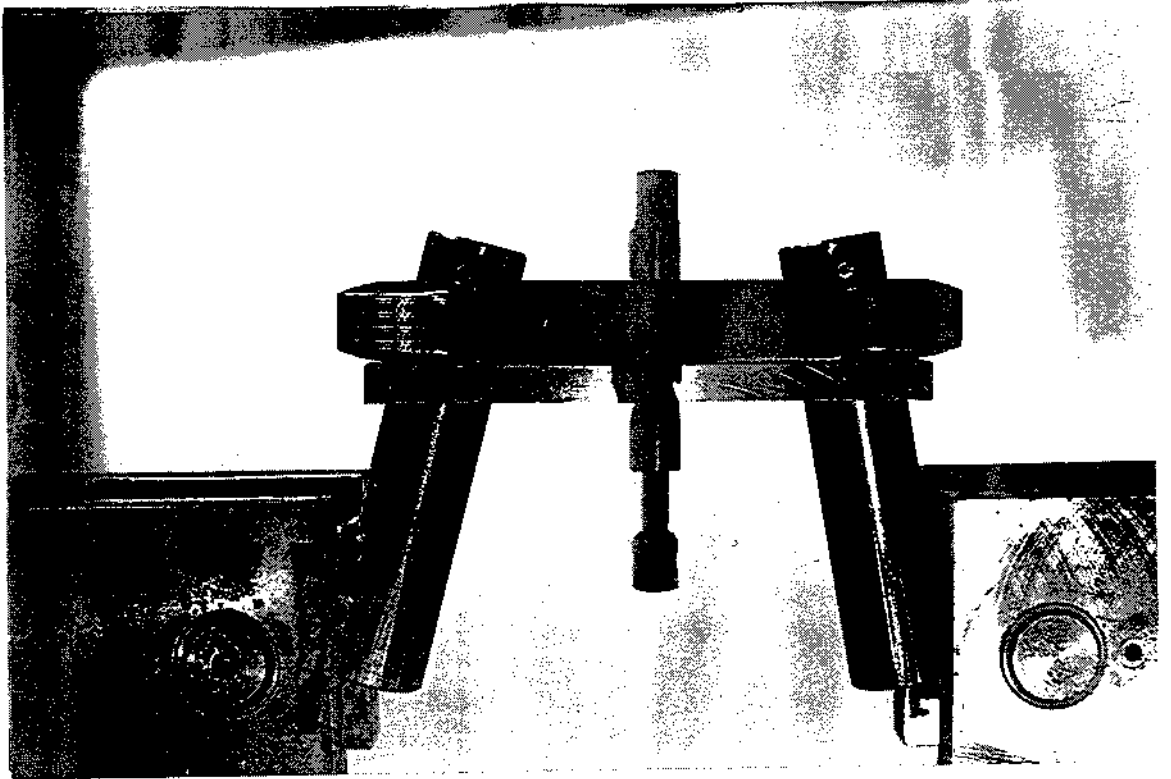
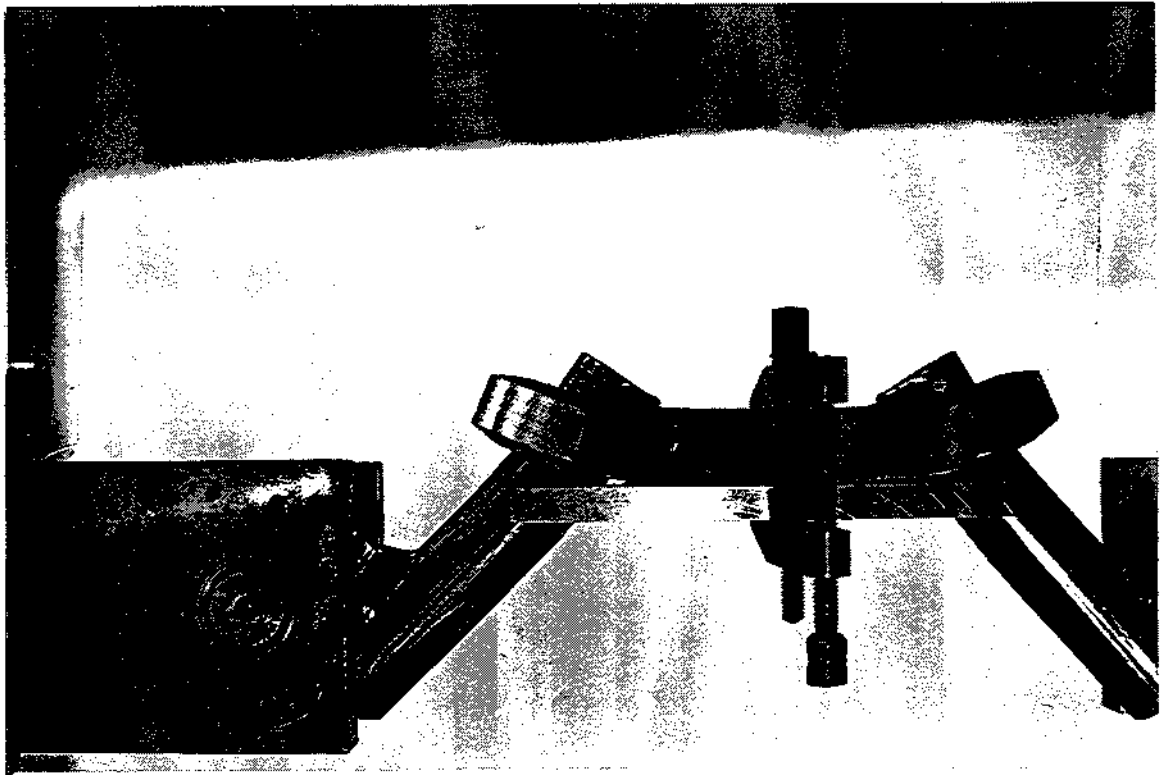
FIGURE 3 TEST SET UP AT 0.1 kN AND 50 kN

Photos of the test set up at 0.1 kN and 50 kN respectively in **Figure 3** demonstrates the decrease of the arm of momentum due to deformations.

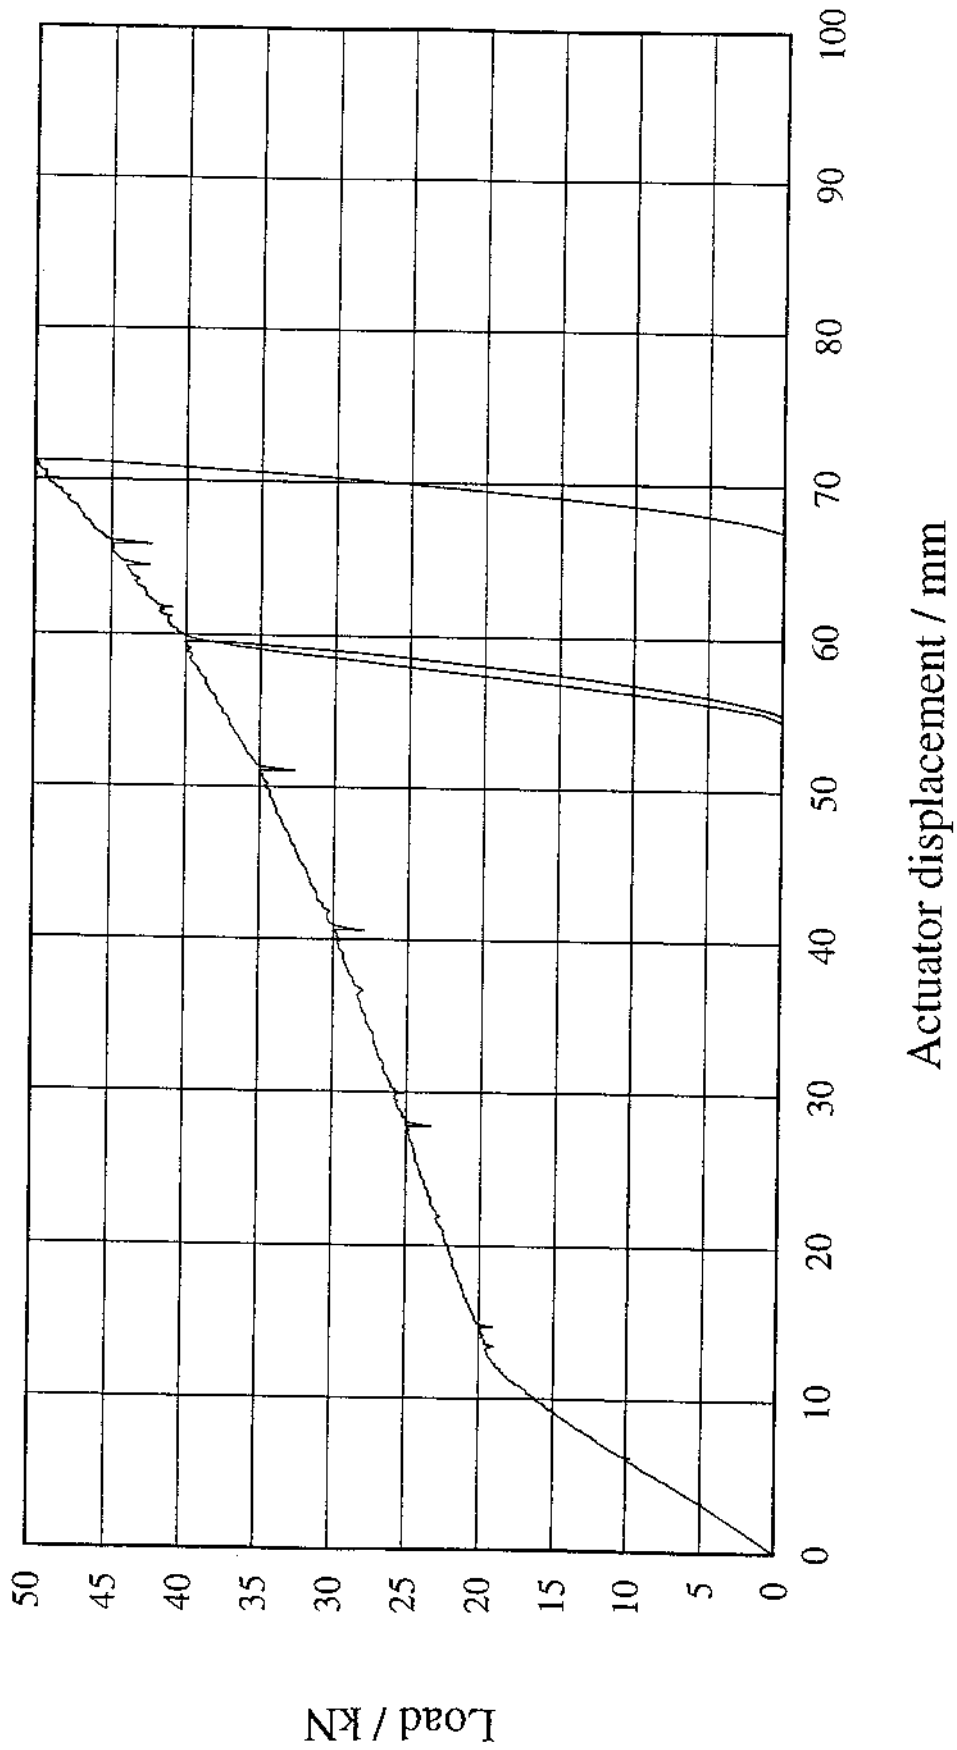
FIGURE 4

The test specimen was loaded in increments of 10 kN. It was photographed at each load level. The length of the lug and the deflection in way of the centre of the hole were measured at each step. Plastic deformation started to develop at the edges of the holes at 10 kN. Loading was continued until the deformation as measured as the angle between the stem of the lug and the bolt was about 30 degrees. This could not be determined accurately during the test as the bolts themselves showed significant bending. The testing was suspended at a load of 50 kN. Load versus loadpoint displacement is shown in **Figure 4**.
