SUPPLEMENT No. 525

Report. Damage to bow visor locking devices of passenger car ferry "DIANA II" in January, 1993, and preliminary conclusion i.r.o. the loss of the bow visor of m.v. "ESTONIA" on September 28th, 1994.

REPORT

Damage to bow visor locking devices of passenger car ferry "DIANA II" in January, 1993. and preliminary conclusion i.r.o. the loss of the bow visor of m.v. "ESTONIA" on September 28th, 1994

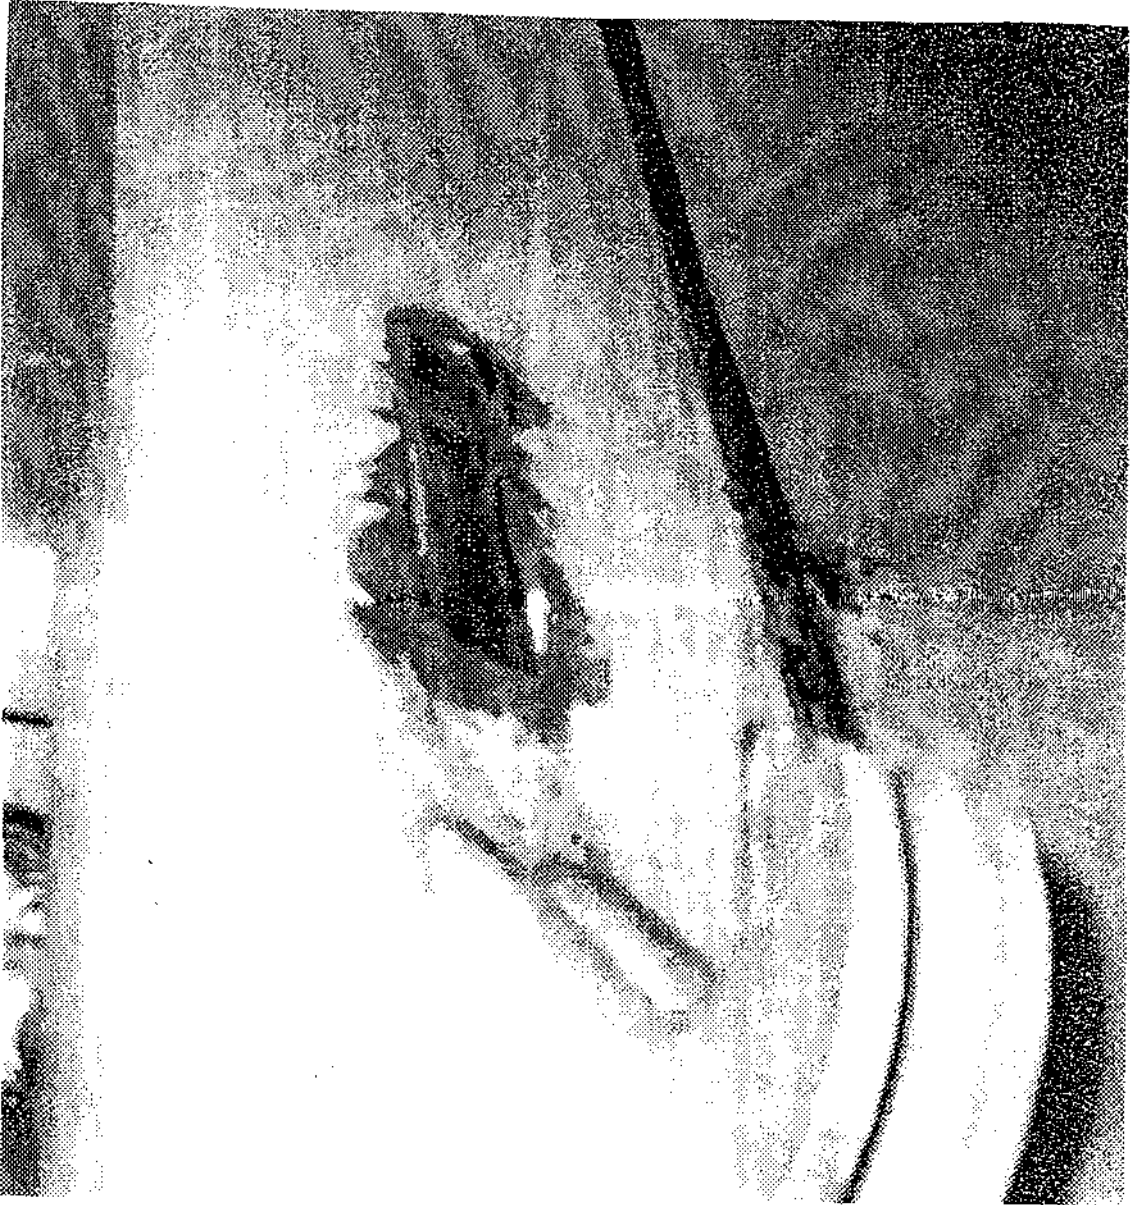
"DIANA II"

The lug for SB lock plunges was lost.

PICTURE OF THE DAMAGED BOW VISOR'S SB SIDE LOCK

The lug SB side renewed, with a doubling plate on the back side.

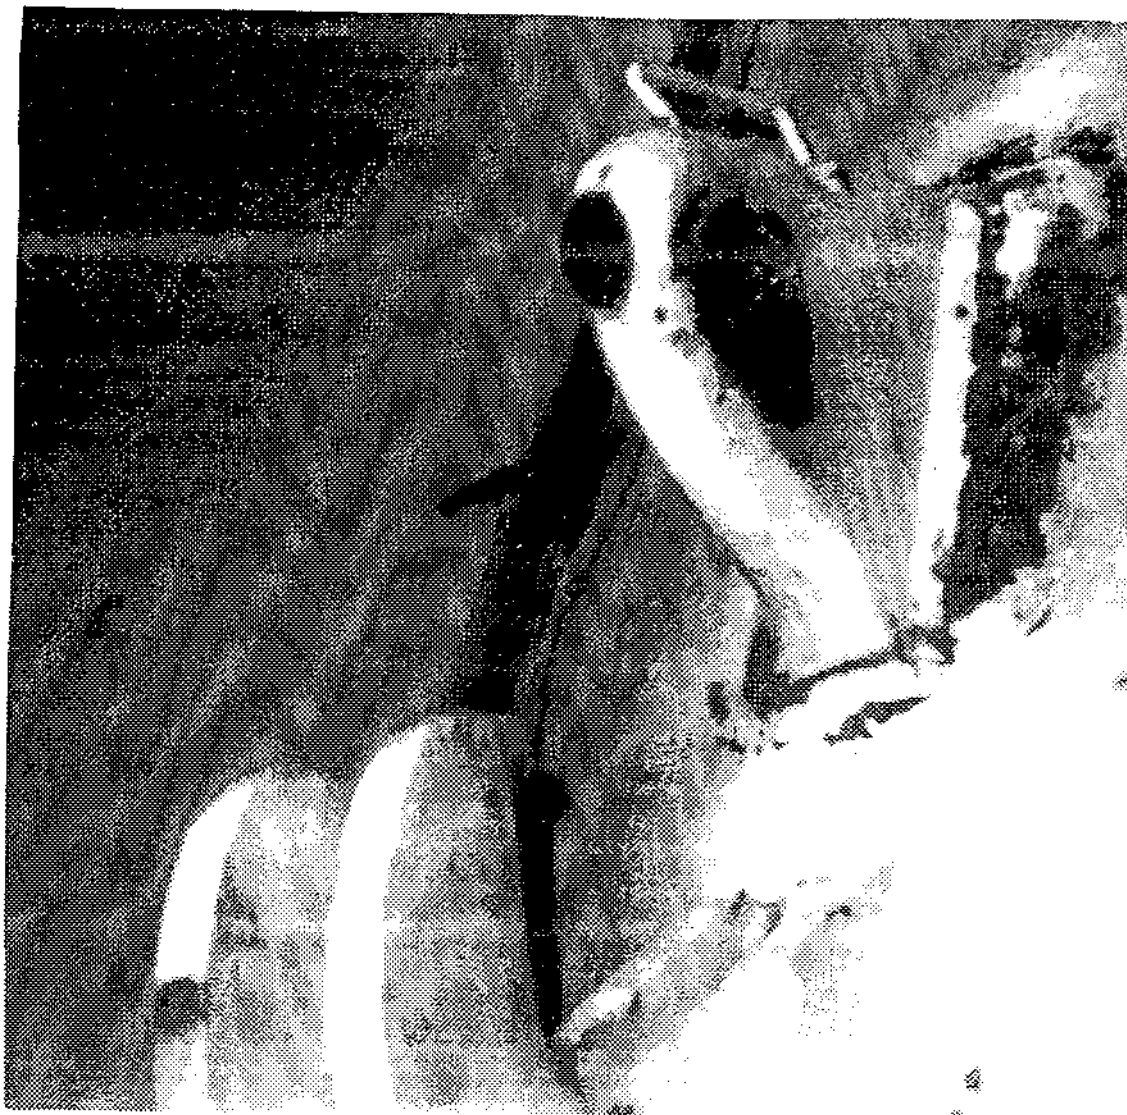
"DIANA II"

The lug for Port side lock plunges was bent and the weld cracked. A minor crack at the hinge on SB side.

PICTURE OF THE DAMAGED BOW VISOR'S PORT SIDE
LOCK

The lug Port side faired and the crack chiselled and welded.

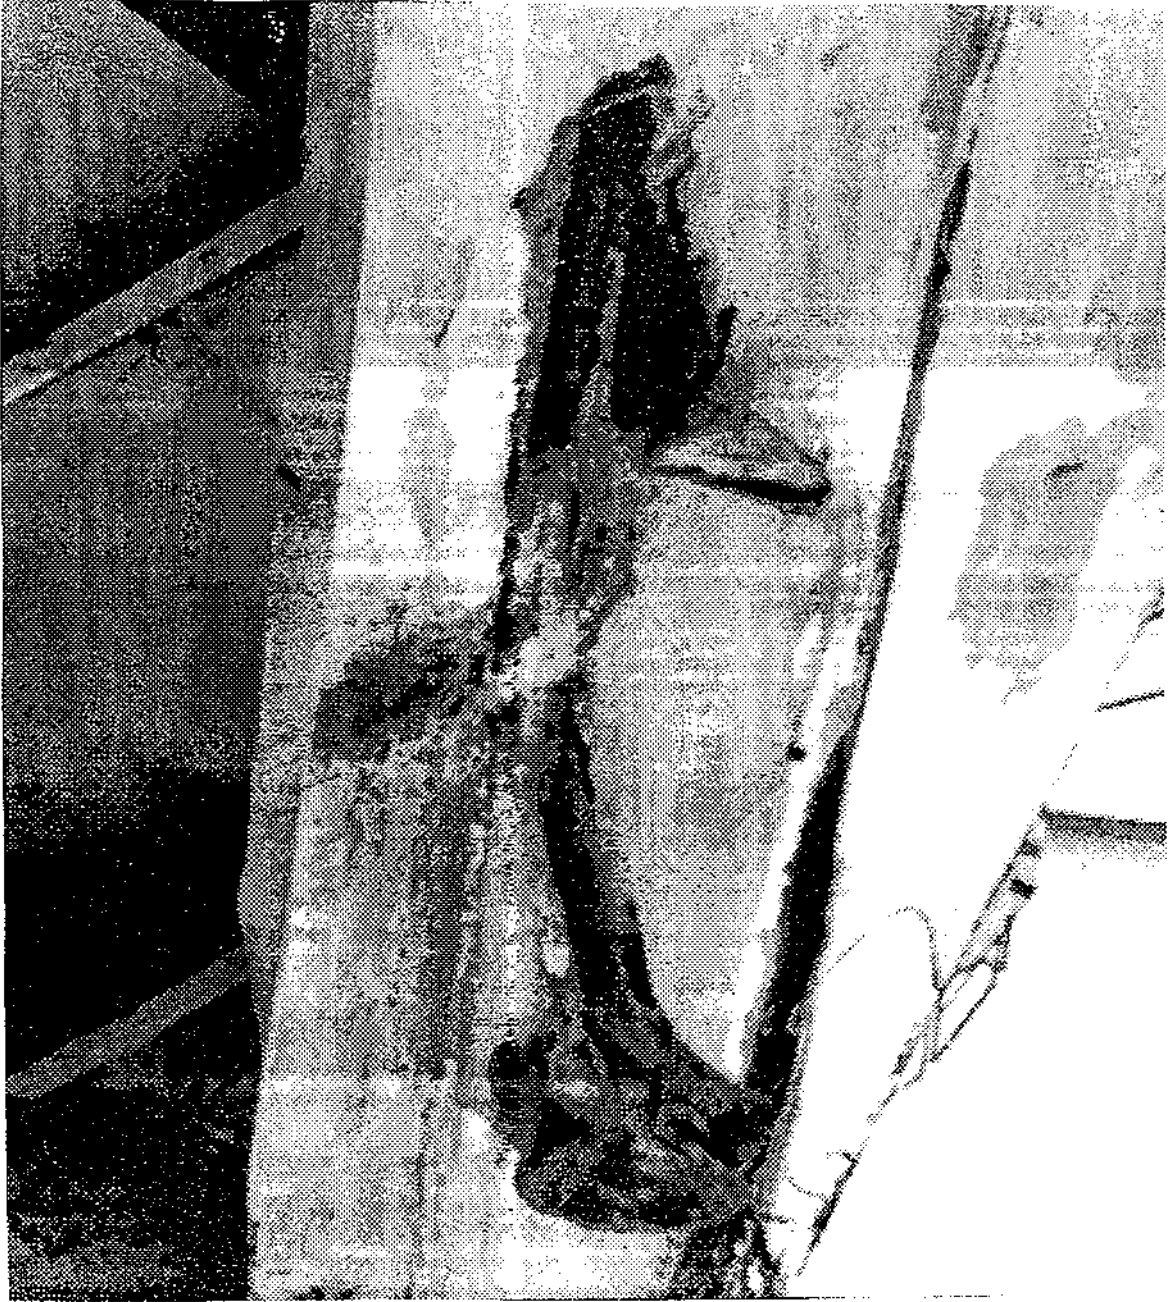
"ESTONIA"

PICTURE OF THE DAMAGED BOW VISOR'S SB SIDE
LOCK

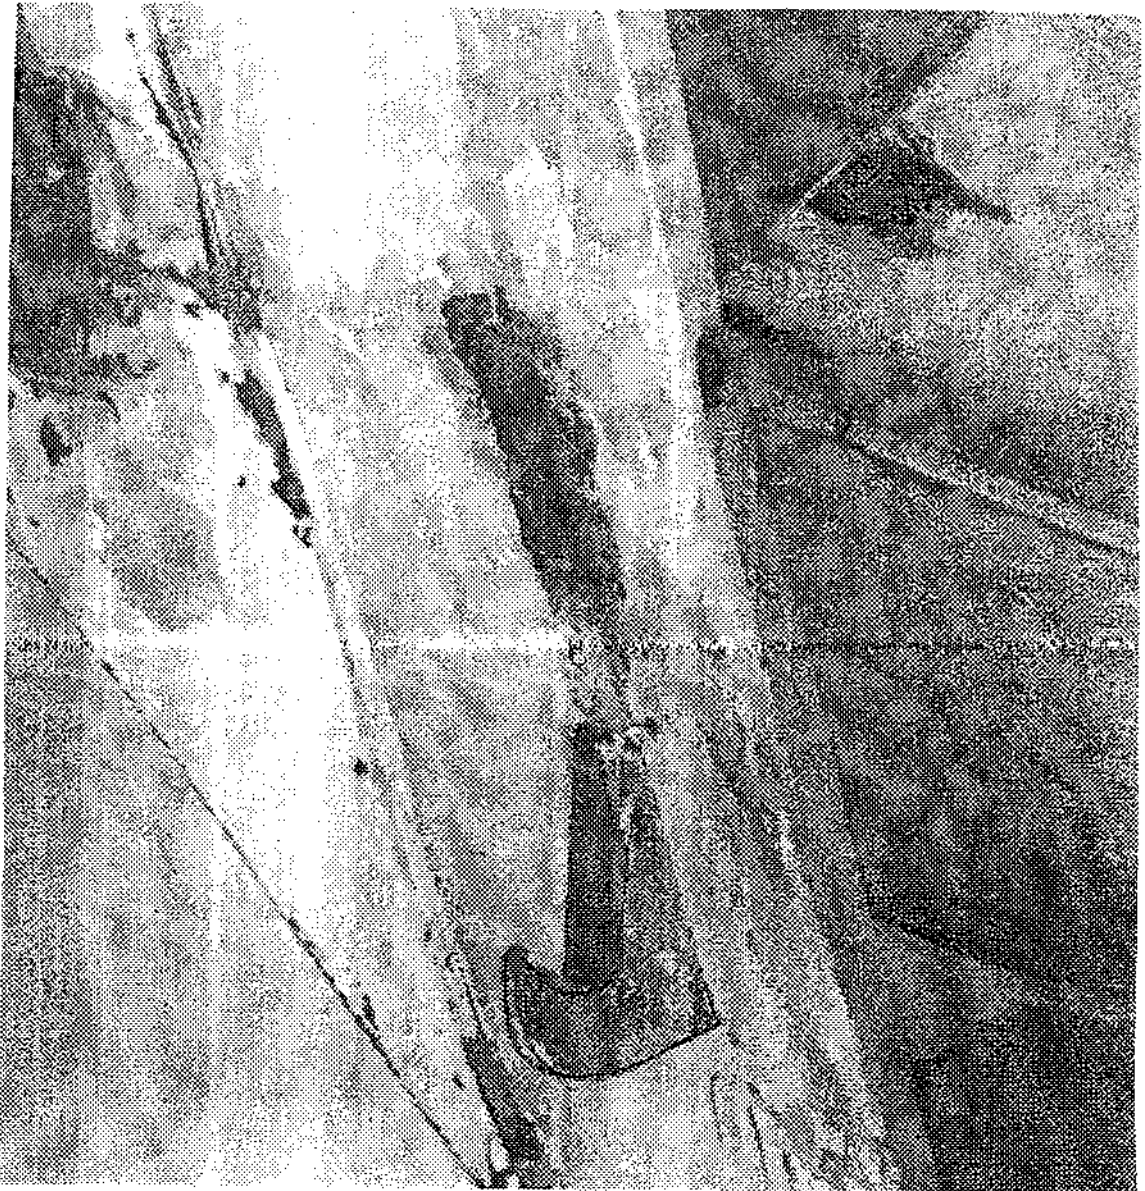
"ESTONIA"

PICTURE OF THE DAMAGED BOW VISOR'S PORT SIDE
LOCK
