Tutkintaselostus

D14/2008M

Kahden henkilön tajunnan menetys lastitankissa 4.11.2008 säiliöaluksella

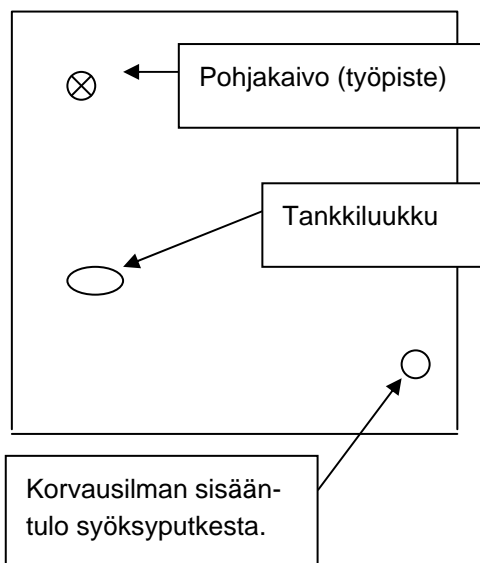
Riittämätön tuuletus mahdollistaa paikallisten kaasutaskujen muodostumisen tankkiin, ko. tankissa työntekijät olivat mahdollisesti tuuletuksen katvealueella, koska työskentelivät syöksytorvesta katsottuna tankkiluukun toisella puolella.

Kuva 6. Tankki ylhäältä päin katsottuna.

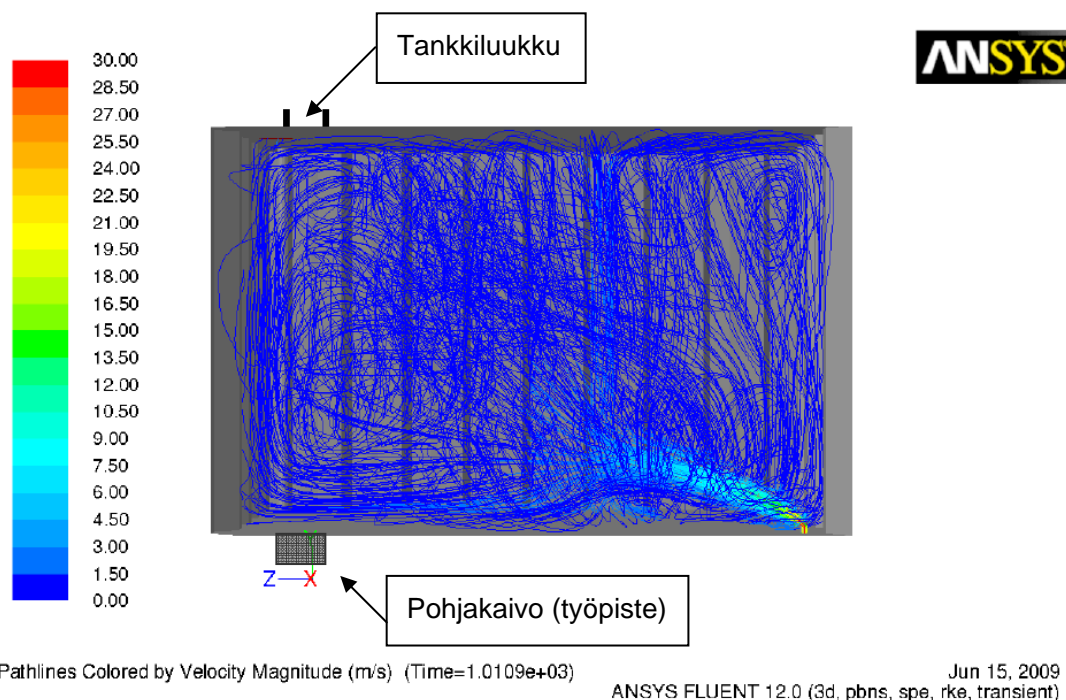
Ilmanvaihto turmatankissa oli alhainen tuuletuksen aikana, etenkin, kun muita tankkeja tuuletettiin samaan aikaan samalla tuulettimella. Asiantuntijan mukaan ilman likaisessa ko. tankin kokoisessa tilassa tulee vaihtua vähintään $3960 \text{ m}^3/\text{h}$. Esimerkkinä voidaan mainita myös pumppuruuman tuuletus vaatimus 20 ilmatilan vaihtoa tunnissa.

Kuva 7. Kuva varustamon tekemästä tutkielmasta tankin tuuleuksesta. Se kuvaa tilannetta aluksella kun tankkiluukku on auki. Näin tuuletettaessa pelkästään suojavaasupuhaltimella on ohjeellinen tuuletusaika noin 6 tuntia.

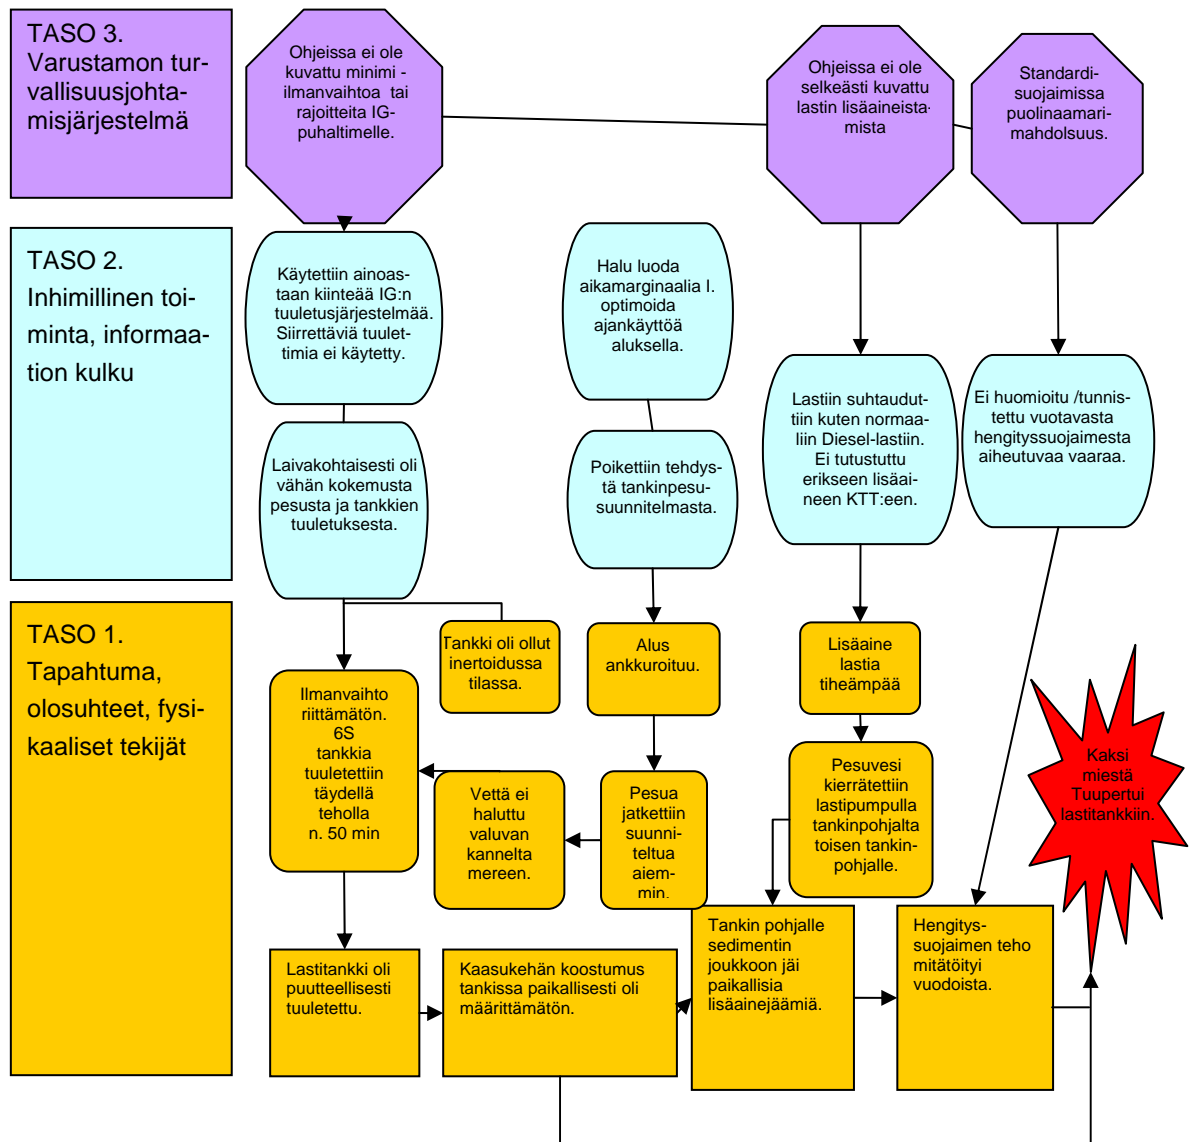
Kuva 7. Syyanalyysikaavio

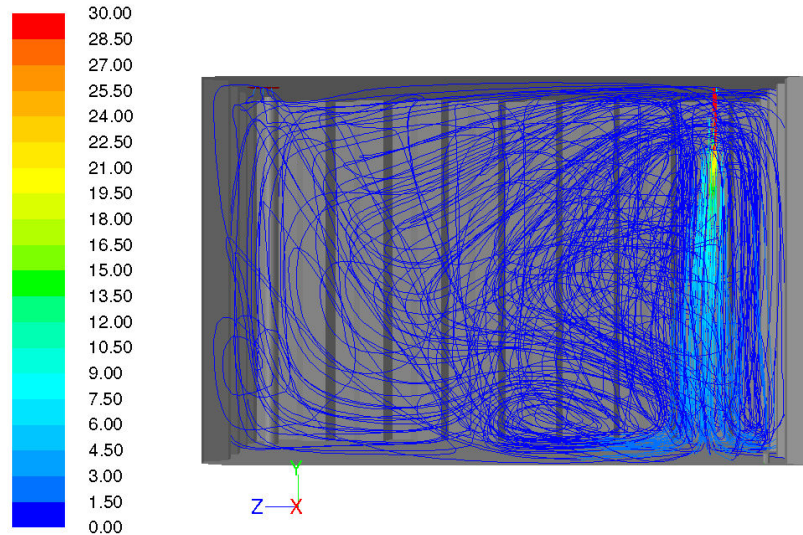
Kuvan 5 mukaan ilma sekoittuu hyvin tankissa vaikkakin suurimmat virtausnopeudet pysyvät lähellä sisääntuloa. Miesluukun lähellä virtaus on hidasta, mutta pitkällä tuuletusajalla ilma sekoittuu melko hyvin.

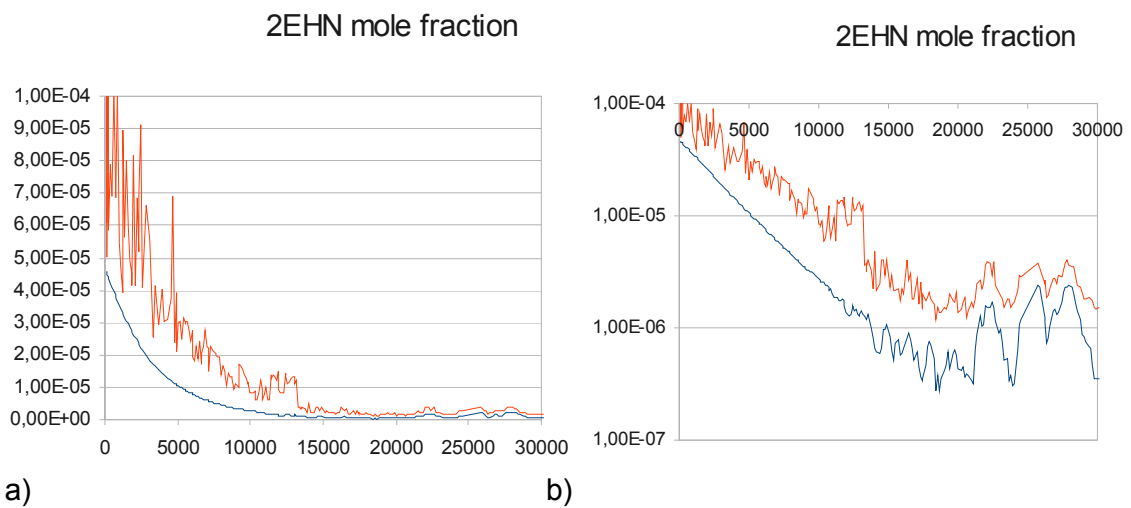
Kuva 6. a) 2EHN:n mooliosuus tankissa ajanfunktiona (sekunteina) b) logaritmisella skaalalla. Maksimiarvo on punaisella ja keskiarvo sinisellä.

Kuvassa 6 2EHN:n maksimiarvo on simuloinnin alkuvaiheessa hieman heiluva ja ajoittain syntyy maksimiarvoja. Nämä saattavat osittain riippua laskennan tarkkuudesta, mutta koska kaasut sekoittuvat melko hyvin tankissa, niin pitkä tuuletusaika poistaa haitallisen kaasun varmasti. Ajanfunktio logaritmisessa skaalassa on hyvin lineaarinen, niin sitä voi jatkaa riippuen miten pieni pitoisuus on toivottu. Ekstrapoloiden kuvaa 6 maksimipitoisuuden raja-arvo 1 ppm saavutetaan noin kuudessa tunnissa.

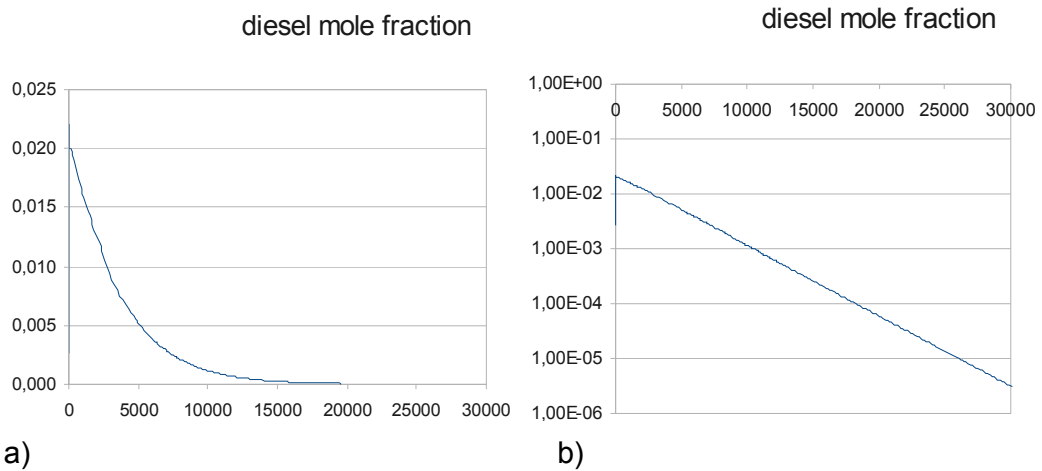
Kuva 7. Dieselin konsentraatio tankissa ajan funktiona (sekunteina). b) logaritminen skaala

Räjähdyksikaasun, tässä tapauksessa diesel-ilmaseoksen, pitoisuus vähenee hyvin tasaisesti ajan funktiona. Kolmessa tunnissa ja 45 minuutissa mooliosuus tippuu suunnilleen 500 ppm:ään, eli räjähdysvaaraa ei ole.

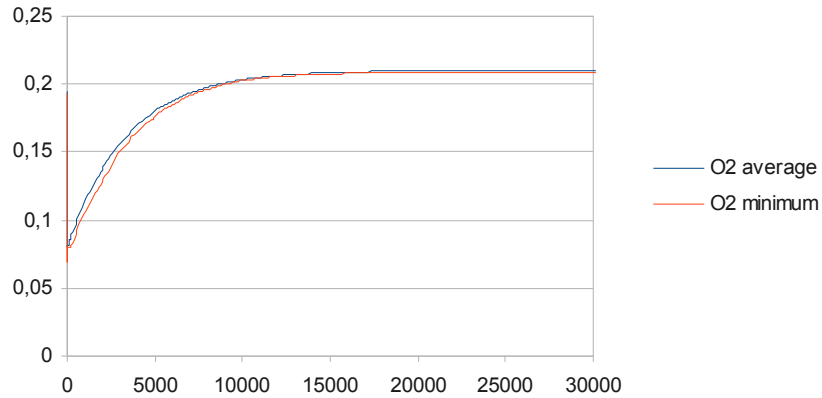
Kuva 8. Hapen mooliosuus tankissa ajan funktiona (sekunteina).

Kuva 8 mukaan happikonsentraatio saavuttaa normaalilukemia noin 13500 sekunnin kuluttua, mikä tarkoittaa 3 tuntia ja 45 minuuttia. Tämän jälkeen muutokset ovat hyvin pieniä.

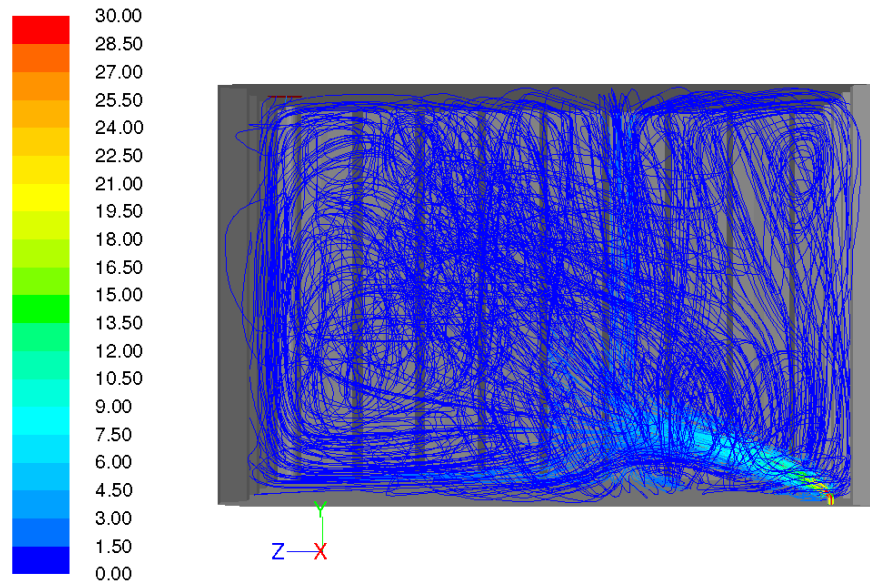
Kuvan 9 mukaan ilma sekoittuu hyvin tankissa vaikkakin suurimmat virtausnopeudet pysyvät lähellä syöksylinjan sisääntuloa. Miesluukun lähellä virtaus on hidasta, mutta ilma kiertää joka paikassa.

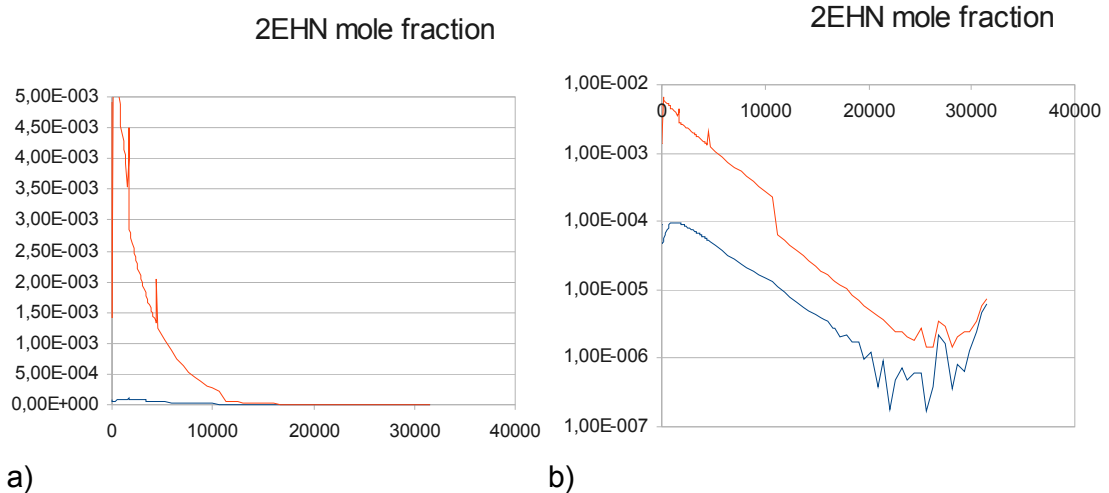
Kuva 10. a) 2EHN:n mooliosuus tankissa ajanfunktiona (sekunteina) b) logaritmisella skaalalla. Maksimiarvo on punaisella ja keskiarvo sinisellä.

2EHN:n maksimiarvo nousee simuloinnin alkuvaiheessa. Tuloksista nähdään että uuden ilman virratessa sisään se työntää tankissa olleen kaasun syrjään ja syntyy hetkellisiä maksimiarvoja. Pitkää tuuletusaikaa tarvitaan poistamaan haitallinen kaasu, ekstrapoloidessaan tässäkin tarvitaan noin 6 tuntia että maksimipitoisuus saavuttaa raja-arvon 1 ppm.

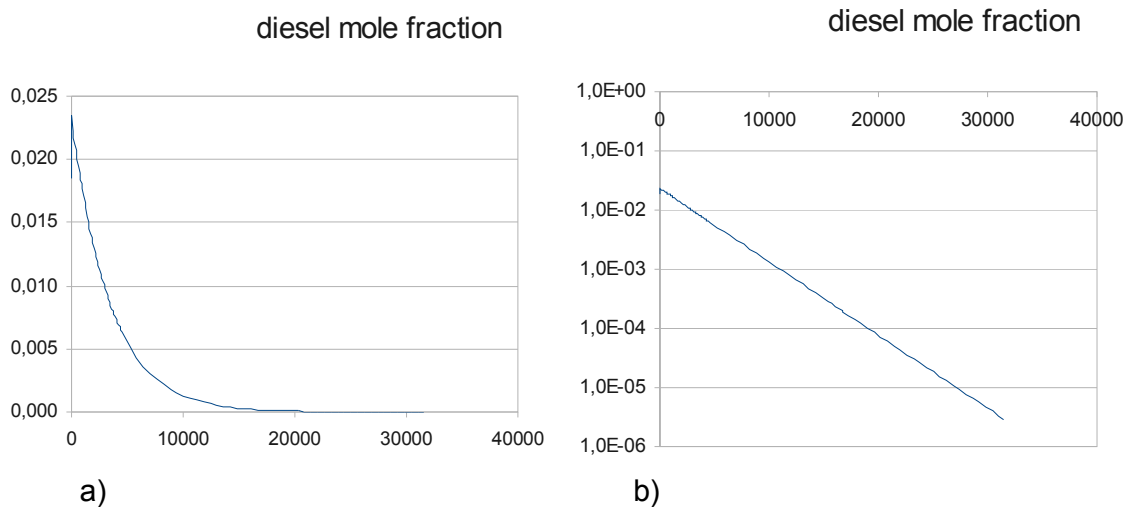
Kuva 11. Dieselin konsentraatio tankissa ajan funktiona. b) logaritminen skaala

Räjähdykskaasun pitoisuus vähenee hyvin tasaisesti ajan funktiona. Siinä ajassa kun 2EHN:n on tuuletettu pois, niin räjähdysvaaraa ei enää ole.

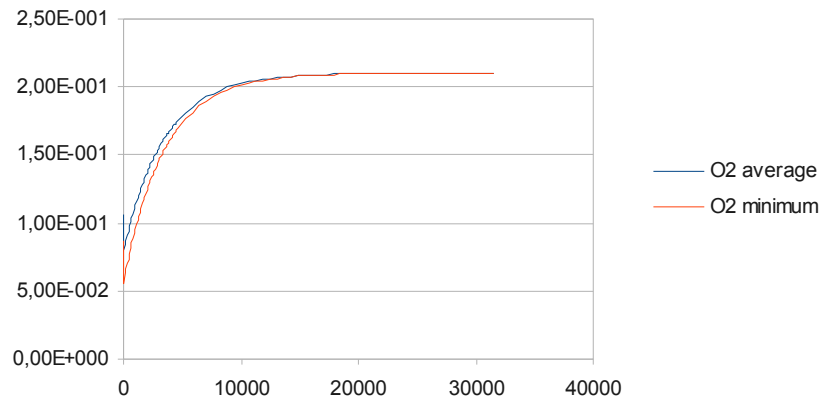
Kuva 12. Hapen mooliosuus tankissa ajan funktiona.

Kuva 12 mukaan happikonsentraatio saavuttaa normaalilukeman samassa ajassa kuten edellisessä tapauksessa. Tämän jälkeen muutokset ovat hyvin pieniä. Koska sekoittuminen on hyvä, niin tuuletusaika ratkaisee. Tässä tapauksessa vaadittava tuuletusaika on noin 4 tuntia hapen osalta.

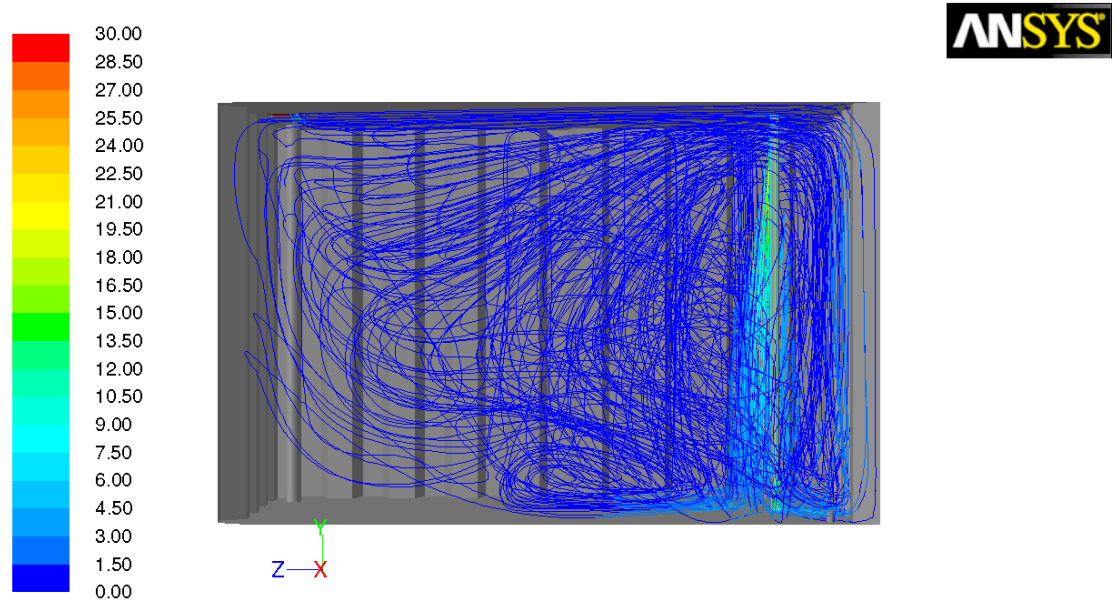
Kuvan 14 mukaan suurimmat virtausnopeudet pysyvät lähellä sisääntuloa. Miesluukun alla virtaus on hyvin hidasta, mutta pitkällä tuuletusajalla ilma sekoittuu melko hyvin. Tässä tapauksessa kun ilmamäärä on suurempi niin pituisuudet tippuvat nopeammin.

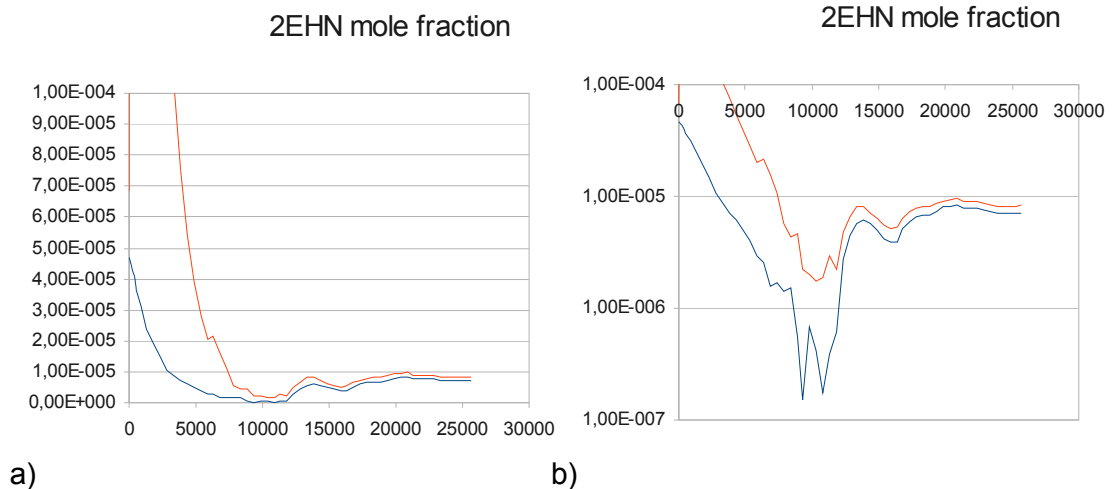
Kuva 15. a) 2EHN:n mooliosuus tankissa ajanfunktiona b) logaritmisella skaalalla. Maksimiarvo on punaisella ja keskiarvo sinisellä.

2EHN:n maksimiarvo nousee simuloinnin alkuvaiheessa, niin kuin edellisessä laskennassakin. Laskennan puolivälissä näkyy selvästi milloin laskennan tarkkuus ei enää riitä hyvin pienille pitoisuuksille ja käyrät rupeavat heilumaan. Koska on tiedossa että pitoisuudet laskevat ajan funktiona loputtomiin niin uutta tarkempaa laskentaa ei tässä vaiheessa tehty, vaan pitää vain jättää virheellisen loppuosa huomioimatta.

Tarvittava tuuletusaika tässä tapauksessa on huomattavasti lyhyempi kuin edelliset. Periaate on kuitenkin sama että 5-6 viipymäaikaa tarvitaan. Tässä tapauksessa 1 ppm:n raja-arvo saavutetaan noin 3.5 tunnin jälkeen.

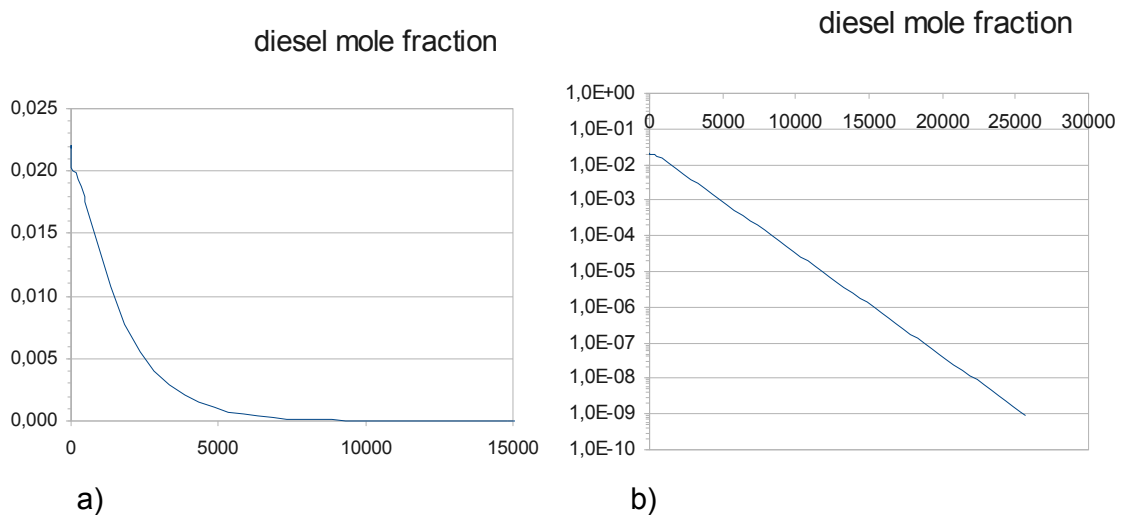
Kuva 16. Dieselin konsentraatio tankissa ajan funktiona. b) logaritminen skaala

Räjähdyskaasun pitoisuus vähenee hyvin tasaisesti ajan funktiona. Siinä ajassa kun 2EHN:n on tuuletettu pois, niin räjähdysvaaraa ei enää ole.

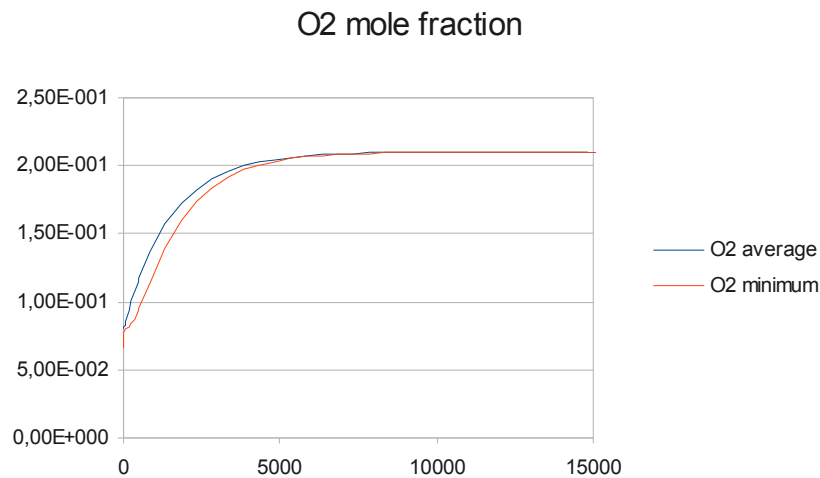
Kuva 17. Hapen mooliosuus tankissa ajan funktiona.

Kuva 17 mukaan happikonsentraatio saavuttaa normaalilukemia noin kahdes-
sa tunnissa. Tämän jälkeen muutokset ovat hyvin pieniä.

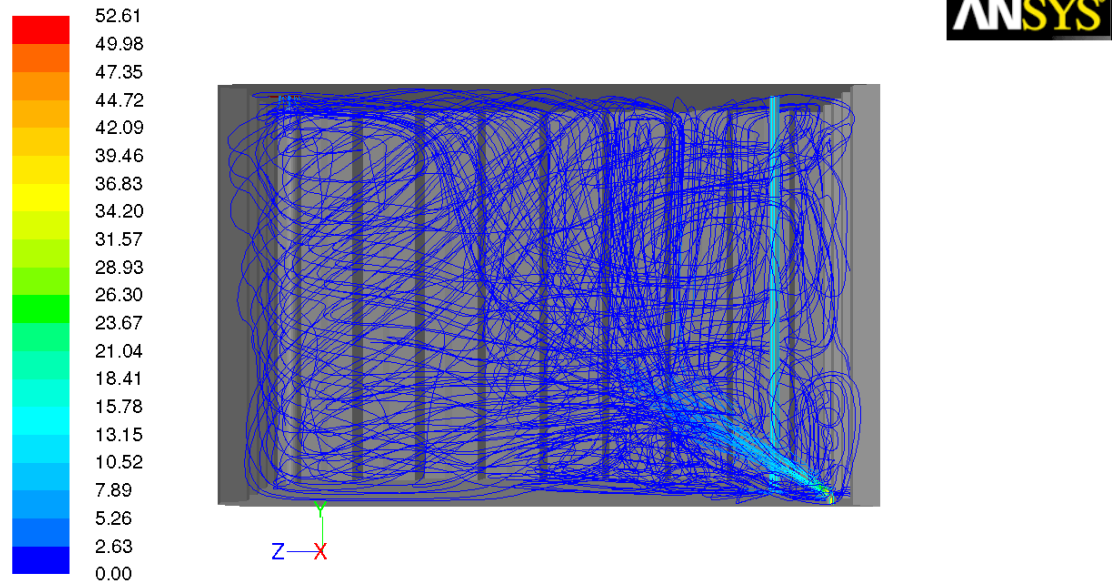
Kuvan 18 mukaan ilma sekoittuu erittäin hyvin tankissa ja virtausnopeudet kasvavat muuallakin kuin lähellä sisääntuloa. Miesluukun lähellä havaitaan virtausta ja tämä puhallinjärjestely vaikuttaa sekoitusmielessä järkevältä.

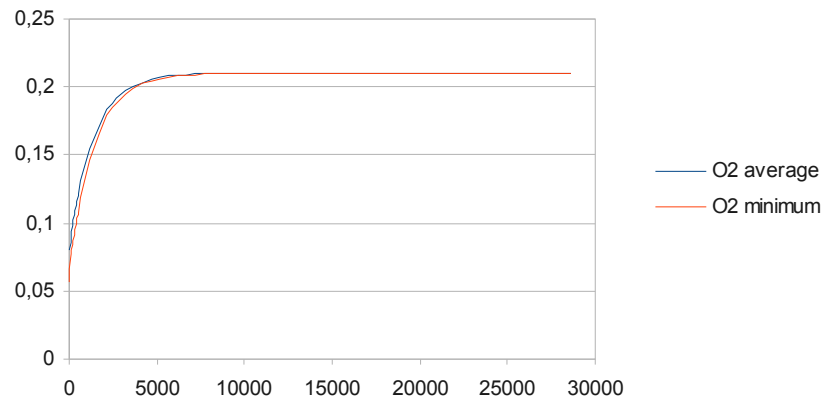
Kuva 21. Hapen mooliosuus tankissa ajan funktiona.

Kuva 21 mukaan happikonsentraatio saavuttaa normaalilukemia noin kahdessa tunnissa. Tämän jälkeen muutokset ovat hyvin pieniä.

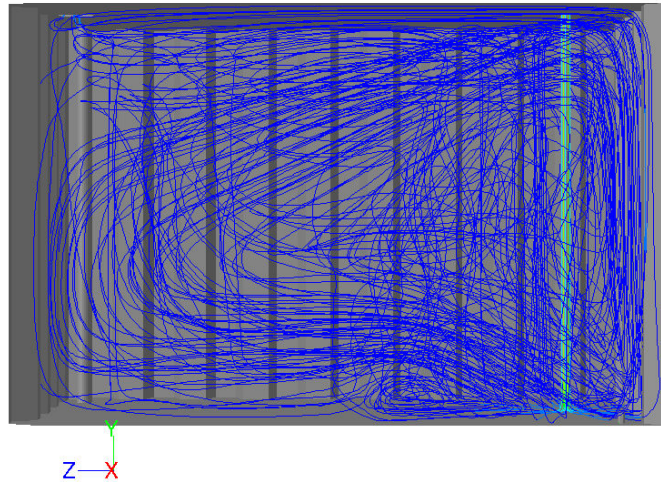
Kuvan 22 mukaan ilma sekoittuu tankissa hyvin, mutta suurimmat virtausnopeudet pysyvät lähellä sisääntuloa. Miesluukun lähellä on virtausta, mutta hitaampaa ja tämä puhallinjärjestely vaatii vähän pidemmän tuuletusajan kuin parhaat tapaukset.

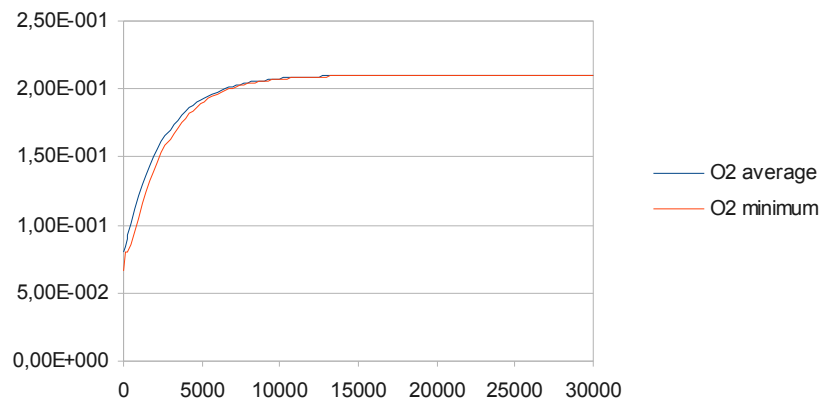
Kuva 25. Hapen mooliosuus tankissa ajan funktiona.

Kuva 25 mukaan happikonsentraatio saavuttaa normaalilukemia noin neljässä tunnissa. Tämän jälkeen muutokset ovat hyvin pieniä.
