UNITED STATES COAST GUARD

THE GROUNDING OF THE FENNICA

ON 07/02/2015

Subj: REPORT OF INVESTIGATION INTO THE JULY 2ND, 2015 GROUNDING OF
THE FENNICA (IMO #9043615) IN UNALASKA BAY, DUTCH HARBOR /
UNALASKA, AK

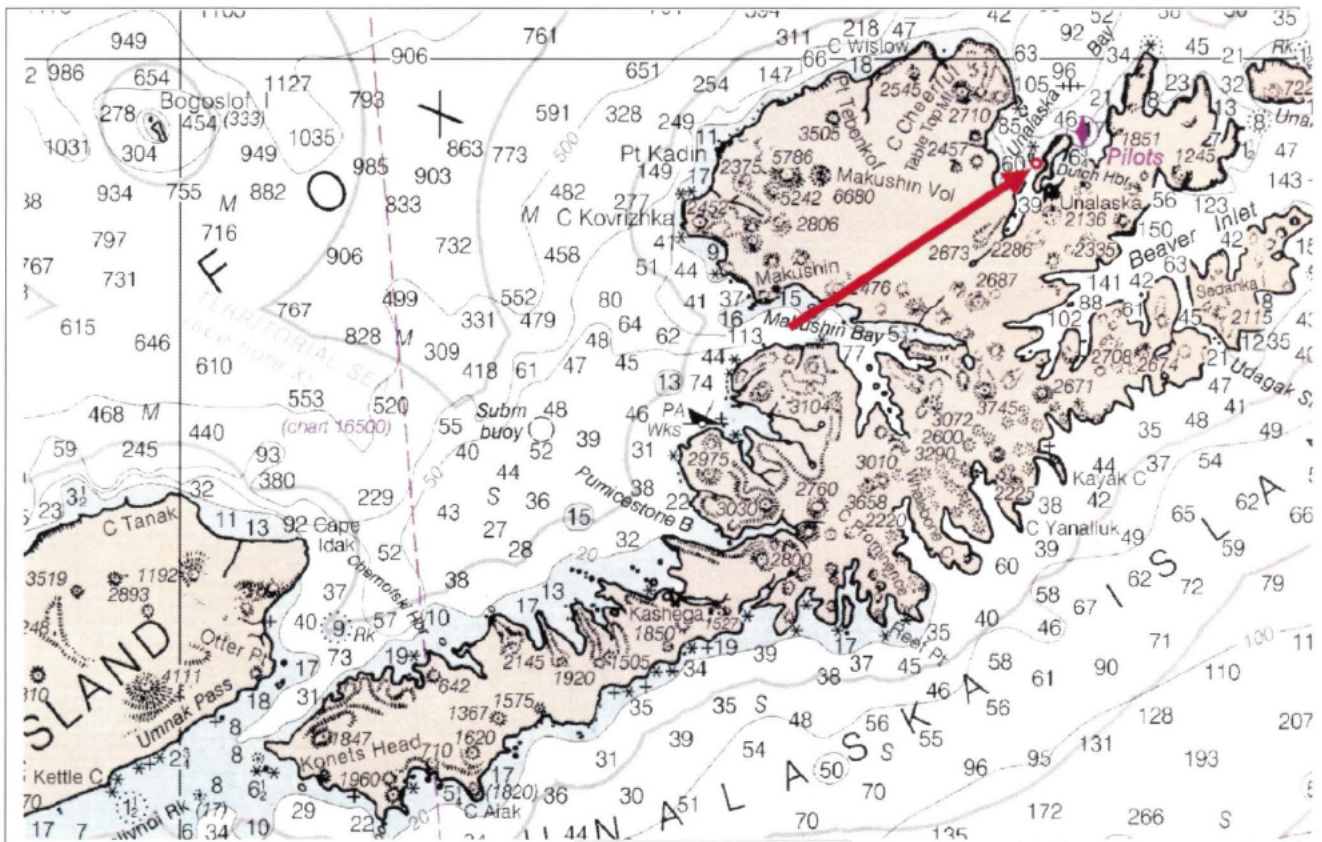
Figure 1: Extract from Chart 16011 showing Unalaska Island and approximate location of grounding (red arrow and circle)

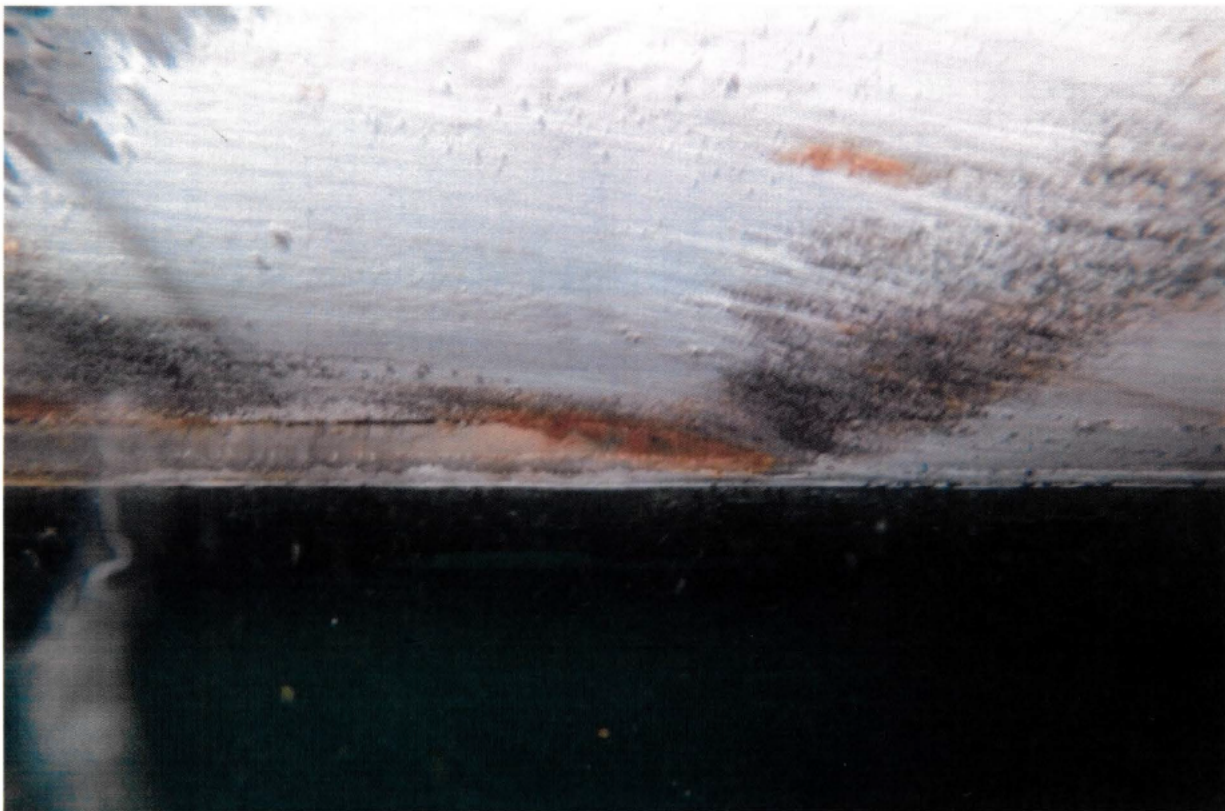
6. Shortly after arrival back in Dutch Harbor, divers began searching for the source of the leak into #4 port ballast tank and found an approximate 3 foot by 1 inch longitudinal fracture between frames #70 and 71, approximately 180 feet aft of the bow and 24 feet outboard of centerline. The bottom plate was also inset approximately 2 inches over 3 foot span.

Figure 4: Picture of damage to the bottom plate of the FENNICA showing fracture and inset in way of #4 port ballast tank; taken underwater by divers

1. The nature and location of the damage along with the Master, Mate, and Pilot's statements strongly suggested the vessel had grounded or struck an object. The NOAA survey post casualty confirmed that a shallow area where the FENNICA had transited was, with the 3 foot tide, approximately 25.5 feet below the surface. The FENNICA was drafting 26.25 feet at the time of the casualty which was 9 inches too deep to transit over the uncharted rock. The vessel's impact with the rock's pinnacle, or similar formation, scraped the bottom of the hull creating an inset of the hull's bottom plate allowing separation from the welded seam along an approximate 3 foot section creating the fracture. However, this impact did not halt the vessel's progress.

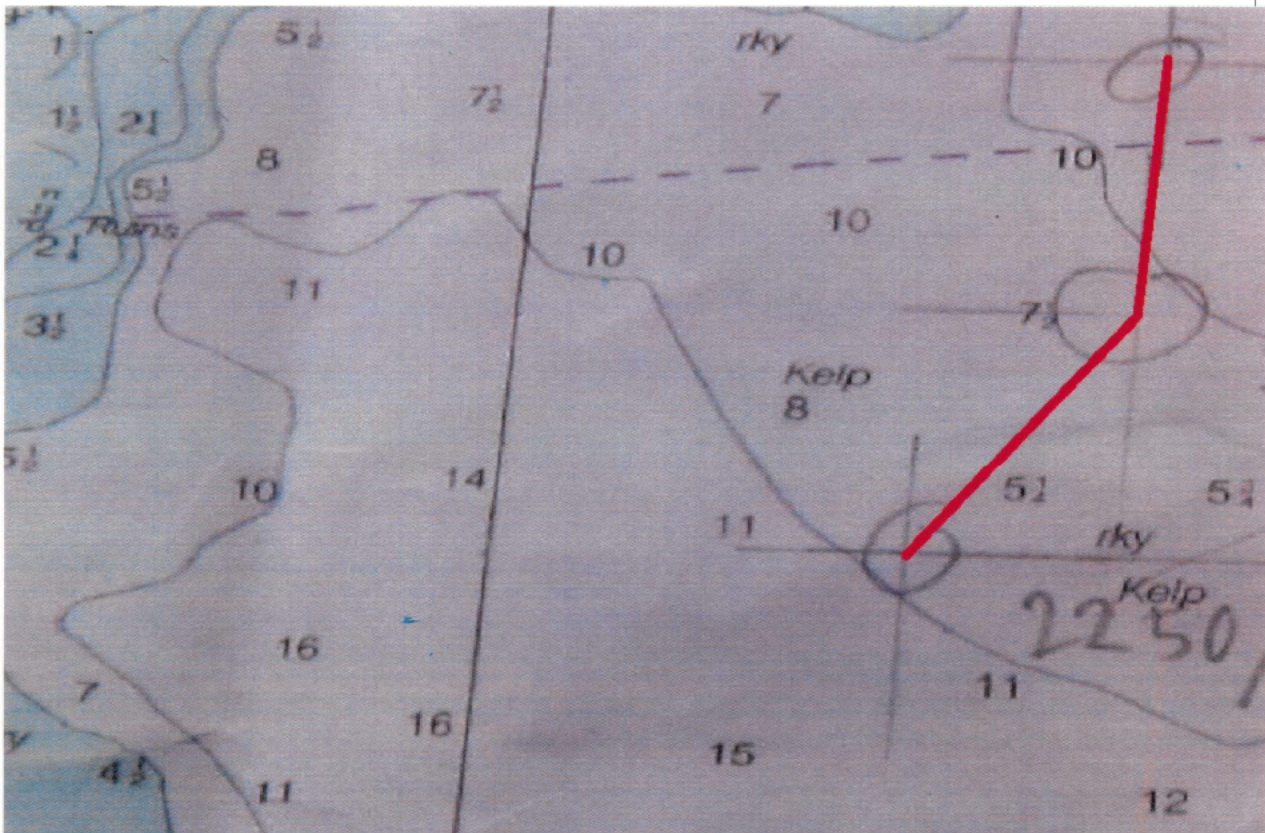
7. After the casualty, a crew from the FAIRWEATHER, a National Oceanographic and Atmospheric Administration (NOAA) research vessel, conducted a hydrographic survey. The results revealed several locations shallower than reported on the relevant charts (NOAA charts 16528 and 16530). In particular a rock at position 53-53-43.9 N 166-33-48.3W which is 22.5 feet MLLW from the surface was found under where the FENNICA transited based on the vessel's trackline¹. Prior to the survey, the charts indicated the shallowest location in that vicinity to be 31.5 feet. At the time of the casualty the tide reported in the vicinity of the casualty was 3.04 feet above MLLW. This area was last surveyed in 1935.

Figure 5: Picture of up to date FENNICA's chart (16530) used on July 2-3, 2015 with markings indicating vessel's positions; red line added showing approximate track line (zoomed-in to grounding location)

1. In accordance with Marine Safety Manual, Volume V, the Initiating Event for this casualty was the grounding that occurred when the FENNICA hit a rock pinnacle, or similar, uncharted formation, at position 53-53-43.9 N 166-33-48.3W.
2. The primary causal factor that led to the casualty is the uncharted rock pinnacle not reflected on current charts as of the date of the casualty.
3. There is no other evidence of actionable misconduct, inattention to duty, or negligent or willful violation of law or regulation on the part of Coast Guard certificated personnel.
4. There is no evidence of failure to properly respond to this situation by the Master or crew of the FENNICA.
5. With the above exceptions, there is no evidence that any personnel of the Coast Guard, any other agency, or any other person contributed to this casualty.

Request NOAA to conduct a hydrographic survey in area B4 of chart 16530 (Unalaska Bay and vicinity).
