DUTCH
SAFETY BOARD

Collision involving crane

Fatal accident on board Lady Christina

The Hague, May 2018

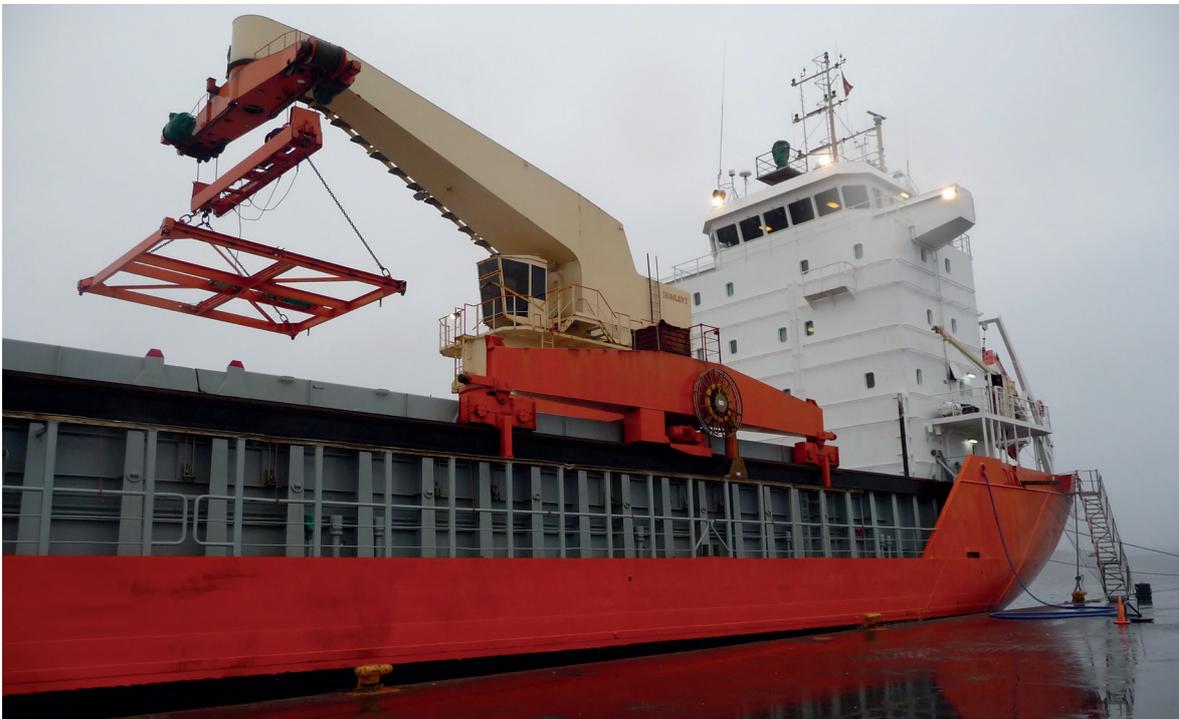
On Wednesday 15 November 2017, the Dutch freighter Lady Christina was moored in the port of Rauma (Finland), where it had unloaded a cargo of china clay. After the unloading, the ship was cleaned by the crew. During the cleaning work, the ship's crane (see figure 1) moved over the hatch coaming, which was cleaned from the crane. At around 9.30¹ hours, a Filipino crew member was found on the port gangway. The crew member was found with a very serious injury to the neck. It was immediately clear that the victim was dead. It is highly probable that the crew member became trapped between the crane moving on the hatch coaming and a horizontal structural element in the gangway.

Figure 1: Crane on board the Lady Christina. (Photo: Dutch Safety Board)

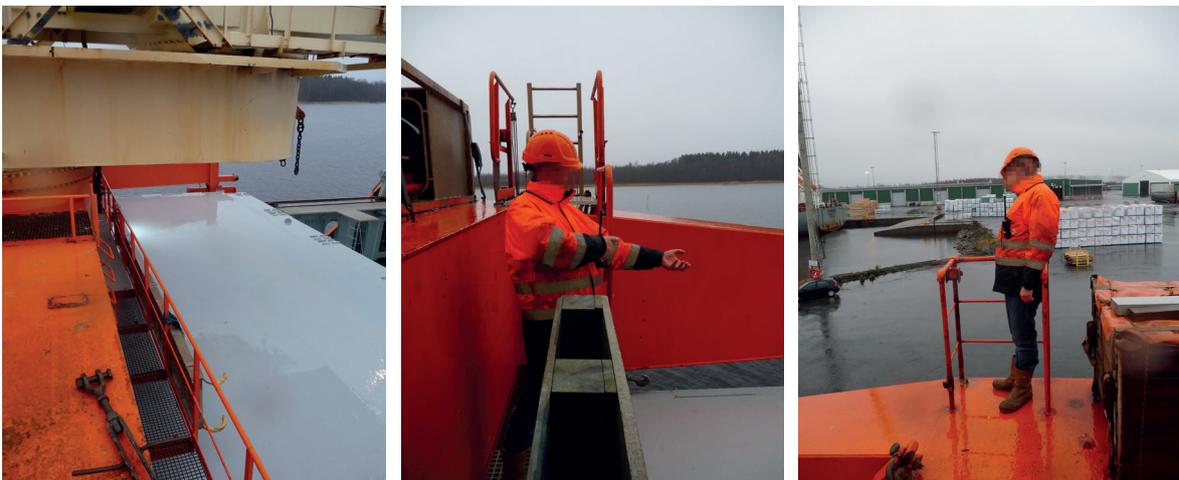
Figure 4: Left, crane walkway; centre, position of AB 2 with hose on starboard side; right, cable watch on port side. (Photo's: Dutch Safety Board)

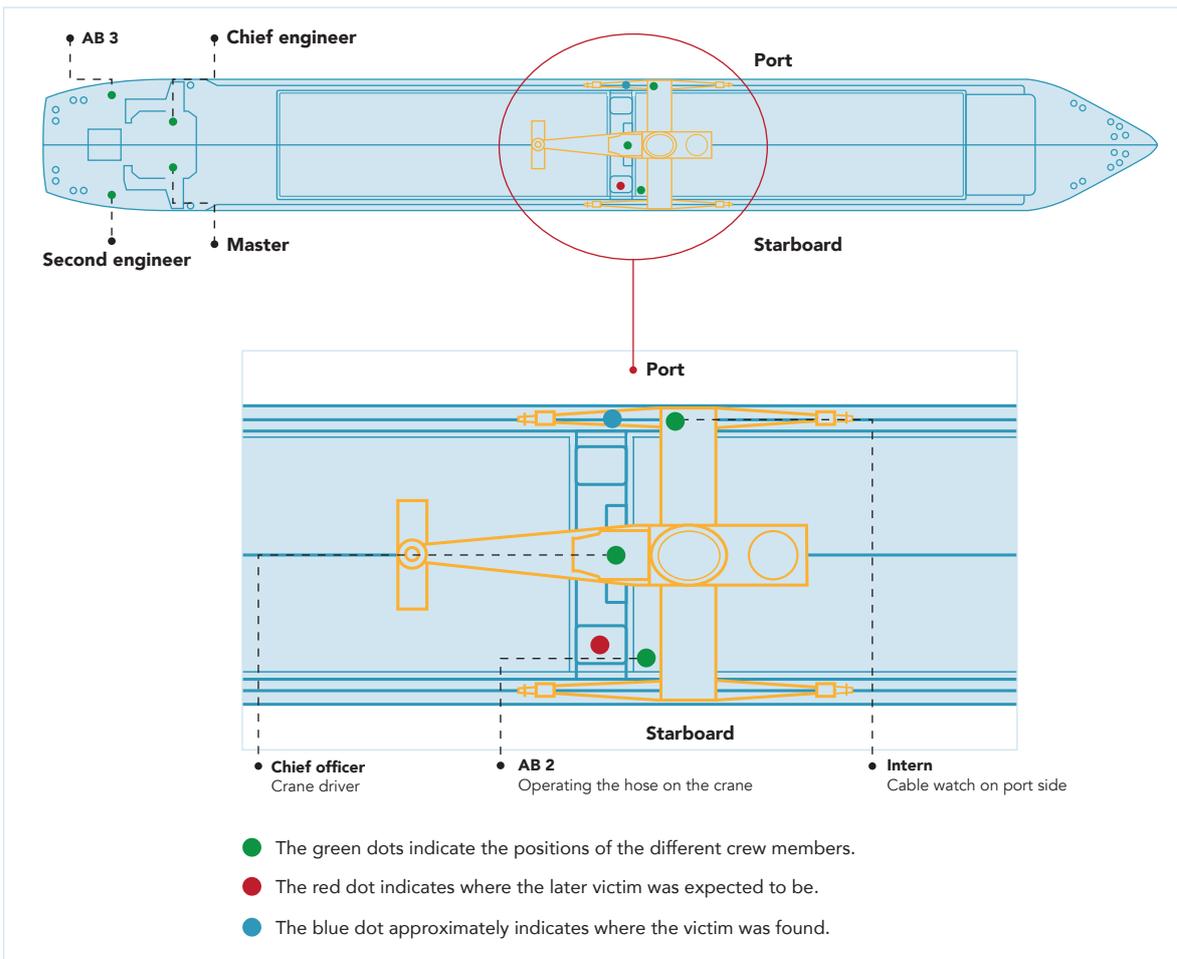
Figure 6: Situational drawing of the roles and positions of the crew members at the time of the accident.

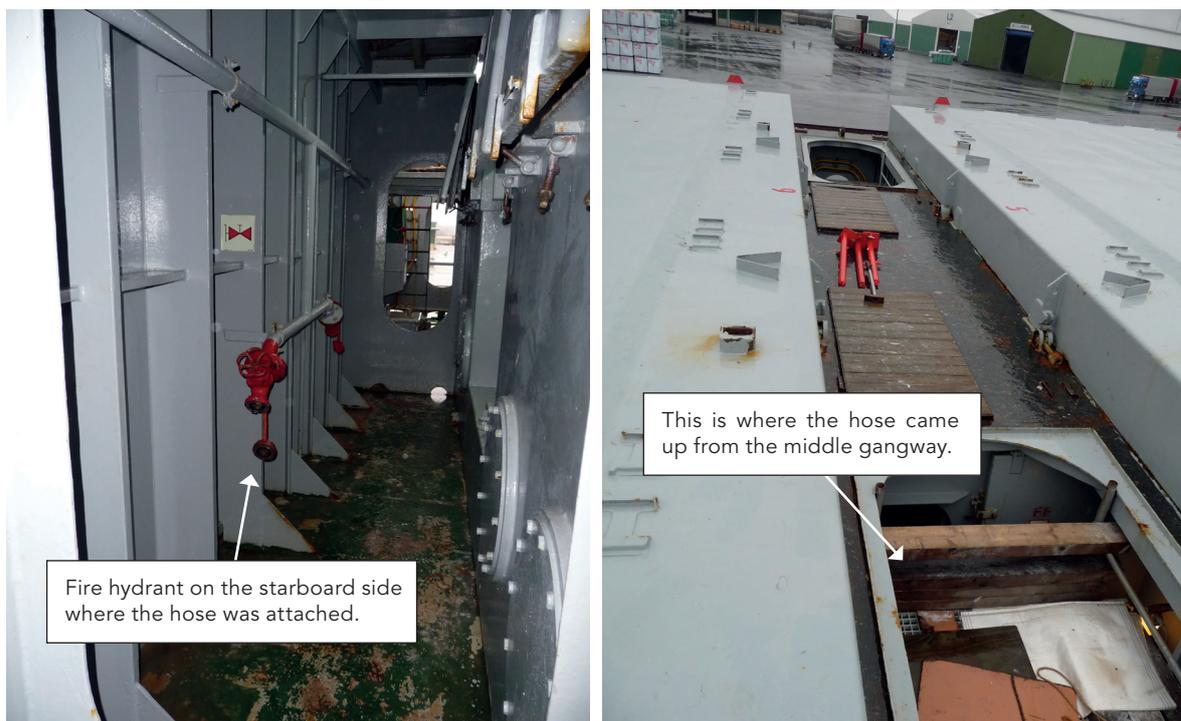
The hose that was used for cleaning the hatch coaming concerned a fire hose of different lengths linked up to each other. It was attached in the middle of the ship to the crane and was fed using the fire extinguisher pump. The hose was pulled upwards from the central gangway to the crane (see figure 7). The hose is fairly sturdy and could easily get caught on something. If this happened, the OS would be instructed via his walkie-talkie to free it.

Figure 7: Middle gangway with fire hydrant. (Photo's: Dutch Safety Board)

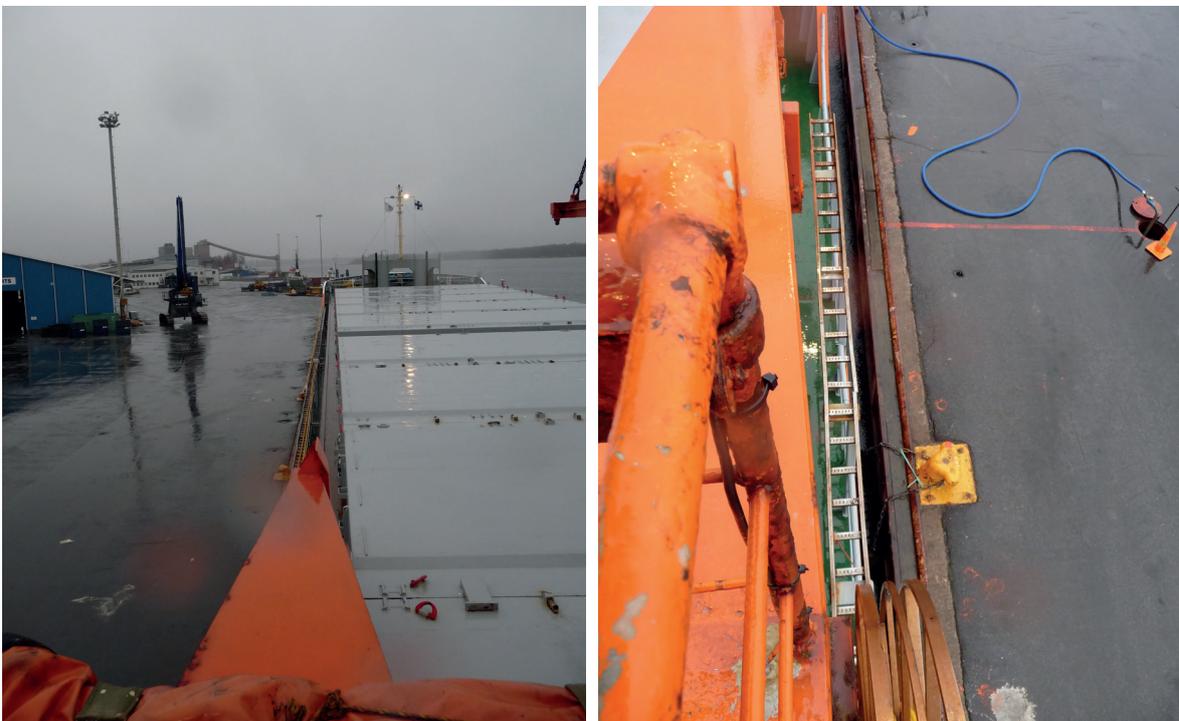
Because of the size of the crane, the driver had no view of the lower gangway. The cable watch on the port side was also unable to see the entire gangway, and certainly not the section directly under the crane.

Figure 8: View of the cable watch on the port side. Left: view to the front; right: view to the rear. (Photo's: Dutch Safety Board)

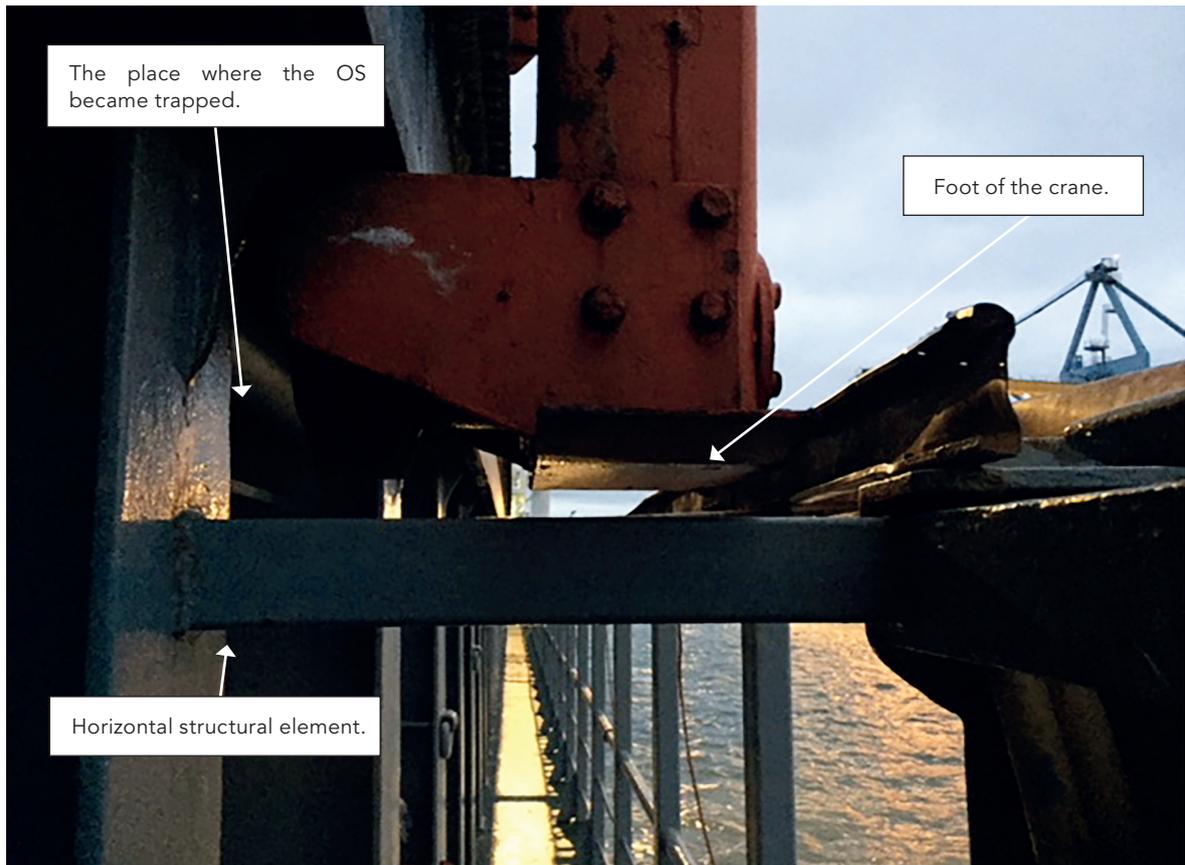
The forensic investigation established that the victim must have climbed onto a number of pipe sections situated under the crane rails, otherwise he could not have been struck by the moving crane and become trapped between the crane and the horizontal structural element in the gangway (see figure 9).

Figure 9: The place of the accident. (Photo: Wijnne Barends)

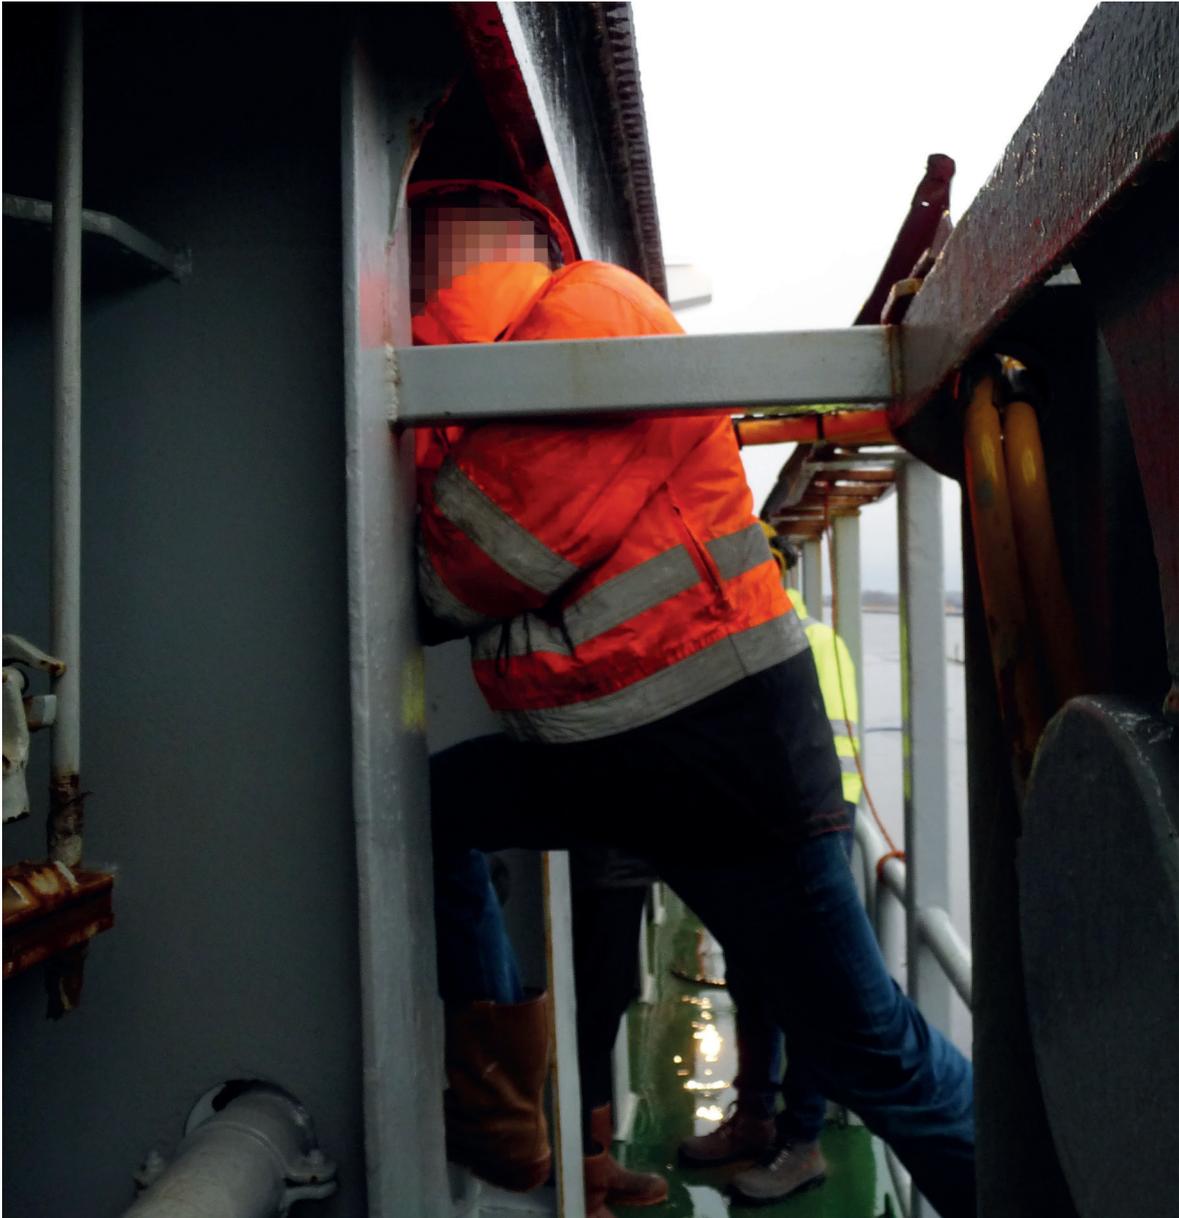
It is impossible for anyone standing with both feet on the gangway to be struck by the moving crane. On-site investigations have not been able to establish why the victim was in that position at the time the crane was passing by. From interviews with the crew members about their normal working practices and from the evidence found, a reconstruction was made of the likely actions of the victim.

Figure 10: Place where the victim must have been standing. (Photo: Dutch Safety Board)

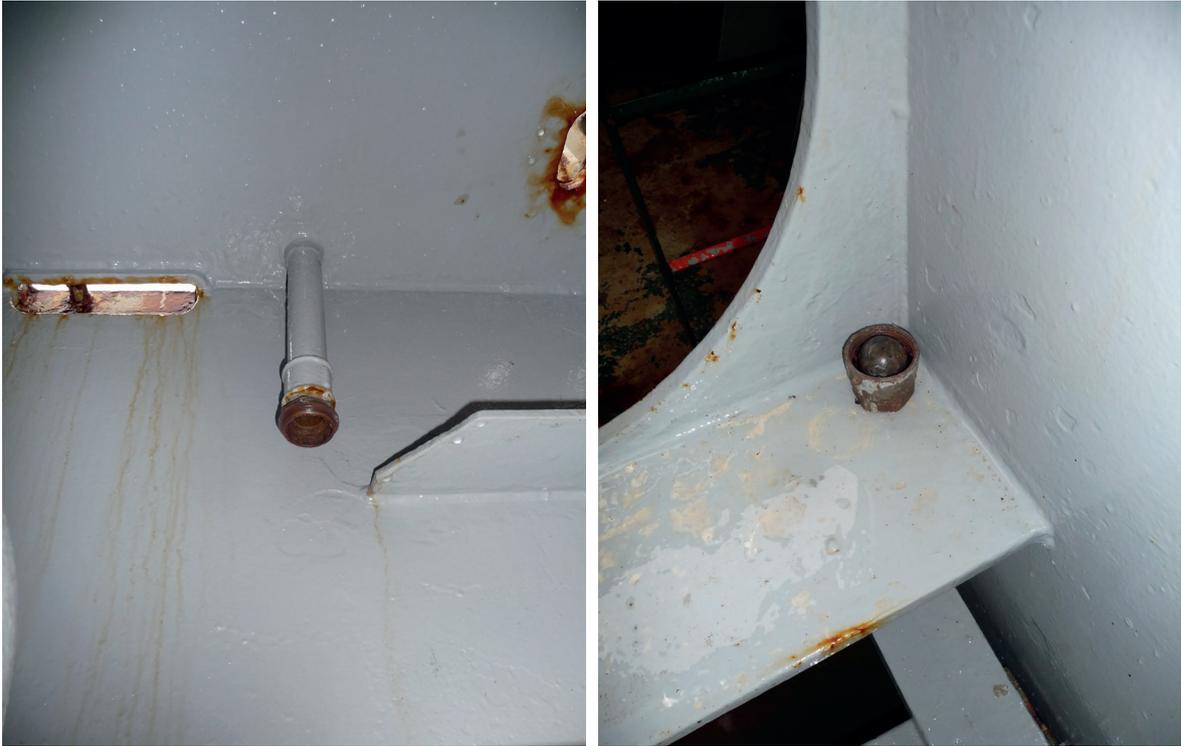
The Lady Christina is fitted with pontoon hatch covers for closing off the top of the hold. These pontoon hatch covers serve to keep the hold watertight. When a pontoon hatch cover is on the coaming, a longitudinal impression strip and a rubber seal form a watertight seal. In order to allow water that has built up on the coaming to run off, the coaming is fitted with drainage pipes. These drainage pipes are fitted with a cap with a non-return valve, which are removed whenever the coaming is being cleaned.

Figure 11: Left: drainage pipe without cap; right: watertight sealing cap with non-return valve. (Photo's: Dutch Safety Board)

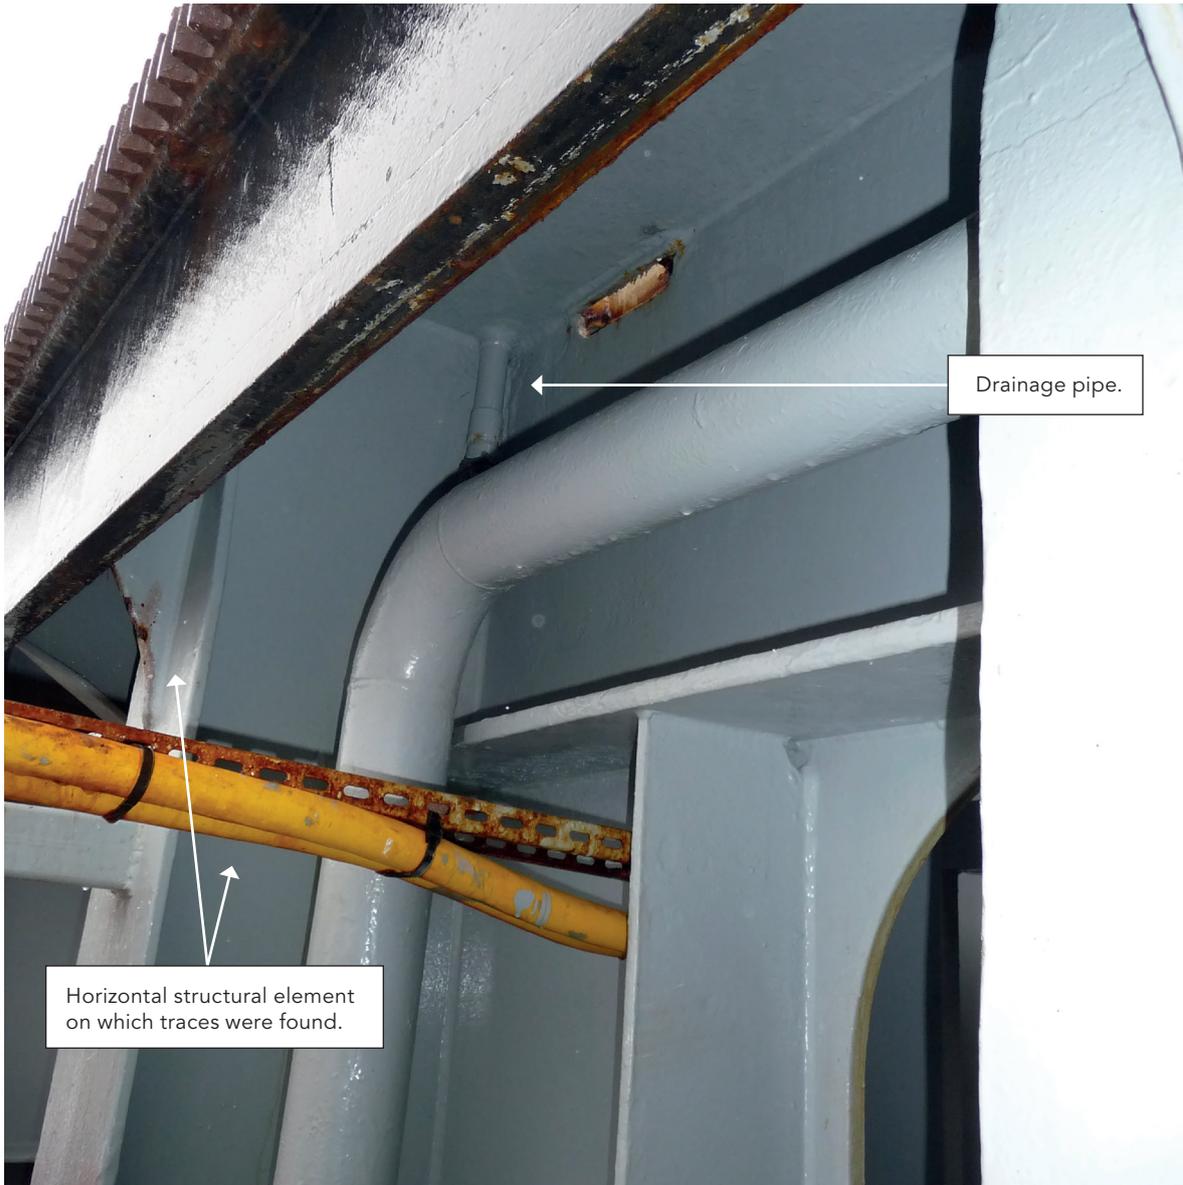
The drainage pipes are located at regular intervals apart. A drainage pipe is located at the place where the victim was found. It has been established that the cap with the non-return valve of the drainage pipe in question was half closed. On the basis of interviews, the place where the victim was found, and the forensic investigation, it can be assumed that the victim was seeking to close the cap with the non-return valve on the drainage pipe on the port side (see figure 11 and figure 12), and was struck by the moving crane in the process. Why the victim climbed up at exactly the moment the crane passed by cannot be established.

Drainage pipe.

Horizontal structural element
on which traces were found.

Figure 12: Drainage pipe at the place of the accident. (Photo: Dutch Safety Board)

The crane was free of any technical faults, was fitted with a clearly audible acoustic signal, and specific reference had been made before the work to the importance of working safely. It is likely that the victim was in the process of closing the cap with non-return valve on the drainage pipe during cleaning work when he was struck by the crane.
