Serious accident with Finish flag
split hopper barge Boann,
IMO 9808792
occurred on 8 April 2019
in Klaipeda State Seaport

SAFETY INVESTIGATION REPORT

No. (L-19/04) 1A-63
6 May 2020

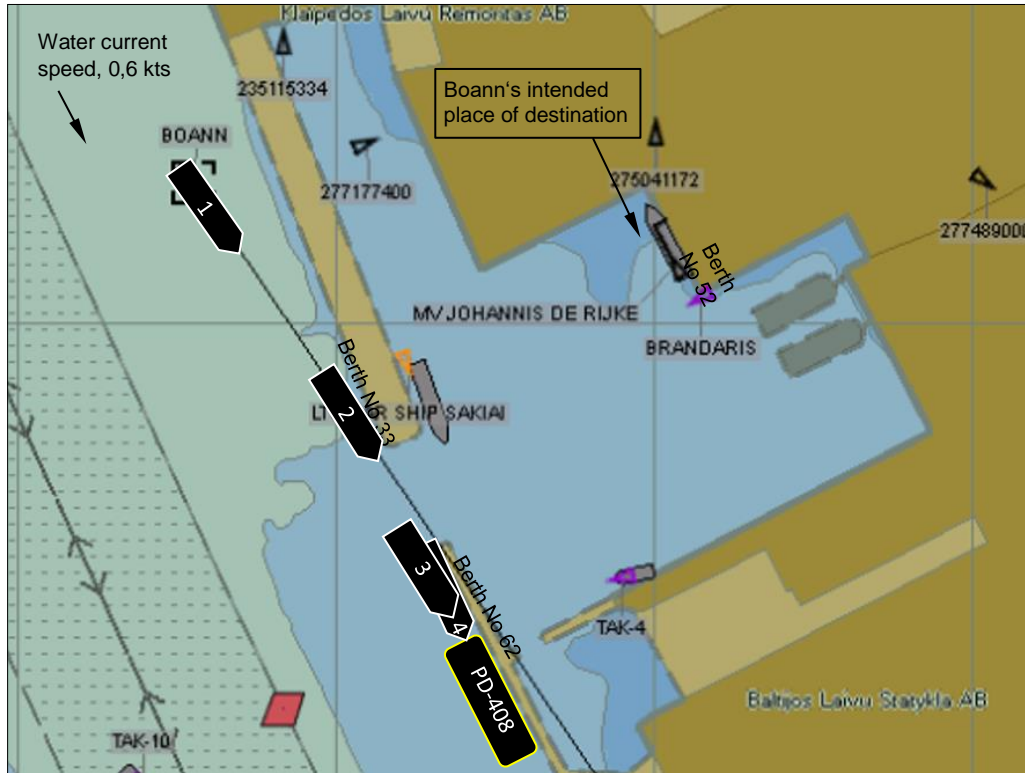
Fig. 1. Boann position before and at the moment of contact to the floating dock PD-408 (AIS data)

23:52:28 ship's speed was 6.6 knots, course 145.8° (position 1, Fig.1). Master started to prepare for manoeuvring and berthing to the berth No 52. Master took steps to change steering mode from automatic to manual. He pressed the STBY button in the steering control system unit. Then turned the steering mode selector lever clockwise and heard the switch click. The master was sure he switched the steering mode from automatic to manual.

23:53:24 Ship's speed was 5.8 knots, course 146.9° (position 2, Fig.1), bow thruster in operation. Ship had port side contact with berth No 33. No damage to berth nor to ship was sustained. Ship's speed started to increase.

23:53:48 Ship's speed 6.6 knots, course 152.3° (position 3, Fig.1). Ship had port side contact with berth No 62. No damage to berth nor to ship was sustained.

23:54 Ship contacted with her bow the floating dock PD-408, which was moored at berth (position 4, Fig.1). Master shifted engines' revolution levers to neutral position.

The ship's route segment before mooring was selected with a sharp turn to the port side (Fig. 1). As Boann navigated this segment at a speed of about 6 knots, there was no time reserve to solve the emerging steering problems.

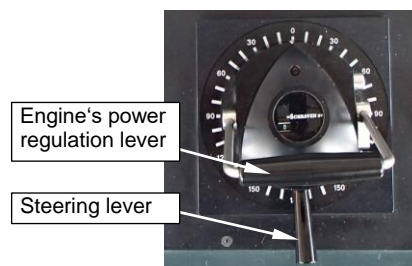
Fig. 5. Steering and power regulation unit

When master started to steer the ship with disabled manual steering levers (Fig. 5), he realized that the routinely used manual steering mode does not work. As ship was quickly approaching towards berth No 33 and after 16 sec contacted it, master did not have sufficient time to determine and eliminate the cause of that non operation. Therefore master attempted to avoid contact by trying to steer the ship to the starboard side using a bow thruster. At that time, the ship was moving at a speed of 5.7 knots, so the thrust generated by the bow thruster had a very slight effect on the ship's course: within 16 seconds, the ship changed her course only by 1.6° to starboard. Further action - an attempt to engage the reverse mode by turning the steering levers by 180° and increasing the power of the engines with engines' power regulation levers (Fig. 5) had no impact to the course of the ship, but increased the ship's speed.

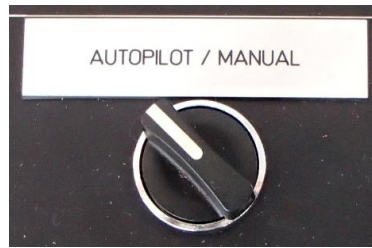
Fig. 7. Steering mode selector lever in position AUTOPILOT

The position of the steering mode selector lever (Fig. 7) is changed by turning it with fingers. The selector lever has to be released when it is in the required position. Click is heard when switching. After the accident the test was carried out and it was found that a similar click was heard when the selector lever was released by not turning it all the way (not to the right position) but only at the angle of 30° to 40°. In the latter case, the lever returns to its initial position.

The steering mode selector lever was not clearly visible at night. There was no other signal, such as a beep, to indicate selector's position change. There are no mandatory requirements for the installation of such arrangements on Boann-type vessels.

To establish the actual position of the Steering mode selector lever (Fig. 7) during the dark hours of the day, great efforts should be made. There were no any other safety features installed on board, eliminating possibility of an error, which could occur when selecting the manual steering mode.

When switching the steering mode from automatic to manual, the master rotated the steering mode selector lever (Fig. 7) and released it when it was not in the required MANUAL position. For this reason selector lever returned to its original AUTOPILOT position. Upon hearing the switch characteristic click, the master did not suspect that the steering mode selector lever may not have been switched.

The position of the steering mode selector lever (Fig. 7) was not easily seen during the dark hours of the day, as it was not illuminated. There was no other signal (such as a beep), indicating lever switching. As a result, the master, after he rotated the lever, could not see and understand that the lever had not been switched.

It is recommended to Wasa Dredging Oy Ltd, on its Boann-type vessels, to implement permanent arrangements, which enable proper evaluation of the steering mode engaged.
