Tutkintaselostus

1/1995

The Grounding of the M/S SILJA EUROPA at Furusund in the Stockholm Archipelago on 13 January 1995

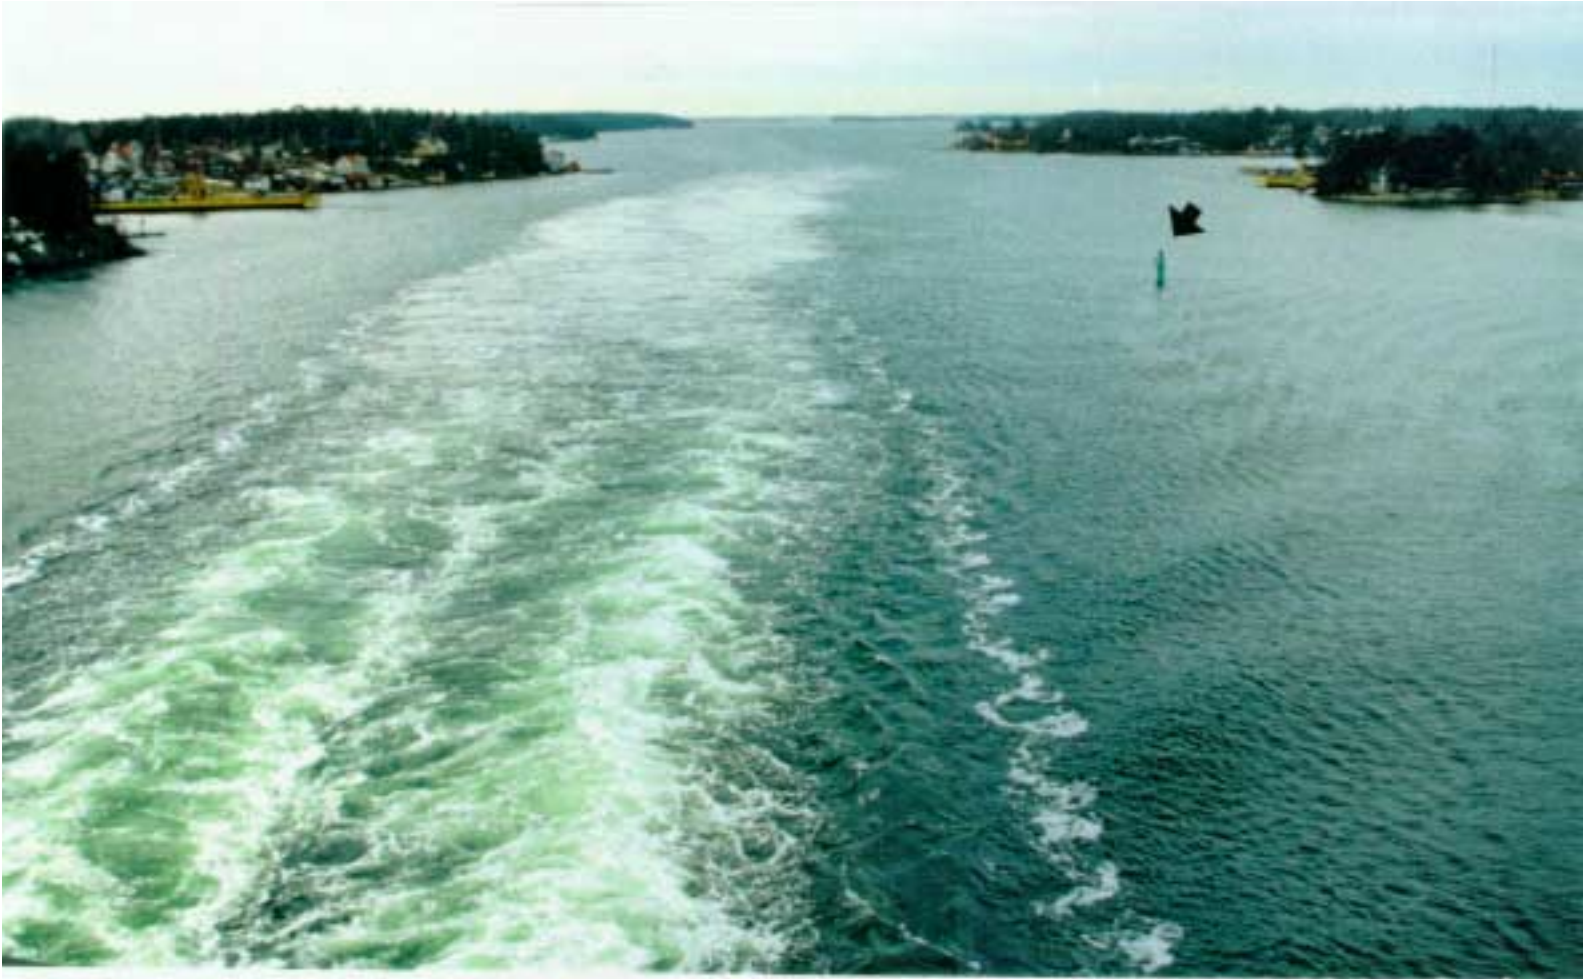
View of the Furusund narrows, looking west from Turku to Stockholm. The wake of a vessel can be seen in the picture. The Furusundsskaten beacon is marked with an arrow.

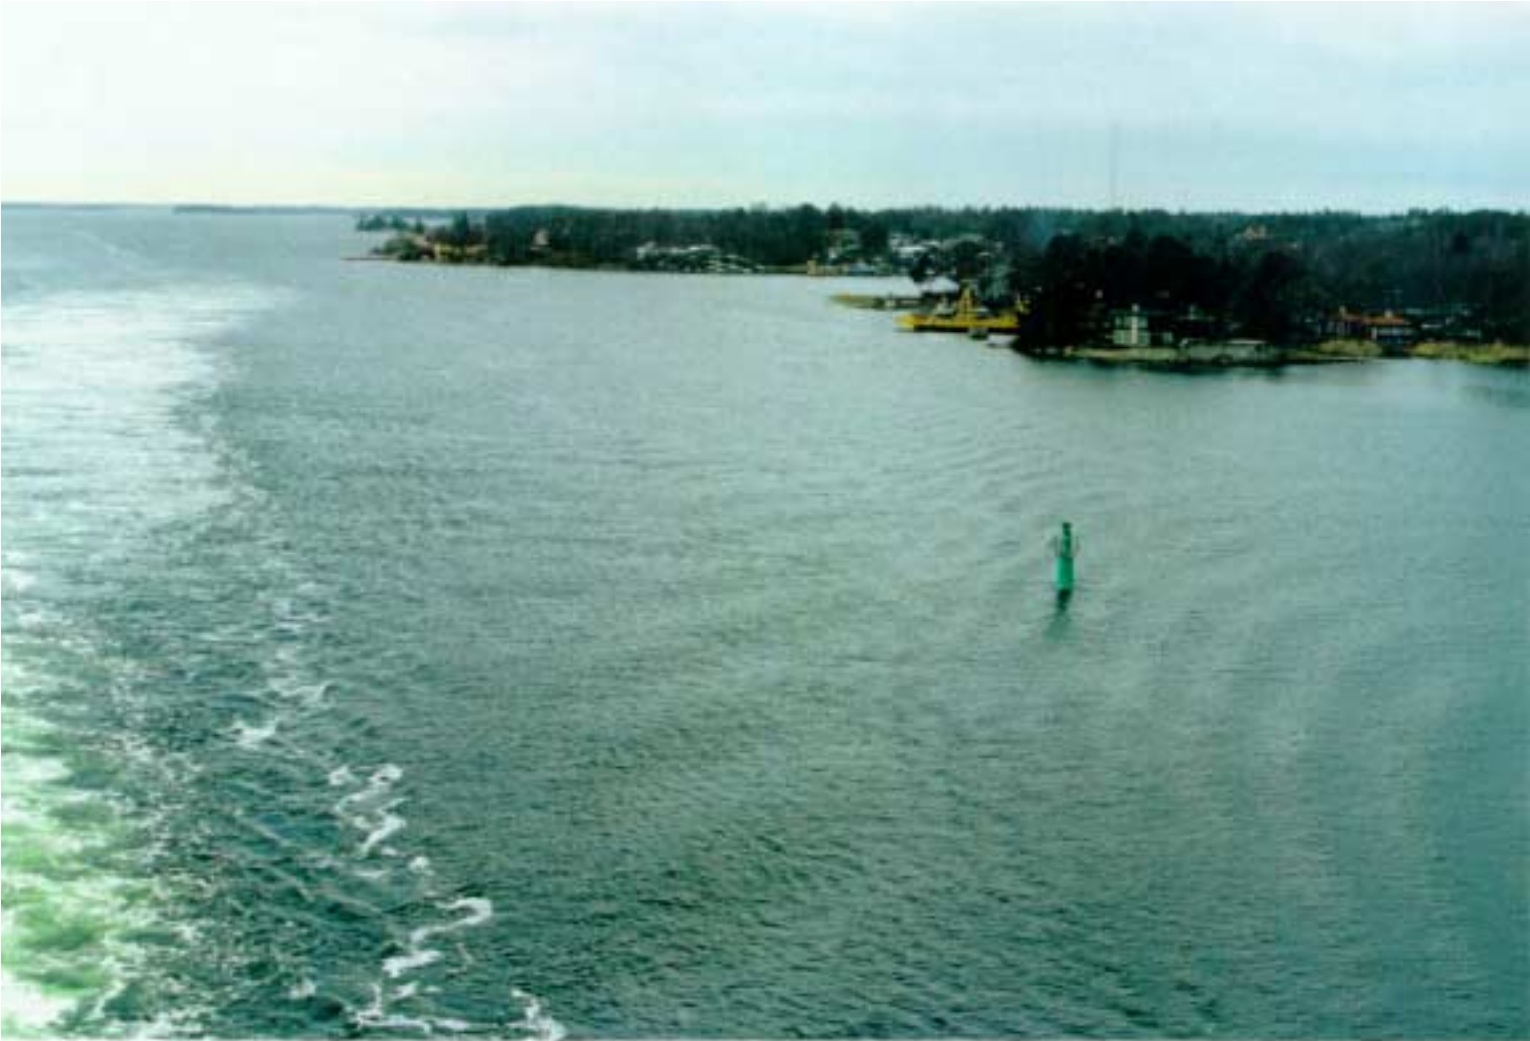
Close-up of the Furusundsskaten beacon, looking west from Turku to Stockholm. The wake of a vessel can be seen in the picture. The SILJA EUROPA ran aground to the right of the beacon.

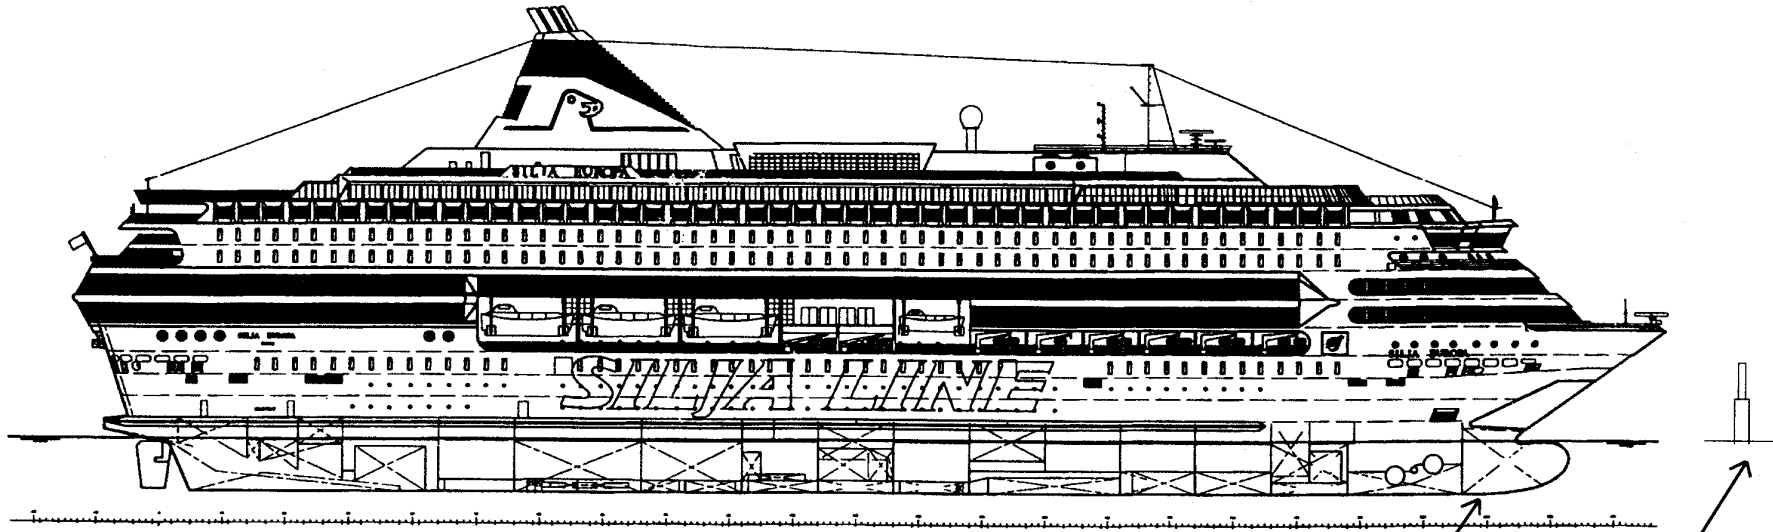
Sideview of the SILJA EUROPA.

The location of the detached instrument bulb is marked with an arrow.

The part of the Furusundsskatan beacon that is above sea level is drawn in proportion to the size of the vessel.

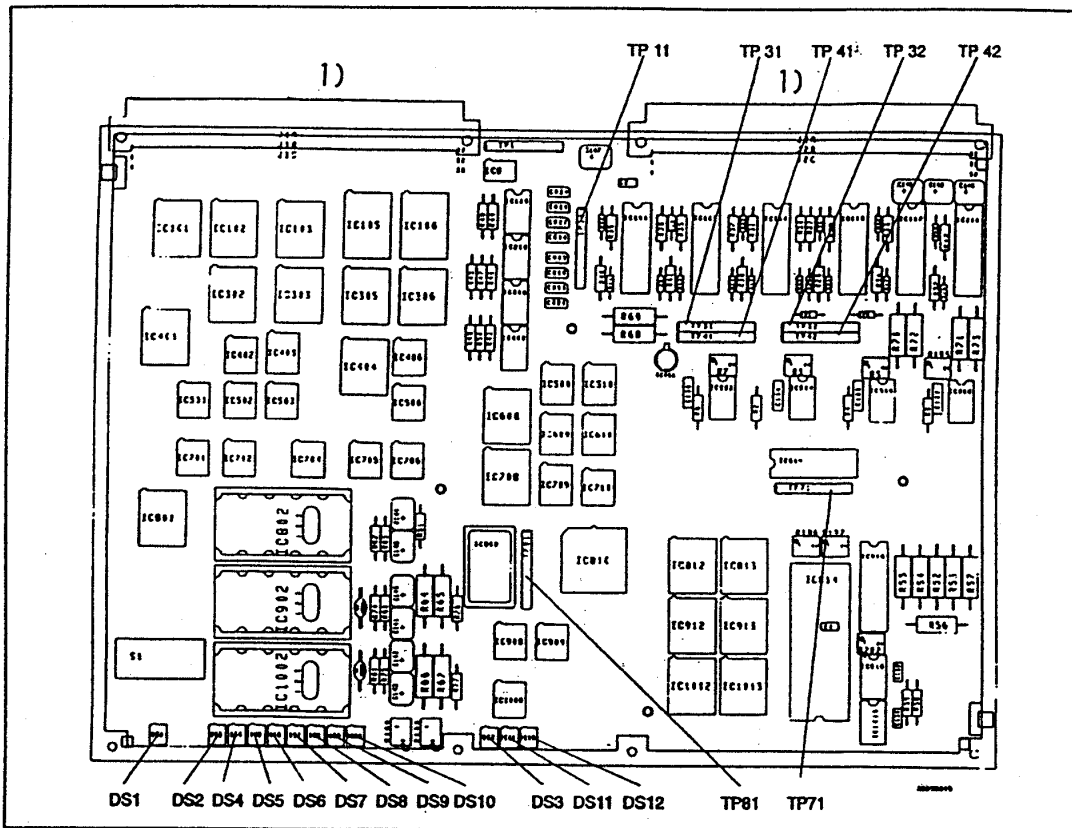
LAY-OUT OF THE SPEEDPILOT'S ENGINE INTERFACE CARD 1

The structure of engine interface card 1 is shown on page 25. In the tests at the STN Atlas Elektronik by the Investigation Commission, it was shown that the detachment of this circuit card from its connector caused a corresponding situation to what occurred on the SILJA EUROPA before the grounding. The SPEEDPILOT could not be switched off.

Thus the only verifiable possible error remains the detachment or loosening of the SPEEDPILOT's engine interface card 1 from its card connector to the motherboard on the electronics frame. In this case, the SPEEDPILOT becomes locked on. In the simulation, detachment or loosening of the card has been found to have the same results as in the accident. It is possible that engine interface card 1 was improperly installed in the electronics frame, permitting vibration to detach it from its connector.

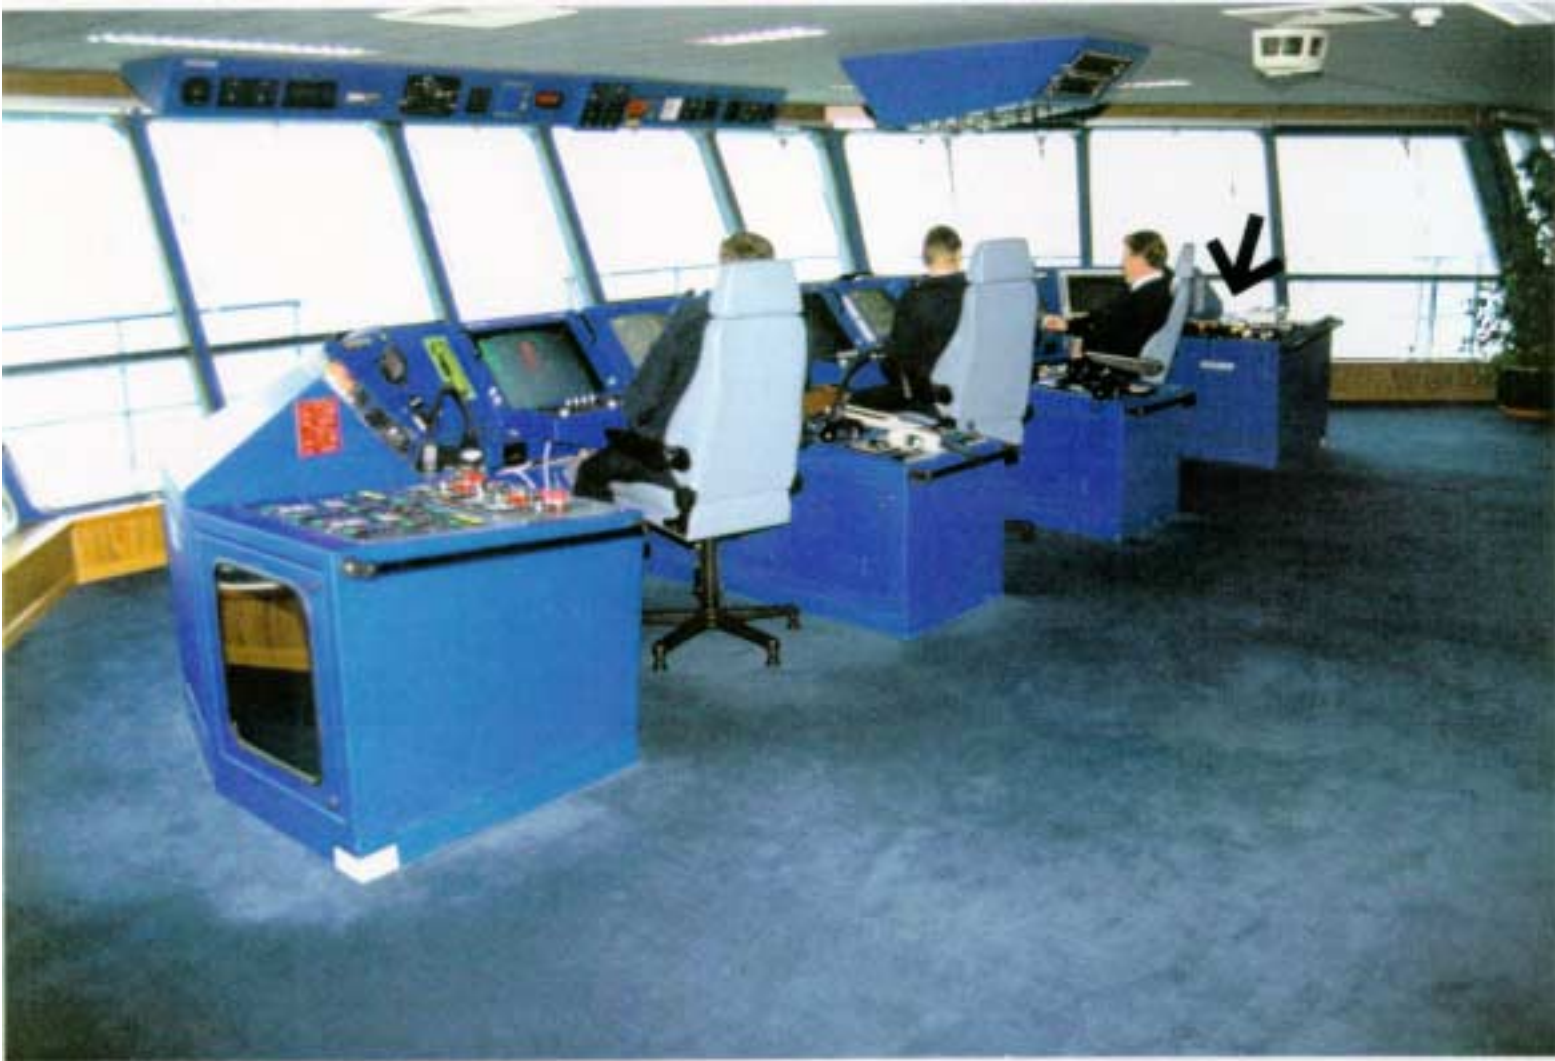
The navigation desk on the bridge of the M/S SILJA EUROPA.
The arrow indicates the location of the BY-PASS switch.

- * The switch was inadequately marked and the entire switch was in the wrong place. The navigator would have had to move to SB to turn the switch.
- * There were no written instructions or information on the use of the BYPASS switch. Information on installation and operational training had been given orally to the masters onboard during the installation work. They had passed the information on to the others while sailing. The installation, the use of the switch and how to use it were not recorded in the minutes of the officers' meeting. The switch was not added to the vessel's departure checklist.

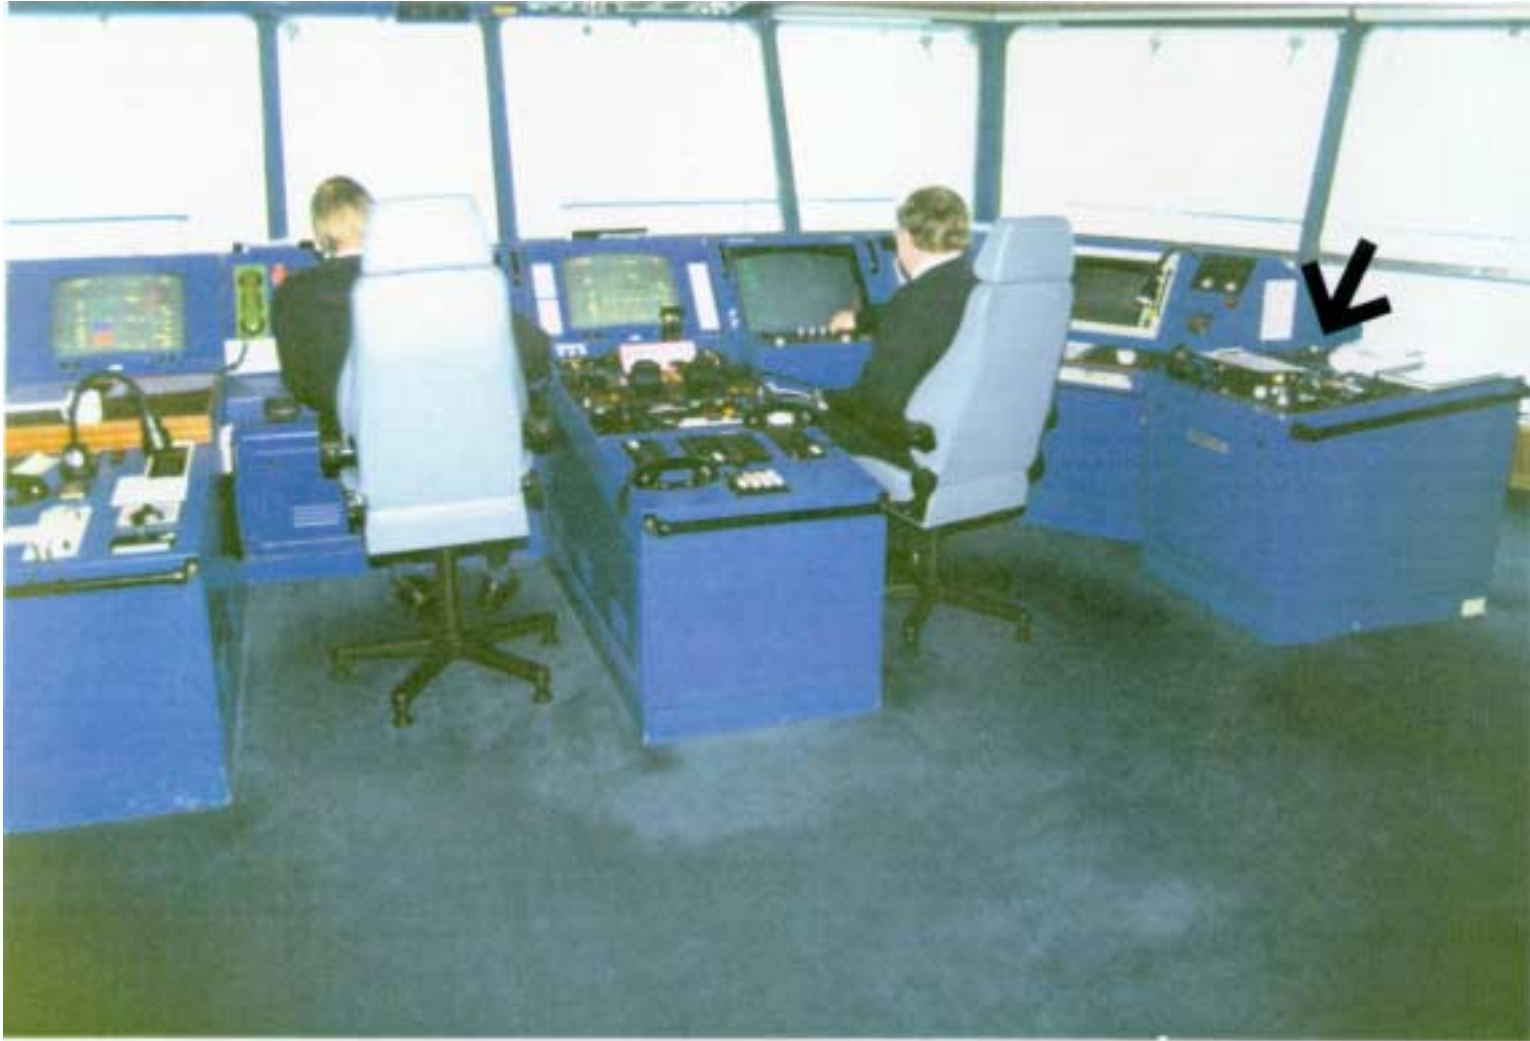
Close-up of the navigation desk. At the time of the accident, the pilot sat on the left and the officer of the watch sat on the right. The arrow indicates the location of the BY-PASS switch.

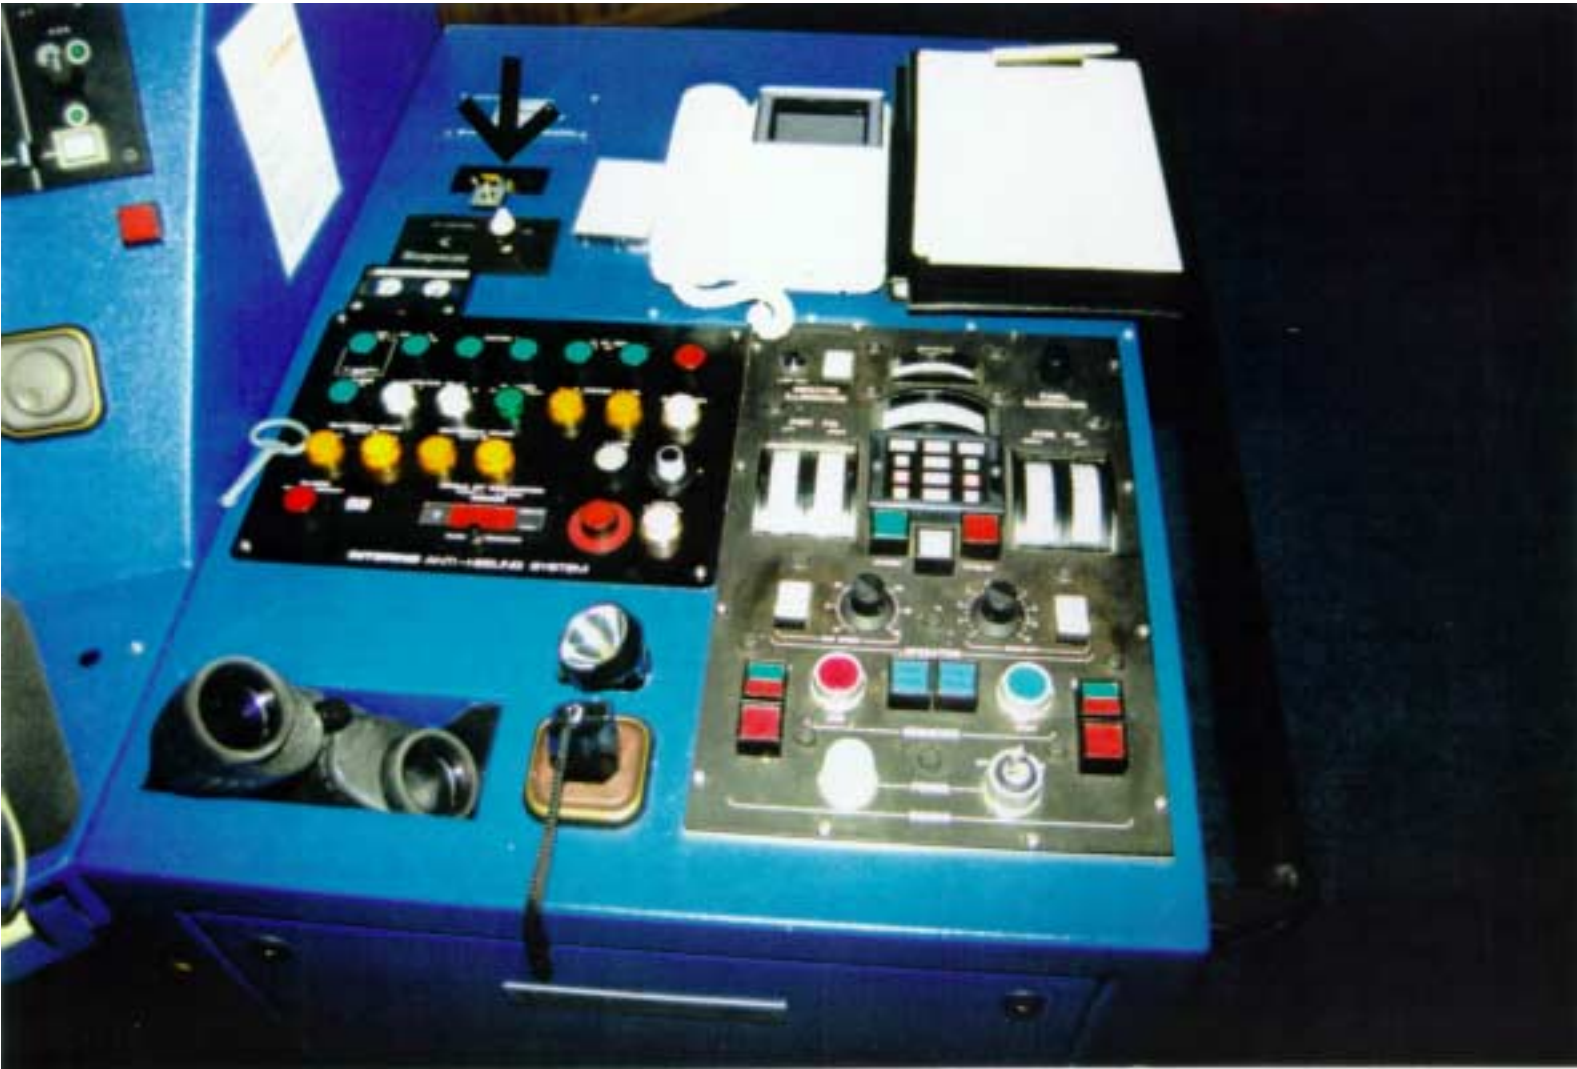
The right-hand side of the navigation desk. The arrow indicates the location of the BY-PASS switch.

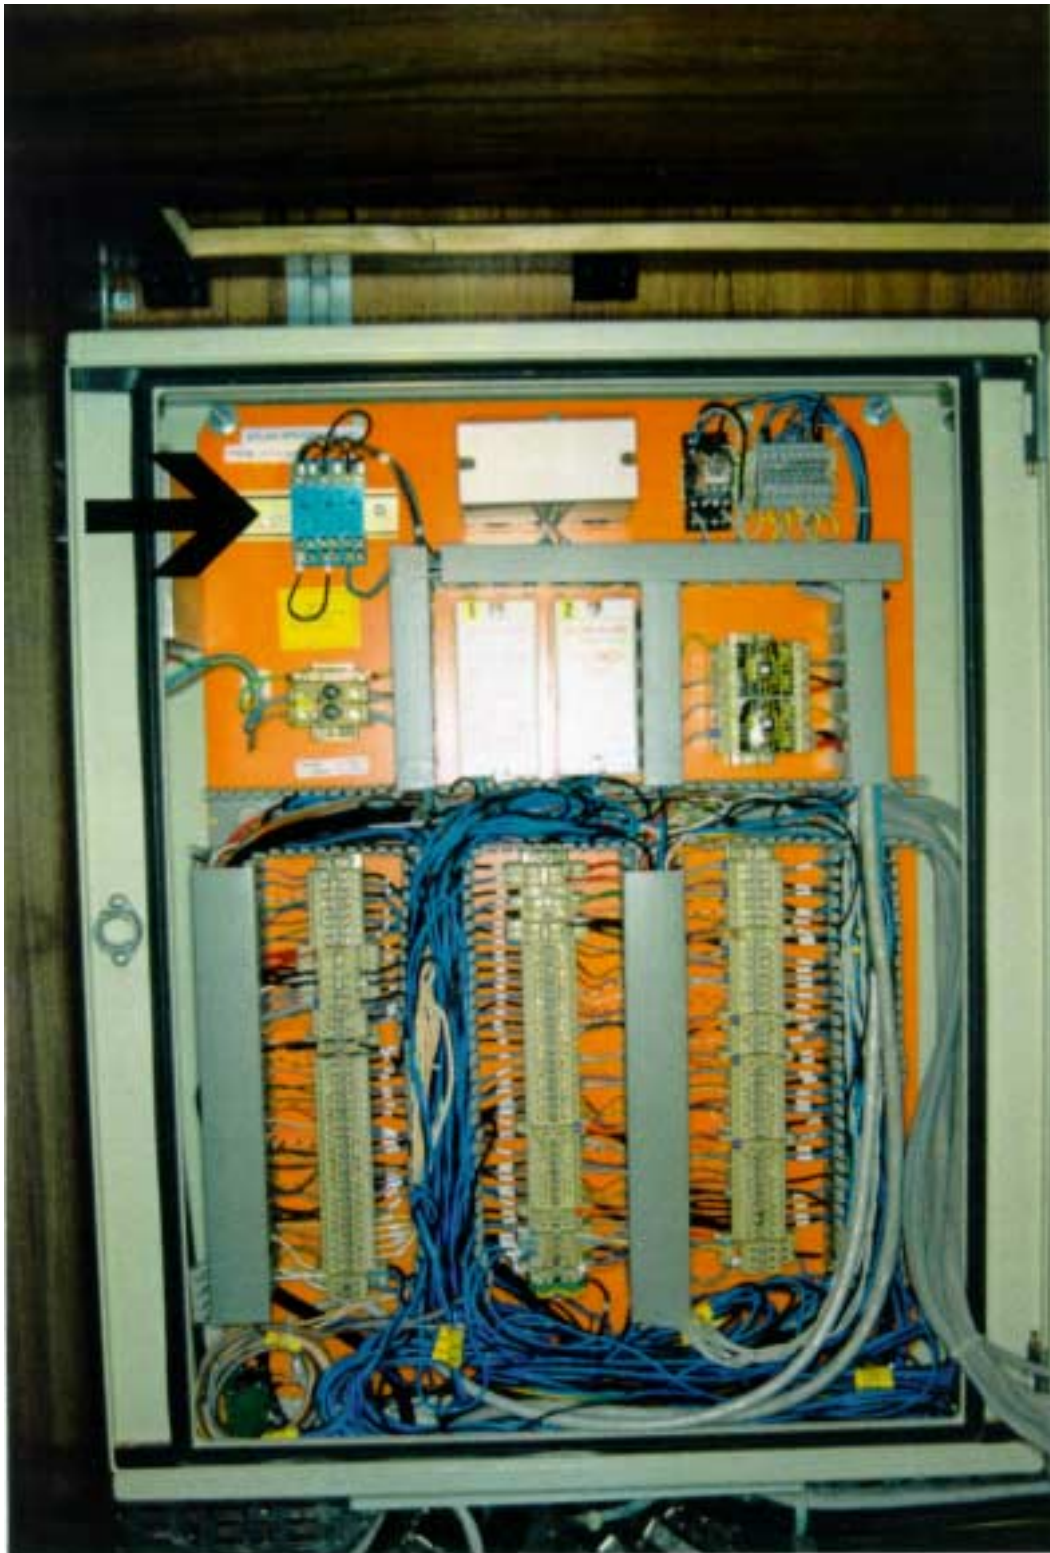
The Joystick's electronics cabinet in the equipment room of the bridge. The arrow indicates the switch-off relays for the SPEEDPILOT.

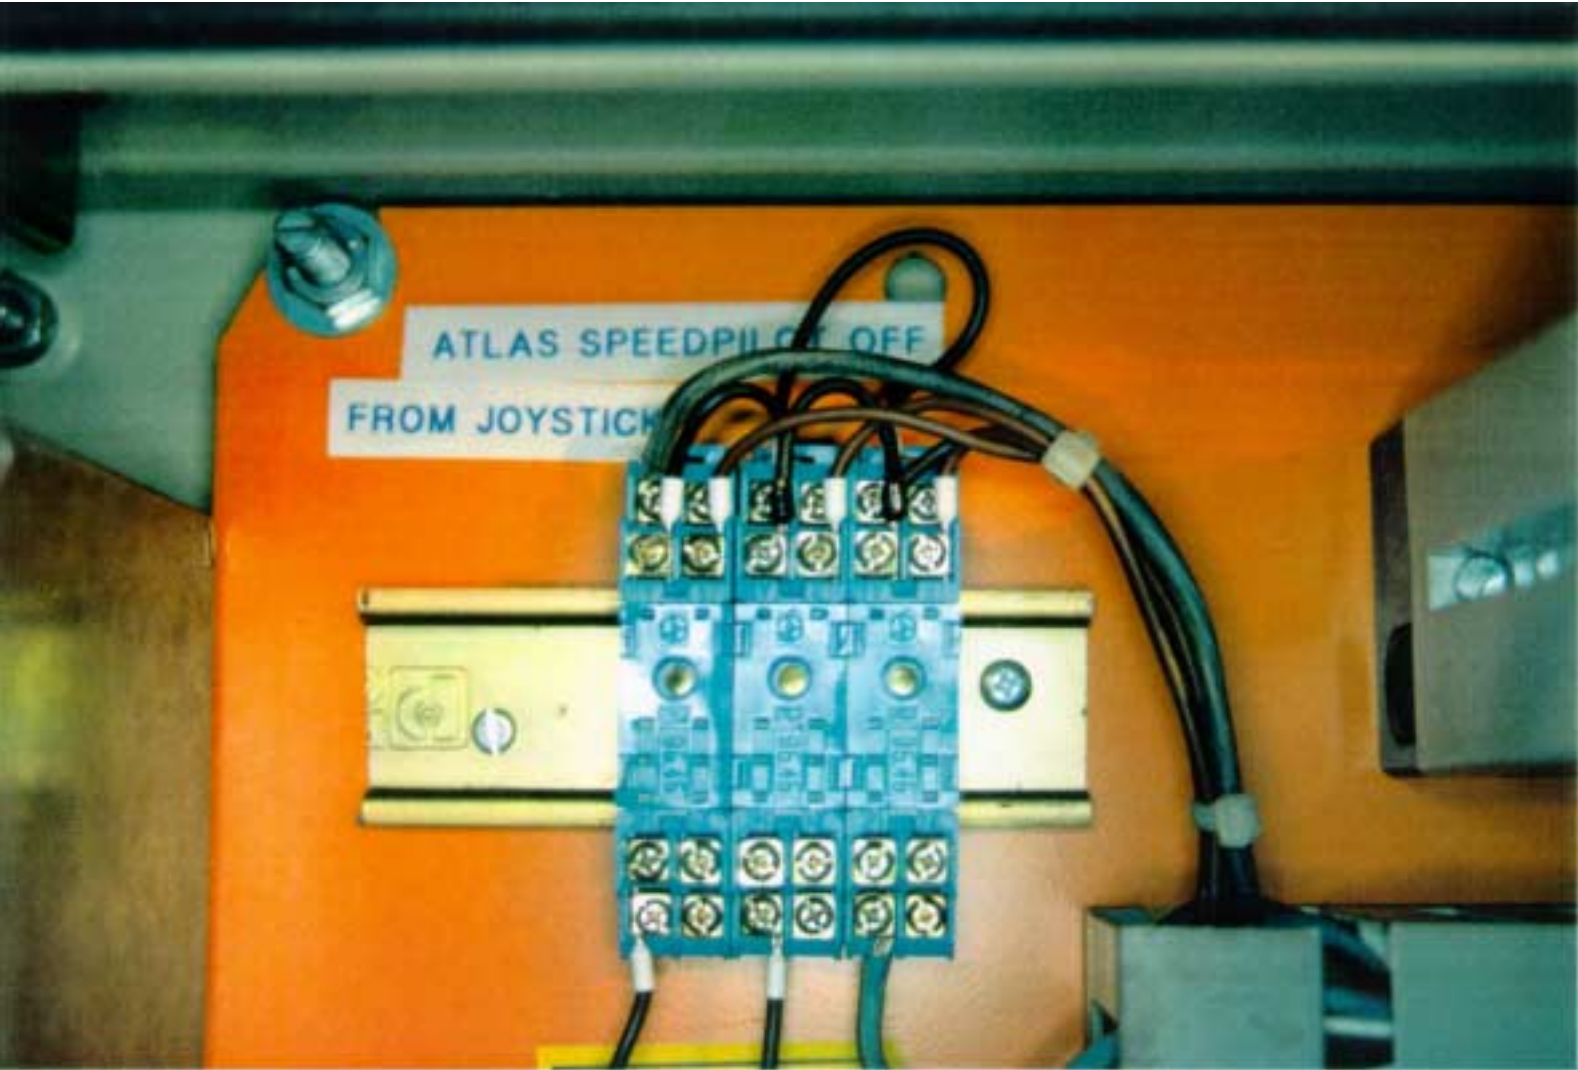
Close-up of the SPEEDPILOT's switch-off relays in the Joystick's electronics cabinet.

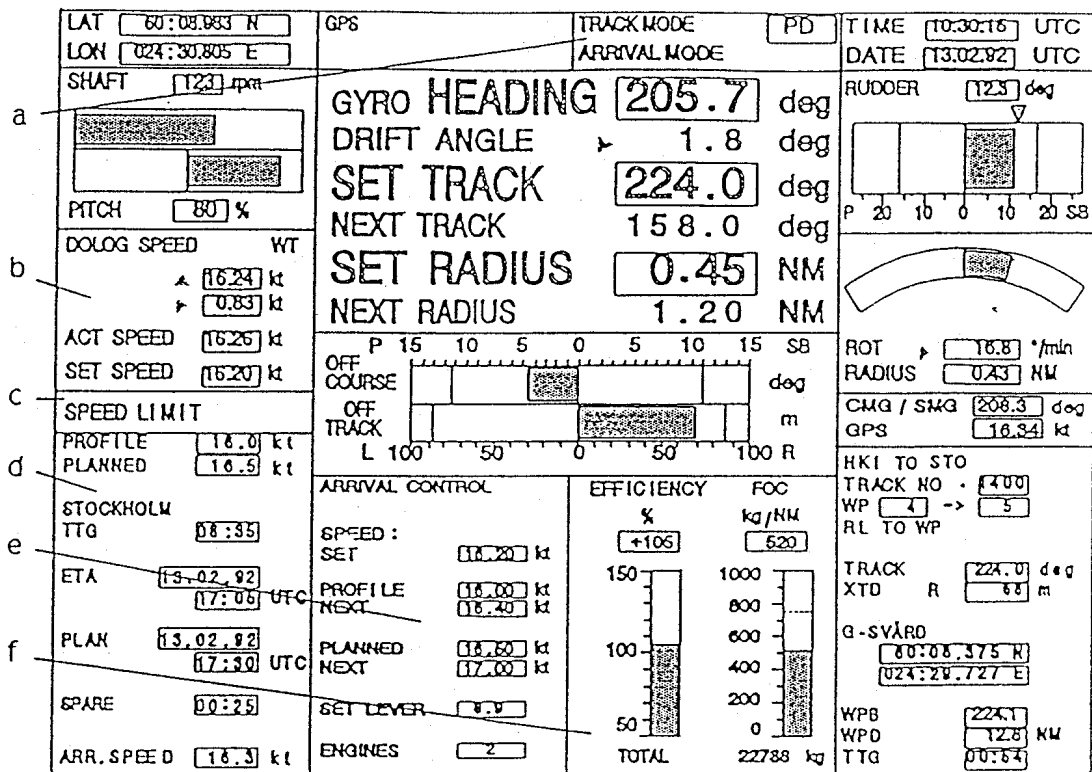
- * The transfer can be found in text form in the display (MANUAL SPEED). The text was not noticed. The display has a large quantity of information all at the same time, and the operator has to select from this what is essential at the time. The text indicating the selected speed sensor is on the left side of the display (b).

The equipment displays the SPEED SENSOR FAULT alarm. The alarm list on board recommends changing the speed sensor as an alternative to CANCL in the
