Estonian  
Safety  
Investigation  
Bureau

# INVESTIGATION REPORT

ACCIDENT, LOSS OF CONTROL WITH AIRBUS A320-214  
NEAR TALLINN AIRPORT ON 28.02.2018

ESIB: A2802118

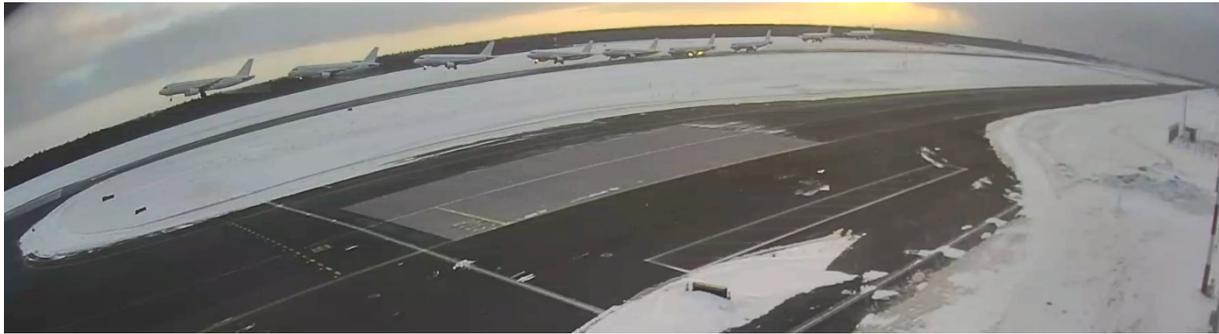
7. While the landing gear was in transit, the aircraft hit the ground with aircraft engines approximately 200m from the end of the runway at 15:05:28 with the vertical acceleration of 2,85 g (see Figures 7 and 8). The pitch attitude was 0.7° Nose Up. The airspeed was 192 kt. Two seconds after the impact, the airspeed increased to 206 kt, the pitch attitude to 9,1° Nose Up and the aircraft started to gain altitude at 6000 ft/min.

Figure 8. Aircraft hitting the ground (screenshots from the recordings of Tallinn Airport surveillance cameras)

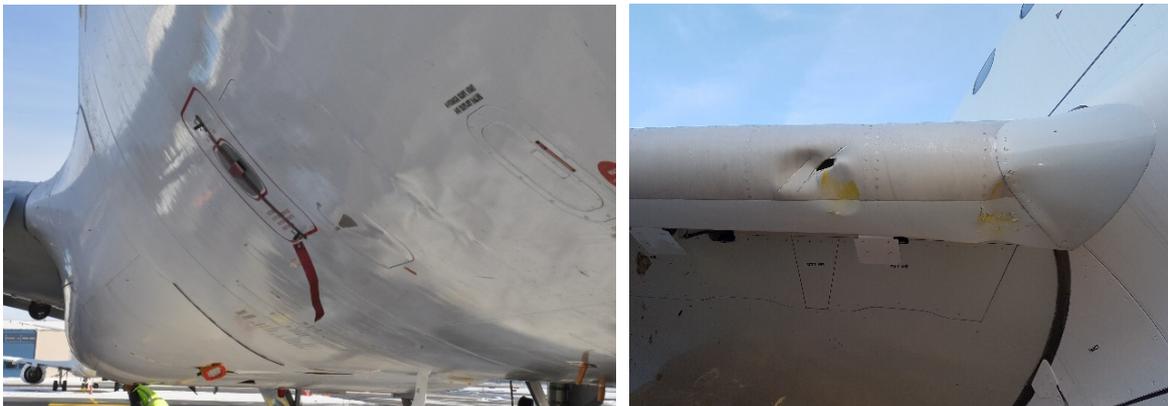
All observed damages were consistent with post-impact damages.

Figure 31 A/C skin wrinkled, fairings damaged by landing lights; slat punctured

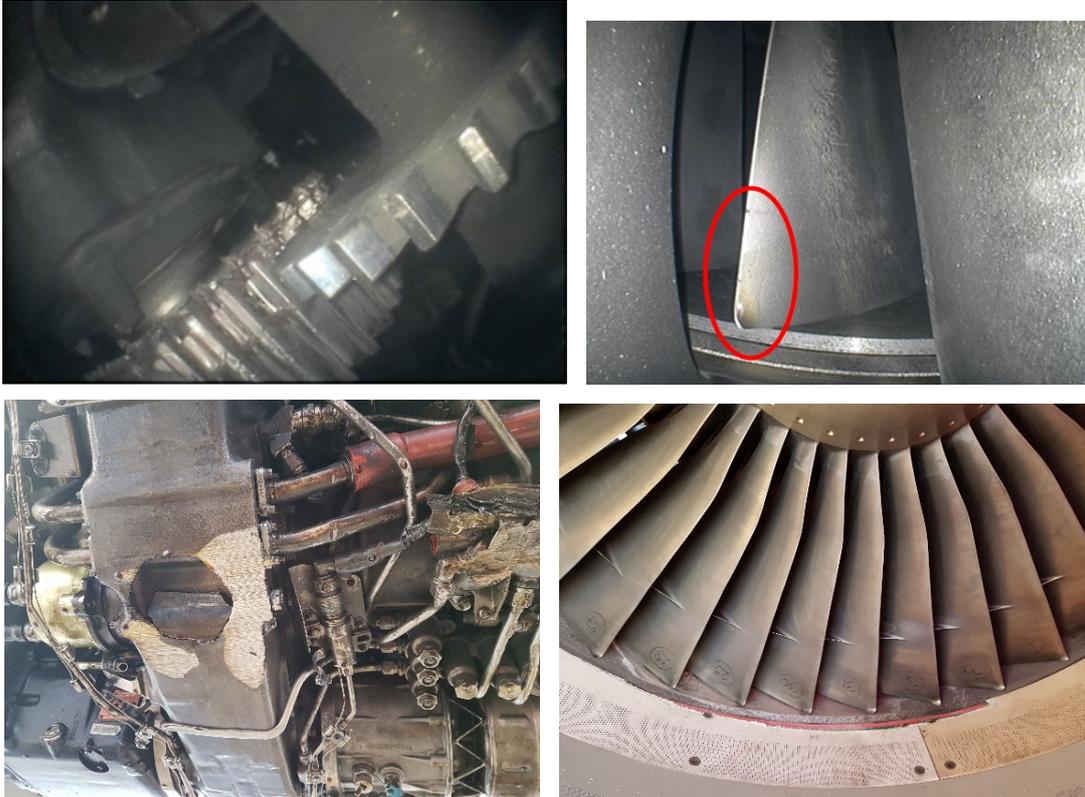
All damage was consistent with an impact with the ground.

Figure 32 Bound gears in AGB; minor tip curl at compressor stage 4; Perforated AGB case; Fan blade tip curl and scraped lining.

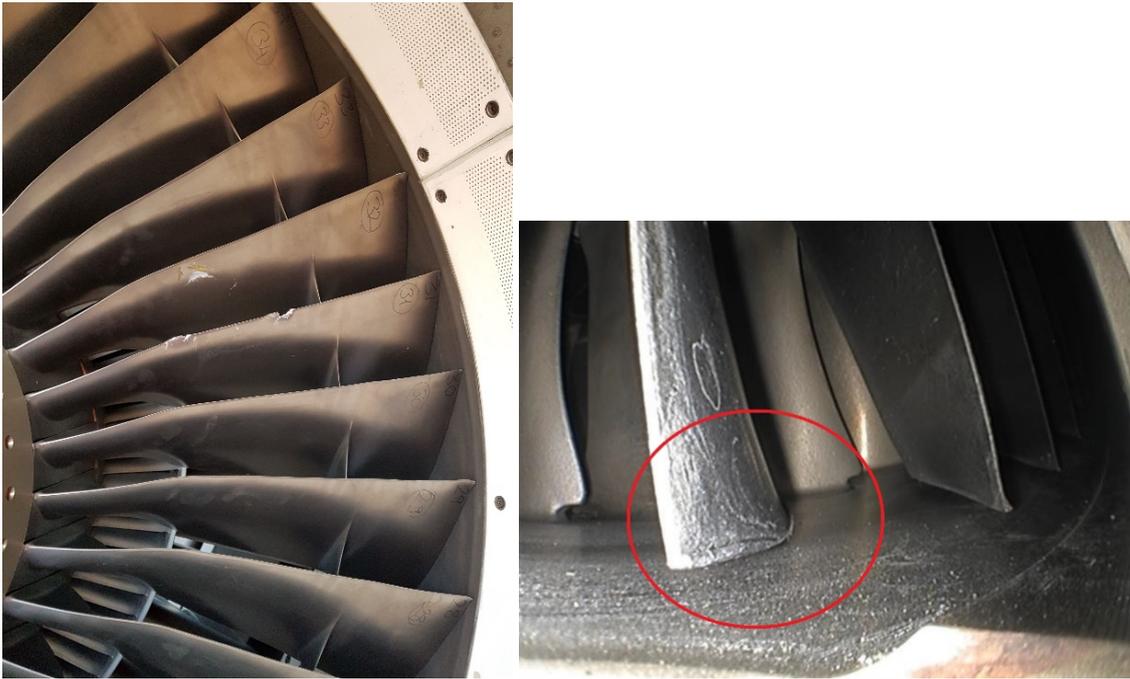
All damage was consistent with an impact with the ground.

Figure 33 FOD on fan blades; tip rub at compressor stage 3

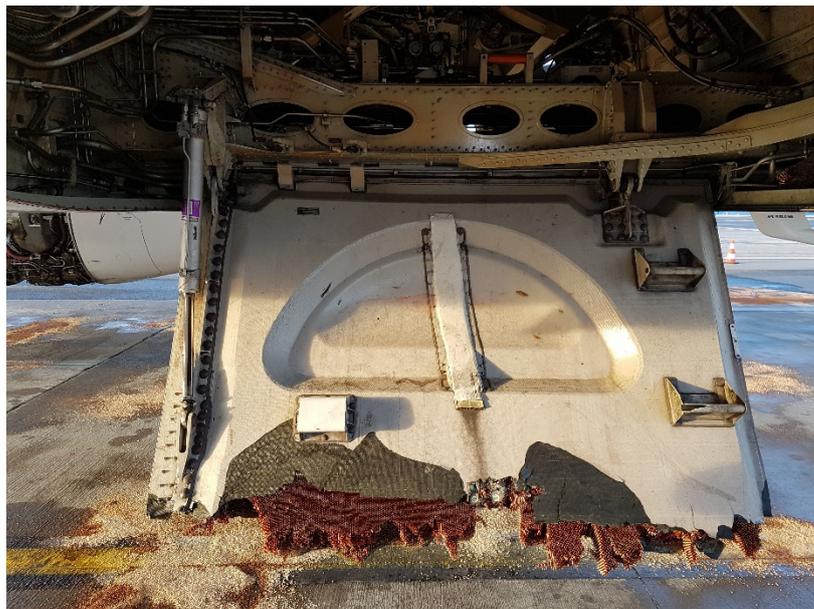
Main door, lower lip was completely missing, strut door attach rods sheared and door actuator piston rod bent (Figure 34). Both tires were burst with a flat spot. Hydraulic fluid leakage from O/B of the Rib 5 area.

Figure 34 Bent LH landing gear actuator and damaged door

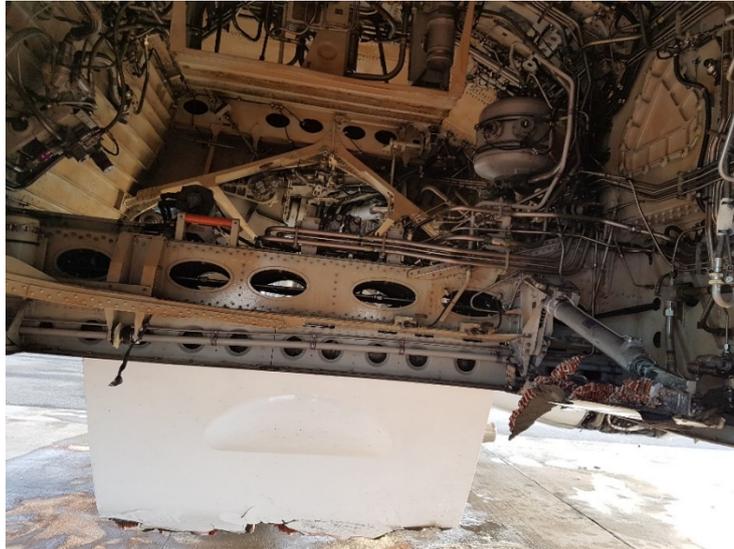
Main door was completely missing (Figure 35), hinge points remained intact, door actuator was in retracted position. Strut door actuator piston rod was bent. Both tires were burst with a flat spot. Evidence of significant Hydraulic fluid leakage, Rib 5 area.

Figure 35 RH landing gear actuator and missing door

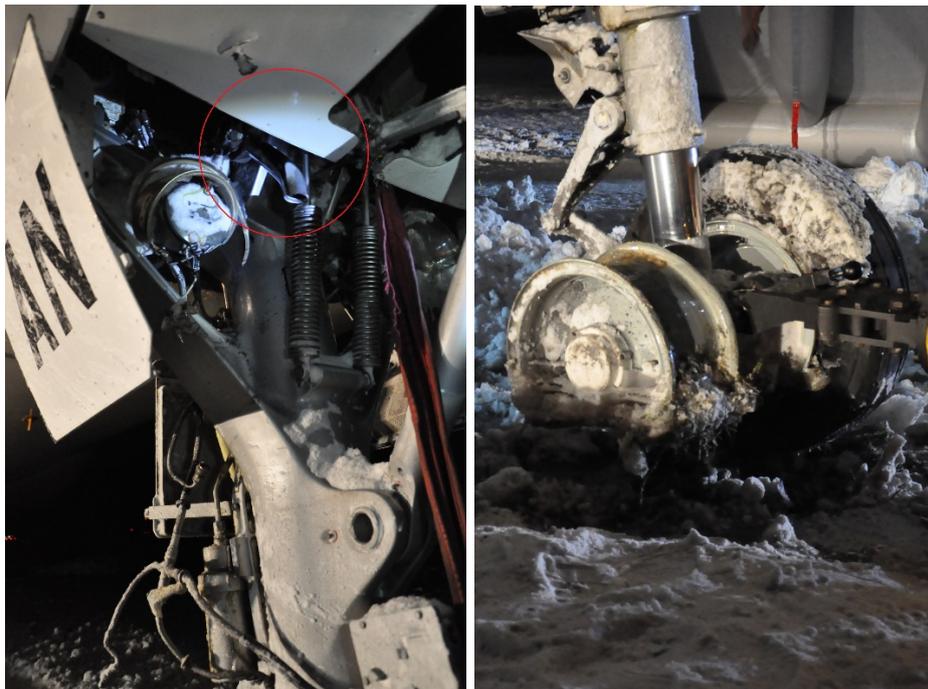
Figure 36 Sheared front landing gear actuator; abraded front wheel

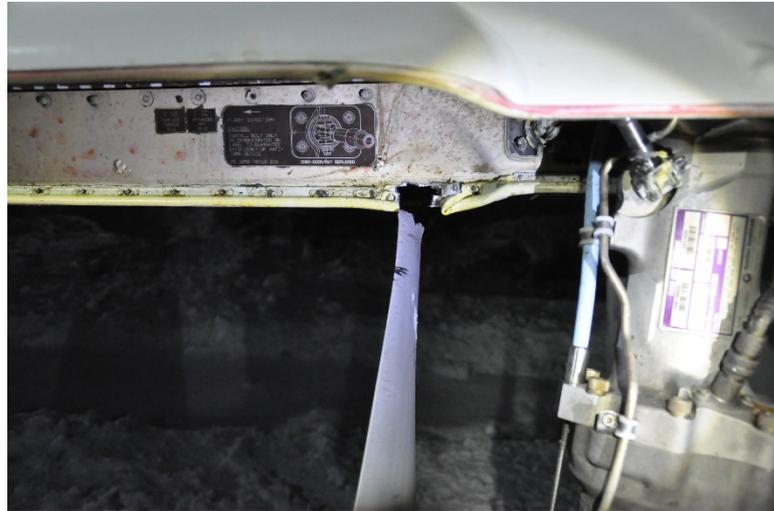
RAT was deployed, blade tips were damaged from the contact with the right RAT doors (Figure 37). RAT door link damper was broken and bent, one was missing.

Figure 37 Damaged RAT blade tips and rat doors

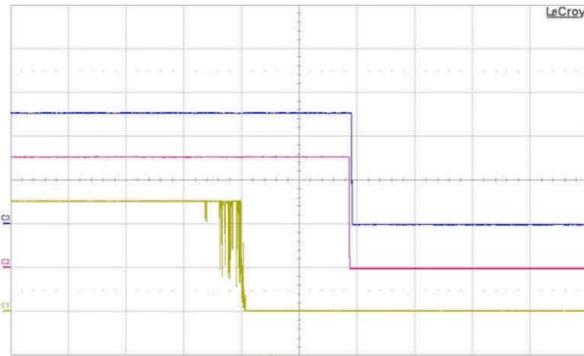
Figure 52 While ground setting is launched and manual input is held, switch 1 signal is activating with abnormal spikes. Switch 2 and 3 appears with delays after 2s.

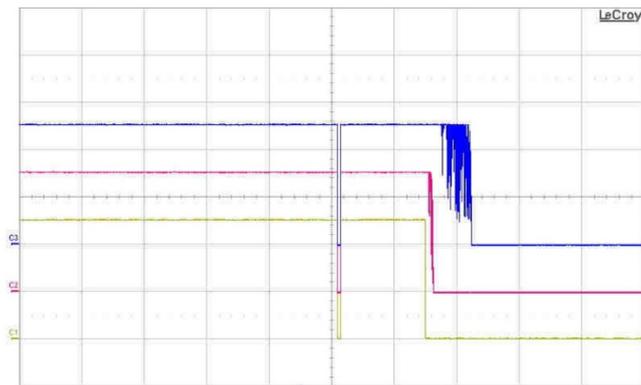
Figure 53 While ground setting is launched and manual input is held, switch 1, 2, 3 signal is transiently compliant for 100ms, disappears for 1,2s activating with abnormal spikes. Switch 2 and 3 appears with delays after 2s.

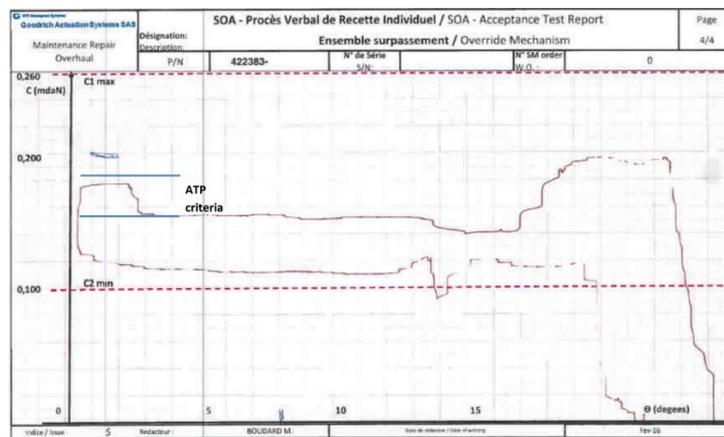
Figure 55 Override test results, the actual friction curve is slightly under the required criteria

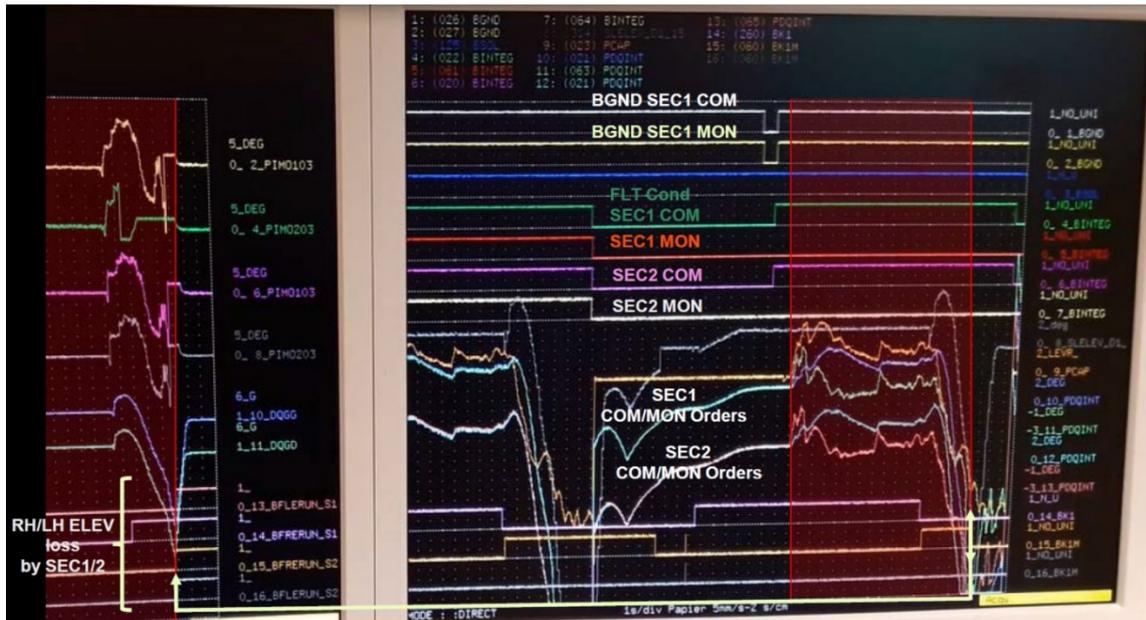
Figure 64 Loss of ELEV control by the two SECs by the discrepancy between SEC COM and MON Ground/Flight condition
