CASUALTY REPORT

August 18, 2003
Case 199927017

Collision on 12 August 2002 between the Danish fishing vessel EATON and the Finnish cargo vessel FINNMERCHANT

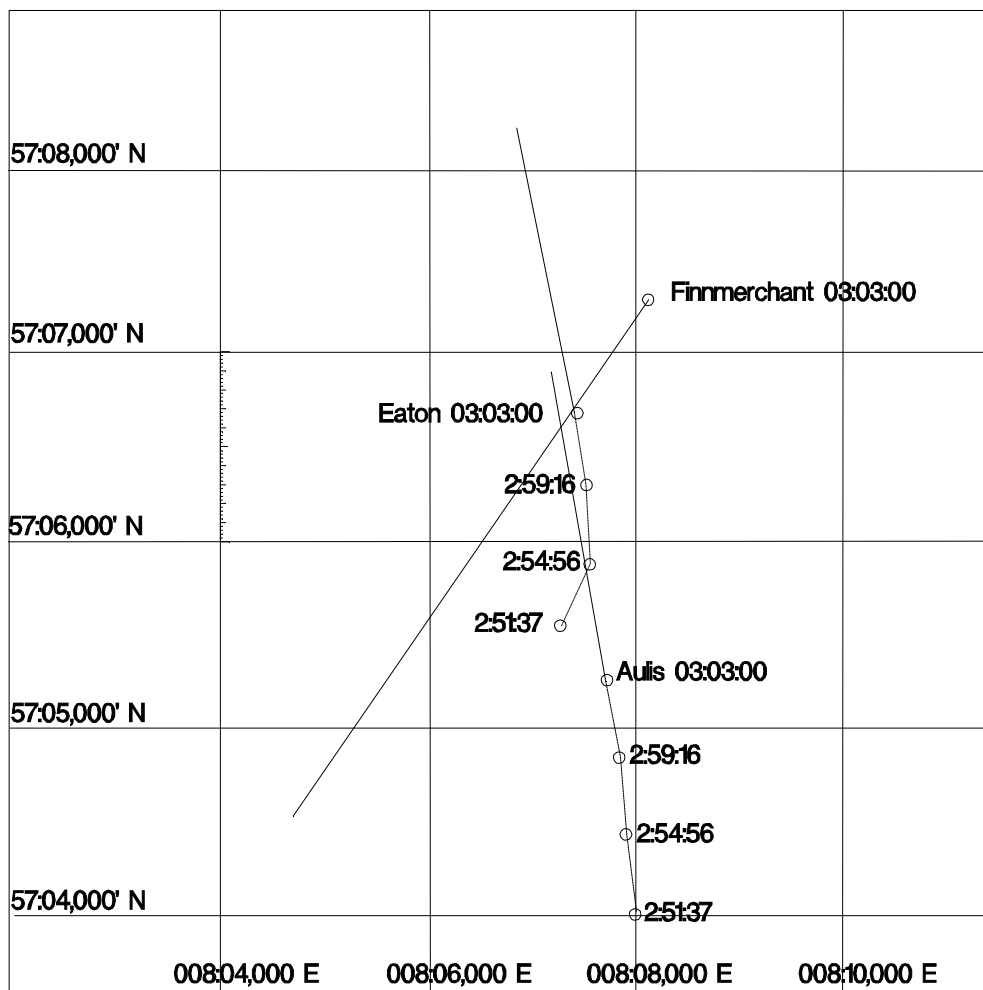
Reconstruction no. 1

According to the fisherman on board EATON, he altered course some time before watch shift to avoid collision with another vessel. He returned to course approx. 349 degrees before the mate took over the watch. The fisherman had probably not observed FINNMERCHANT on the radar before he returned to course 349 degrees, because the distance on the radar was set on 1.5 nm and the distance between the vessels was more than 3 nm.

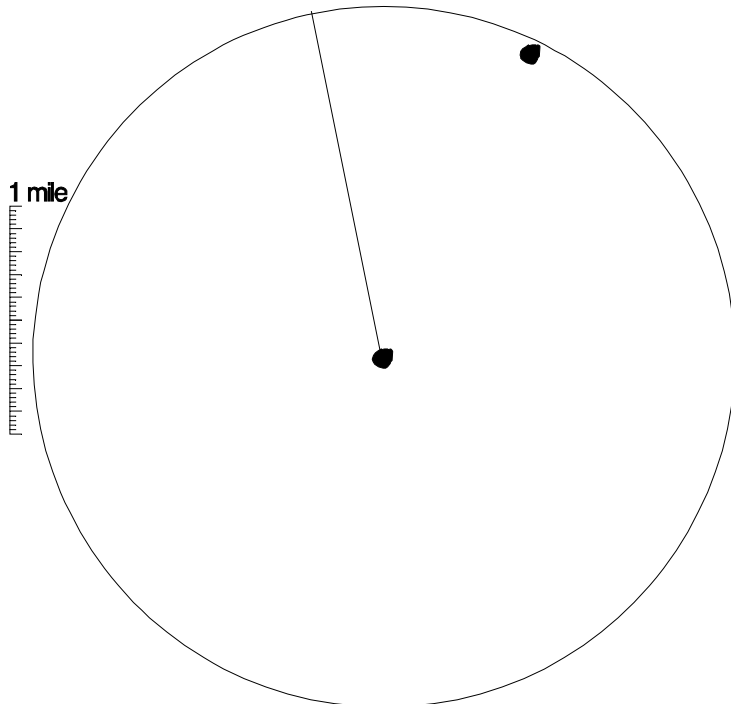
Eaton's radar on 1.5' range at 03:01.
 Finnmerchant appears approximately on 1.5' range

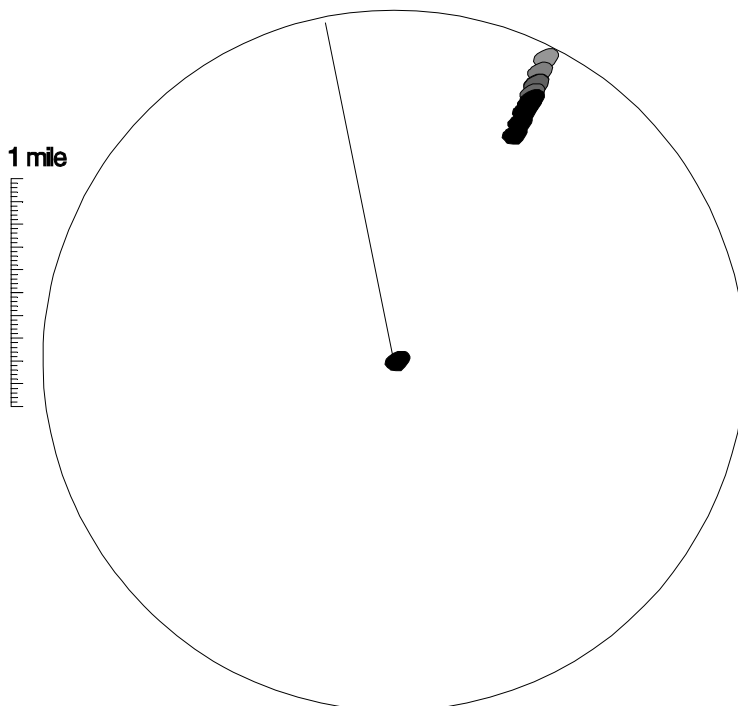
Eaton's radar on 1.5' range at 03:02.
 Finnmerchants relative movement on the radar is 202 degrees.

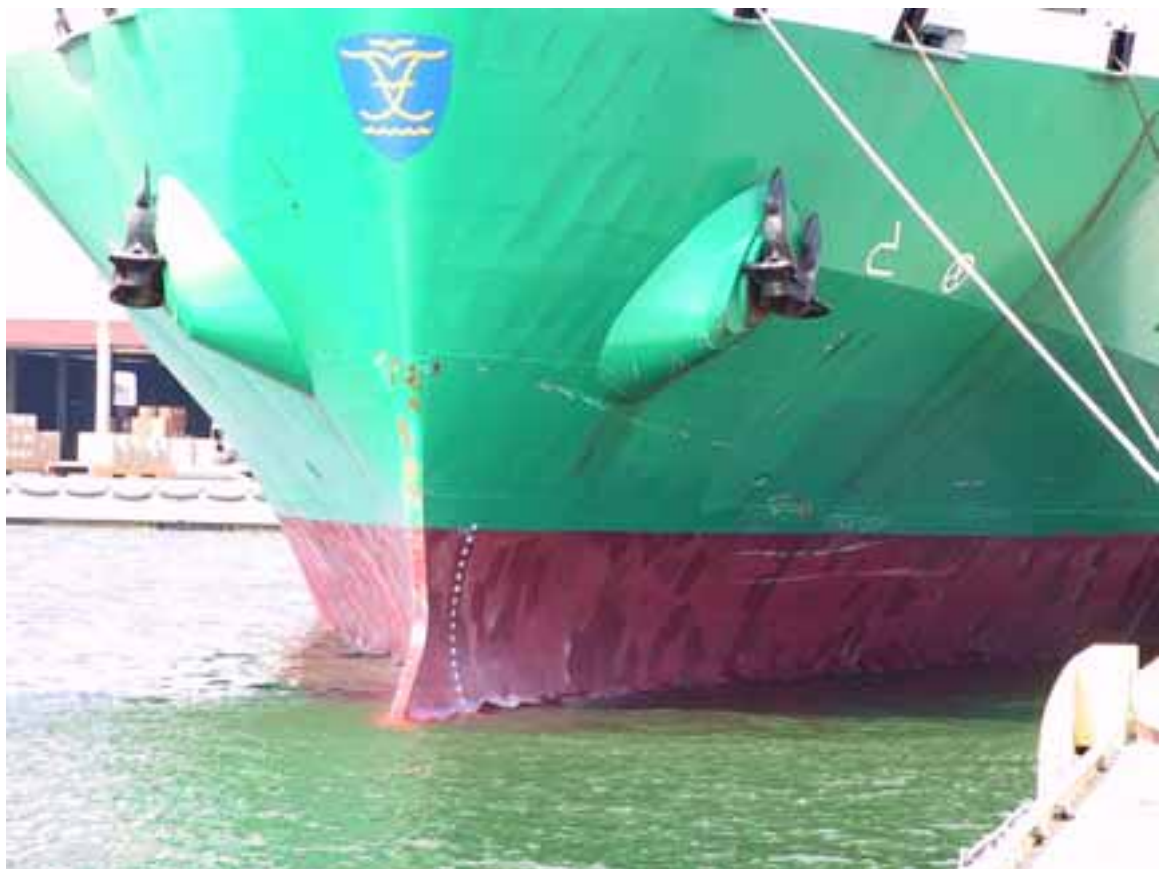
FINNMERCHANT

The main contact between the vessels was on FINNMERCHANT's port bow and EATON got damages in port side.

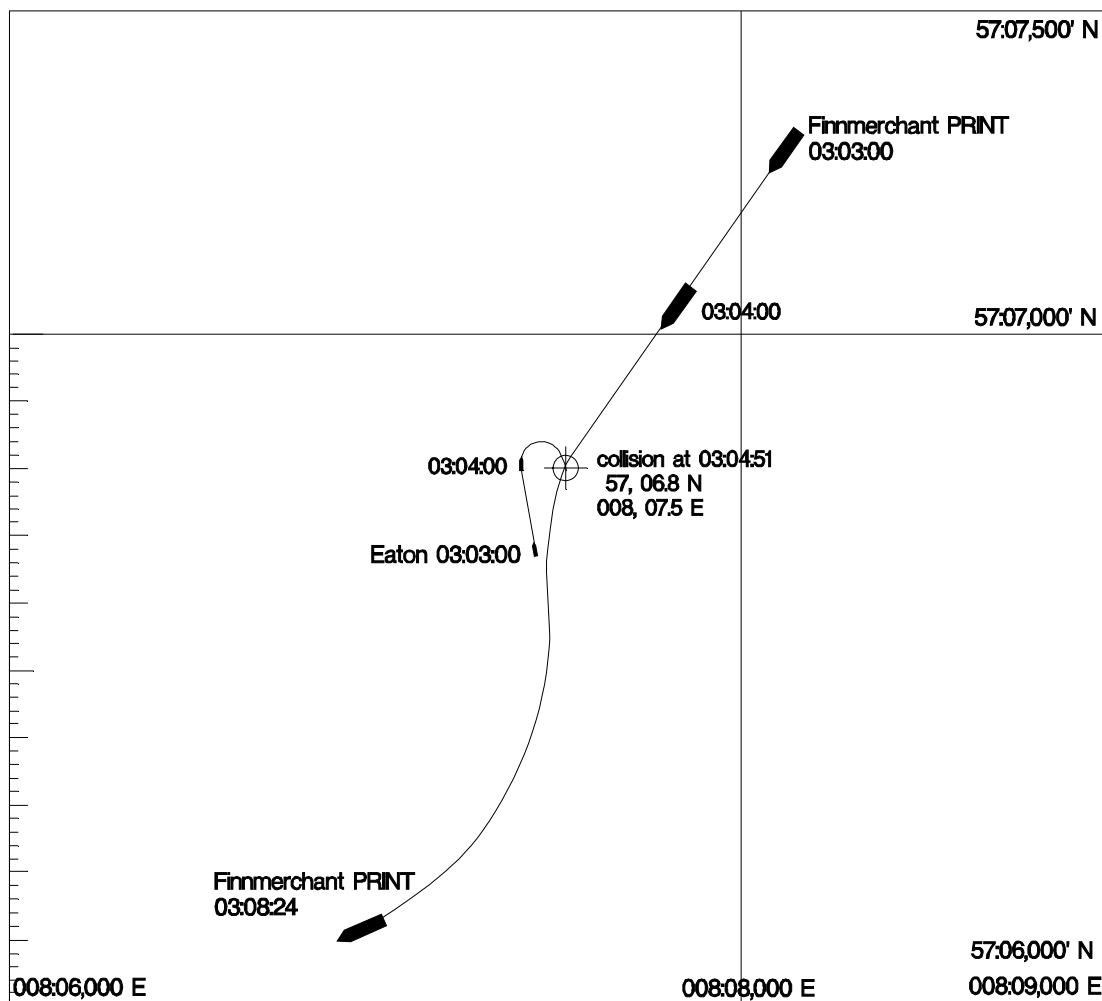
Reconstruction no. 4

The figure illustrates Eaton's turn.

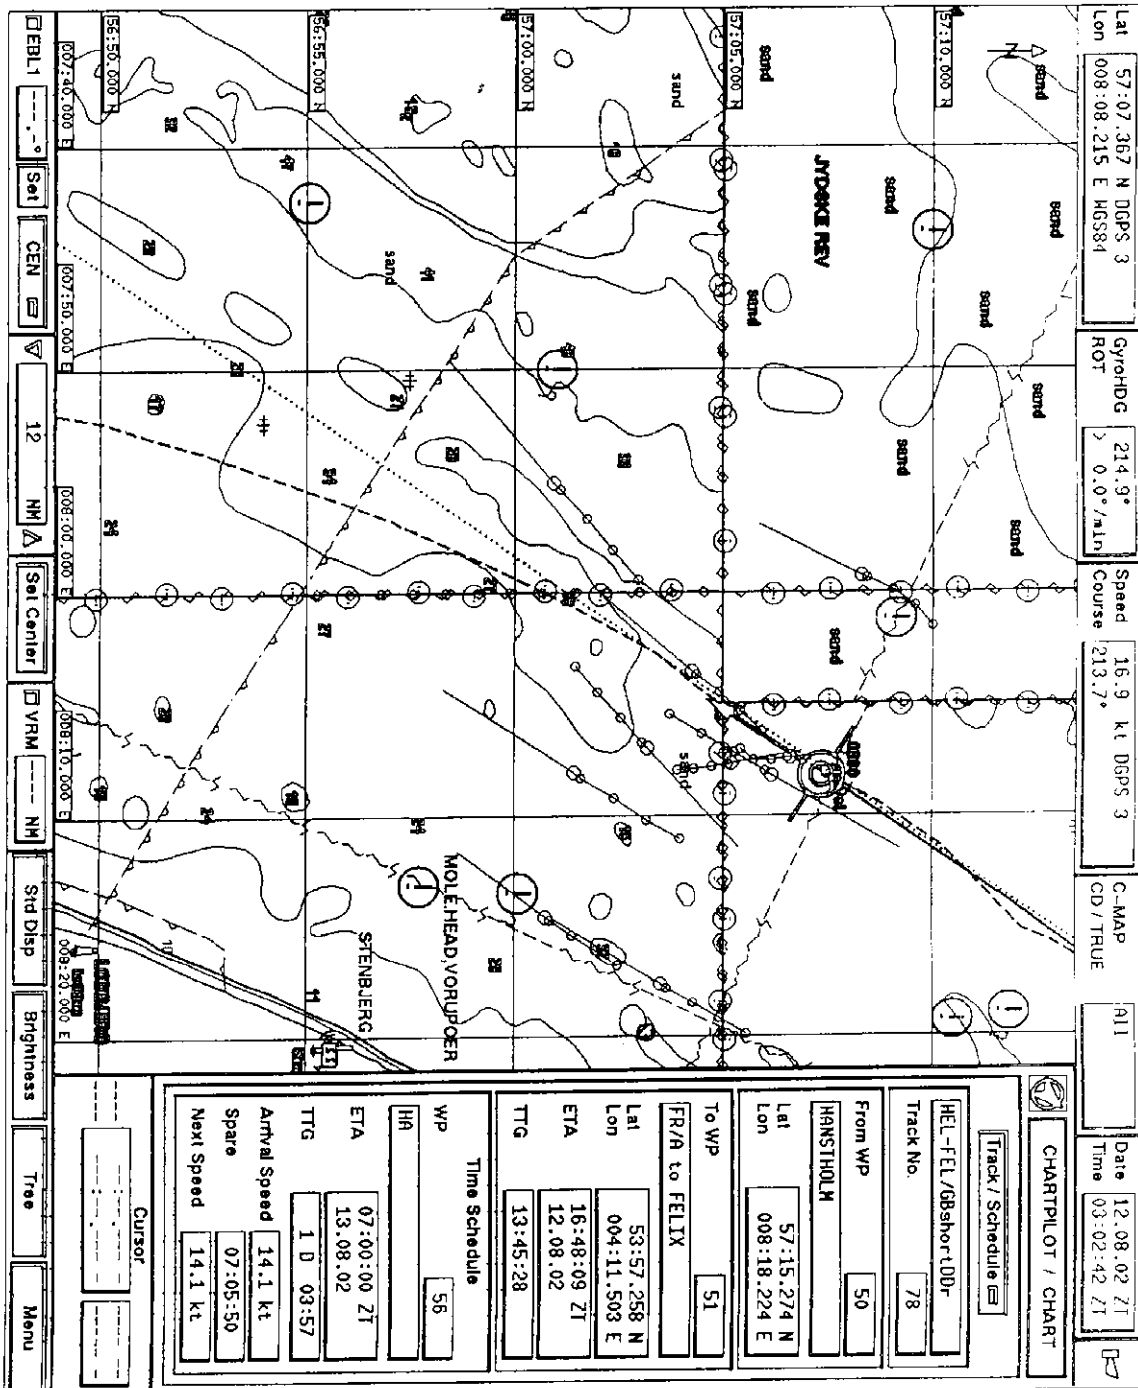
Appendix 1:

There are prints from the electronic chart showing the situation at 03.02.42 and 03.03.00 shortly before the collision (see appendix 1 and 2). The vessels in the vicinity, which were plotted on the ARPA radar are shown on the prints. The tracks of the vessels plotted are marked for every three minutes. EATON and AULIS are shown on a course of approx. 355 degrees. There are also other vessels in the vicinity. One vessel on a north easterly course has passed between EATON and AULIS and is shown on the print on the port side of FINNMERCHANT in distance approx. 1 nm. Another vessel is approx. 4 nm ahead of FINNMERCHANT on the same course as FINNMERCHANT.

EATON is shown on the prints on the heading line of FINNMERCHANT approx. 0.7 nm ahead. The track of EATON shows, that EATON was on a north easterly course until approx. 6 minutes before the print was taken.

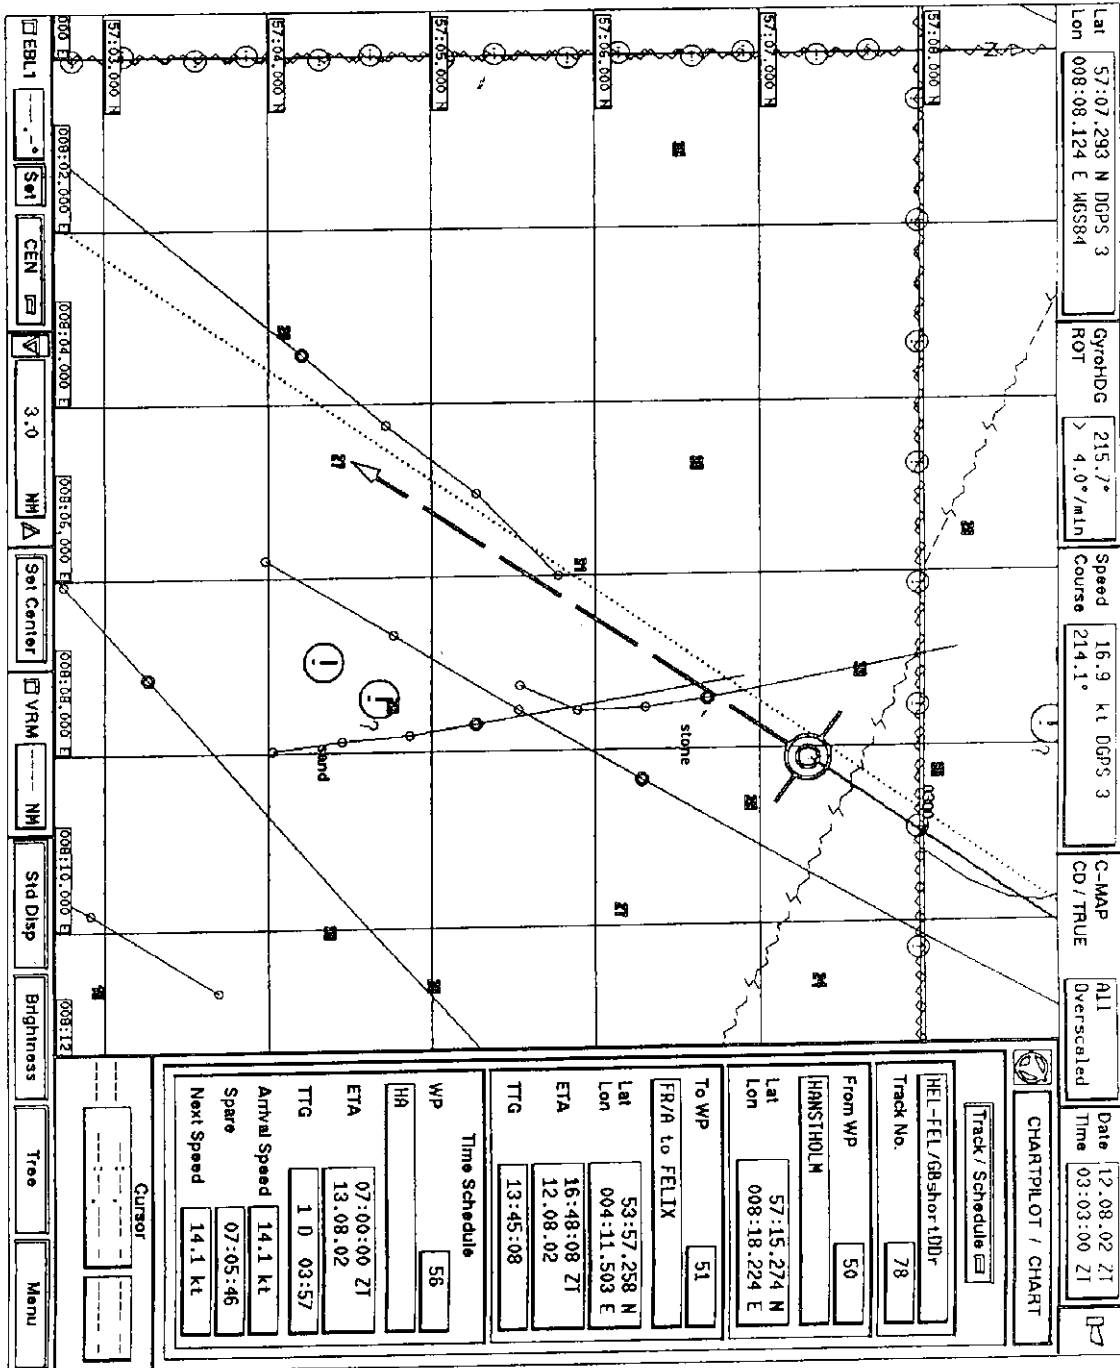
Appendix 2:

The 2nd officer printed out the situation again at 03:03:00 (see appendix 2), when EATON was 0.7 nm ahead of FINNMERCHANT. The CPA would then be 0.3 nm passing starboard to starboard.

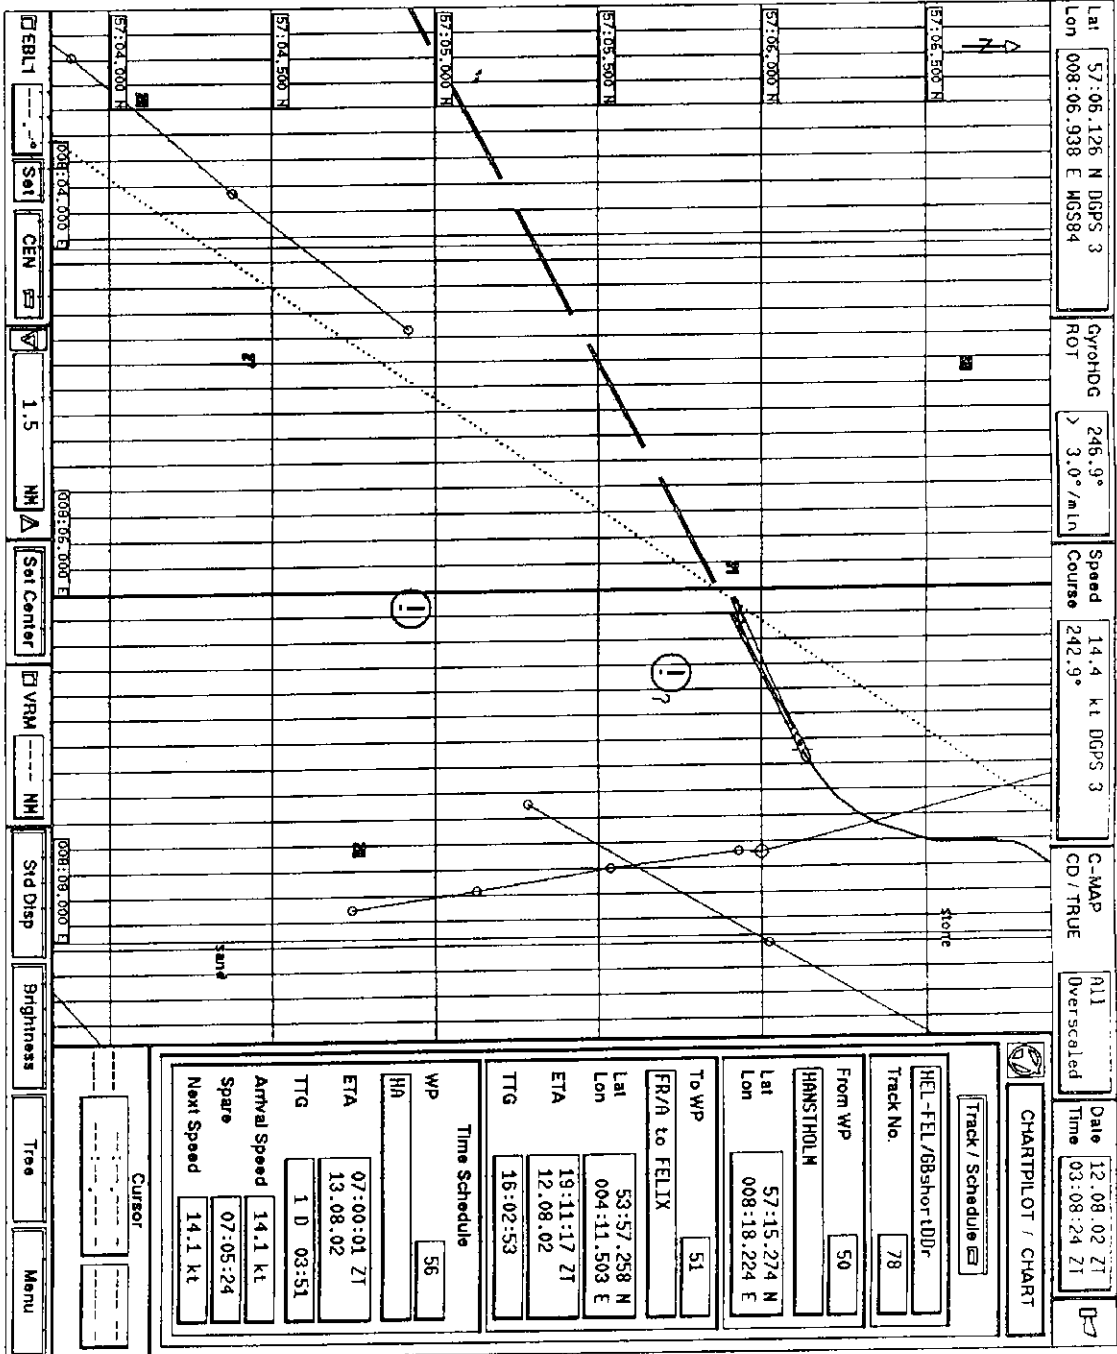
Appendix 3:

Another print was taken at 03.08.24 after the collision. This print shows that FINNMERCHANT first turned to port and then turned to starboard. According to the position

of EATON on the print of 03.03.00 the collision must have taken place approximately where FINNMERCHANT begins to turn to port (see appendix 3).
