## Investigation report

B 6/2004 M

# Ms SUPERFAST VIII, Fall of an MOB boat to the sea in a drill in Hanko West Port on 9.11.2004

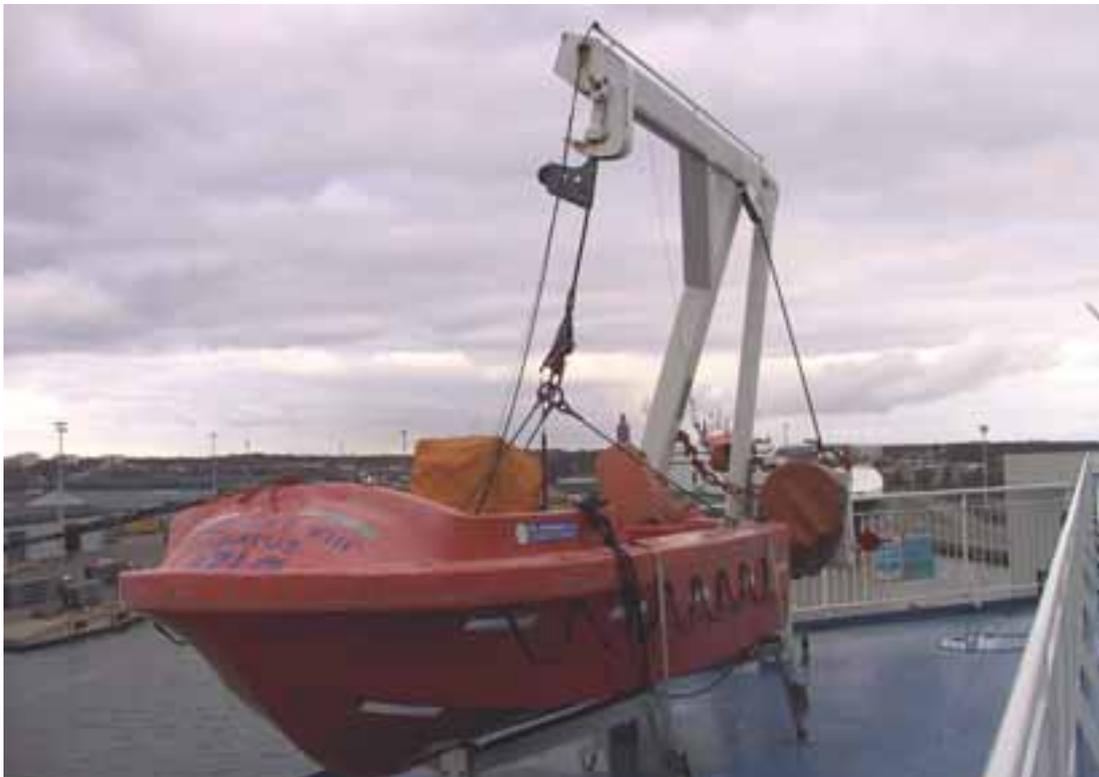
Figure 2. *The MOB boat, the hoisting davit and the hoisting hook. In addition to the hoisting wire, also the charging cable of the battery and its support wire came from the davit.*

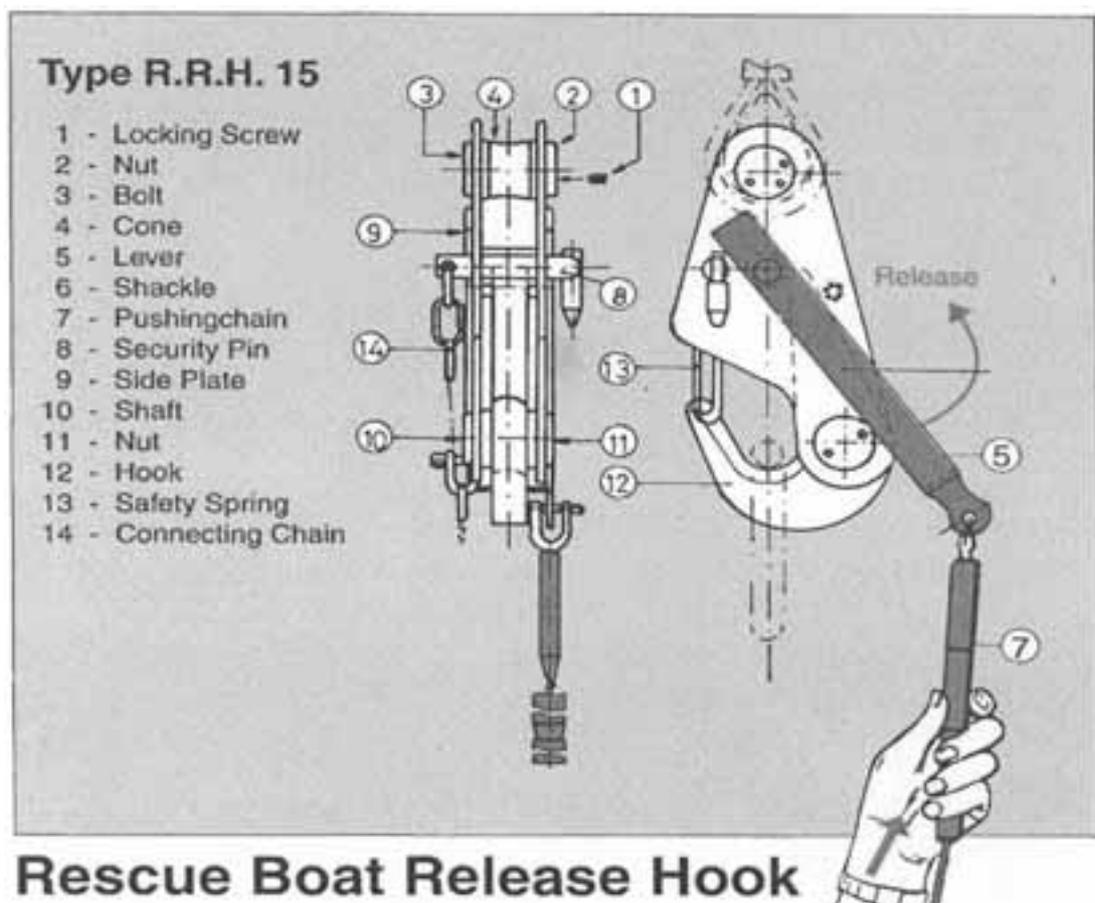
Figure 3. Hook RRH15. Unlike in the figure, the hook involved in the accident did not have a security pin (8), but a bolt, and it had been secured by means of a safety spring placed in a hole bored in the bolt.

The purpose has been to prevent accidental opening of the hook by means of the security pin in case the lever is hit by something or because the unsecured loaded hook might be opened if the boat swings for example in rough seas. In this case the securing did not work because at the time of the accident the security pin was not in place.

The head of the original security pin belonging to the hook is turning so that the turning head prevents the pin from sliding out of place. In the hook related to the accident, the security pin had been replaced with a bolt, which was hanging from the hook at the end of a short chain to prevent it from being lost. To ensure that the bolt stayed in place, a safety spring was used, which was placed in a hole bored in the bolt.

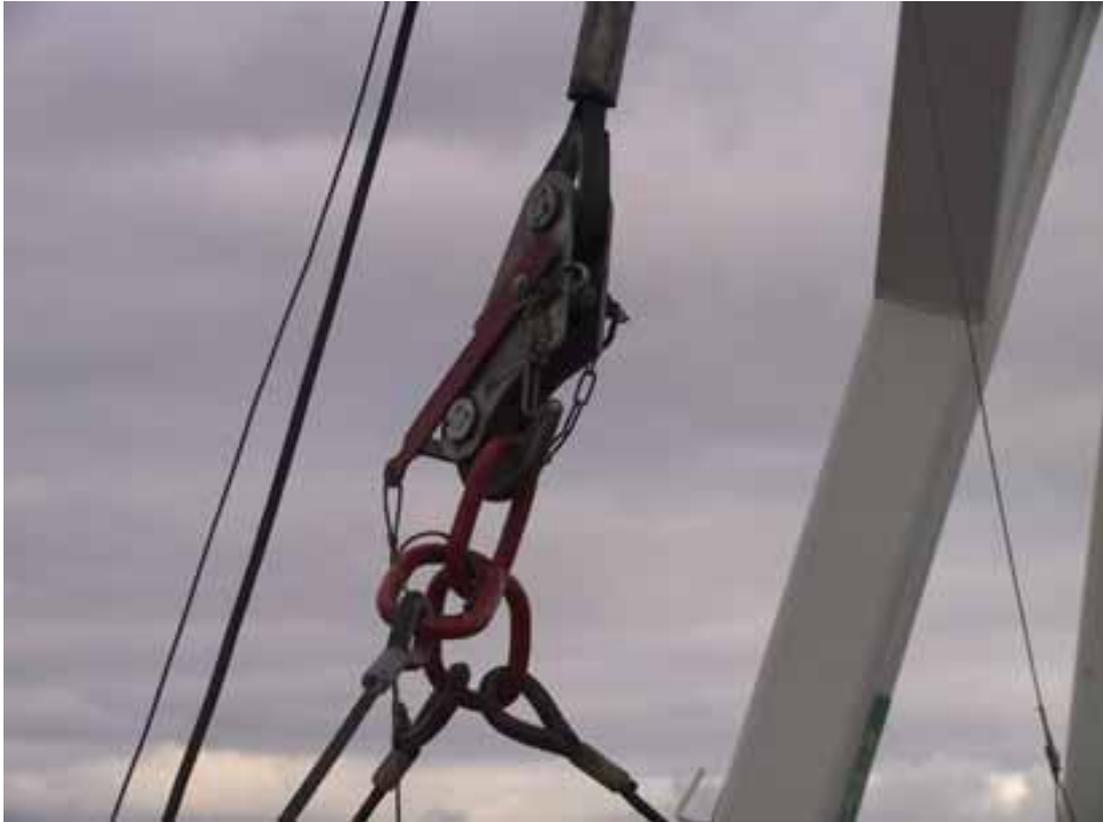
*Figure 4. The hook of the boat in the accident, where the bolt used as the security pin is in place. The release wire goes downwards from the release lever. The charging cable of the battery and its support wire are on the left.*

The hook is an essential security factor, and changing it without approval of the manufacturer is not recommendable. In this case, however, the bolt and the safety spring, if in place, prevent the accidental opening of the hook quite as certainly as the original pin. A weakness compared to the original is that the safety spring may be lost and the fact that there is no certainty about the endurance of the bolt and safety spring in sea conditions. In this case, the spring was not lost nor was there any significant corrosion.

The investigation did not reveal when and why the security pin has been changed. It is possible that the original has been lost and that the lost pin has been replaced with the bolt. It is also possible that the change has been made to make the use easier, because for example one of those in the boat has stated in the police interrogation that the use of hands is difficult when wearing the survival suits and the gloves forming part thereof. Both hands have to be used when removing the original pin, because the end of the pin has to be turned to a horizontal position while pulling from the other end of the pin. The pin made from the replacement bolt could be removed with one hand by first pulling out the safety spring and then the whole security pin.

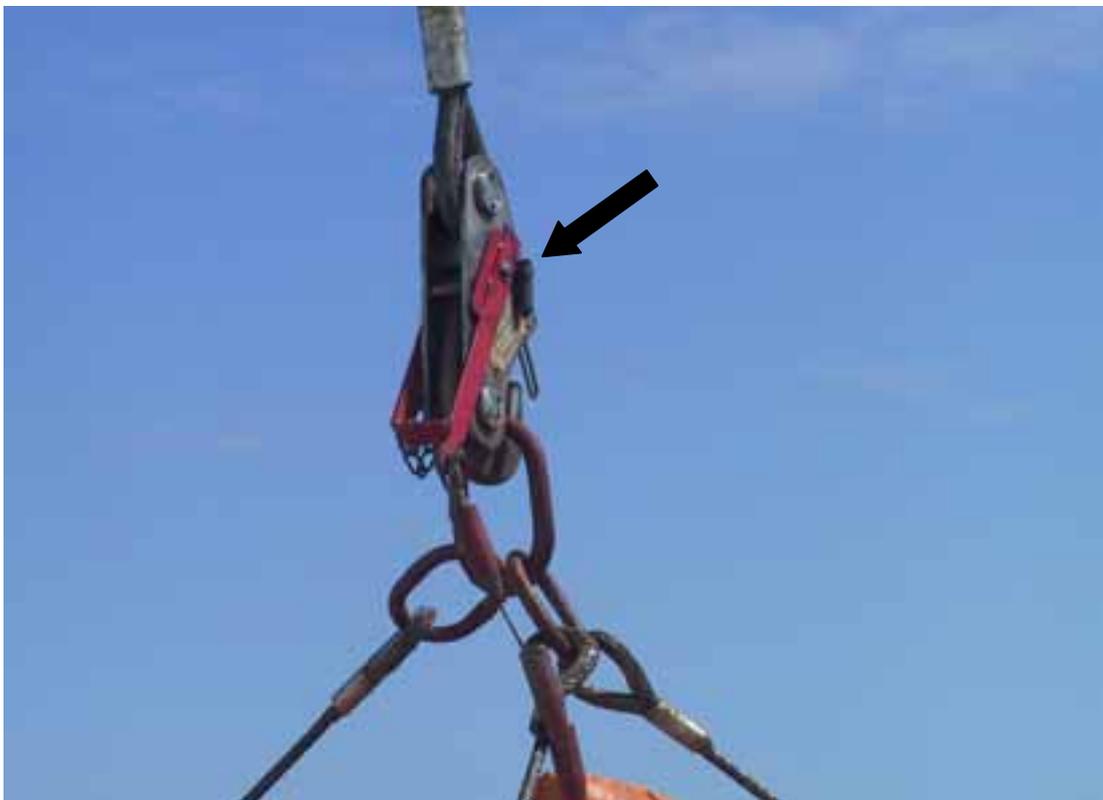
*Figure 6. The hoisting hook mechanism of the corresponding boat of the sister vessel, where the arrow points to the original security pin. The red plastic cones around the release wire are here correctly, i.e., with the tapered end downwards. In the hook involved in the accident, the tapered end pointed upwards, which made the releasing slightly more difficult.*

In the accident hook, **the plastic cones of the release wire** were upside down compared to the drawings of the manufacturer and the sister vessel. When placed the wrong way, the release wire does not function as well as when installed in accordance with the instruction, but the hook can, nevertheless, be released. The way the plastic cones were installed did not have an effect on the accident.

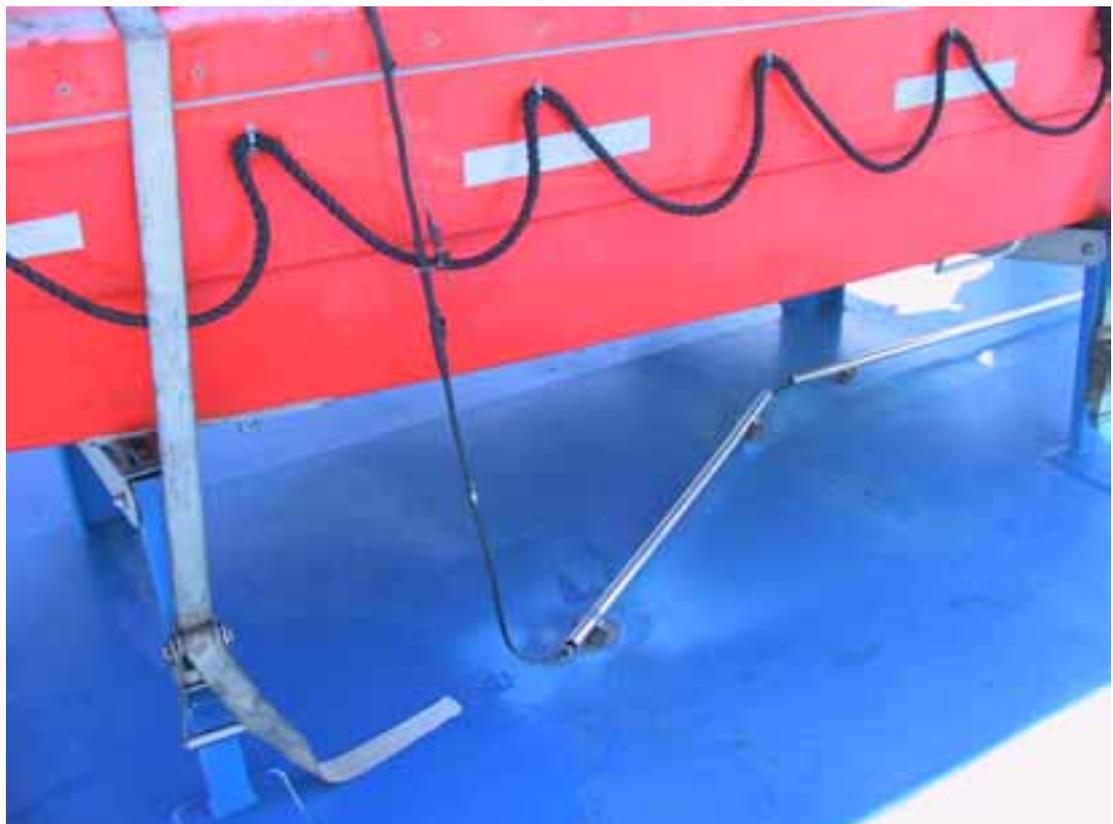
*Figure 7. The changed route of the battery charging cable, picture from the sister vessel.*

**Placement of the charging cable of the battery.** The cable had been fastened to the support wire evidently to make it easier to handle in windy conditions. When brought to the boat through the davit, the cable and the wire had an essential effect on the acci-
