Investigation Report

C2/2007M

MS CLAUDIA, grounding off Tornio on 23.10.2007

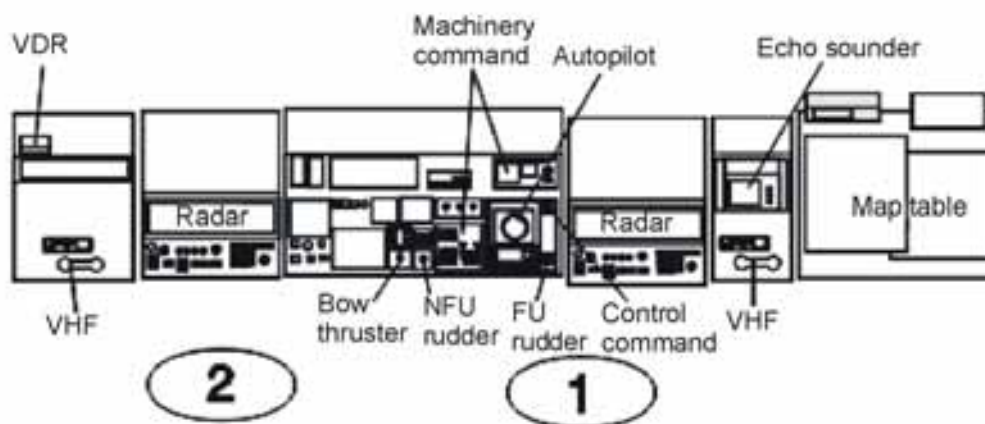
Figure 3. The manoeuvring and navigation console on board the CLAUDIA.

Two navigator's places of work can be discerned in the manoeuvring and navigation console. Place of work no. 1 is clearly the place of work of the watchkeeping officer. He/she has the radar in front of him/her. The radio telephone, echo-sounder and the nautical chart are located on the starboard side. The autopilot, FU (Follow Up, voyage steering), manoeuvring mode switch and engine controls are on the port side.

Place of work no. 2 clearly belongs to the assisting navigator. He/she has the radar and radio telephone in front of him/her. From this place of work it was not possible to both steer and to monitor the radar at the same time.

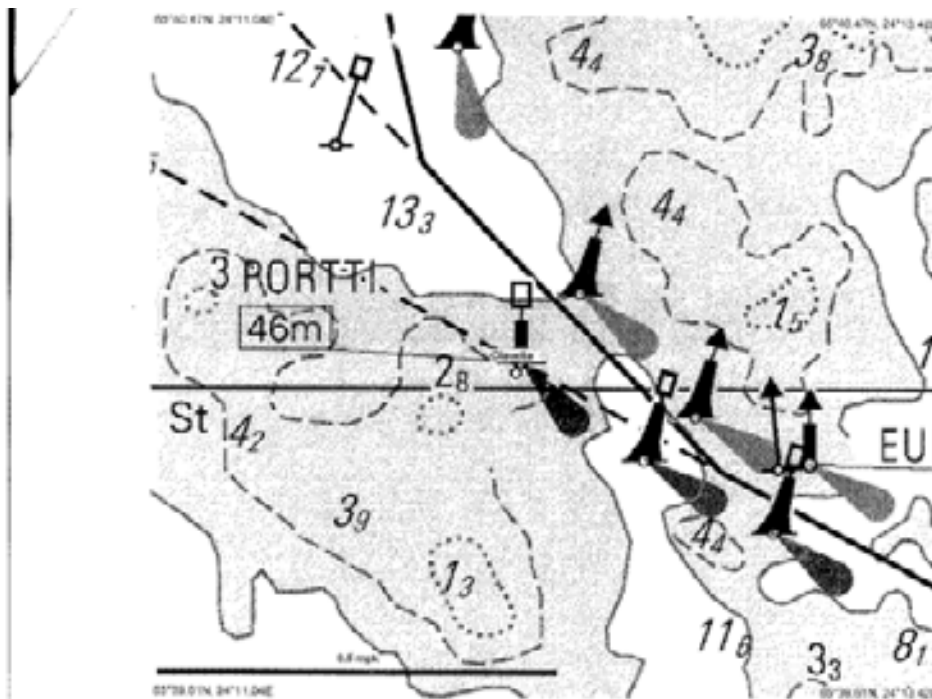
Figure 5. The scene of the accident in the Røyttä fairway⁷.

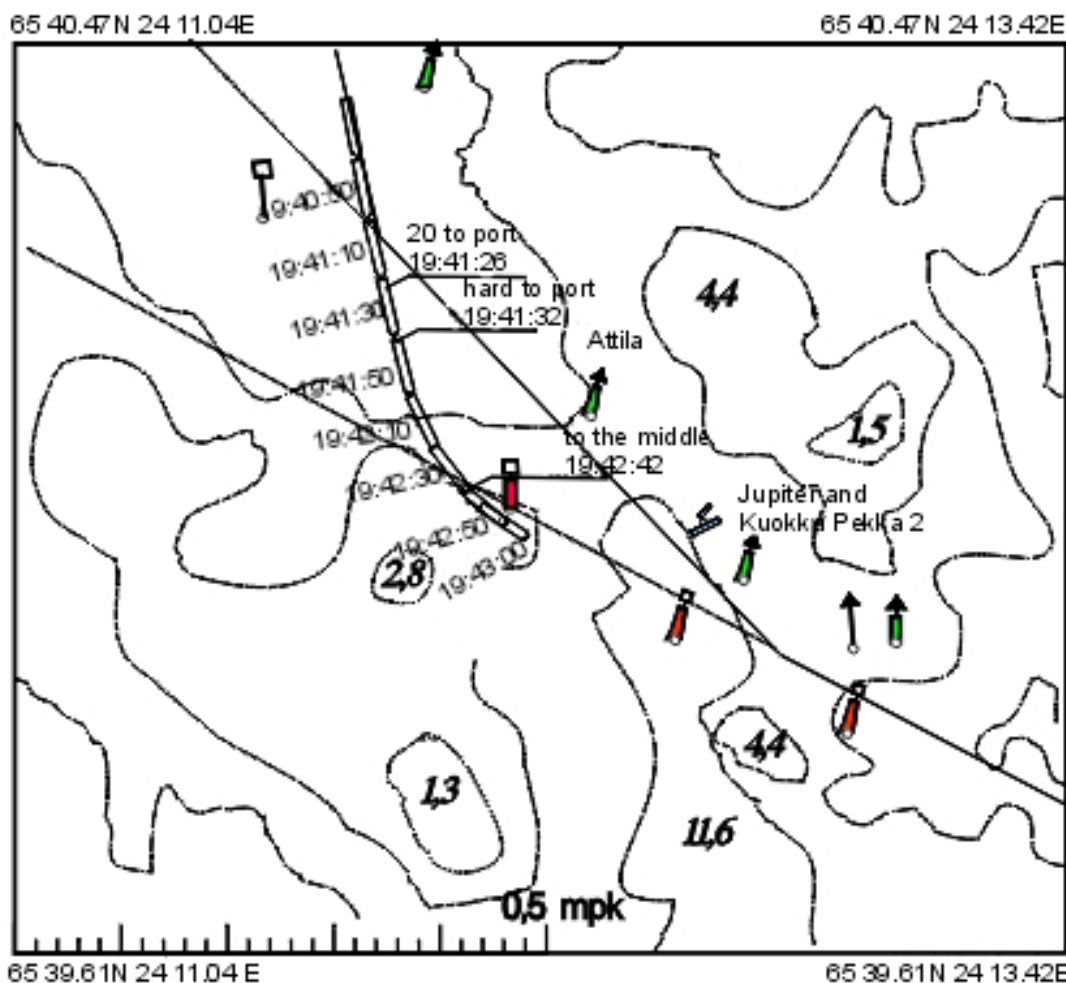
In the investigation, the helm orders were simulated by using a work-station simulator. According to the simulation, the rudder was turned 20° to port at 19:41:26 and hard to port after six seconds. The vessel did not turn enough. The master had reduced the speed, which was only 7–8 knots at the time of the grounding. The pilot went to the bridge wing. At that point he saw the border mark ahead to port. The pilot told the master to stop the propeller. The vessel stopped south of the border mark at 19.43. The master told that the speed had been 7–8 knots (Figure 6). At 19.45 it was established that the vessel was aground¹³.

Figure 6. The accident event. At 19:41:26 the rudder 20° to port and at 19:41:32 35° to port¹⁴.

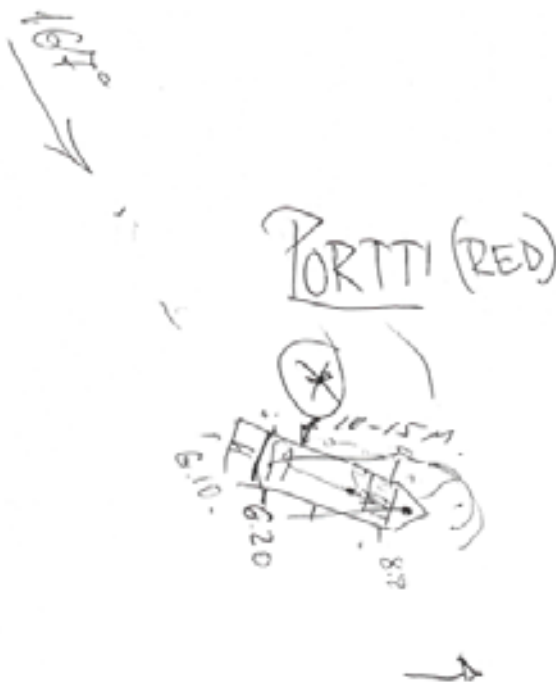
Figure 7. A drawing made by the chief officer on the location of the grounding. The drawing describes how the vessel turned after running aground. When grounding, the course of the vessel was 120°.

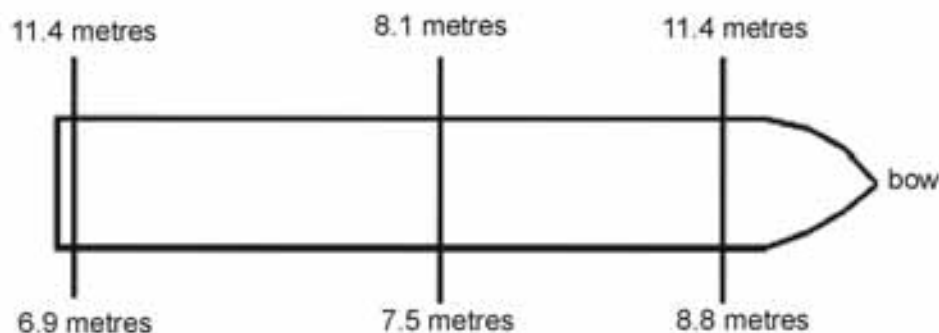
The master immediately ordered tank soundings to be taken. The draught of the vessel at the stern was 6.20 metres as it at the time of departure had been 6.6 metres. It was established that the vessel was aground at the stern. The bow was floating.

Figure 8. The soundings around the vessel confirmed that it was aground aft.

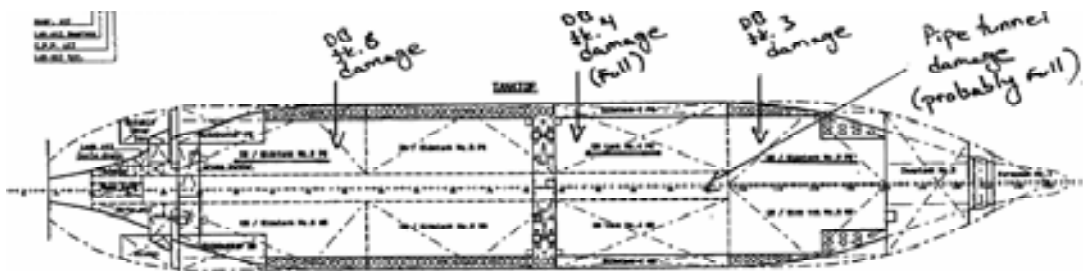
- There were leakages in tanks 3, 4 and 6. There were no oil leakages.
- The forepeak was dry. The DT tank was dry.
- STS 1 port was dry
- STS 1 starboard, water level one metre (ballast water).
- *Double-bottom tank (DB) 3 port was damaged, 42 cm of water.*
- Double-bottom tank (DB) 3 starboard was dry.
- *Double-bottom tank (DB) 4 port was damaged and full of water.*
- Double-bottom tank (DB) 4 starboard was dry.
- Double-bottom tank (DB) 5 port was dry.
- Double-bottom tank (DB) 5 starboard was dry.
- *Double-bottom tank (DB) 6 port was damaged. 8 cm of water.*
- Double-bottom tank (DB) 6 starboard 248 cm of ballast water.
- *The pipe channel was damaged. After the grounding an alarm of a serious danger was made.*

Figure 9. The damages to the bottom of the vessel in the sketch and the list above.

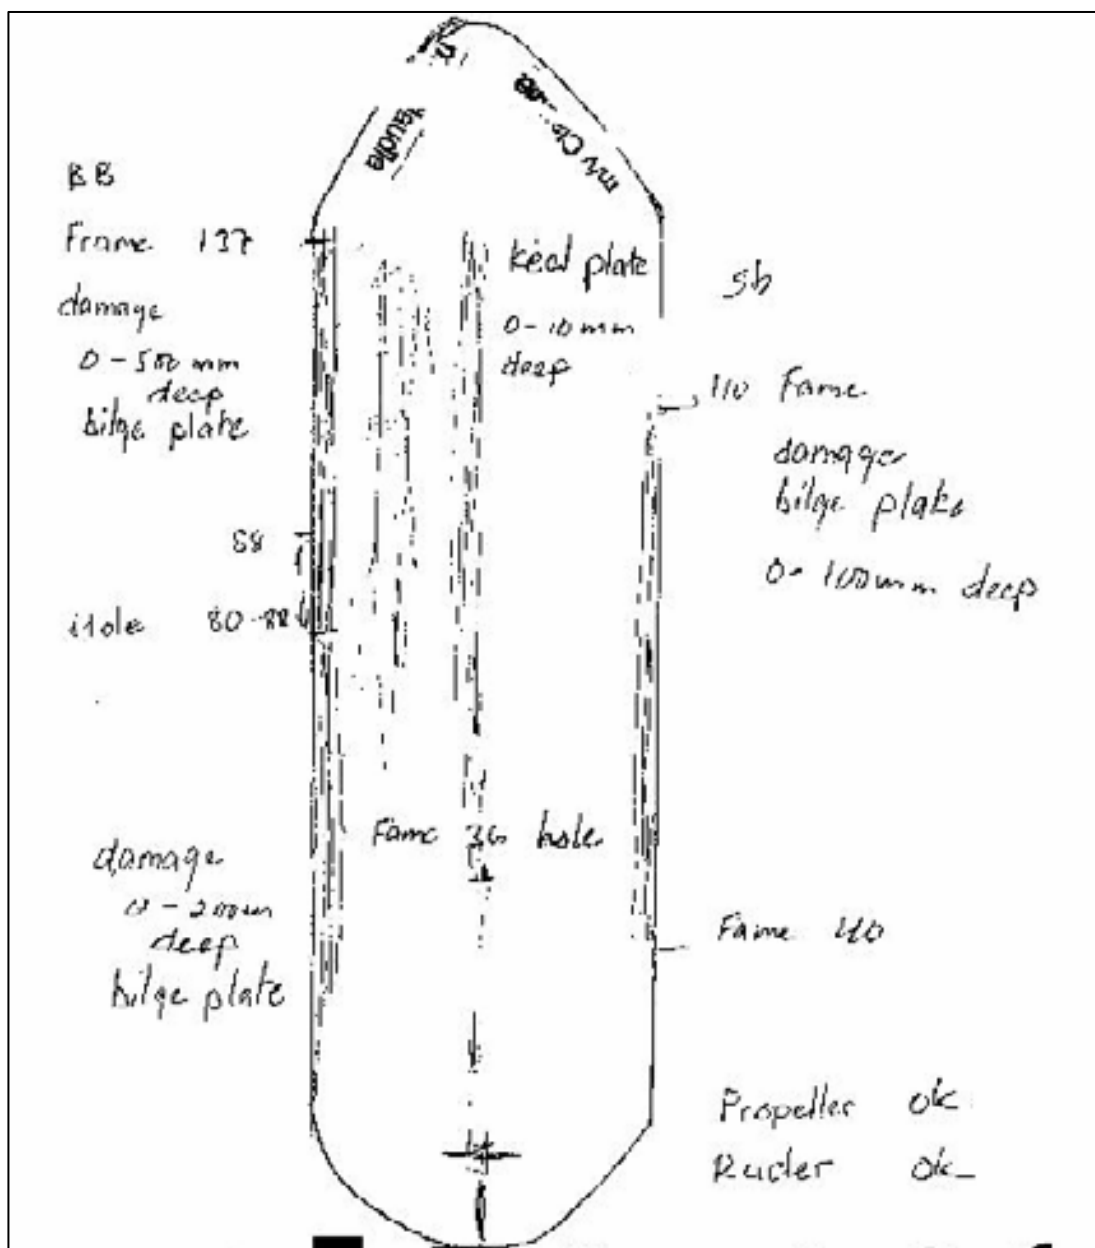
Figure 10. A drawing made by a diver on the damages to the bottom.

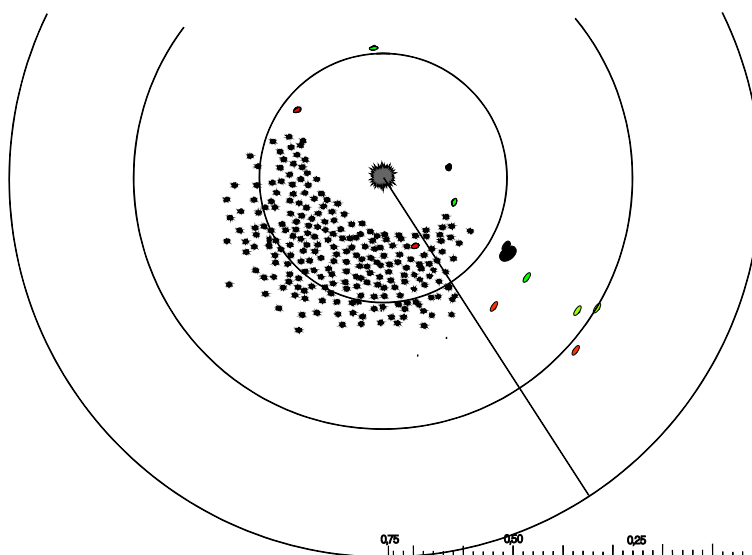
The effects of sea clutter on the radar picture are shown in Figure 13. The pilot has to concentrate to a disproportionate extent on the quality of the radar picture. The buoys can always be seen in the right position, but the specks caused by waves change places with every sweep made by the radar antenna.

Figures 13 and 14 illustrate the radar sea clutter according to the simulation clock of chart pictures 11 and 12 at 01:40. The temporary course of the vessel was 147° . As to the sea clutter, the figures are only the investigator's mental picture. There could have been considerably more sea clutter. There is less sea clutter in this figure so that it is possible for the reader to identify the positions of the buoys.

Figure 13. The normally used NORTH UP display. The scale is 0.75 miles from the centre to the side of the radar scope. For the sake of clarity, the navigation marks have been drawn using colours, but there were no colours on the radar display.

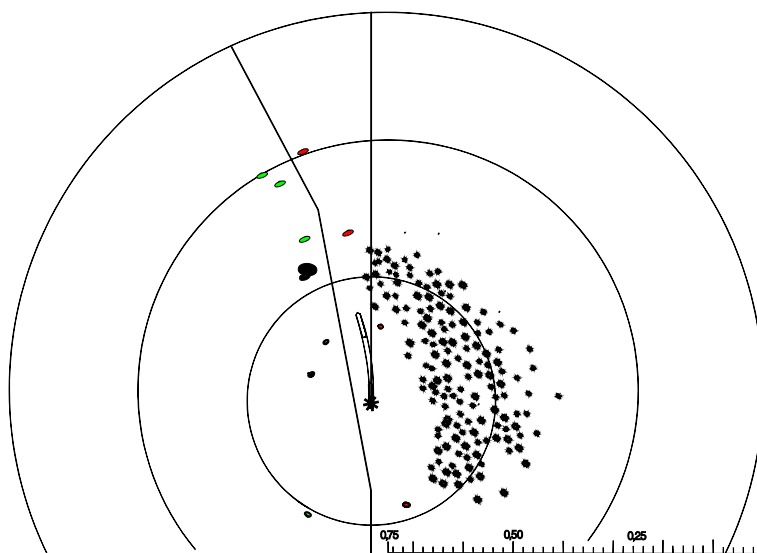
Figure 14. COURSE UP display gives the targets the same bearing as the view from the window. There is a 40-second-prediction of the motion of the vessel on the display. The temporary course of the vessel is 147° . The route plan describing the fairway line following the IMO requirements can also be seen on the radar display.

The COURSE UP display which shows a prediction of the vessel's motion makes monitoring relative movement easier, but sea clutter still disturbs. The vessel's officers can prepare for sea clutter by programming the navigation lines of nautical charts on the radar. This would indicate the deviations from the fairway.
