Investigation report

D8/2007M

M/S GRACHTBORG, hatch crane accident in the port of Kokkola. Finland, on 11 August 2007

Translation of the Finnish original report

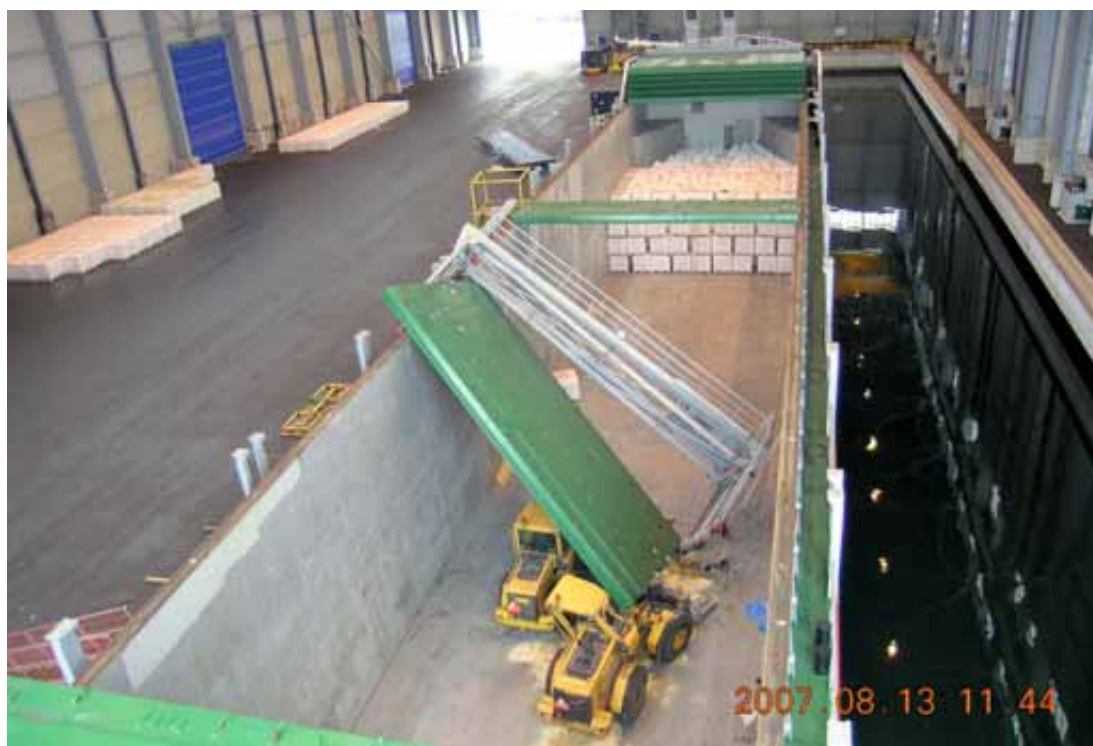
An ambulance was immediately called to the vessel and the mate was taken to hospital. According to the examination, the mate broke his rib and he received bruises, but no more serious damage. One of the wheel loaders in the cargo hold of the vessel, the Volvo L 70, was badly damaged as the hatch fell on top of it. The machine was so badly damaged that the insurance company redeemed it. The second wheel loader remained intact.

The mate was injured and both the hatch crane and the machine in the hold were damaged. There was also damage to the deck hatch and the structures of the vessel.

Figure 2. The hatch cover and the crushed tractor in the cargo hold.

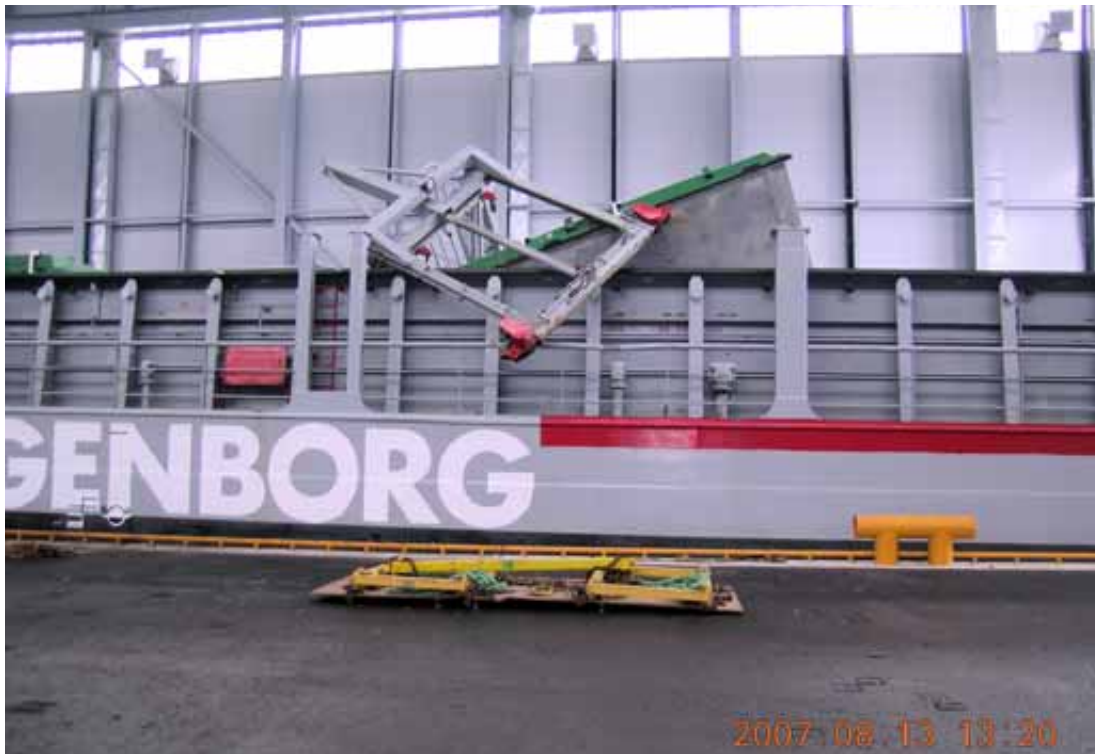
According to the safety instructions of the shipping company, when deck hatches are moved, two persons have to ensure that the lifting hooks are placed in the hooking pockets of the hatch on both sides of the cargo hold. As they were still on their way, the mate had already lifted the deck hatch using the crane and the crane was along mid-ships. The chief mate was lifting hatch number 7, which weighs 13 tons. According to the master the crane moved in an odd way and a moment later the deck hatch and the crane fell down. The lower right-hand side of the crane, the rail wheels, slid over the end of the hatch and the hatch fell into the cargo hold, about 7–8 metres. The right edge of the hatch remained against the edge of the cargo hold. The chief mate was at the controls of the crane, from where he then fell into the cargo hold as the crane capsized.

Figure 3. M/S GRACHTBORG's collapsed hatch crane.

The weight of a cargo hatch is 13 tons and the maximum allowed load of the crane is the same. When the lifting hooks are properly in the hooking pockets of the deck hatch, the whole structure becomes stiff for the period of the lifting and the move. If the lifting hooks are not exactly in their right places, the structure is shaky. Also regarding this accident, it can be assumed that all the lifting hooks were not correctly in the hooking pockets. The rails of the crane are at the level of the deck and the rail wheels have a flange of a few centimetres to keep them from falling off the rails. Also the trim and roll have an effect on safe work and the manufacturer of the crane has set a maximum for these values.

When the hooks are placed wrong, a small sway or tug will cause the deck hatch to slide from the top of the hook and the crane to become loose. In this case, the hatch falls lifting the wheel off the rails.

The crane was an older model, in which there is no security to keep the rail wheel from falling off the rail and capsizing. In newer cranes the falling of the rail wheels off the rails is structurally prevented by equipping the wheel with a security plate. It prevents the wheel from rising off the rail. Also in the newest ones the crane controls are at one end of the crane so that the crane driver can himself see how the hooks are placed at the other end.

From the perspective of the occupational safety of the dock workers it is absolutely necessary that they are not in the cargo hold when the deck hatches of the vessel have to be moved. The communication between the vessel and the dock workers has to be clear and there is no room for misunderstandings. The stevedoring company had clarified its instructions to vessels to the effect that the crew of the vessel is not allowed to move and lift deck hatches if there are dock workers in the cargo hold of the vessel.

Accidents that have occurred with this type of deck crane should be examined more closely. What is the number of accidents and are they very common, for example at European ports. This could be done in co-operation with the authorities of different countries. On the basis of vessel traffic and the cargoes it is possible to deduct the most common ports used by this type of vessel in Europe. Also the manufacturer should be asked to submit further information on these accidents.

The dangers of this type of deck crane should be better communicated. The dock workers have to be aware of these dangers and they must be able to prepare for dangerous situations with the help of sufficient safety instructions.

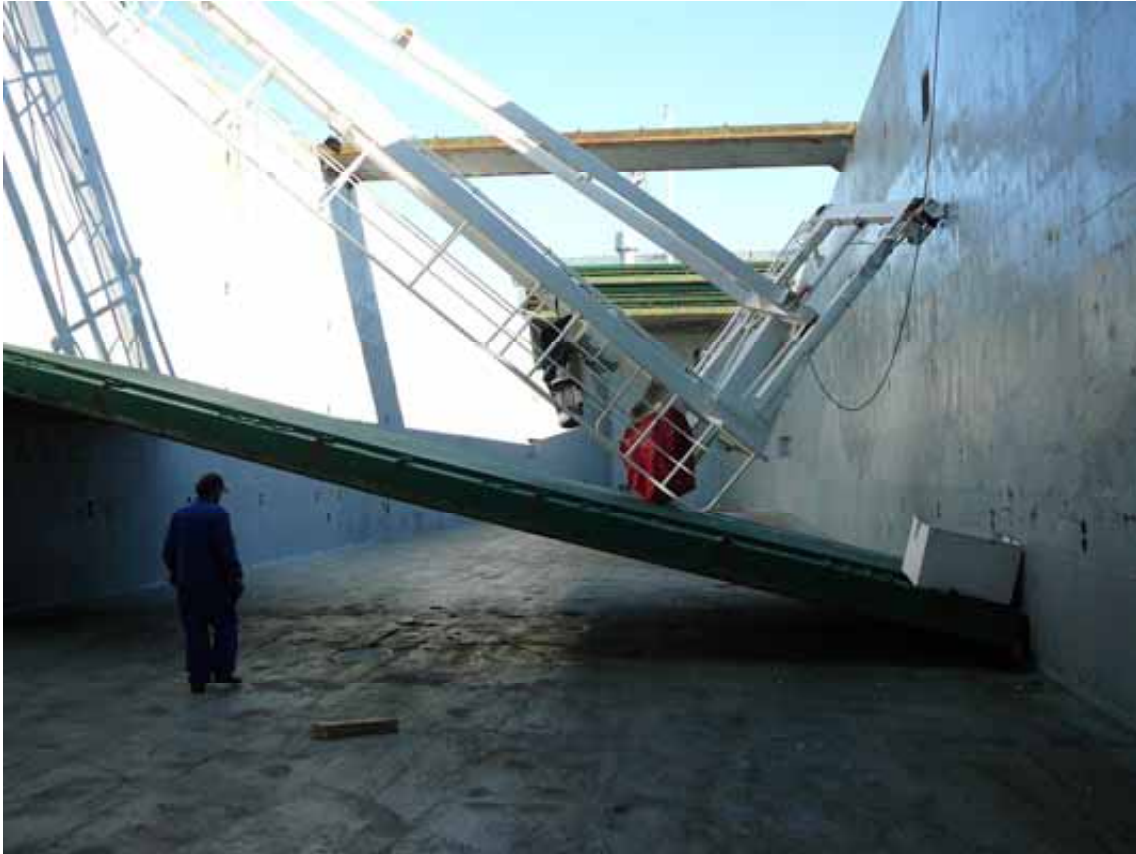
Another hatch crane accident on 2007 (picture)

Figure 1. Another case on 2007.
