## Investigation Report

C1/2008M

# **M/S OOCL NEVSKIY, grounding south of Helsinki Pilot Station Harmaja on 27.2.2008**

Translation of the original Finnish report

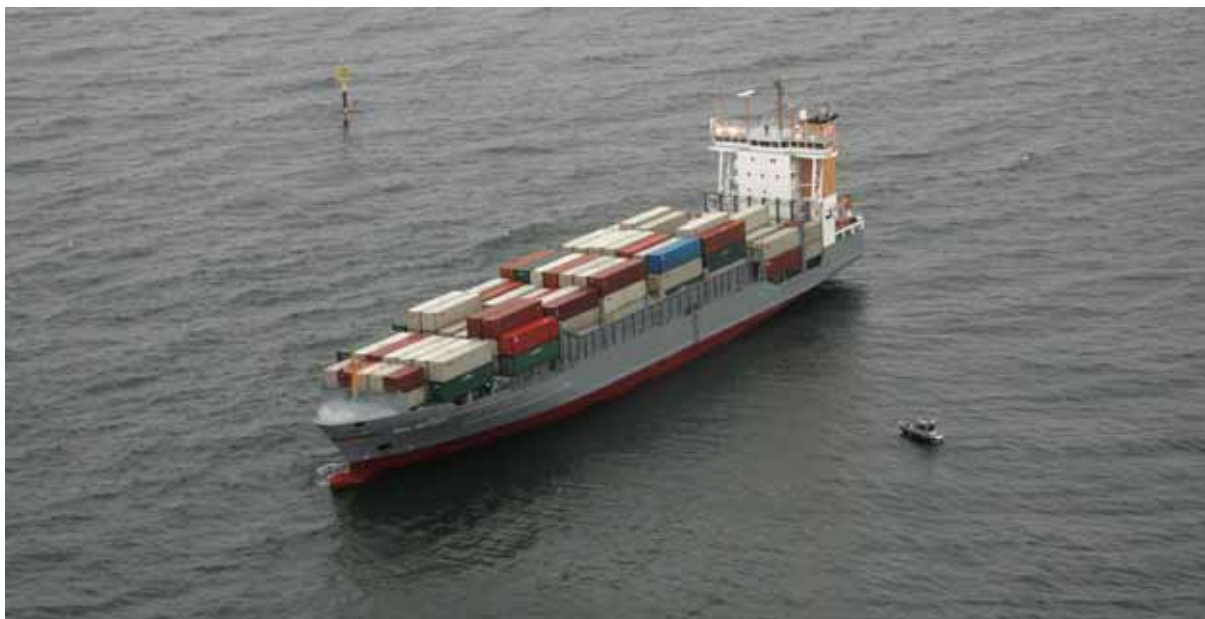
Figure 1. The OOCL NEVSKIY aground, the tender vessel AV-005 next to her.  
(© Rajavartiolaitos / Vartiolentolaivue)

When the vessel was aground, divers checked the bottom of the vessel and discovered that the vessel did not leak oil to the sea and that there were no serious damages.

At Hernesaari Quay the divers inspected the hull of the vessel more thoroughly. Damages were detected in the bottom in an area which was limited between the frames 40-125 on the port side of the middle line. The damages consisted of several 30 cm dents and of tears, which were as large as 20 x 2 cm. Some of the tears were so deep that they reached through the bottom to the vessel's ballast tanks, and seawater was leaking into them.

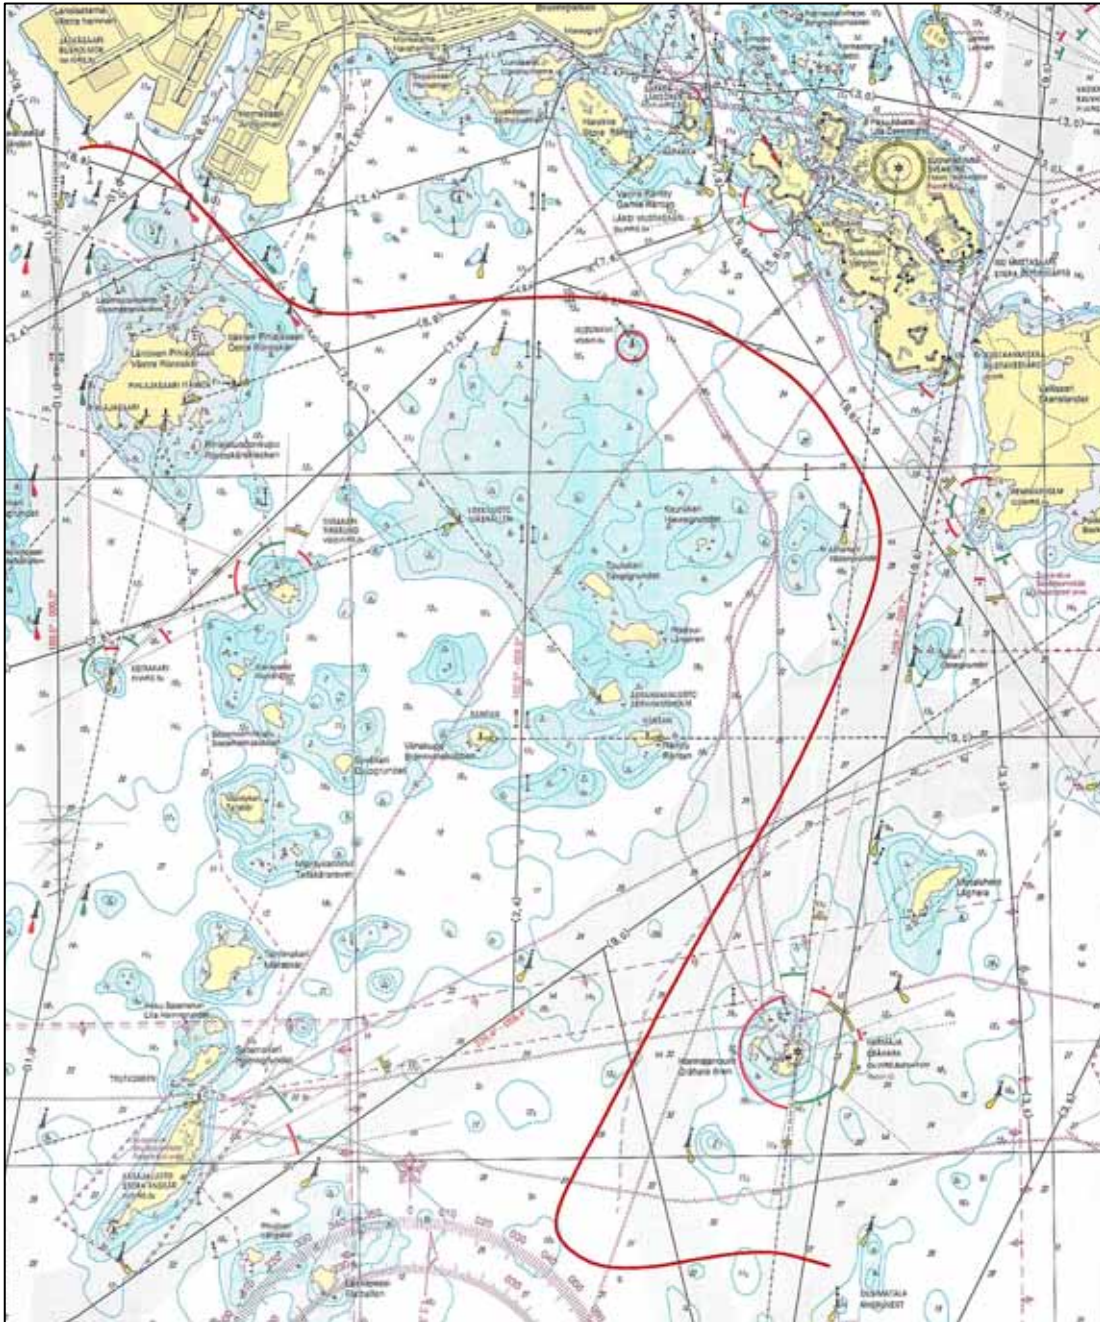
Figure 4. The OOCL NEVSKIY's route from West Harbour to Uusimatala.

After the pilot had departed vessel, the Master changed the automatic steering into manual steering and the vessel turned as far towards port as to the course 075°.

After the pilot had departed, the vessel was presumably navigated on the basis of erroneous optical observations. The available compass, radar and electronic chart were probably not utilised. The Master said that the pilot had pointed out a navigation mark which was supposed to be left on the starboard side of the vessel. However, turning the vessel across the fairway made the situation unclear and most likely led to a situation where the wrong navigation marks were followed. The Uusimatala and Flathällgrund

border marks might have been mixed because the vessel had turned more to port than was intended in connection with the pilot departing it.

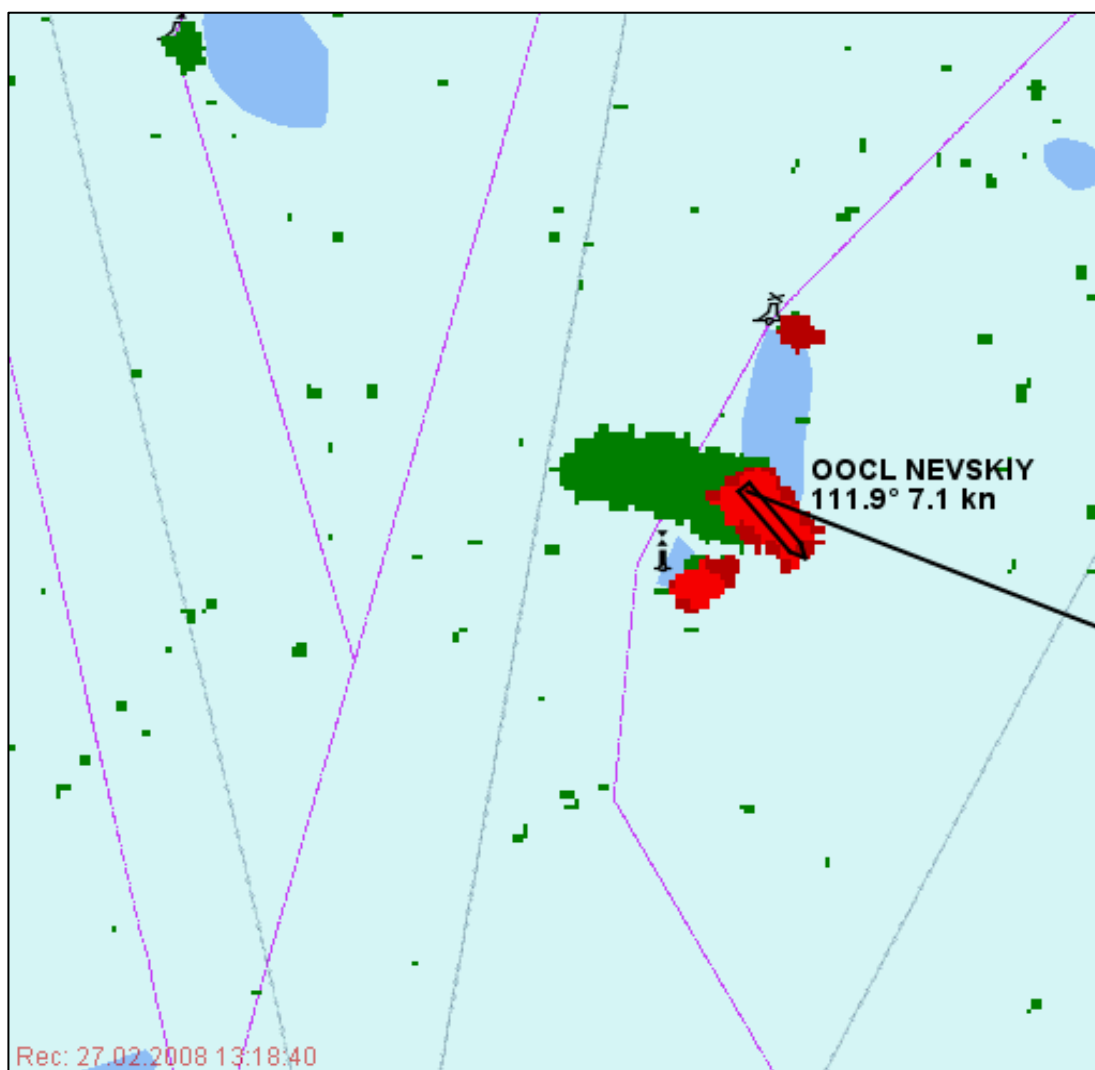
The pilot followed how the vessel proceeded from the pilot vessel's AIS display and by looking back towards the vessel every now and then. After a couple of minutes he noticed that the AIS display indicated that the course of the vessel was 075° and the speed 10 knots. In the pilot's opinion this led the vessel too much towards east, and he asked the VTS to inform the vessel about this. The VTS had also discovered that the vessel was drifting toward the Uusimatala shoals, so it called the vessel. After the call had been made twice, the vessel answered, and the VTS then asked "*could you take astern please... right away*" and gave the warning "*You are heading for shallow waters*". Almost immediately after this the VTS repeated the advice "*full astern please*", and the vessel complied with this. However, the manoeuvre did not prevent the OOCL NEVSKIY from grounding at a speed of approximately seven knots. According to the VTS recording, the vessel first touched the ground at 13:18:40 and then slid to the shoal.

Figure 5. A picture of the VTS recording at the time of the grounding.

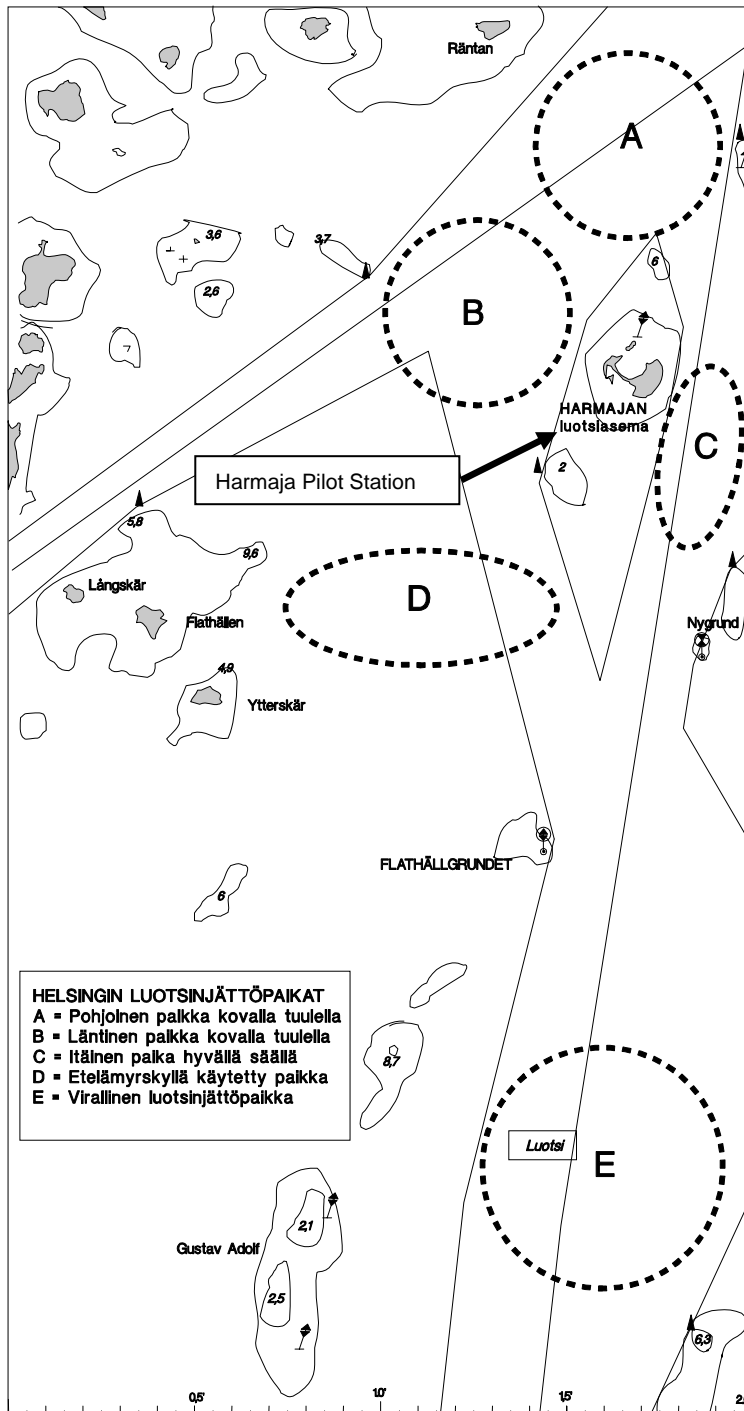
Figure 6. Pilot departing places in Helsinki. (Figure 3 from the AURORA Investigation Report)

According to the pilot, a pilot typically departs a vessel southwest of Harmaja (area D) when the wind blows from between south and west. This is because at the official pilot boarding place the roll of the sea is usually heavier and the swell of the sea follows the direction of the wind. According to the pilot, it is risky for the vessel to use the official pilot boarding place, because there is not very much space to make enough lee for the pilot vessel due to the narrowness of the fairway. Without enough lee the pilot vessel cannot stay safely alongside the vessel and it is almost impossible for the pilot to board the pilot vessel. In winter the pilot vessel is also at risk of freezing because of water splashes.

When studying the chart, it appears that there is plenty of space to make lee for the pilot vessel. However, it is possible that the area is felt to be narrow because the necessary lee cannot be made on the west side of the fairway, but the vessel has to be turned in the middle of the fairway and it drifts over the fairway to the "wrong side". The return back to the fairway also becomes more demanding than in area D, where making lee and returning towards the fairway happens more naturally.

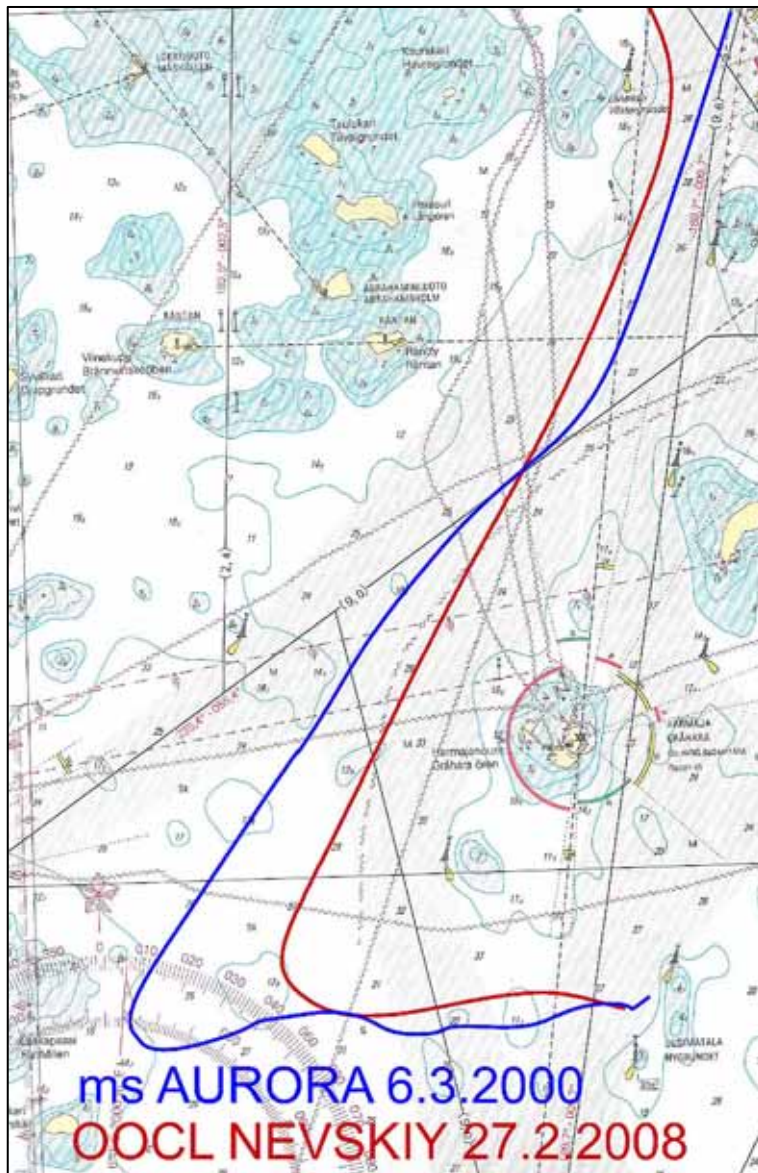
The M/S AURORA ran aground on 6 March 2000 on the same Uusimatala shallow as the OOCL NEVSKIY. By comparing the routes of the OOCL NEVSKIY and the M/S AURORA it is possible to notice that pilot departing took place according to a similar plan. In both cases the plan with reference to pilot departing was neither exceptional nor rare. These cases show that if disturbing factors occur during pilot departing or after that, the safety margins are minor when the vessel is placed across the fairway with respect to the direction of traffic.

Figure 7. The OOCL NEVSKIY and the M/S AURORA.
