Investigation report

C5/2008M

F/V HENDRIK SENIOR and M/S BIRKA EXPORTER, Collision in International Waters 17 NM off the Netherlands, on 8.12.2008

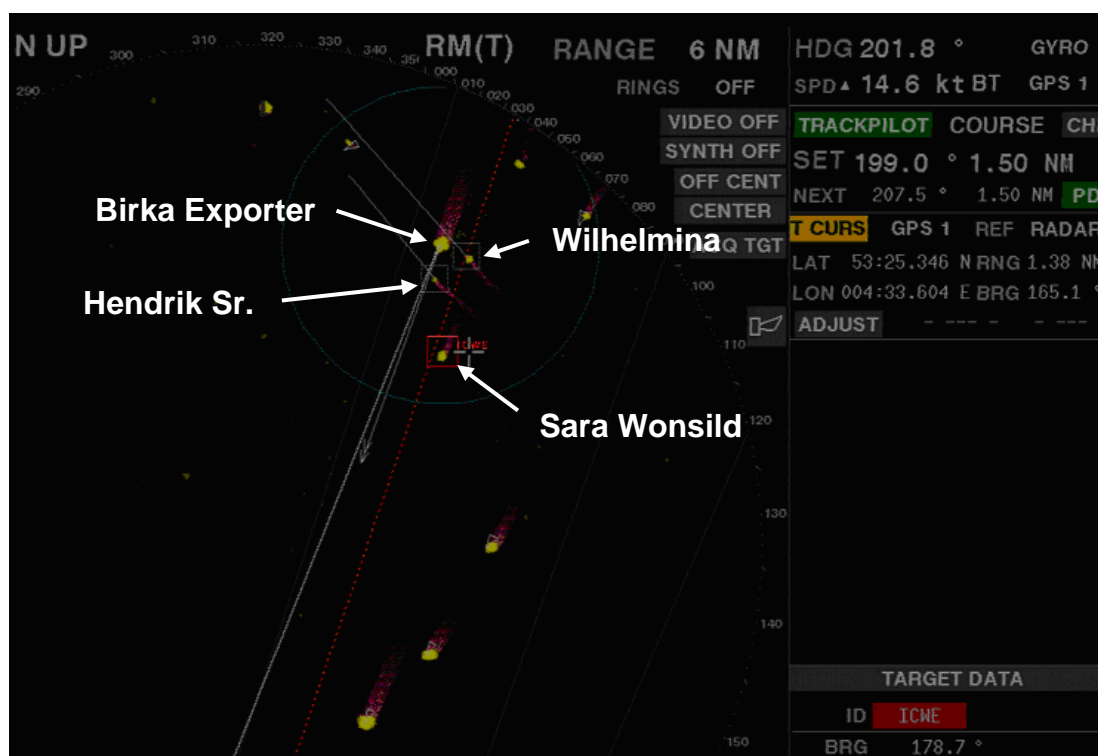
Figure 14. At 05:28:14 UTC (47 seconds before the collision) HENDRIK SENIOR is seen passing ahead of BIRKA EXPORTER with a close distance.

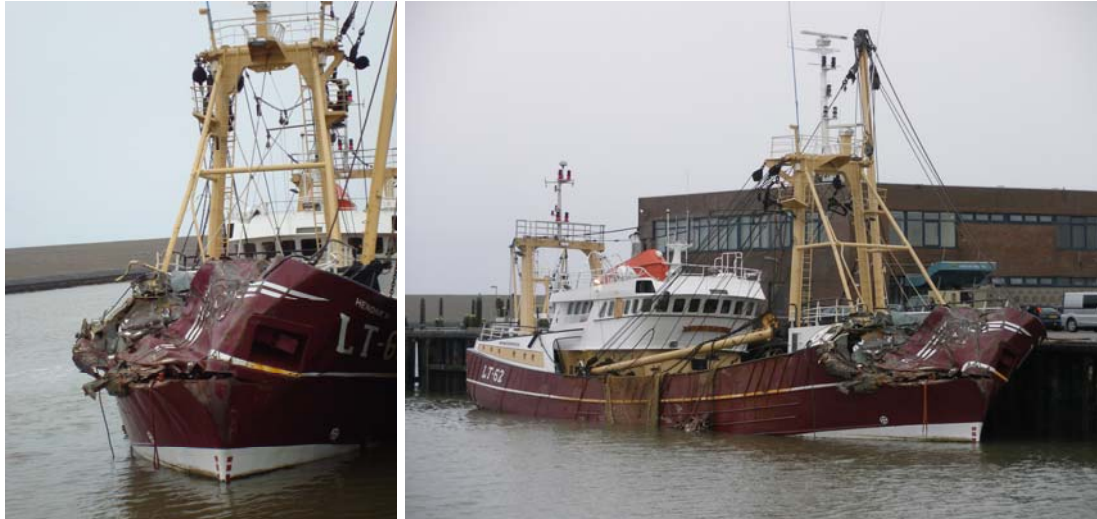
Afloat. Several surveyors and inspectors, including one from the MCA, boarded HENDRIK SENIOR in Harlingen. In addition to the obvious damage to the forward part of the vessel, extensive damage to the vessel's structure on the starboard side was noted. Frames and shell plating were set in, in way of the cabins, the engine room and the steering compartment.

Figure 16a and b Damages to HENDRIK SENIOR above waterline.

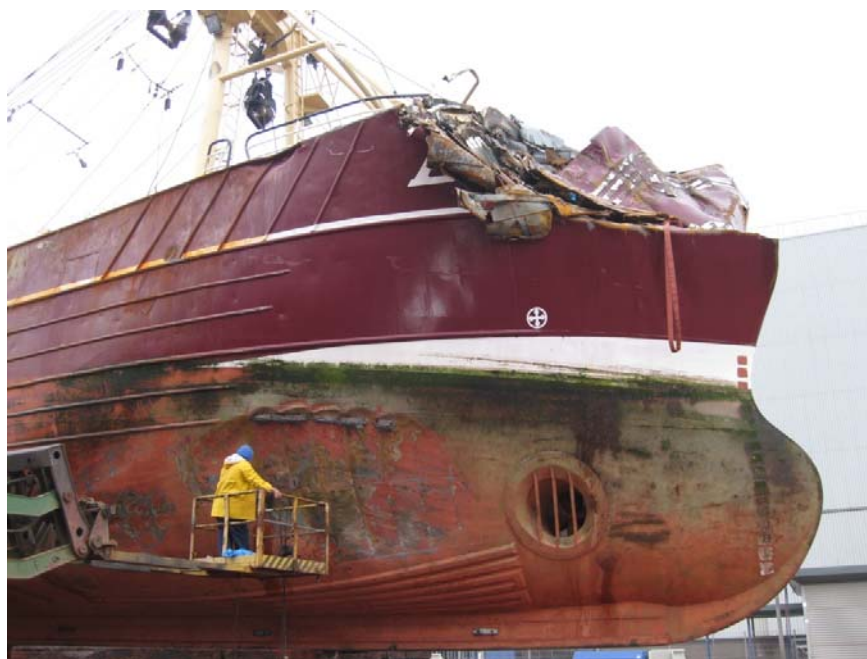
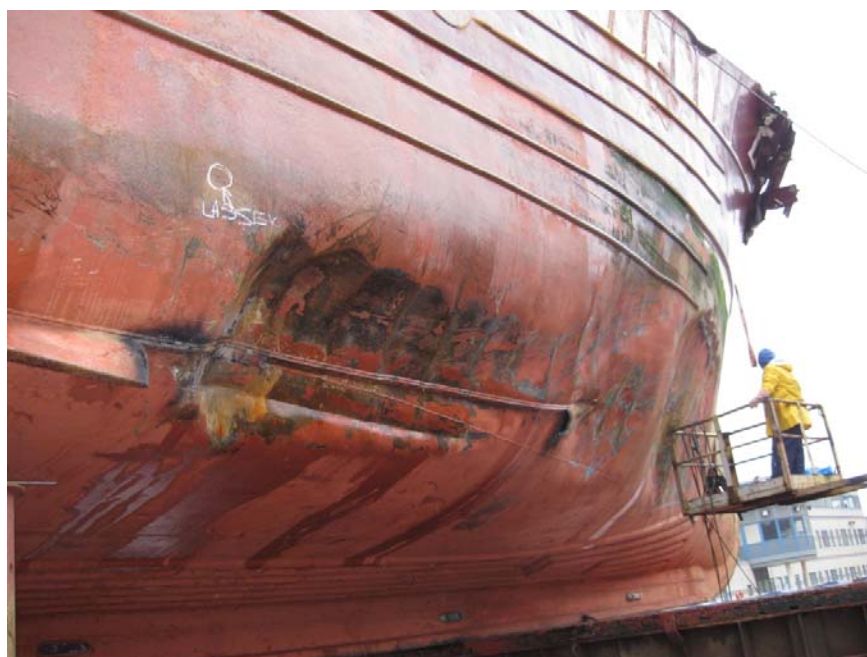
HENDRIK SENIOR was later placed on a ship lift. Very extensive underwater damages were found. As a result of damage sustained during the collision, HENDRIK SENIOR was sent to ship breakers on 10 February 2009.

Figure 17a and b. Underwater damages on HENDRIK SENIOR.

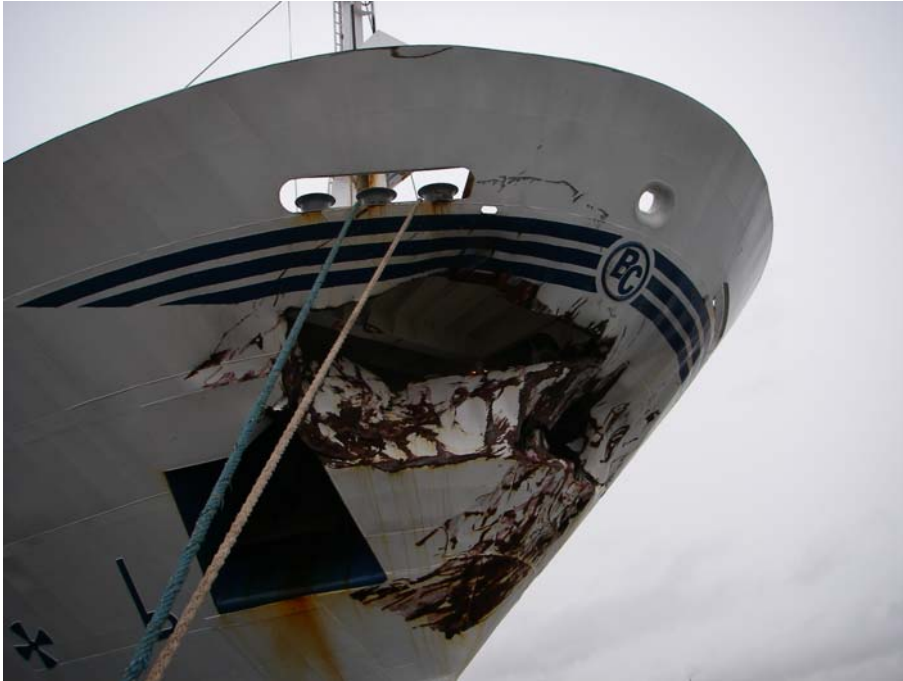
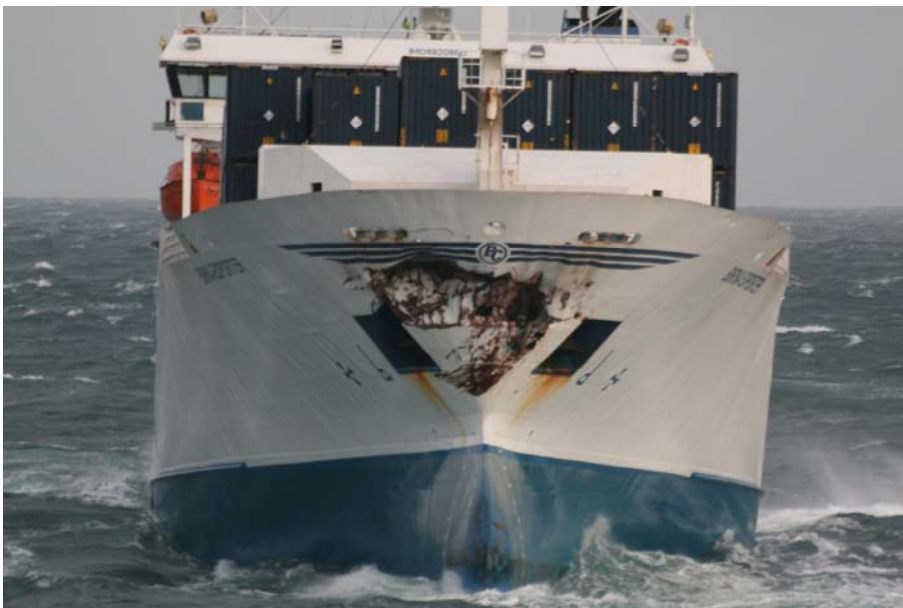
BIRKA EXPORTER suffered damages in the bow above the waterline with a 2m x 6m tear into the forecastle. The bulb had some scratches but no tears due to the ice strengthened bulb. 10 tons of steel plates were replaced in the bow.

Figures 18 a and b. Damages to BIRKA EXPORTER's bow.

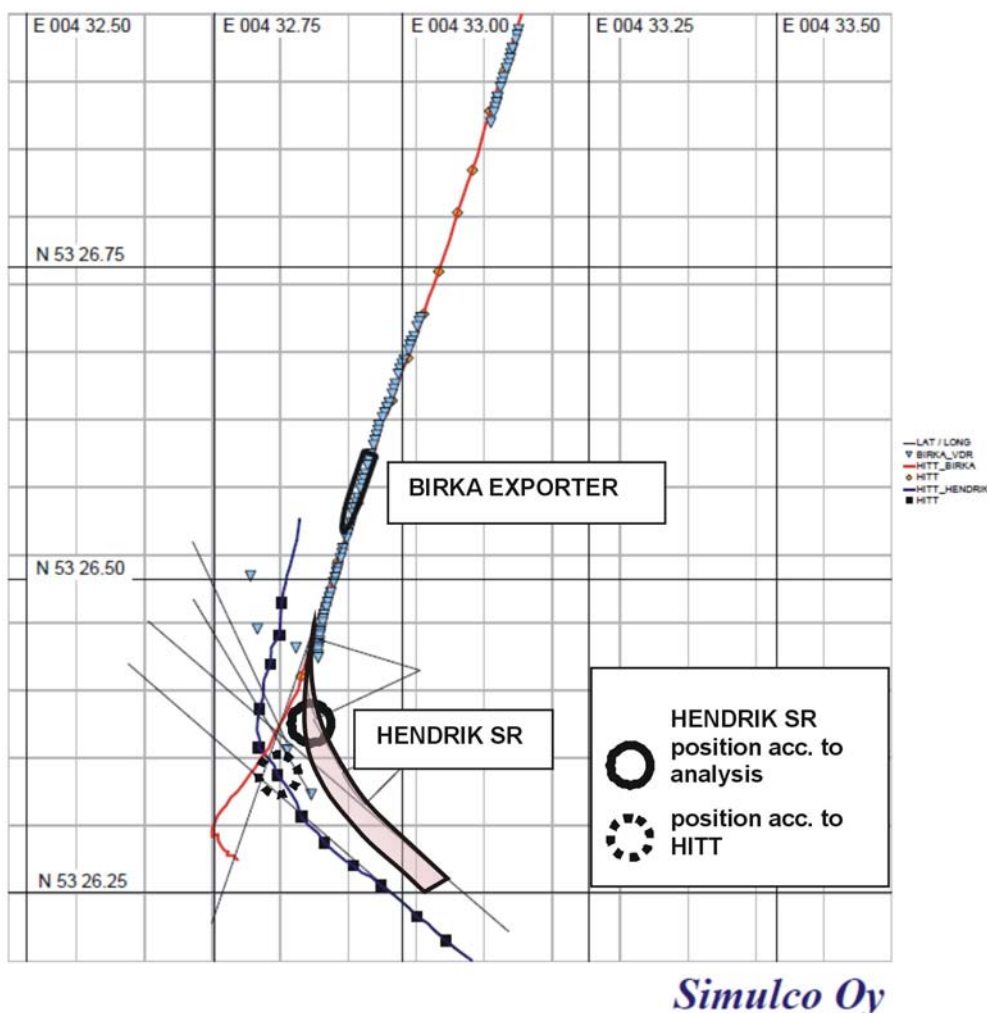
Whilst turning starboard to following seas, the autopilot had increasing difficulty to hold a steady course. HENDRIK SENIOR's oscillating heading as well as BIRKA EXPORTER's slight yawing in waves may onboard HENDRIK SENIOR have been interpreted as BIRKA EXPORTER's manoeuvre to its port, straight on to collision course.

Figure 34 Time 05:28:30 - 05:28:40 UTC. As the second turning manoeuvre of HENDRIK SENIOR started the distance between HENDRIK SENIOR and BIRKA EXPORTER was between 267 and 377 metres (0.14–0,20 NM). From HITT registered position the distance was 367 metres (0,20 NM).

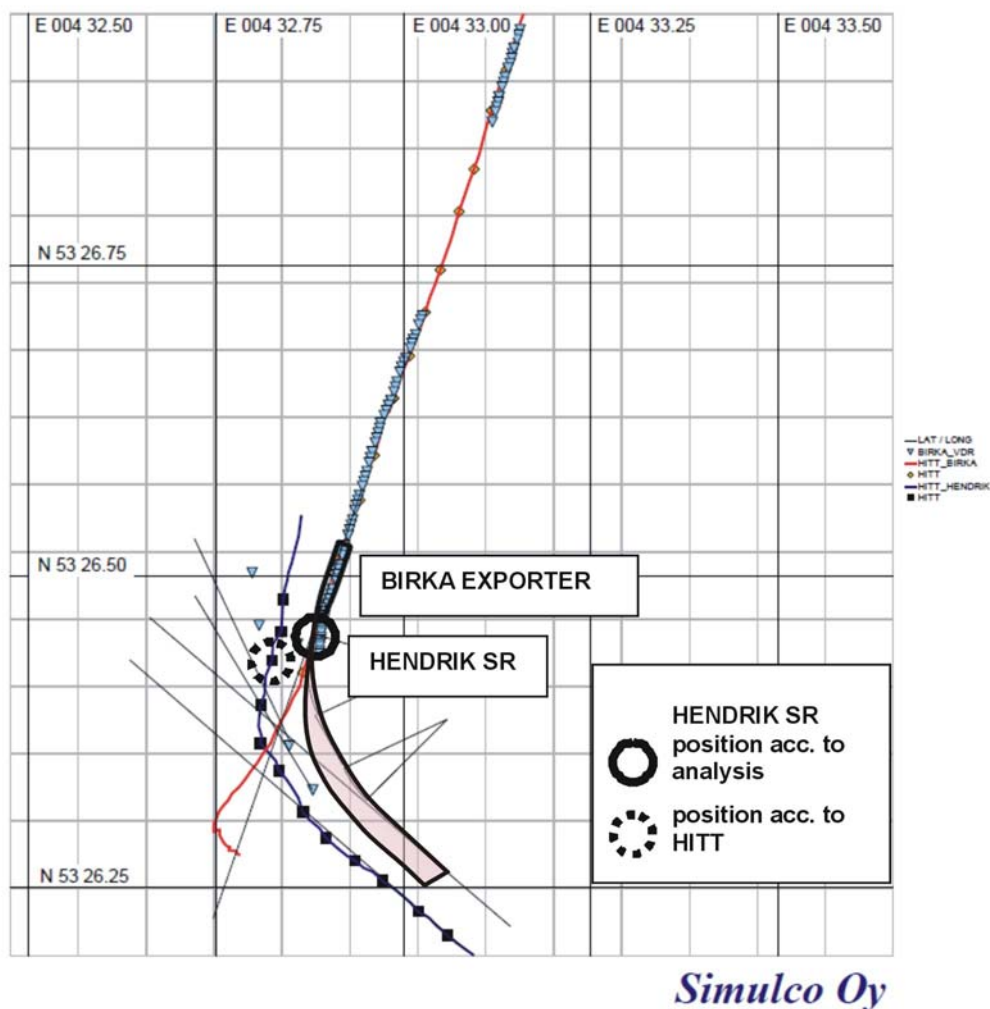
Both data sets (HITT and VDR) confirm that BIRKA EXPORTER maintained a **steady course** and speed throughout, and did not alter course to port, towards HENDRIK SENIOR.

Figure 35 Time 05:29:01 UTC. The time and position of the collision. Note the difference of about 80 metres to southwest in the HITT position when compared to the GPS position.

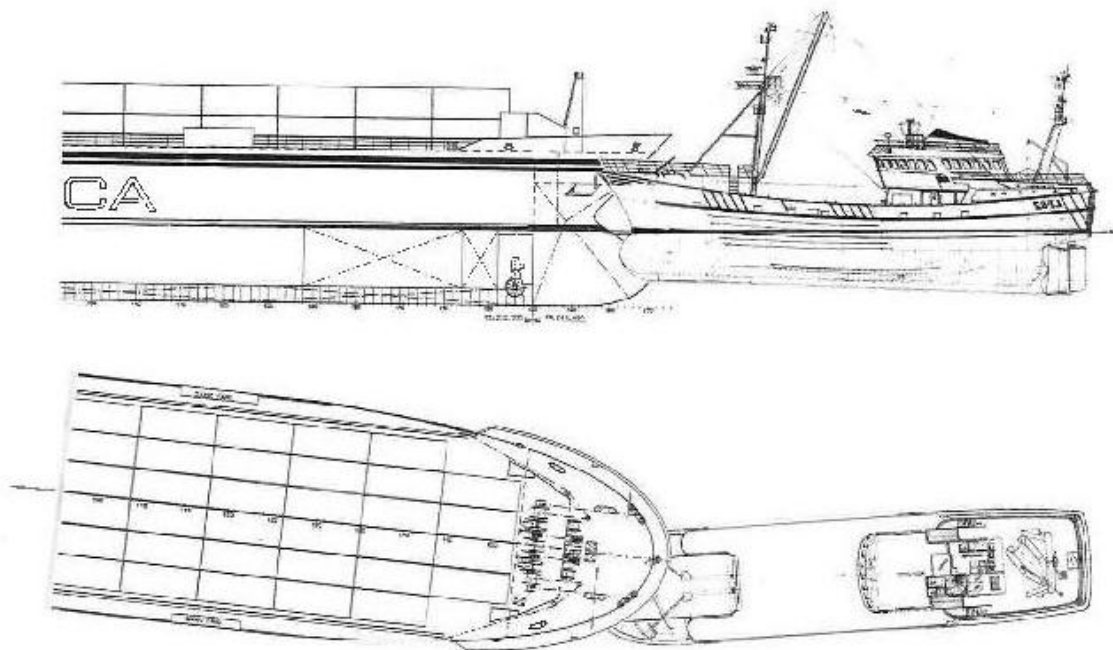
The damages on the trawler were mainly on the starboard side of its bow. That combined with the collision angle of about 10 degrees i.e. the angle of the impact force, as shown in figure 36, could produce the moment on HENDRIK SENIOR resulting it almost instantly turning 180 degrees. Some of the indentations below the waterline on the forward starboard part of the trawler (figure 17b) could be caused by BIRKA EXPORTER's bulb when the other vessel was leaning on the bulb while making the 180 degree turn after the impact.

Figure 36 The positions of the vessels at the impact according to the extent and location of damages of both vessels. The collision angle is assumed to be about 10 degrees. The analysis of the collision angle is based both on the damages and the tracks of the vessels.
