## Investigation report

D14/2008M

# Loss of consciousness by two persons in the cargo tank of a tanker on 4 Nov 2008

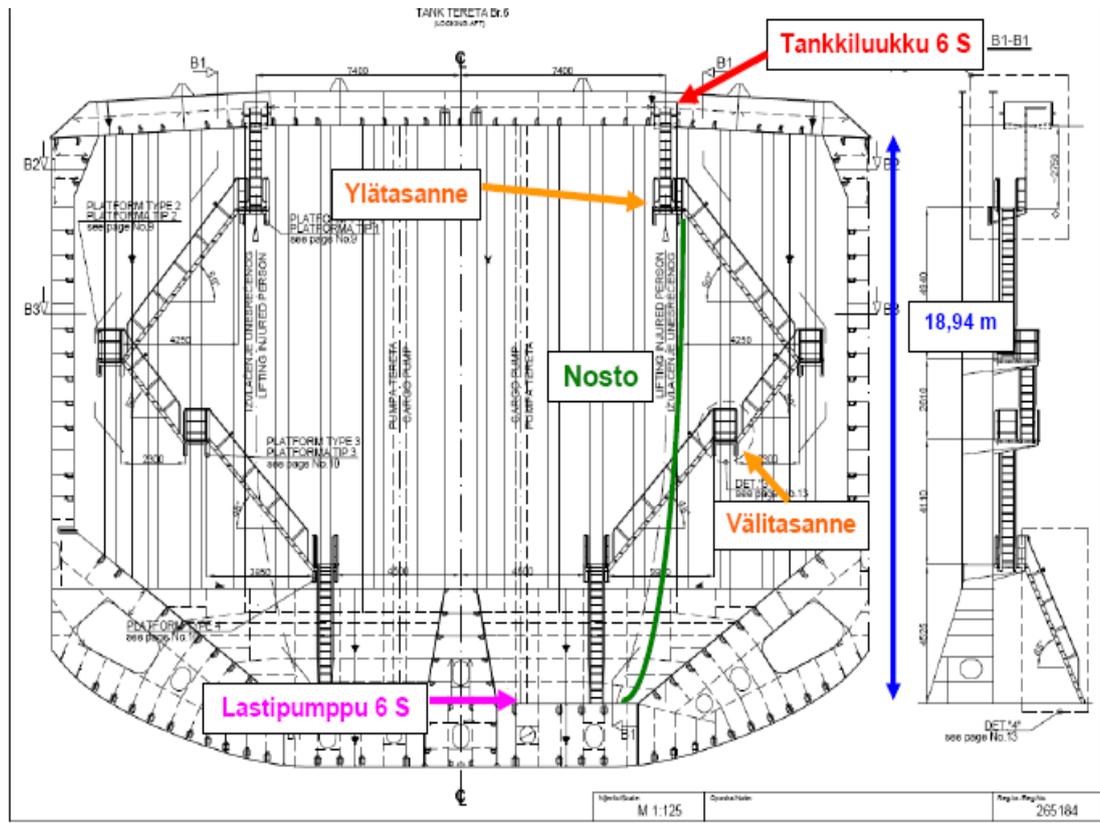
Figure 3. Hoisting from the tank.

The hoisting cable was re-lowered and attached to the fall protection harness of deck hand LL, who reached the deck at 10.47. In the second hoisting operation, the repairman assisted in attaching deck hand LL to the cable at the bottom of the tank, and the Chief Engineer assisted in the hoisting by pulling at the cable on the intermediate landing.

The total time that elapsed from the alarm till both patients had been hoisted to the deck was approx. 37 minutes.

The interviews indicated that the crew members involved in the rescue did not hear alarms sounded by the instruments while in the tank. A person who was on the deck said in the interview, "An alarm was possibly heard from down there." Based on the available information, it is not possible to say if the gas monitor that was used sounded an alarm.

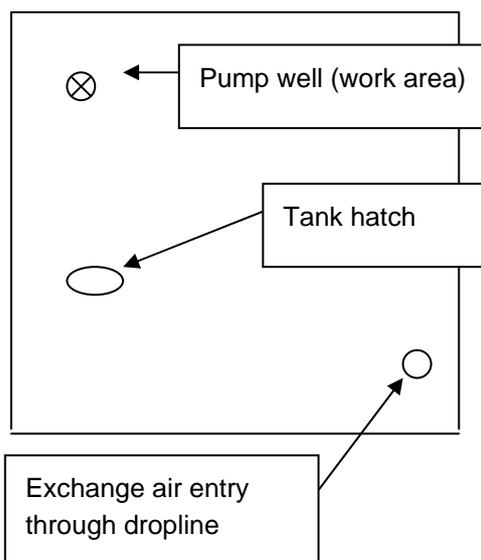
Figure 6. Tank seen from above

Inadequate ventilation will enable the formation of local gas pockets in the tank; in the tank in question, the employees may have been in a shadow zone of ventilation, as they were working on the far side of the tank hatch seen from the dropline.

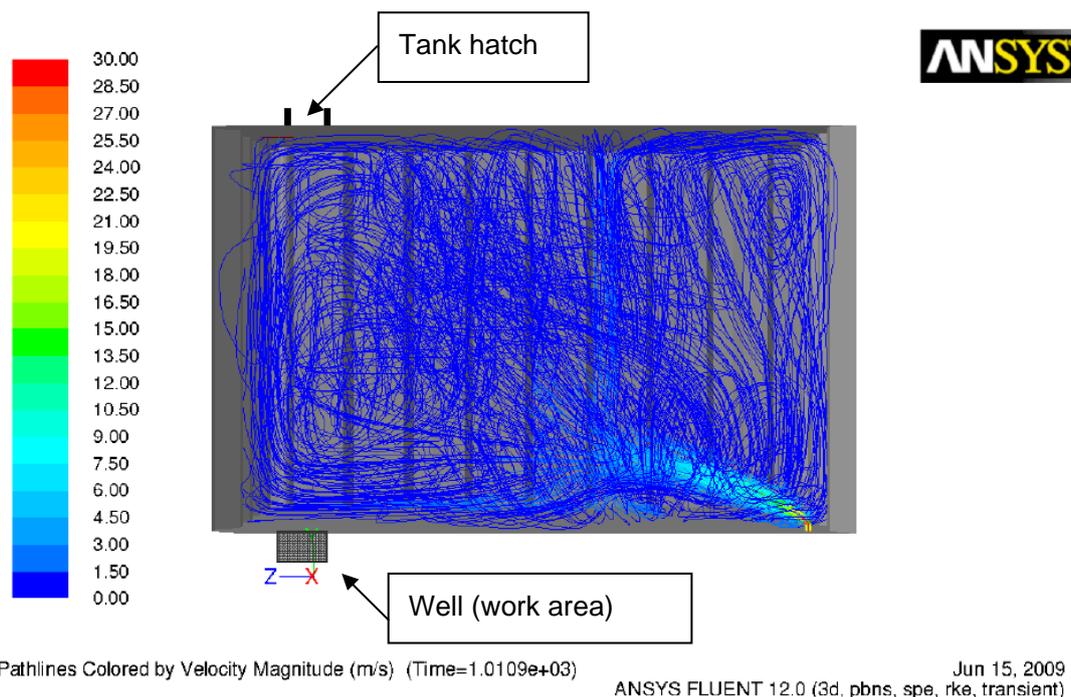
Figure 7. Figure from study commissioned by the shipping company on tank ventilation. It describes the situation on the vessel while the tank hatch was open. With this method of ventilation using the inert gas fan only, the reference ventilation time is some 6 hours.

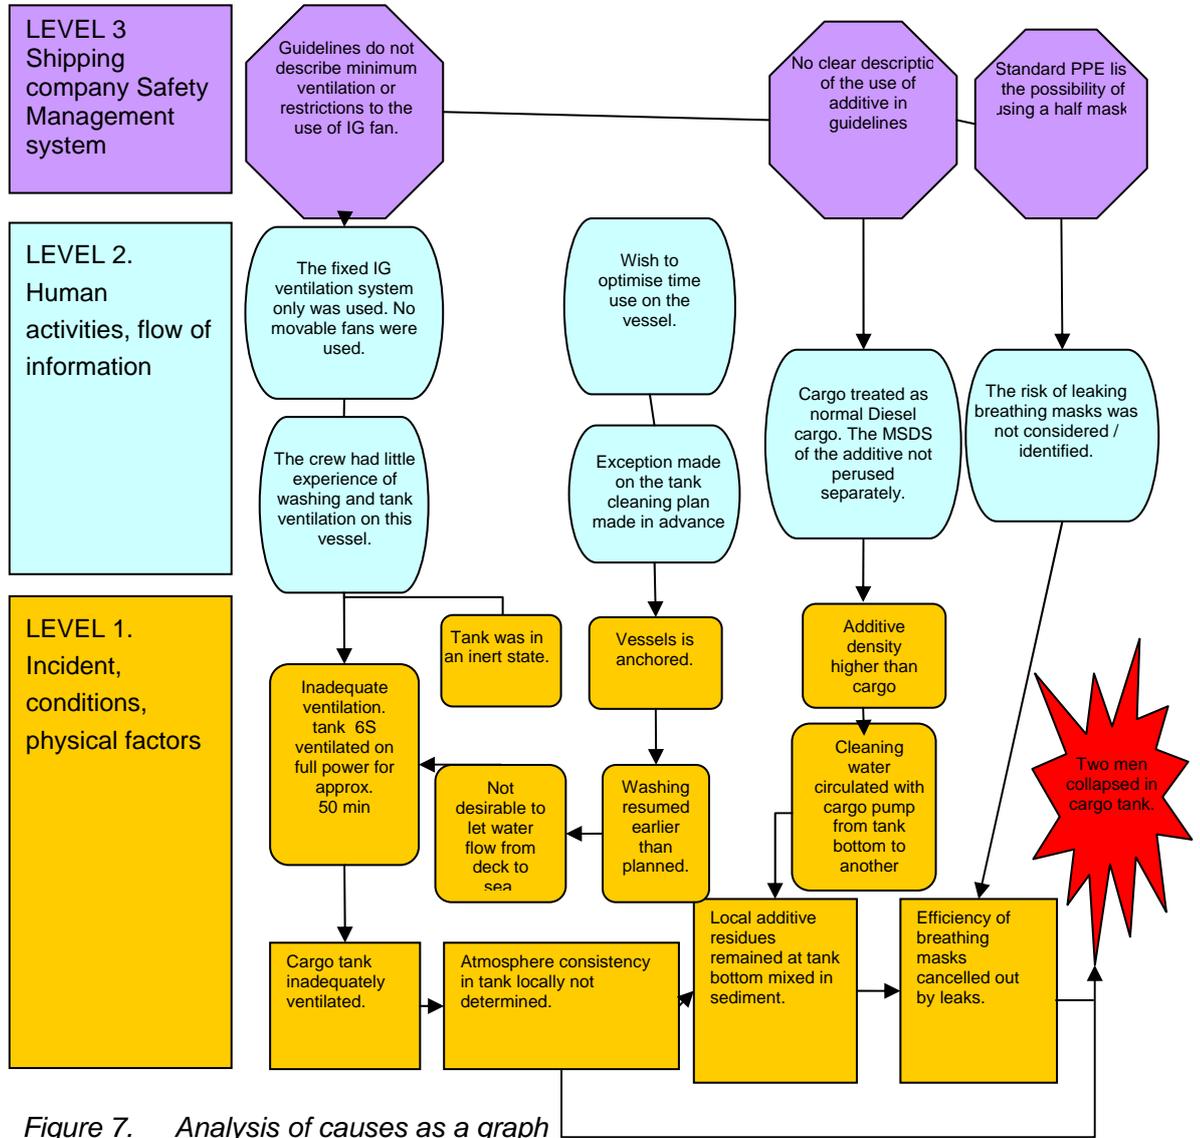
Figure 7. Analysis of causes as a graph

**As a conclusion it must be stated that no unambiguous and clear cause or causal relationship can be pinpointed for the loss of consciousness. The shipping company investigation team takes the following view of the events:**

Additive was introduced into the tank, the density of which is higher than that of the cargo. This addition was carried out by means of a pump through the sampling port in the top part of the tank. It is possible that some of the additive has flown through the cargo to the tank bottom in a "bubble". When loading, the vessel was informed that the shore tank would be emptied into the vessel tank. In this type of situation, such as rust usually ends up at the tank bottom. The additive may have become mixed with this sediment locally. The cargo was circulated using the cargo pump in connection with the introduction of the additive and before unloading. In the circulation process, cargo is sucked out of the tank bottom and returned into the hold bottom to the corner diagonally opposite the outlet point. The circulation is thus not complete but allows the possibility of unmixed zones remaining in the tank.

When the tank was washed, additive-containing sediment may have been left at the bottom. The person drying the tank had stirred that sediment and possibly released the 2EHN in it into his respiratory air. The inadequate ventilation in the tank did not dilute the gas compound fast enough, and the person had inhaled the additive-containing air. The half-mask type respiratory protective devices that were used had leaks, which enabled the entry of additive-containing air into the respiratory organs. The compound that was inhaled was concentrated enough to induce loss of consciousness.

There were residues of the inert gas and/or the carbon monoxide contained in it in the tank. The carbon monoxide content of the inert gas may have been higher than normal because of a fault in the inert gas system. The inadequate ventilation of the tank did not dilute the gas compound fast enough, and the persons had inhaled low-oxygen air containing carbon monoxide. The half masks in use do not protect against a lack of

1. The use of half-mask type respiratory protective devices is discontinued. These are replaced by full masks or fresh air breathing apparatuses, in which leaks around the nose and exposure of eyes to hazardous substances are eliminated.
2. In the Safety Management System, instructions on introducing additives into the vessel tank are clarified.

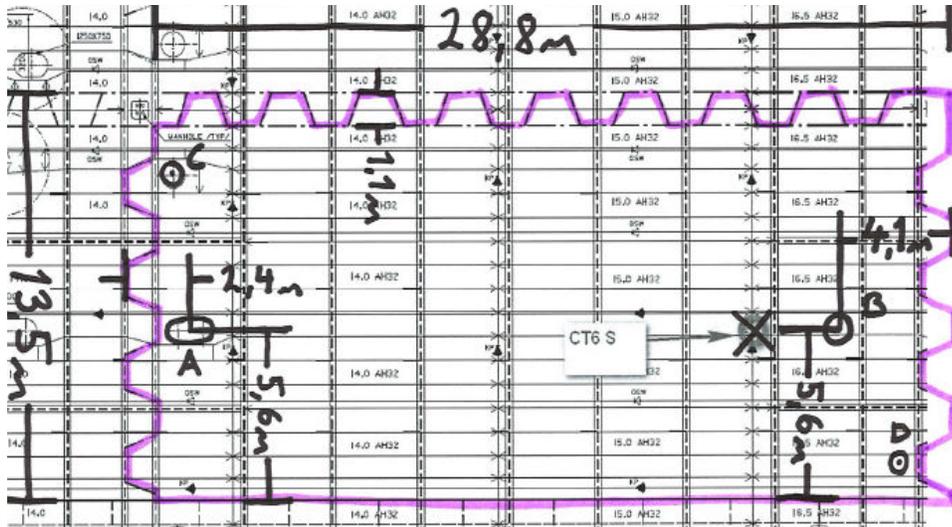
Kuva 1. Onnettomuusalueen lastitankin geometria.

Kuvaan 1 lastitankin sisäänmenoluukku (1800x700mm) on merkitty A kirjaimella. Sisäänmenoluukku toimii tuuletusprosessissa ilmanpoistoluukkuna, jonka kautta tuuletusilma poistuu lastitankista ulkoilmaan. Tuuletusluukku on merkitty kuvaan B kirjaimella, jonka kautta liikutettavan tuuletusjärjestelmän tuuletusputkisukka lasketetaan lastitankin sisälle. Tuuletusputkisukka lasketaan noin 1.5 m etäisyydelle lastitankin pohjasta. Lastitankin sisällä oleva lastiputki C on otettu myös malliin mukaan sen aiheuttaminen virtausvastusten selvittämiseksi. Lastitankin kiinteä tuuletusjärjestelmä on merkitty kuvaan D kirjaimella. Kohdassa D sijaitsee kiinteän tuuletusjärjestelmän syöksypuhallus, jonka kautta tuuletusilma johdetaan lastitankin pohjalle (0.5 m tankin pohjasta). Kiinteän tuuletusjärjestelmän avulla voidaan myös puhaltaa tuuletusilmaa lastitankin yläosaan. Tämä kohta sijaitsee aivan B tuuletusluukun vieressä.

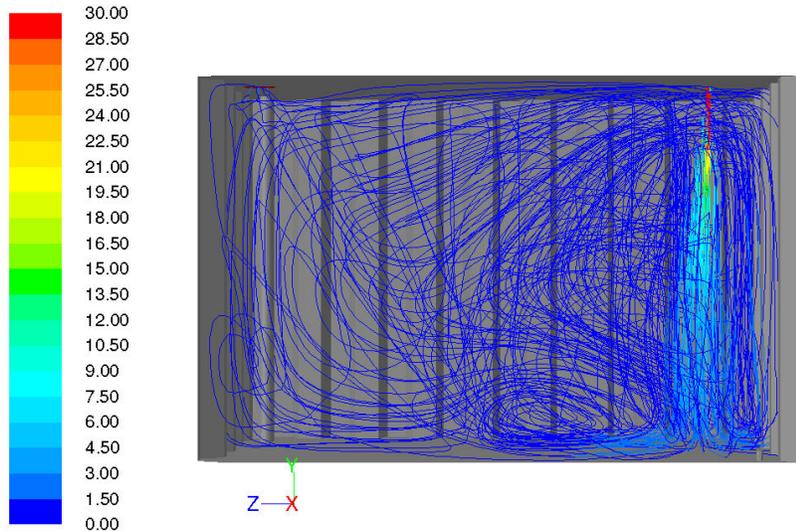
Kuvan 5 mukaan ilma sekoittuu hyvin tankissa vaikkakin suurimmat virtausnopeudet pysyvät lähellä sisääntuloa. Miesluukun lähellä virtaus on hidasta, mutta pitkällä tuuletusajalla ilma sekoittuu melko hyvin.

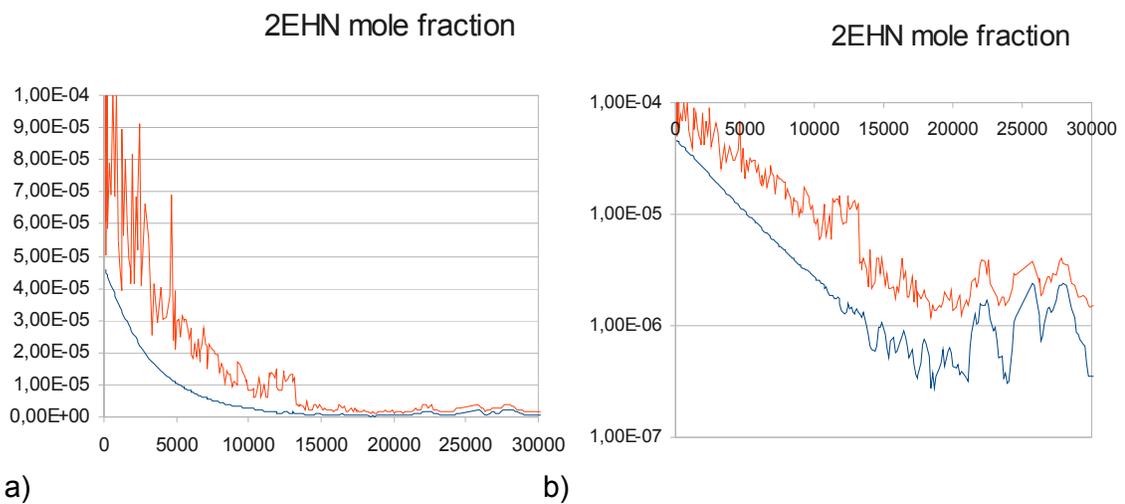
Kuva 6. a) 2EHN:n mooliosuus tankissa ajanfunktiona (sekunteina) b) logaritmisella skaalalla. Maksimiarvo on punaisella ja keskiarvo sinisellä.

Kuvassa 6 2EHN:n maksimiarvo on simuloinnin alkuvaiheessa hieman heiluva ja ajoittain syntyy maksimiarvoja. Nämä saattavat osittain riippua laskennan tarkkuudesta, mutta koska kaasut sekoittuvat melko hyvin tankissa, niin pitkä tuuletusaika poistaa haitallisen kaasun varmasti. Ajanfunktio logaritmisessa skaalassa on hyvin lineaarinen, niin sitä voi jatkaa riippuen miten pieni pitoisuus on toivottu. Ekstrapoloiden kuvaa 6 maksimipitoisuuden raja-arvo 1 ppm saavutetaan noin kuudessa tunnissa.

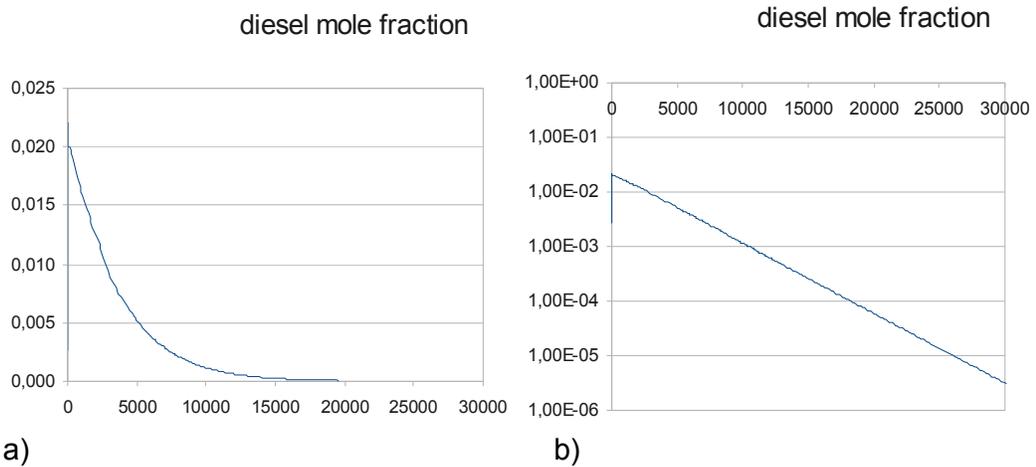
Kuva 7. Dieselin konsentraatio tankissa ajan funktiona (sekunteina). b) logaritminen skaala

Räjähdyksikaasun, tässä tapauksessa diesel-ilmaseoksen, pitoisuus vähenee hyvin tasaisesti ajan funktiona. Kolmessa tunnissa ja 45 minuutissa moolisuus tippuu suunnilleen 500 ppm:ään, eli räjähdysvaaraa ei ole.

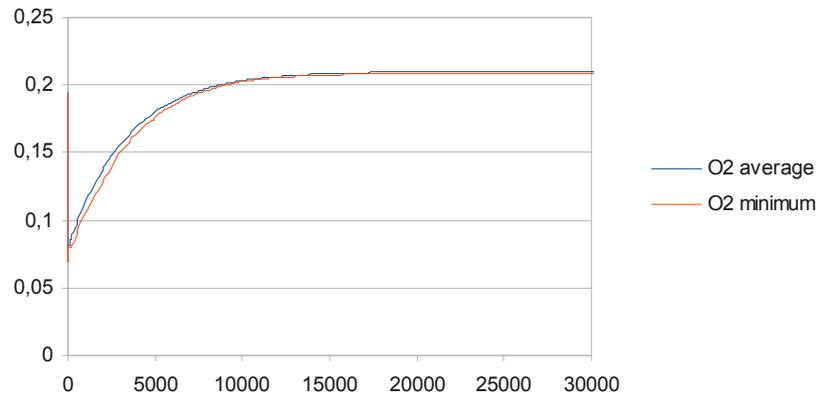
Kuva 8. Hapen mooliosuus tankissa ajan funktiona (sekunteina).

Kuva 8 mukaan happikonsentraatio saavuttaa normaalilukemia noin 13500 sekunnin kuluttua, mikä tarkoittaa 3 tuntia ja 45 minuuttia. Tämän jälkeen muutokset ovat hyvin pieniä.

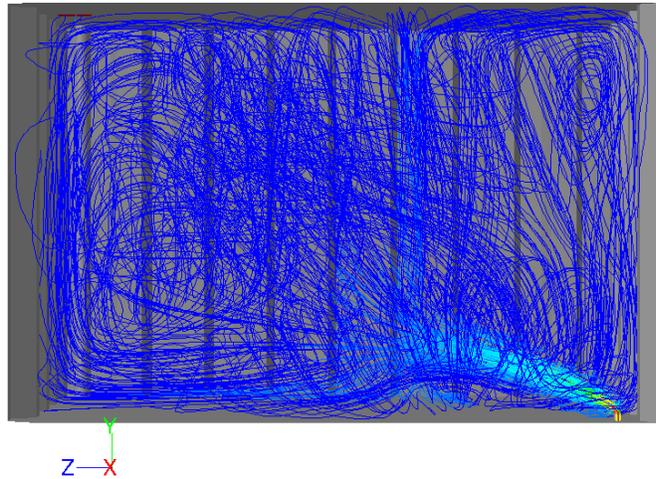
Kuvan 9 mukaan ilma sekoittuu hyvin tankissa vaikkakin suurimmat virtausnopeudet pysyvät lähellä syöksylinjan sisääntuloa. Miesluukun lähellä virtaus on hidasta, mutta ilma kiertää joka paikassa.

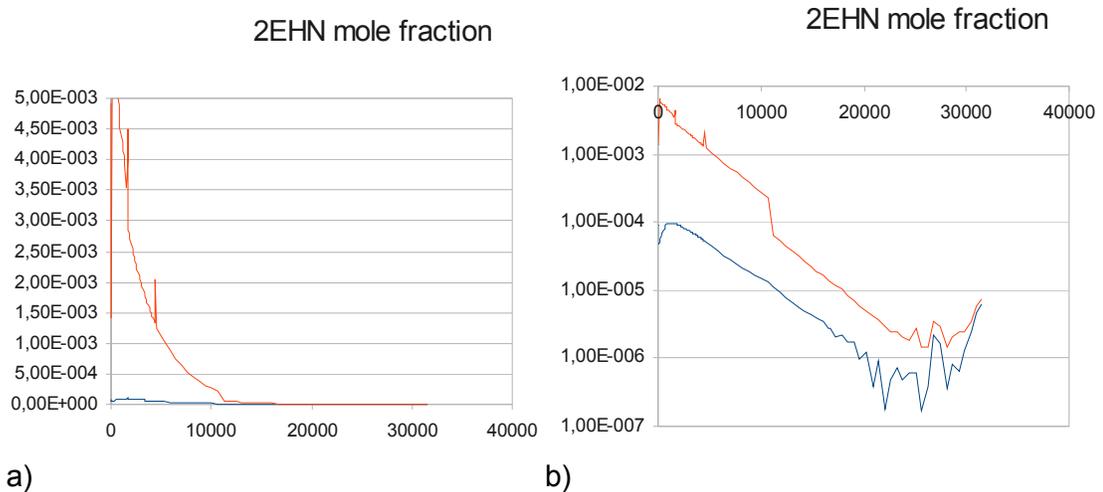
Kuva 10. a) 2EHN:n mooliosuus tankissa ajanfunktiona (sekunteina) b) logaritmisella skaalalla. Maksimiarvo on punaisella ja keskiarvo sinisellä.

2EHN:n maksimiarvo nousee simuloinnin alkuvaiheessa. Tuloksista nähdään että uuden ilman virratessa sisään se työntää tankissa olleen kaasun syrjään ja syntyy hetkellisiä maksimiarvoja. Pitkää tuuletusaikaa tarvitaan poistamaan haitallinen kaasu, ekstrapoloidessaan tässäkin tarvitaan noin 6 tuntia että maksimipitoisuus saavuttaa raja-arvon 1 ppm.

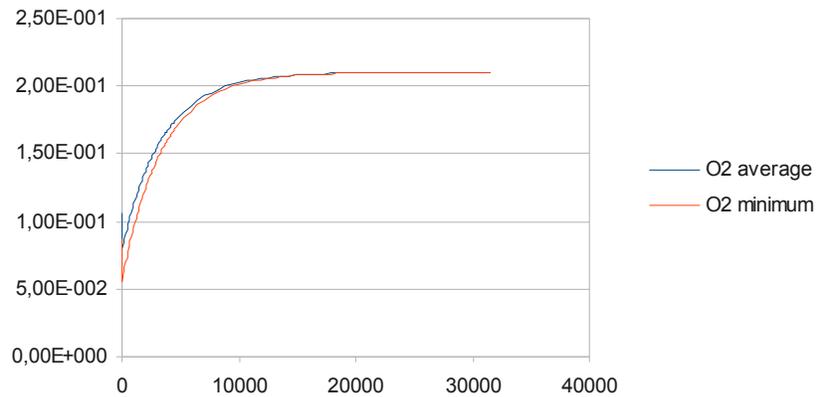
Kuva 12. Hapen mooliosuus tankissa ajan funktiona.

Kuva 12 mukaan happikonsentraatio saavuttaa normaalilukeman samassa ajassa kuten edellisessä tapauksessa. Tämän jälkeen muutokset ovat hyvin pieniä. Koska sekoittuminen on hyvä, niin tuuletusaika ratkaisee. Tässä tapauksessa vaadittava tuuletusaika on noin 4 tuntia hapen osalta.

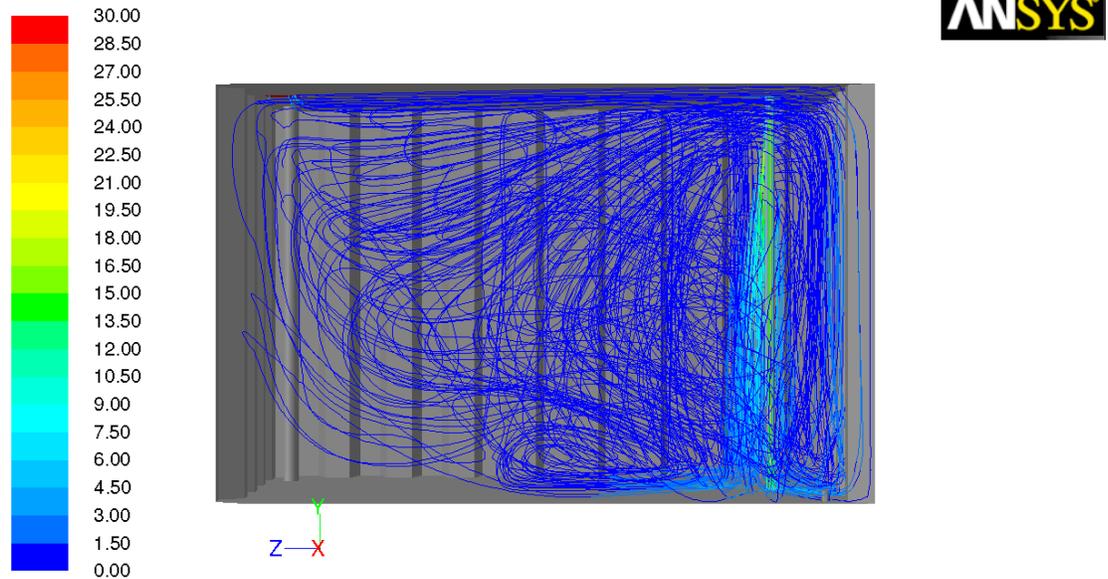
Kuvan 14 mukaan suurimmat virtausnopeudet pysyvät lähellä sisääntuloa. Miesluukun alla virtaus on hyvin hidasta, mutta pitkällä tuuletusajalla ilma sekoittuu melko hyvin. Tässä tapauksessa kun ilmamäärä on suurempi niin pituisuudet tippuvat nopeammin.

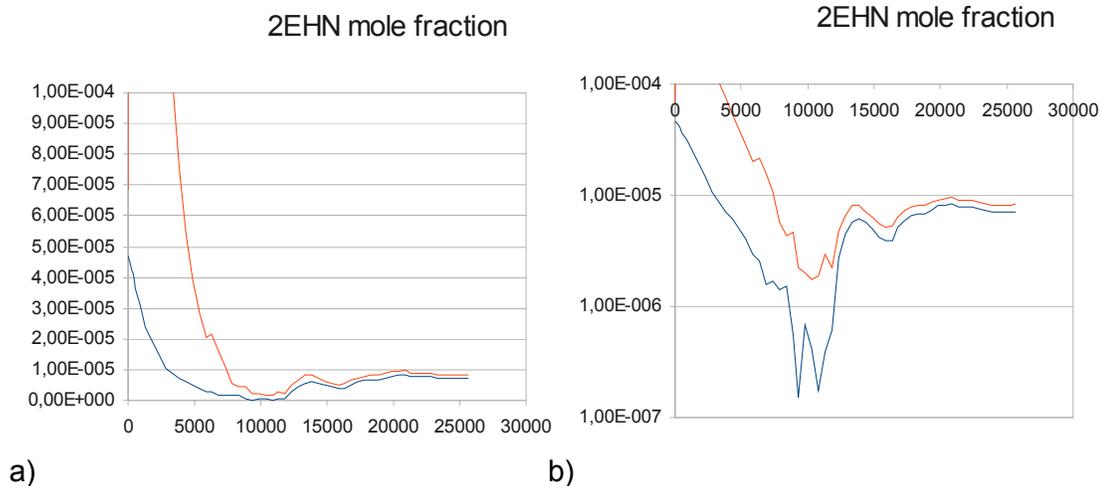
Kuva 15. a) 2EHN:n mooliosuus tankissa ajanfunktiona b) logaritmisella skaalalla. Maksimiarvo on punaisella ja keskiarvo sinisellä.

2EHN:n maksimiarvo nousee simuloinnin alkuvaiheessa, niin kuin edellisessä laskennassakin. Laskennan puolivälissä näkyy selvästi milloin laskennan tarkkuus ei enää riitä hyvin pienille pitoisuuksille ja käyrät rupeavat heilumaan. Koska on tiedossa että pitoisuudet laskevat ajan funktiona loputtomiin niin uutta tarkempaa laskentaa ei tässä vaiheessa tehty, vaan pitää vain jättää virheellisen loppuosa huomioimatta.

Tarvittava tuuletusaika tässä tapauksessa on huomattavasti lyhyempi kuin edelliset. Periaate on kuitenkin sama että 5-6 viipymäaikaa tarvitaan. Tässä tapauksessa 1 ppm:n raja-arvo saavutetaan noin 3.5 tunnin jälkeen.

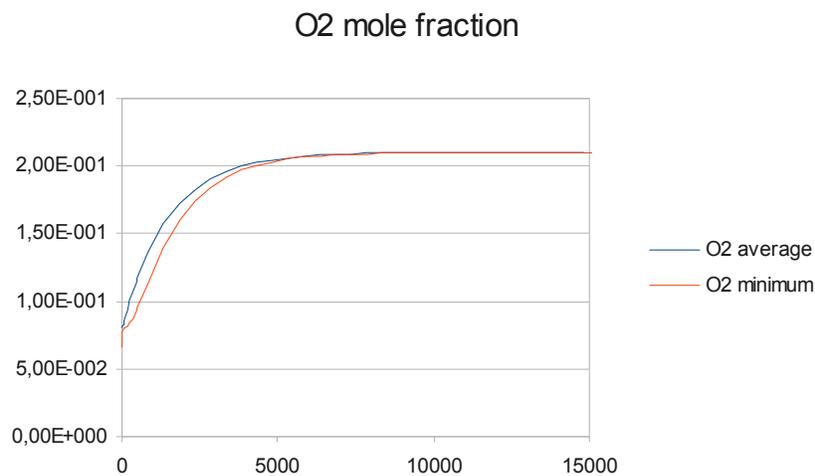
Kuva 17. Hapen mooliosuus tankissa ajan funktiona.

Kuva 17 mukaan happikonsentraatio saavuttaa normaalilukemia noin kahdes-  
sa tunnissa. Tämän jälkeen muutokset ovat hyvin pieniä.

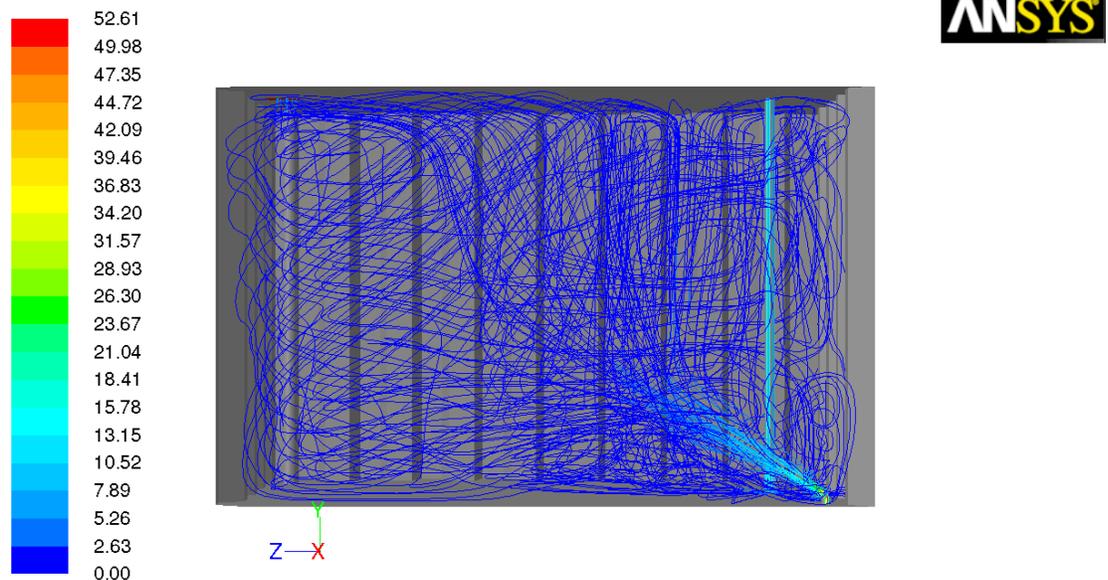
Kuvan 18 mukaan ilma sekoittuu erittäin hyvin tankissa ja virtausnopeudet kasvavat muuallakin kuin lähellä sisääntuloa. Miesluukun lähellä havaitaan virtausta ja tämä puhallinjärjestely vaikuttaa sekoitusmielessä järkevältä.

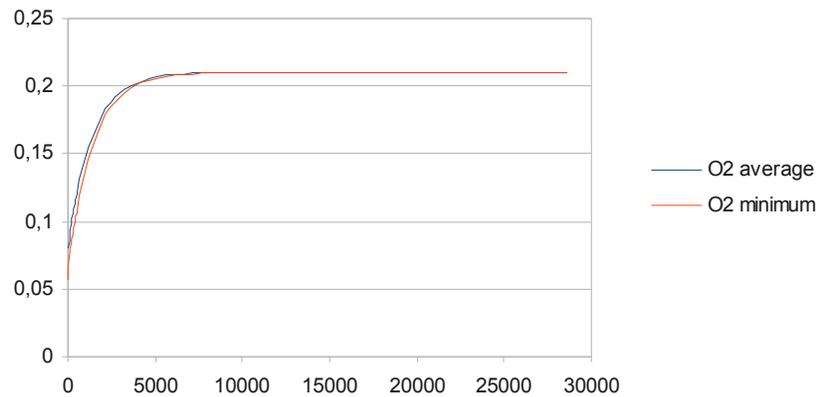
Kuva 21. Hapen mooliosuus tankissa ajan funktiona.

Kuva 21 mukaan happikonsentraatio saavuttaa normaalilukemia noin kahdessa tunnissa. Tämän jälkeen muutokset ovat hyvin pieniä.

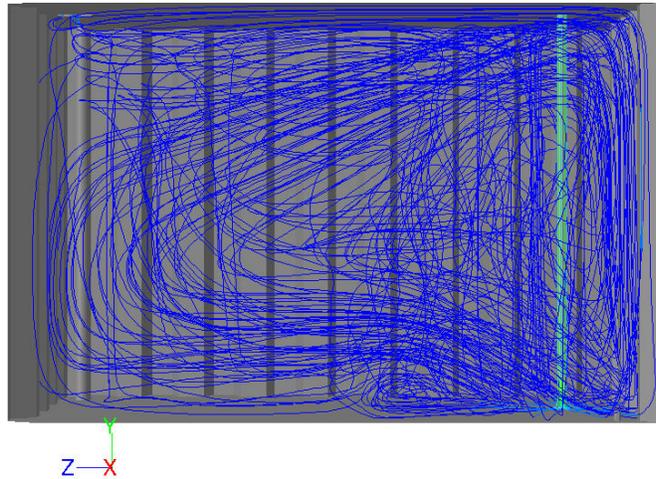
Kuvan 22 mukaan ilma sekoittuu tankissa hyvin, mutta suurimmat virtausnopeudet pysyvät lähellä sisääntuloa. Miesluukun lähellä on virtausta, mutta hitaampaa ja tämä puhallinjärjestely vaatii vähän pidemmän tuuletusajan kuin parhaat tapaukset.

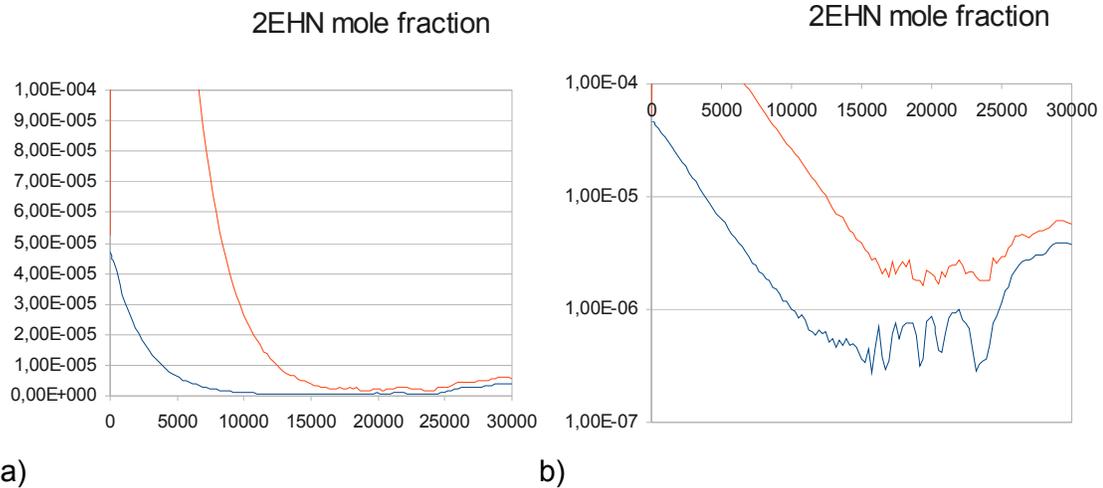
Kuva 23. a) 2EHN:n mooliosuus tankissa ajanfunktiona b) logaritmisella skaalalla. Maksimiarvo on punaisella ja keskiarvo sinisellä.

2EHN:n maksimiarvo nousee simuloinnin alkuvaiheessa samalla tavalla kuten edellisissä tapauksissa. Tämä laskenta oli numeerisesti vähän stabiilimpi ja virheet vaikuttavat vasta lopussa.

Tässä tapauksessa 1 ppm:n raja-arvo saavutetaan vajaan 5 tunnin jälkeen.

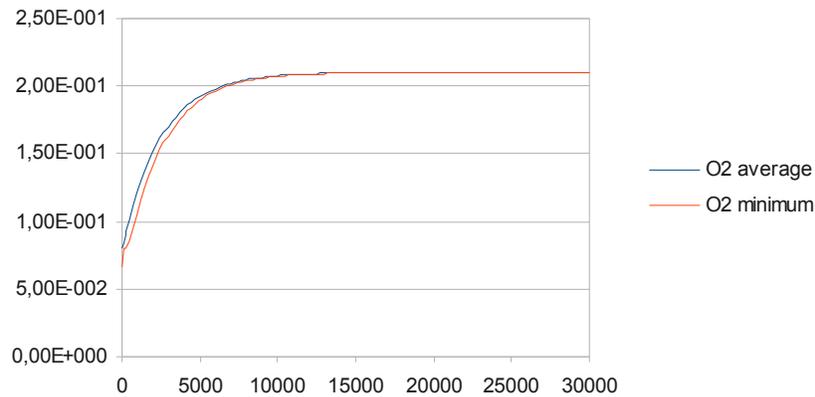
Kuva 25. Hapen mooliosuus tankissa ajan funktiona.

Kuva 25 mukaan happikonsentraatio saavuttaa normaalilukemia noin neljässä tunnissa. Tämän jälkeen muutokset ovat hyvin pieniä.
