Investigation Report

D4/2008M

M/S FORTE, grounding off Kotka on 7 April 2008

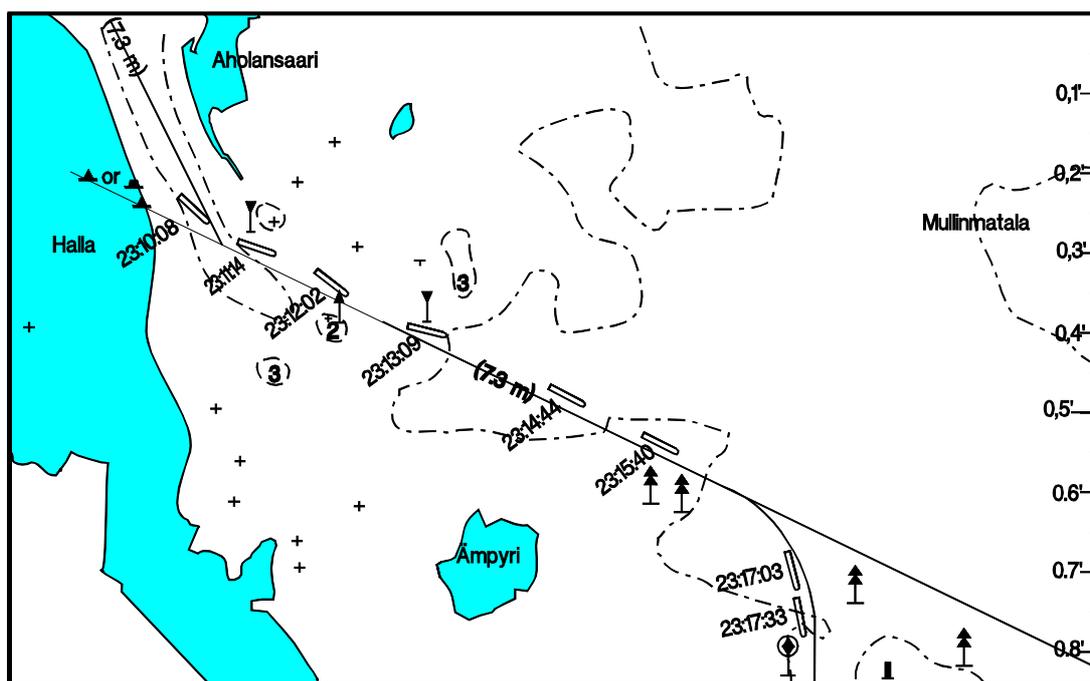
Figure 2. The yawing start of the voyage.

Time	HDG	COG	SOG	
23:10:08	133	133.6	5.4	A turn to port
23:11:14	109	108.7	6.1	For a moment the vessel proceeds straight ahead, but continues its turn to port after that.
23:12:02	128	124.5	6.5	The vessel corrects yawing by turning to starboard.
23:13:09	104	106.2	7.7	The vessel turns to port again.
23:14:44	118	123.4	7.4	Unintentional yawing movement back and forth.
23:15:40	117	117.0	9.9	The vessel proceeds straight ahead before the turn.
23:17:03	165	163.6	8.7	The vessel turns slowly to starboard.
23:17:33	169	171.1	8.7	The vessel turns more sharply to starboard.

The FORTE departed from the port in a yawing manner by using slow speed. According to the AIS recording, the forecastle swerved somewhat at the lighted east spar-buoy (Figure 2). The vessel did not run over this buoy, but according to the recorded AIS position the buoy has been run over. The position of the buoy can also be somewhat too much to east on the VTS chart. The vessel has, however, passed close to the buoy. Because the passing distance is not precise, the passing has not been drawn in Figures 2 or 3.

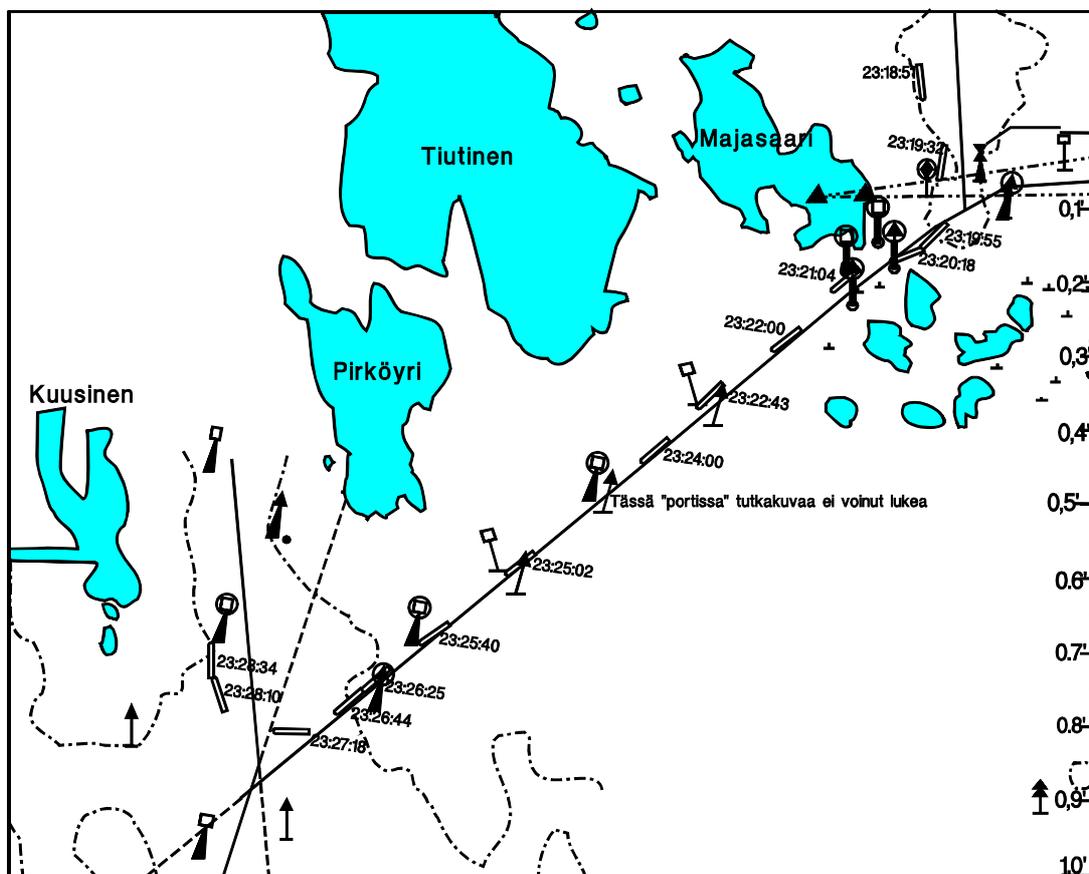
Figure 3. The vessel's route. The numerical values of the route are presented in table 4.

Time	HDG	COG	SOG	
23:18:51	173	171.7	9.5	The vessel has proceeded too much to starboard and steers too close to the edge mark.
23:19:24	177	173.5	9.7	The turn to starboard begins.

23:19:32	189	174.8	9.1	The turn has started. The position of the vessel shifts during the following 17 seconds so it is not possible to follow the turn.

23:19:55	225	205.5	9.0	The vessel's symbol re-emerges. The turn has been somewhat too prolonged because the bend of the fairway is sharp.
23:20:18	248	237.3	8.0	The vessel passes the post at a very close distance.

23:21:04	230	237.8	6.4	A quick slowing down of the speed. The post is passed at a close distance.
23:22:00	232	234.8	8.0	The vessel has returned to the track but drifts again to starboard.

23:22:43	226	227.7	8.4	The red spar buoy is passed at a very close distance.
23:24:00	229	230.5	8.8	The following gate is steered through in the middle. The VTS radar video combines the navigation marks on the chart and the vessel as the same target. The vessel is on the track.

23:25:02	232	230.3	10.6	The vessel is on track in the gate formed by the spar buoys.
23:25:40	235	230.7	10.7	The red buoy is in the same place as the bow.

23:26:25	229	231.8	9.5	
23:26:44	229	231.0	10.0	The turn to starboard begins.
23:27:18	271	251.4	9.3	The turn continues.
23:28:10	342	333.0	7.8	
23:28:34	001	358.6	7.0	The bow is in the same place as the red buoy and the grounding takes place somewhat after this.

The radius of the sharp turn is only 400 metres at Majasaari. The radius should be five times the length of the vessel, i.e. 454.25 metres. The Waterways Department of the Finnish Maritime Administration emphasizes that the users of the fairway have wanted to have such a shortcut fairway even though the fairway planning recommendations of the Finnish Maritime Administration cannot be entirely fulfilled³. The turn was too long also in this case, and the FORTE proceeded very close to the south edge of the fairway. The progress of the vessel was winding after the sharp turn. It was possible to stop the unintentional yawing between Pirköyri and Tiutinen at 23.24.00.

The usable water area did not allow the vessel to be steered in the bend according to the fairway planning guidelines. There was no space so it was not possible to draw a pilot plan for the bend described above. The planned bend was also too short in the previous turn by Majasaari (Figure 3) when the turn was too long and caused the unintentional yawing.

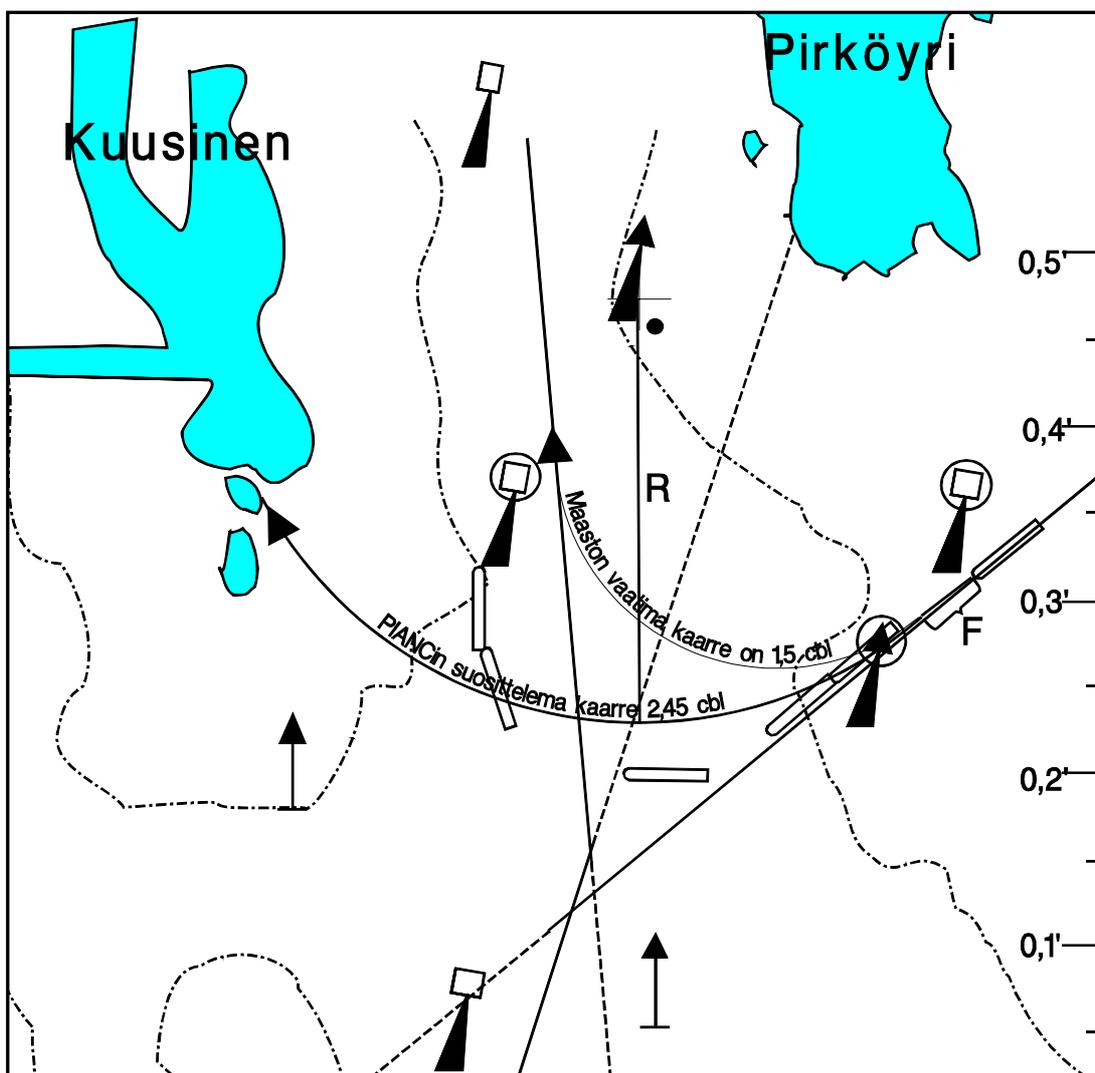
The traffic from Halla to Kotka main harbour is conducted on a new traffic route. The turn from the Ruotsinsalmi fairway around the Pirköyri Island towards the main port has not been planned. According to the chart the turn becomes very sharp.

The fairway planning guidelines drawn by the Waterways Department of the Finnish Maritime Administration is based on international recommendations. According to this instruction, the turning radius cannot be smaller than 5 vessel lengths⁴.

Figure 4. The fairway planning guidelines of the Waterways Department of the Finnish Maritime Administration recommend that the turning radius for a vessel of the size of the FORTE should be 2.45 cable lengths. Based on the chart it can be estimated that the radius is only 1.5 cable lengths. The vessel symbols show the track of the FORTE.

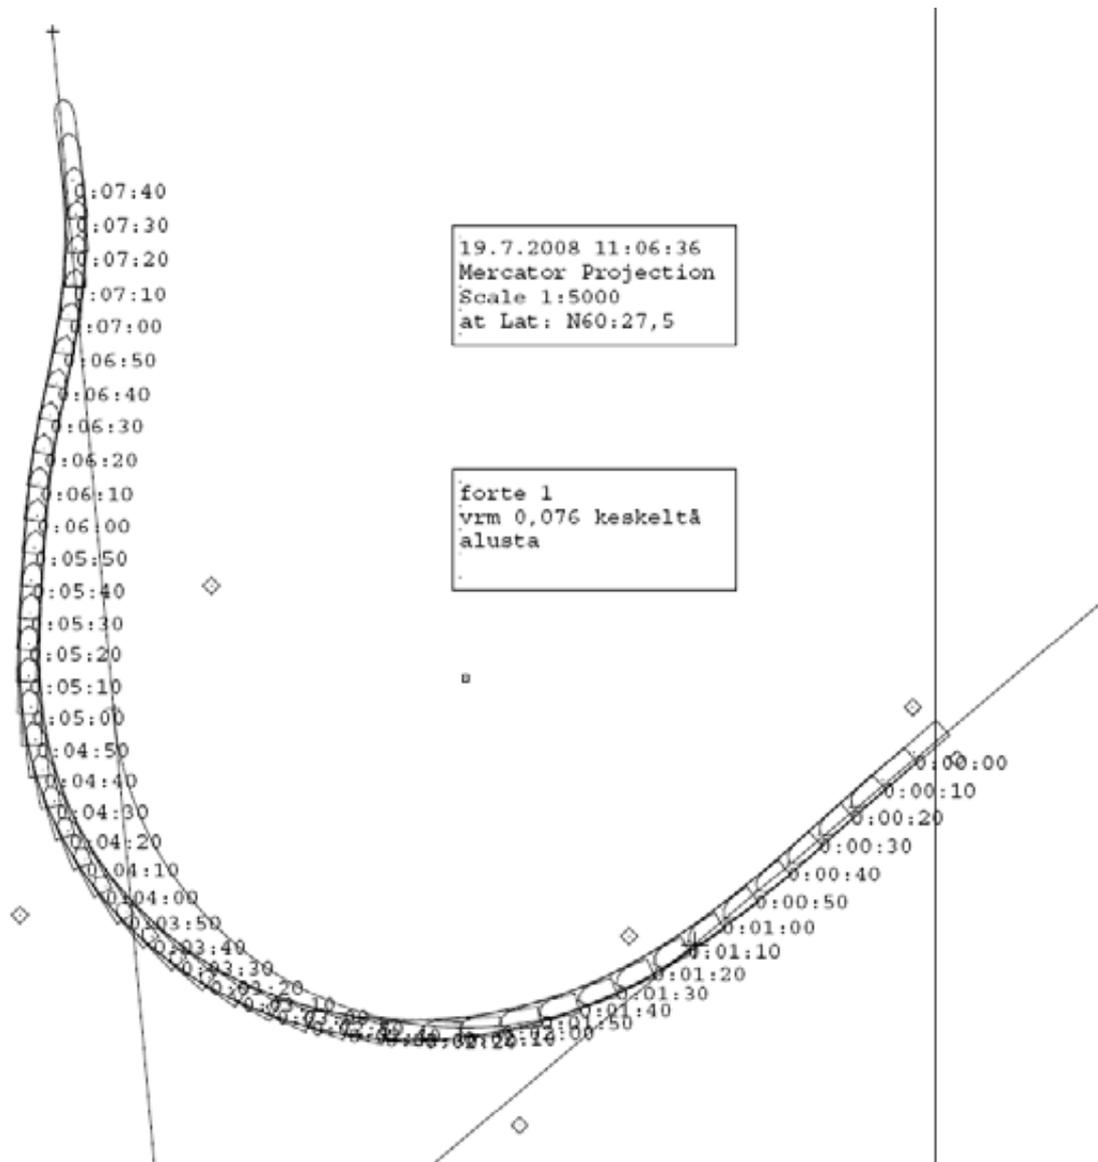
Figure 5. This is a test conducted in a simulator, and it describes how a successful turn could have been completed. In table 5 on the next page e.g. the rudder angles used in the simulator can be seen.

Because the turn is not planned for a vessel of the size of the FORTE, it requires special attention and the turn must be started early enough using adequate rudder angles. If the success of the turn is doubted in advance, the speed should be reduced so that it is very low, and the turn should be assisted by using the bow thruster. Using tug assistance should also be considered, but the need must be known already when the vessel departs from the port.
