## Investigation report

B1/2009M

# MS OOCL NEVSKIY, a fatal fall overboard during load securing on 13 February 2009

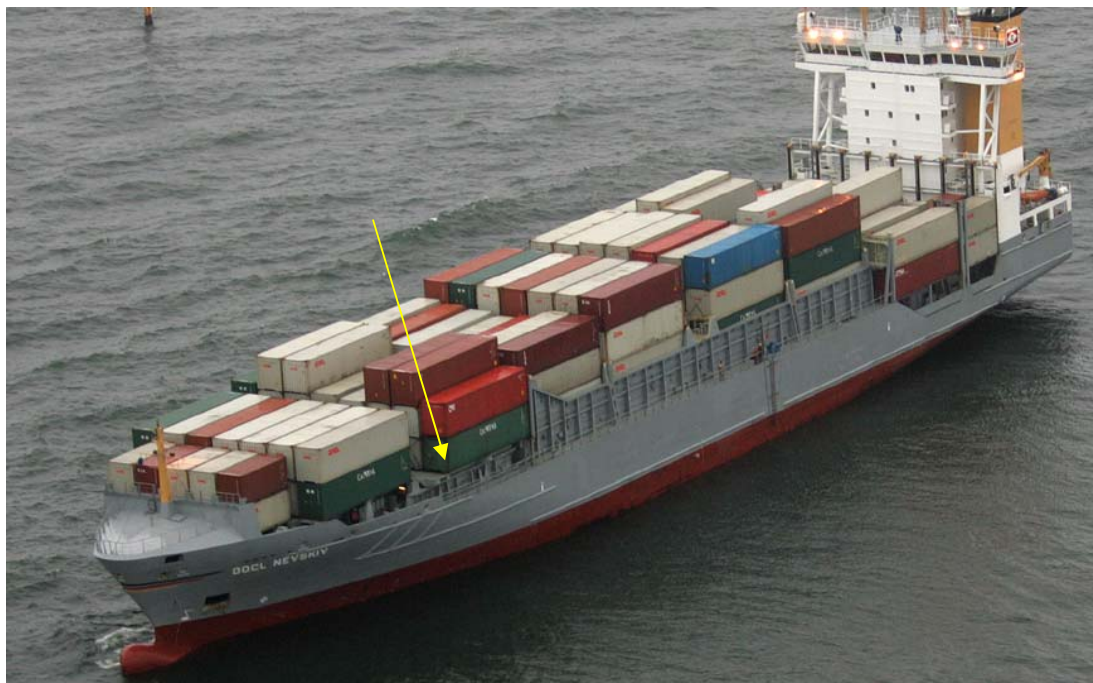
The accident occurred on the port side of the bow, on top of cargo hatch number 2.

Figure 4. The yellow arrow points to the place from where the seaman fell (© Border Guard)

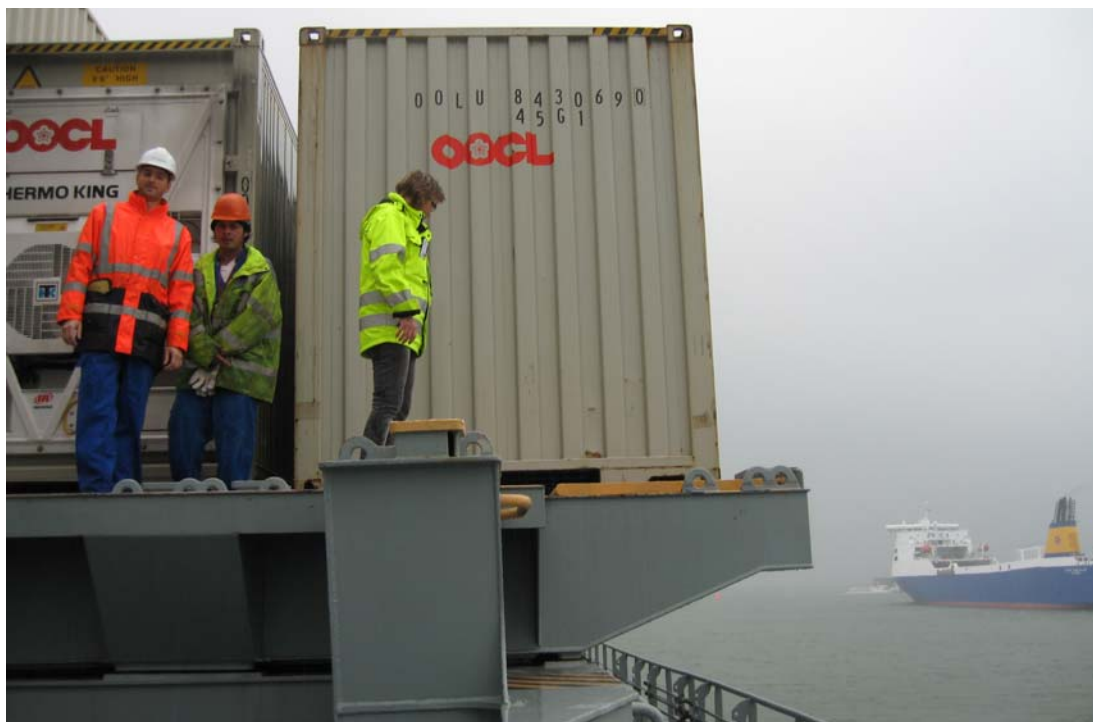
Figure 5. The place of the fall photographed later at the Port of Gothenburg (Sjöfartsinspektion, Sverige).

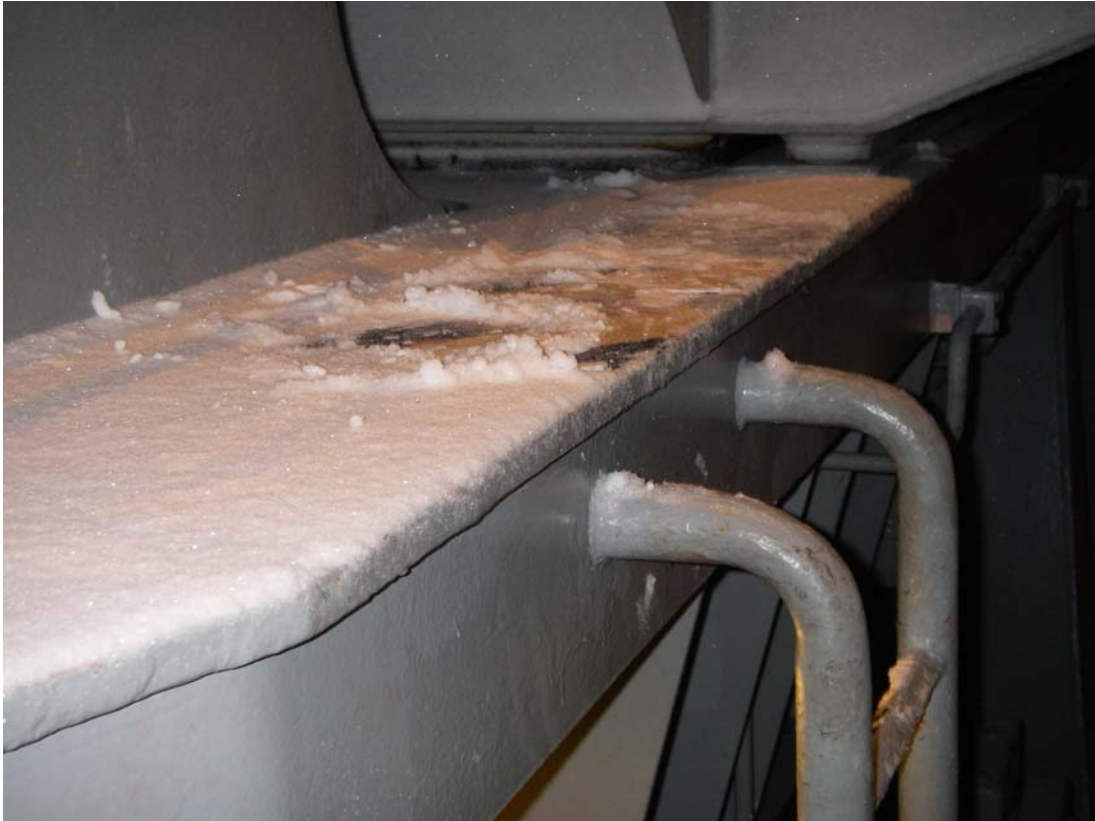
Figure 6. The site of the fall photographed on the night of the accident (Kotka Police).

Photographs clearly show a thin sheet of snow on the deck. This makes the deck extremely slippery.

Weather conditions on the night of the accident were difficult. The deck was slippery with recently fallen snow. When snow falls on a painted steel deck, moving around and working become extremely dangerous. Slippery footwear only increases the risk of an accident. Furthermore, it was dark and the deck was icy at the time of the occurrence.

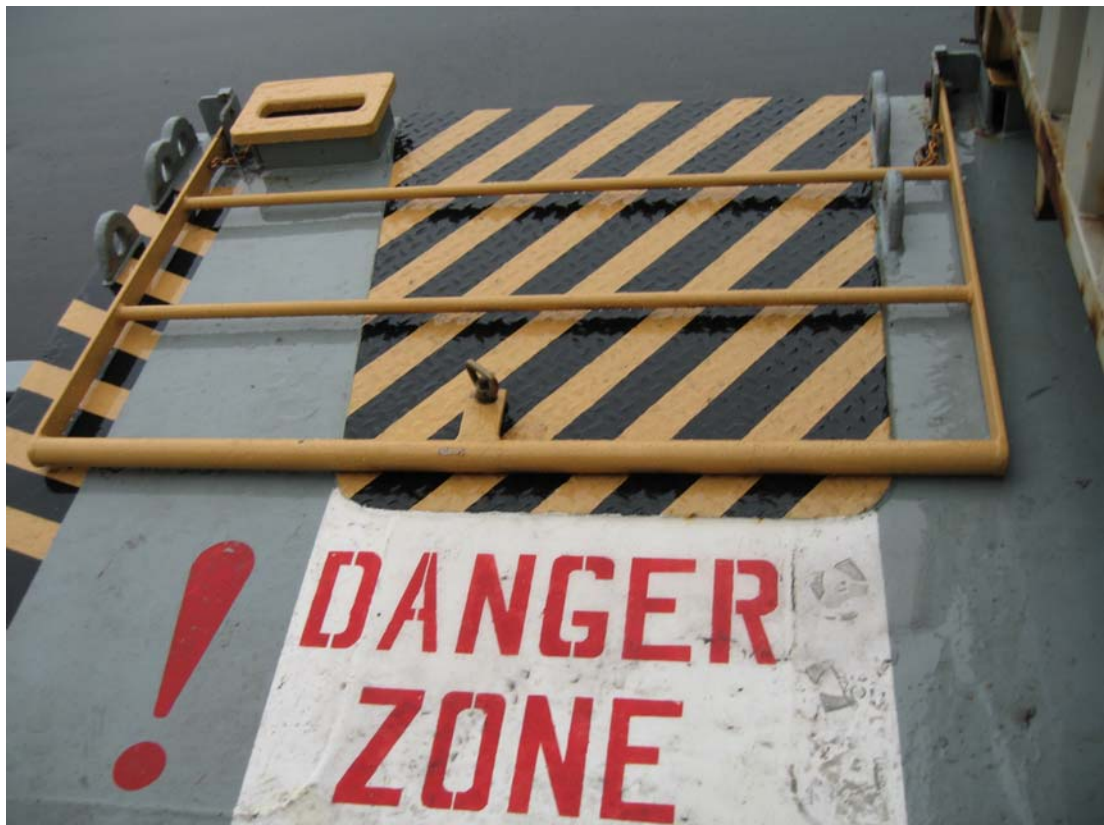
Figure 7. The safety rail and danger zone markings on the starboard side.

The ship has, at least, installed a safety rail and painted danger zone markings at the point of the fall. At the request of AIB Finland, Swedish maritime authorities visited the vessel after the accident and took photographs. The pictures below show the changes that have been implemented. A safety rail has been installed at the work area and clear danger zone markings have been painted on the area.

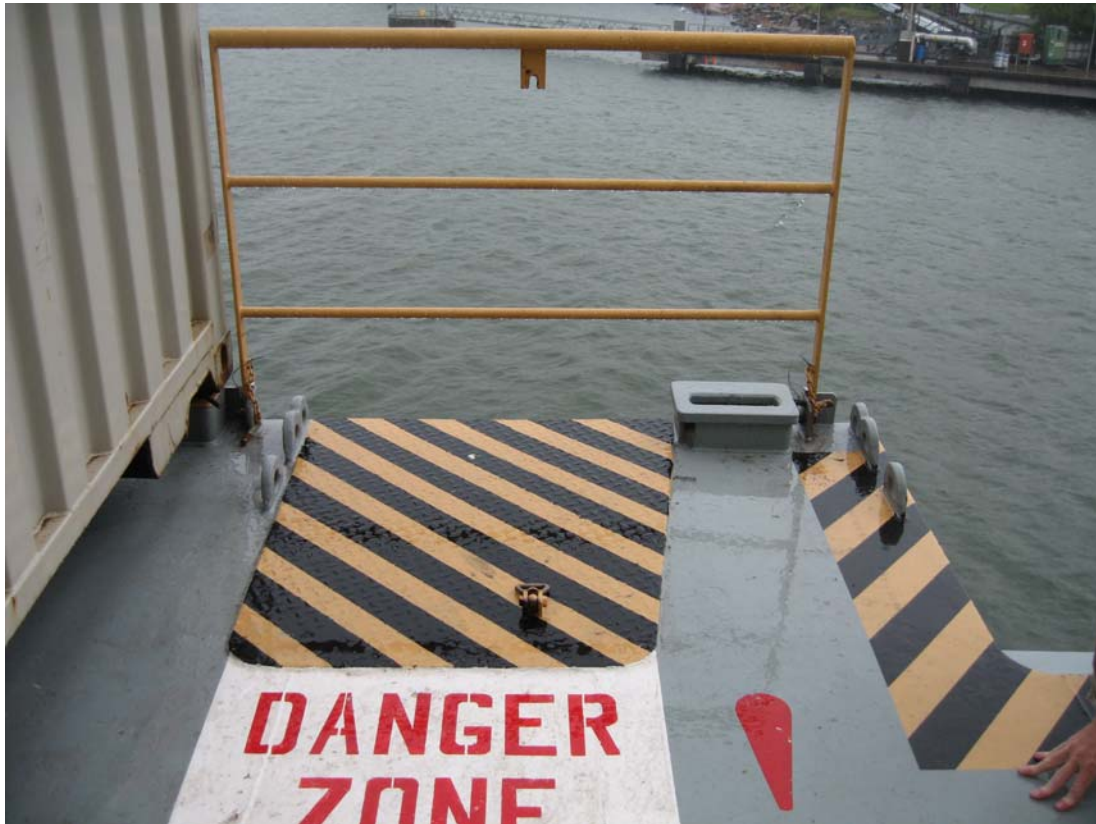
Figure 8. The erected safety rail on the port side.

When erected, the safety rail markedly improves fall protection.
