Investigation report

D20/2009M

MS LAIMA and MS SILVA, collision in the Åland Sea on 13 September 2009

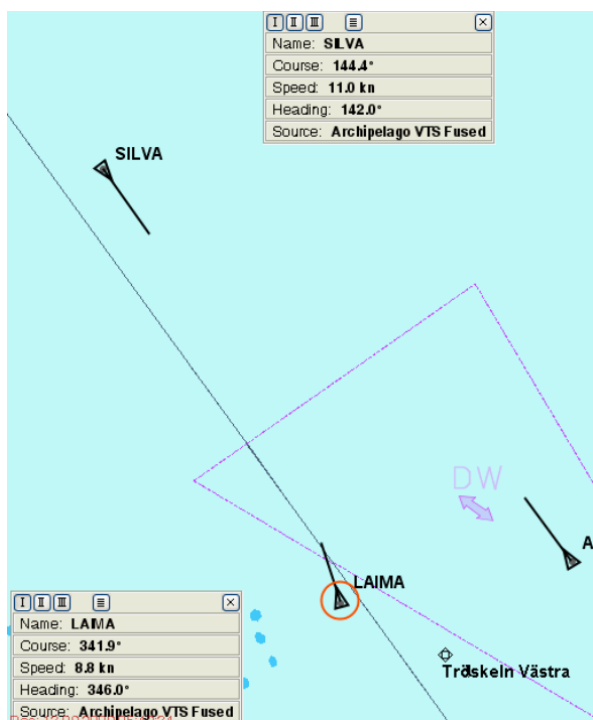
Figure 3. At 05:49:34 the vessels are approximately 3.83 nautical miles away from one another. The LAIMA calls the SILVA at 05:40, but gets no reply. The call is not heard in the VTS recording.

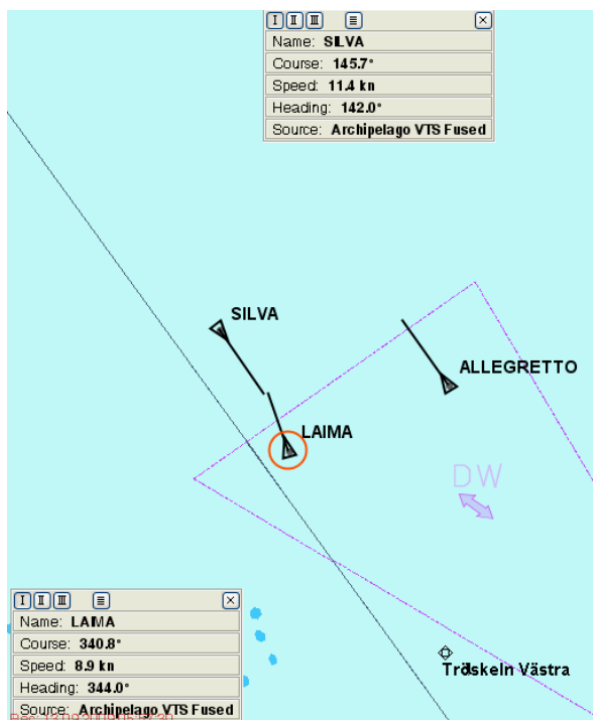
Figure 4. At 05:57:30 the vessels are approximately 1 mile distant from each other. There is imminent danger of a collision or a 'near miss'. From the recording it seems that at this stage the LAIMA was still able to turn to starboard.

When the ships were around one mile away from each other, a close-quarters situation was becoming more and more imminent (Figure 4), and the LAIMA did not see the SILVA making any manoeuvres to avoid a collision or 'near miss'. When they were at a distance of about 0.3 miles away from one another, the LAIMA reported that she was turning to port (not heard on the VTS recording), but received no response to this. Evidently, at virtually the same instant, the SILVA also turned in the same direction, i.e. to starboard. The LAIMA would hardly have begun to turn to port if she had noticed SILVA's manoeuvre to starboard. According to the VTS recording, the LAIMA asked the SILVA three times to turn to port moments before the collision. It is easy to see from the VTS video recording that the LAIMA could have easily avoided the collision by also turning to starboard (Figure 4) without jeopardising the passage of faster ship MS ALLEGRETTO on her starboard side⁵. The LAIMA's officer of the watch said that the reason why he did not steer to starboard was that the ALLEGRETTO was too close and his intention was also to reduce the amount of collision damage.

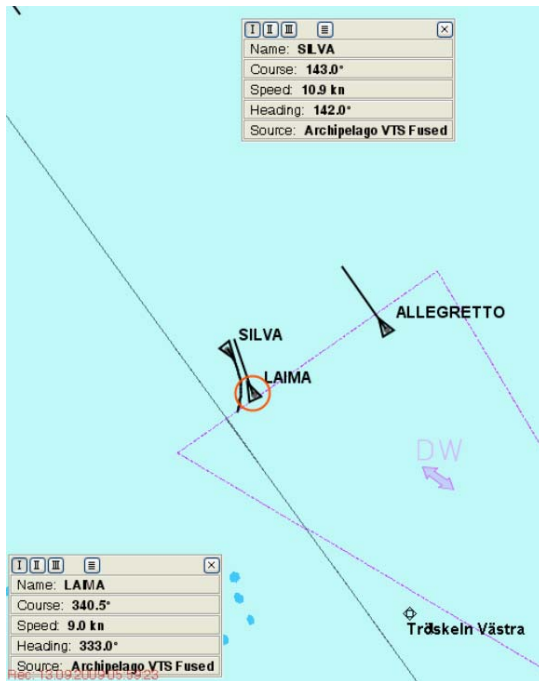
Figure 5. At 05:59:23 the vessels are approximately 0.33 miles away from one another. The LAIMA informs the SILVA that she is turning to port. This is not heard in the VTS recording; instead it can be made out that the LAIMA asks the SILVA three times to turn to port. The SILVA makes no reply and turns to starboard. The vessels turn in more or less the same direction at the same time - westward.

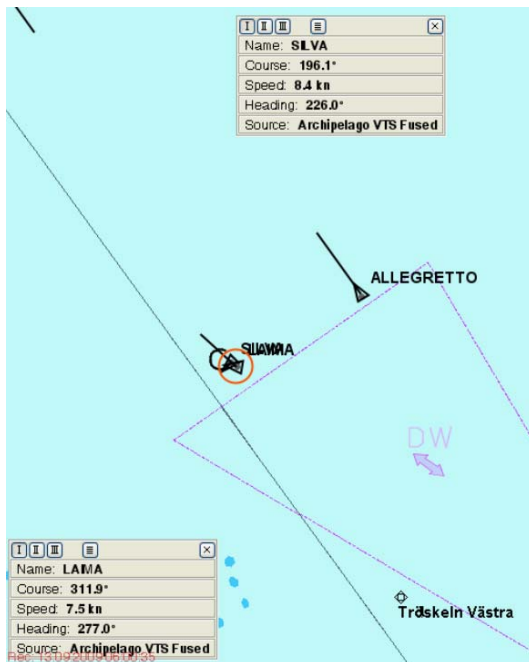
Figure 6. The vessels collide at 06:00:34, according to this VTS record.

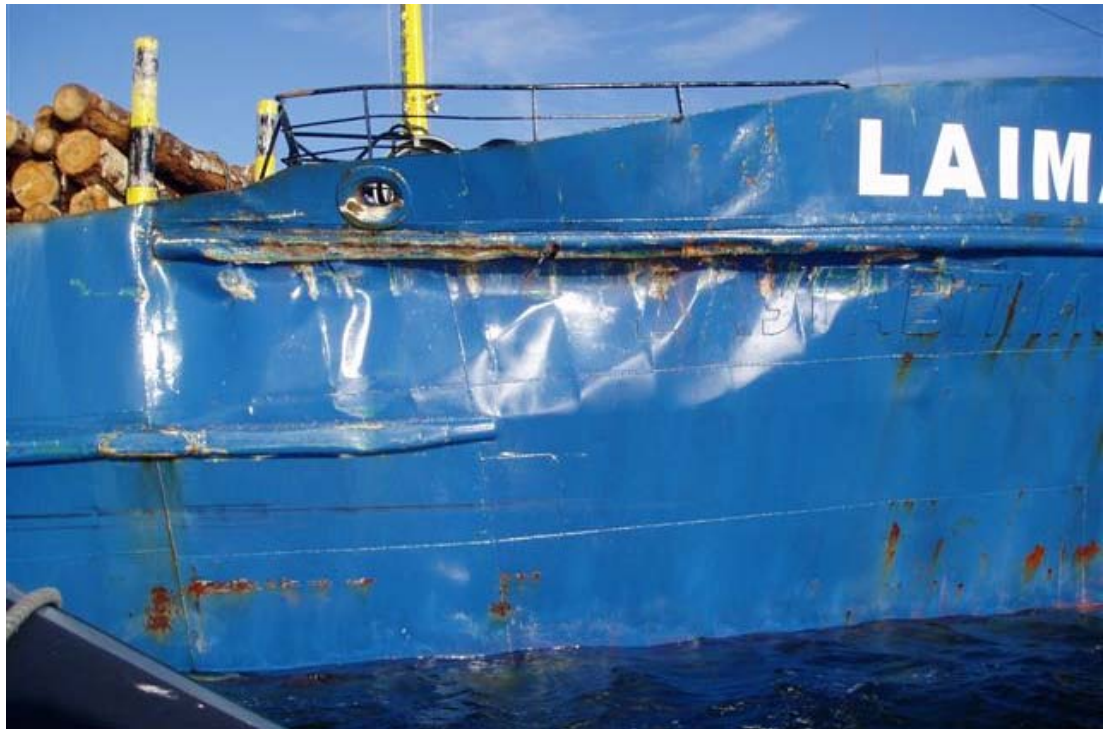
The damage to the LAIMA did not affect her seaworthiness, so she was able to continue her journey after an inspection by the Finnish Maritime Administration, and the damages were repaired later.

Figure 8. The damage to the LAIMA's starboard bow - external view.
(Photo: Finnish Coast Guard)

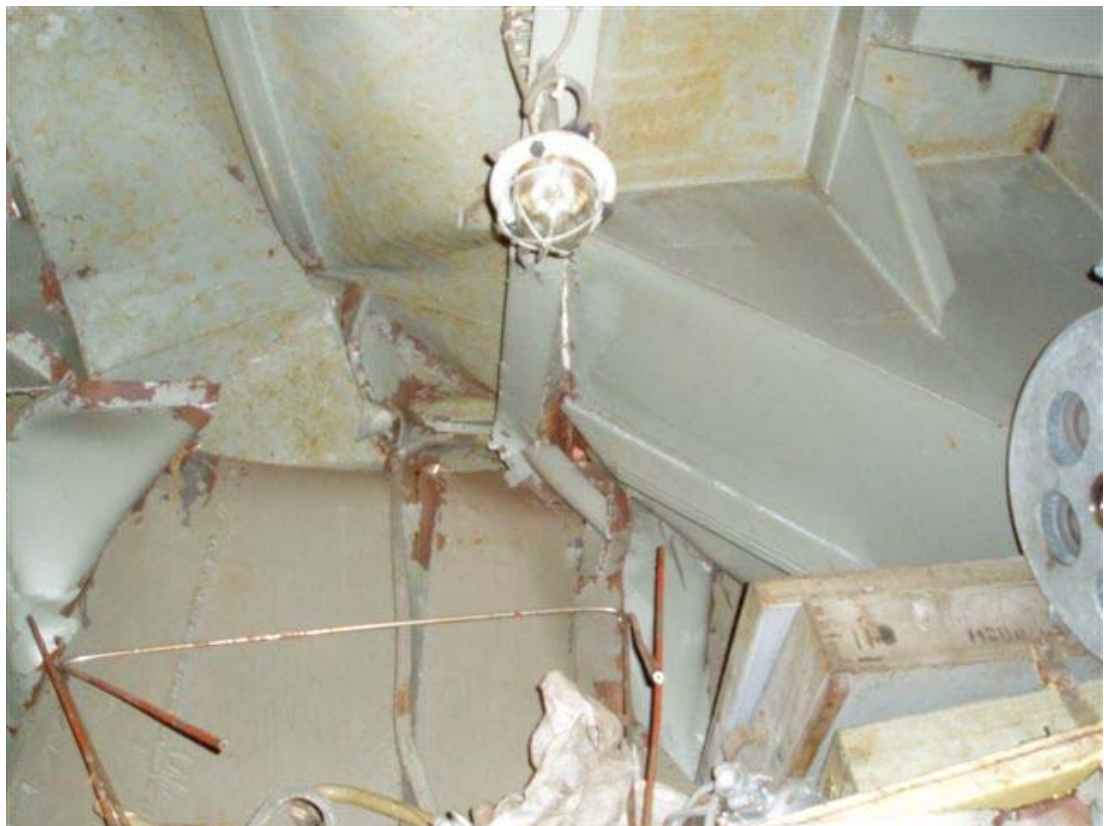
Figure 9. The damage as seen from inside the LAIMA's forecastle.

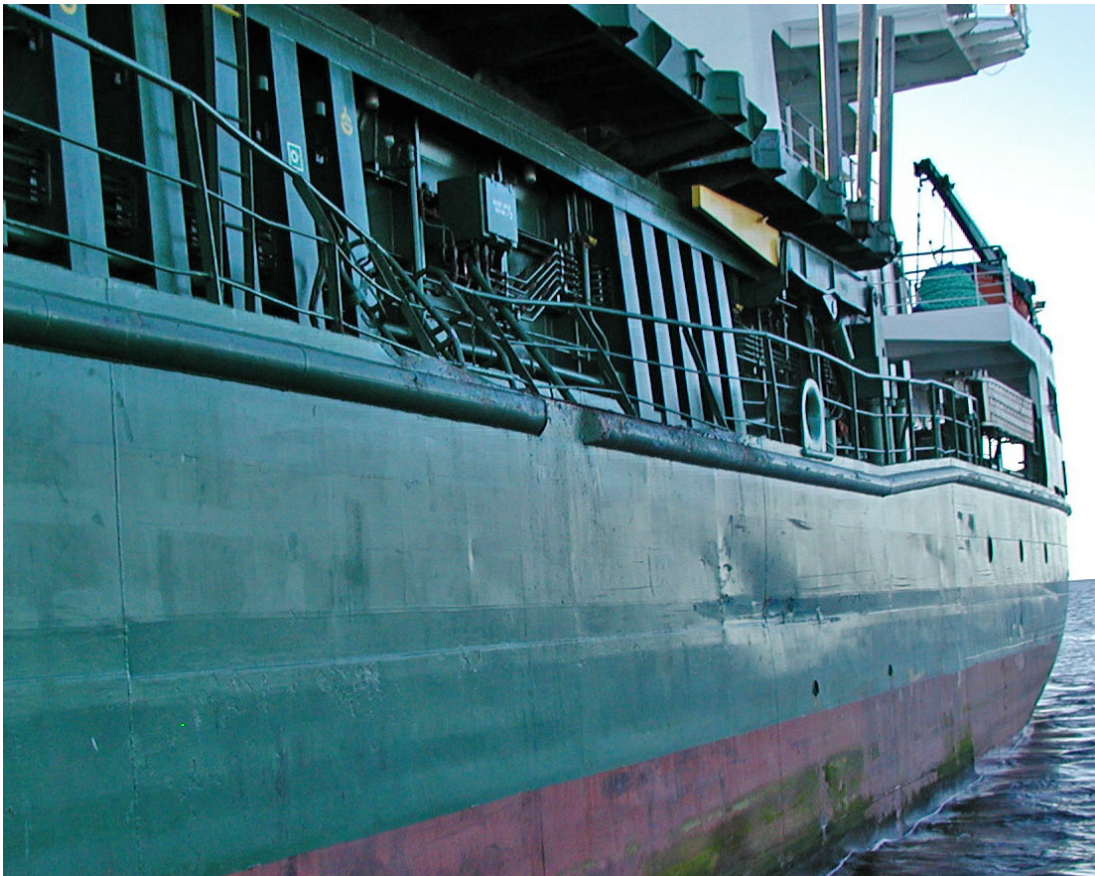
The damage to the SILVA was mainly to her port side, which was dented. The rail was bent inwards.

Figure 10. The damage to the SILVA.

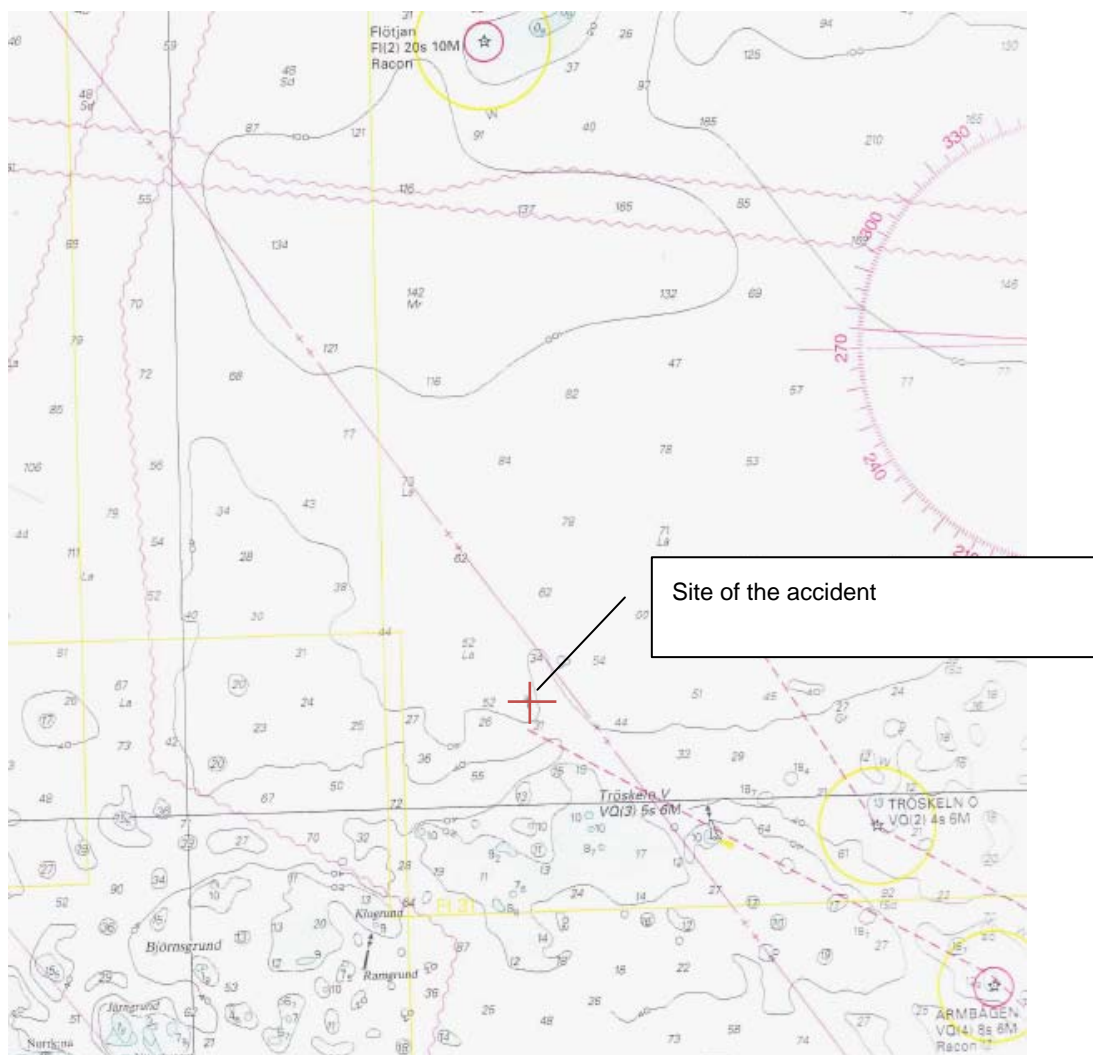
In the case here investigated, the LAIMA was coming from the south and deviated from the west side of the deep water route to make a short cut. Just before the collision she had arrived at a position where there was oncoming traffic in the deep water route. Figure 11 shows the site of the collision at the northern end of the deep water route.

Figure 11. Site of the accident at the northern end of the deep water route. (Section of the Swedish chart 719. Not to scale.)

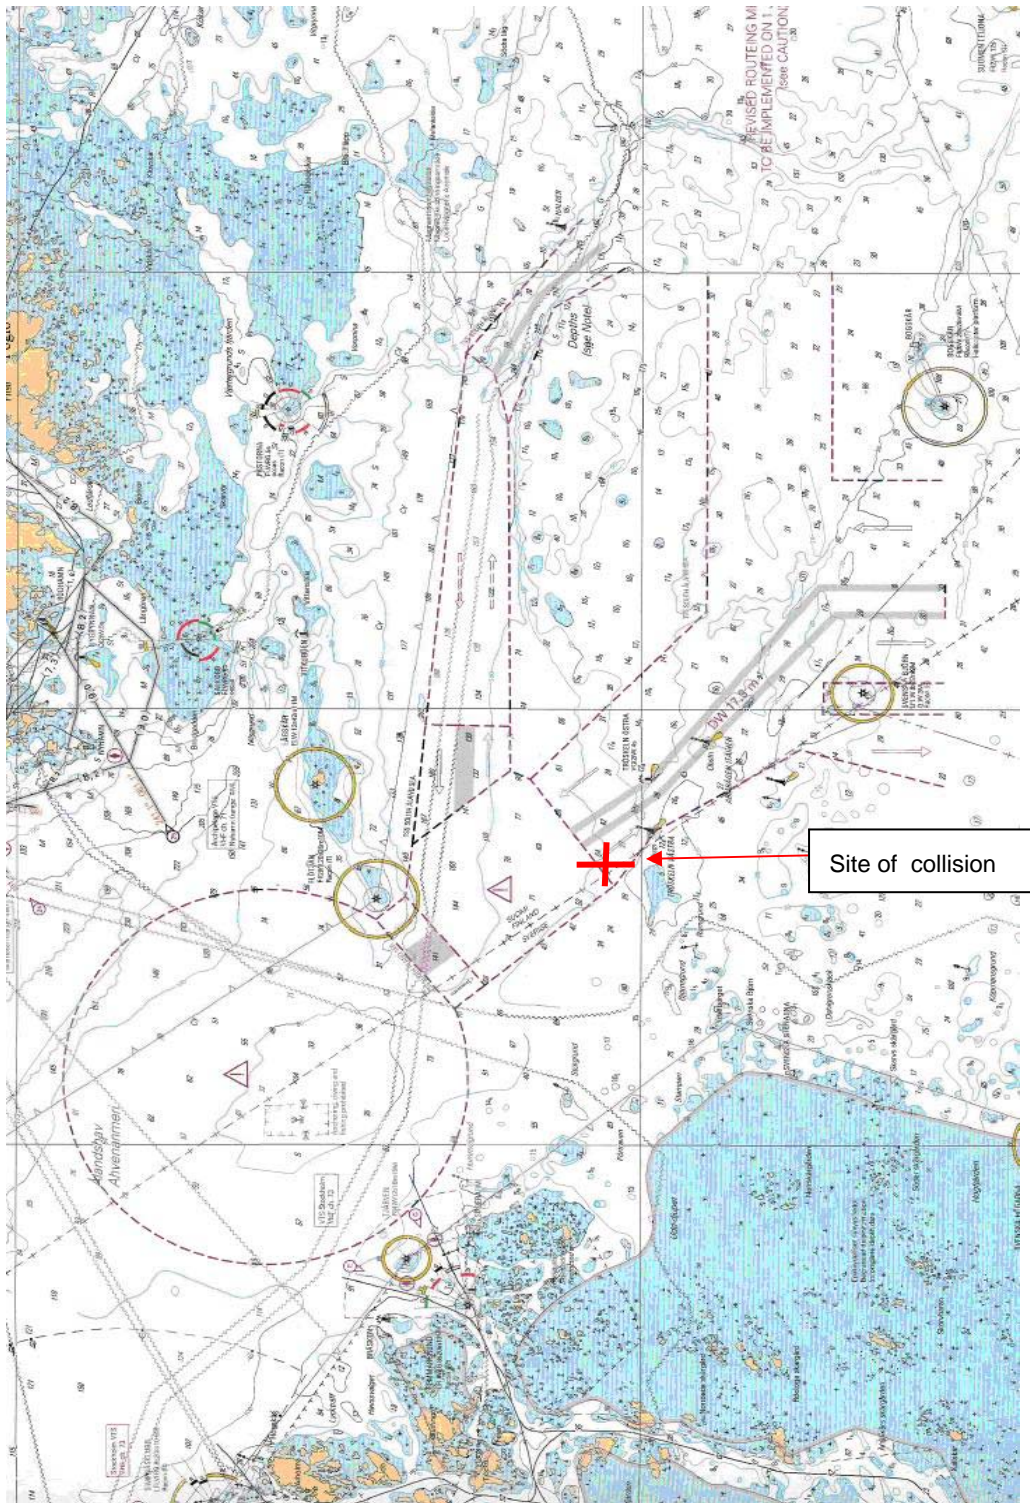
Figure 12. The traffic regulation scheme that came into effect on 1 January 2010. Finnish chart FIN 953. Not to scale so not to be used for navigational purposes.

Figure 12 shows the traffic regulation scheme that came into effect on 1 January 2010. This new scheme is a very welcome one and, if adhered to, could prevent situations such as the one described in this case.
