**Bundesstelle für Seeunfalluntersuchung**  
**Federal Bureau of Maritime Casualty Investigation**  
Federal Higher Authority subordinated to the Ministry of Transport,  
Building and Urban Development

Summary  
Investigation Report 20/09

**Collision on the Kiel Canal (NOK)**  
**between HANSE VISION and BIRKA EXPRESS**  
**on 12 January 2009 at 1424**

1 March 2010

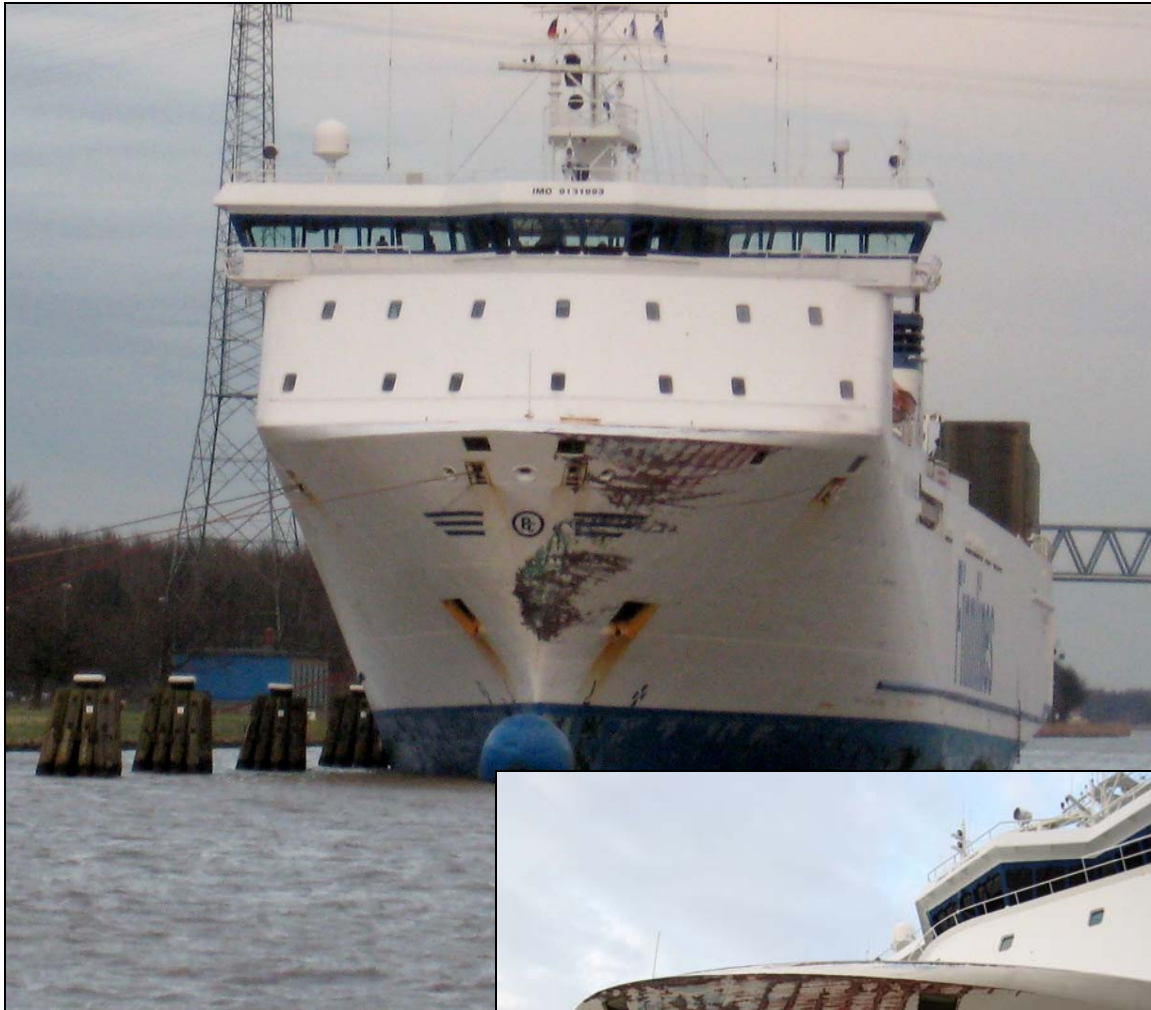
Figure 5: Damage overview

The BIRKA EXPRESS had heavy paint abrasions and deformations on the bow section.

BIRKA EXPRESS

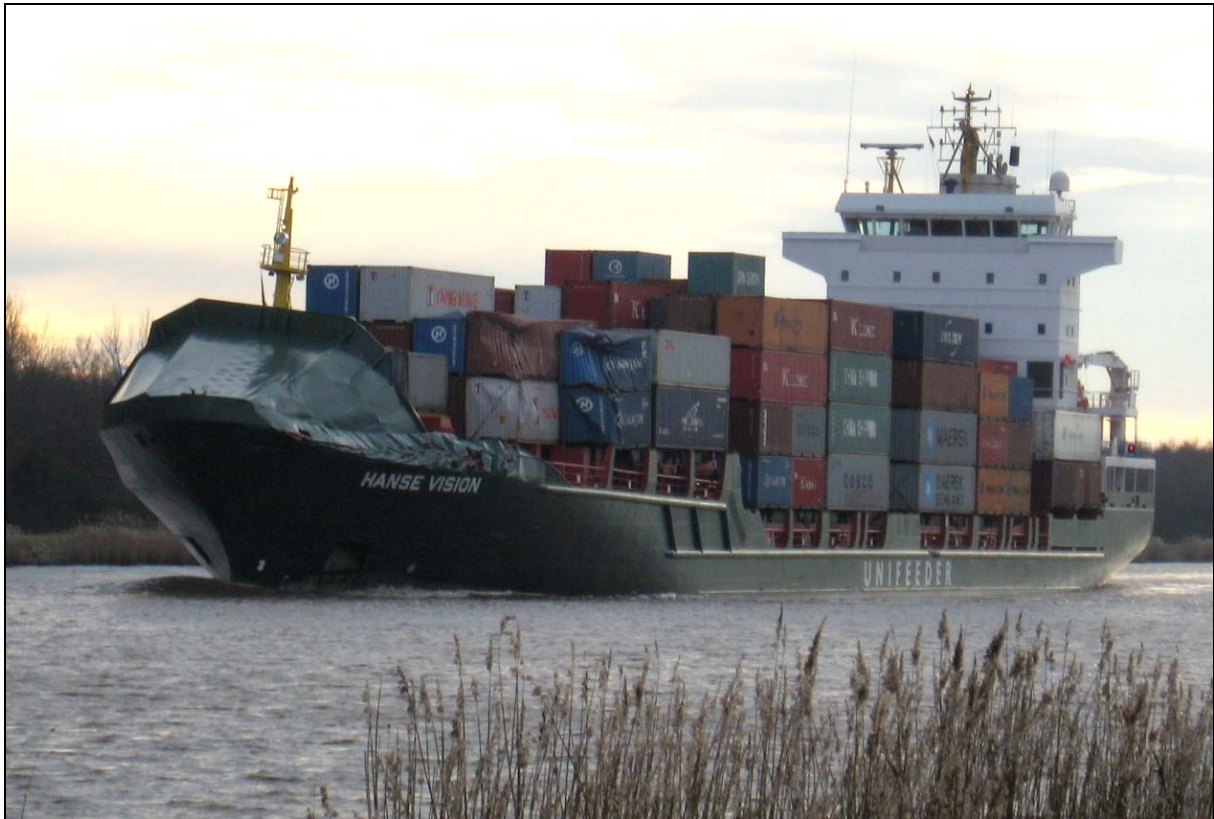
Figure 7: Damage overview HANSE VISION

The HANSE VISION was heavily dented on the port bow above the waterline. Various deck cargo containers were damaged.

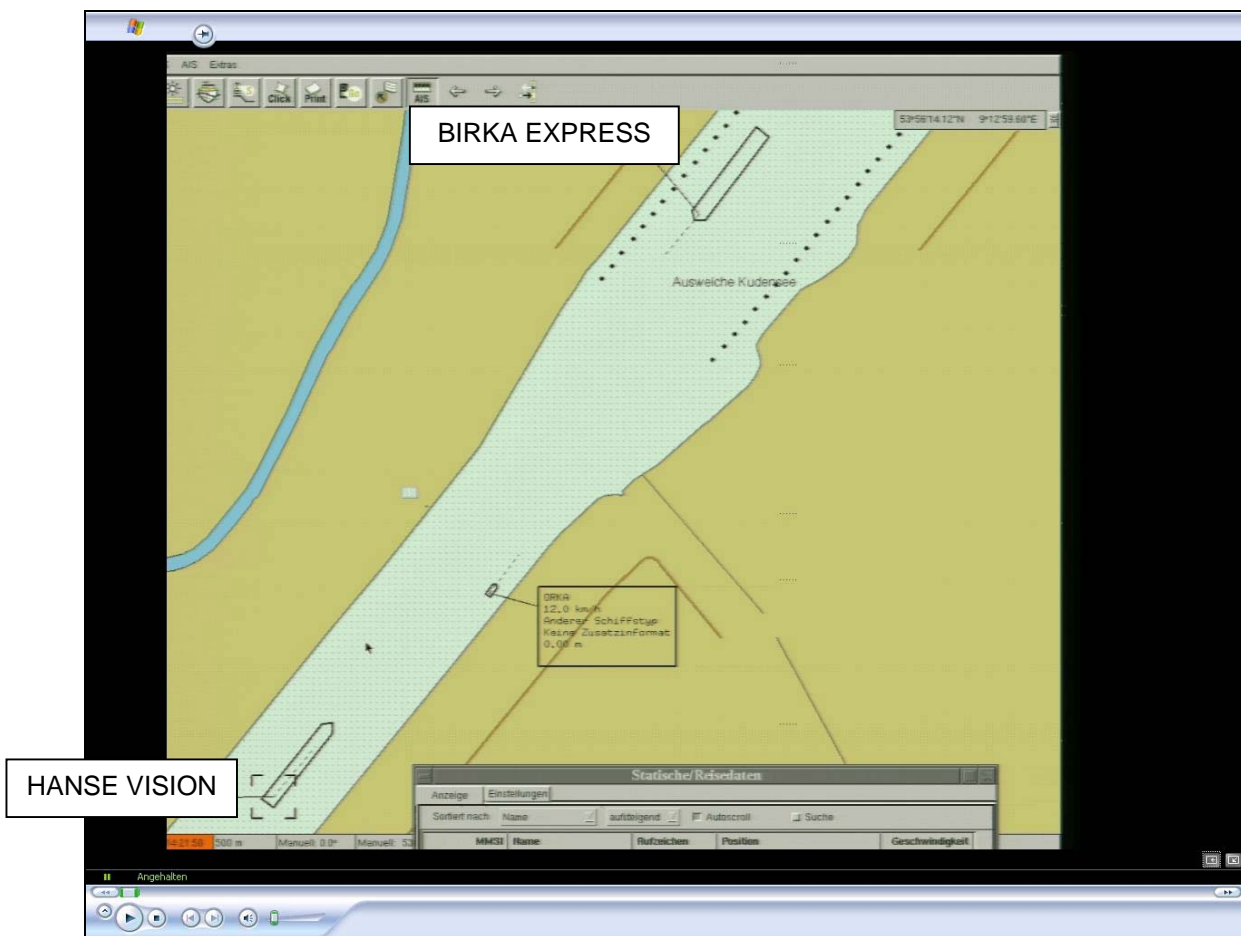
Figure 9: AIS display of the VTS at 142150

Figure 9 shows how the two vessels move towards each other. According to the numerical AIS data, graphically depicted in Figure 10, the BIRKA EXPRESS began to reduce her speed at 1421. At that time, she was located about 200 m from the siding area's western boundary. At about 1423, she increased her speed in order to improve the steering effect.

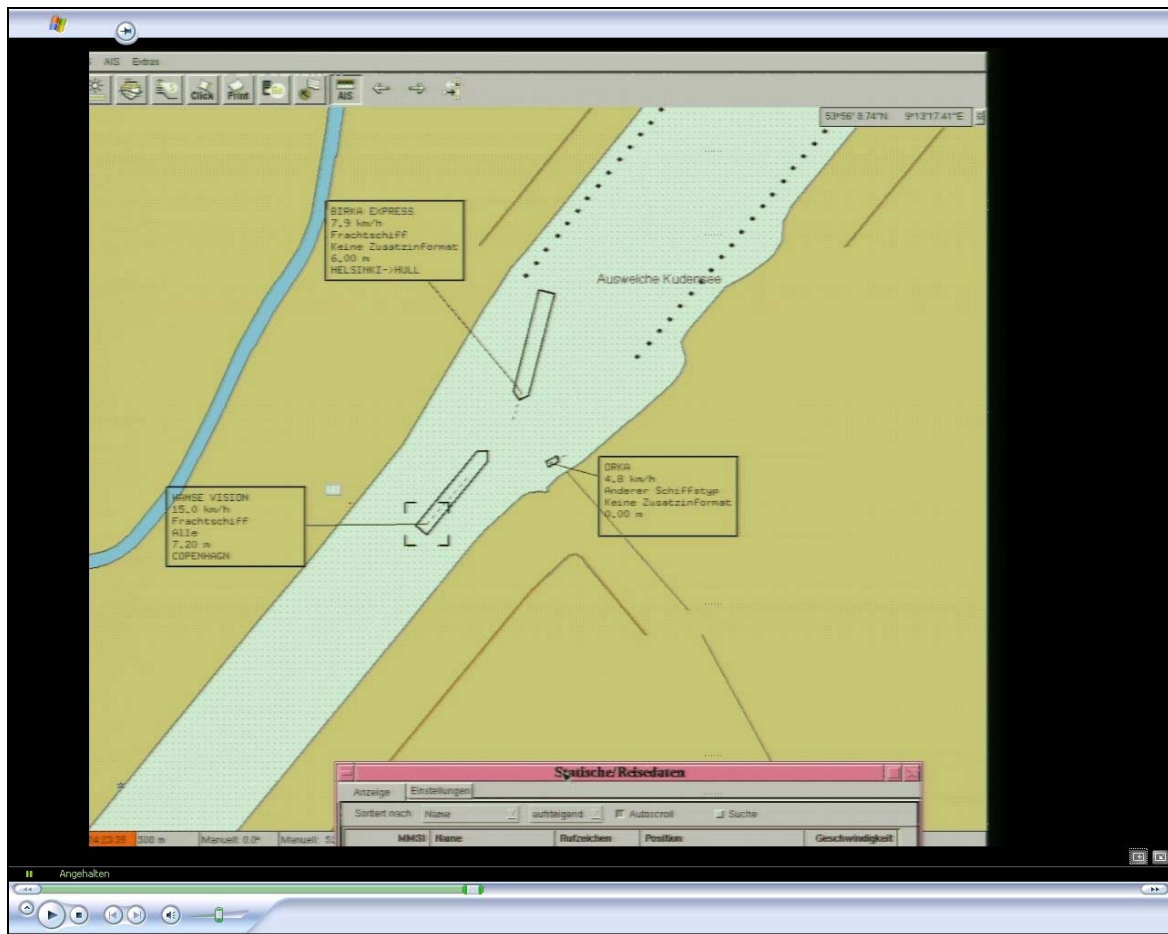
Figure 11: AIS display of the VTS at 142335

In Figure 11 we see clearly that the BIRKA EXPRESS was moving at 11 km/h when she passed the boundary of the Kudensee siding area. In the process, she began to turn to port.

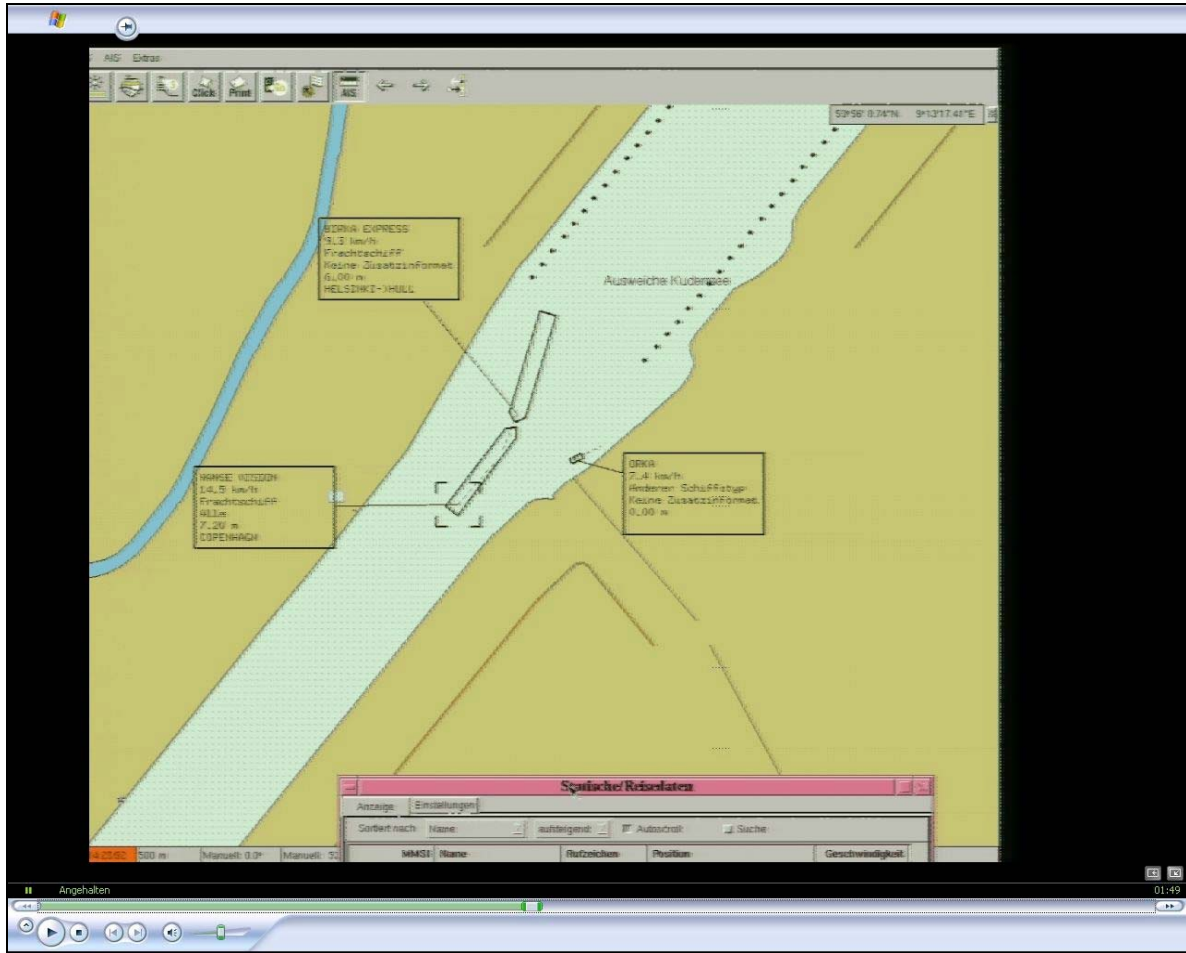
Figure 12: AIS display of the VTS at 142352

Figure 12 shows the time of the collision. The speed of the BIRKA EXPRESS was still 9.3 km/h and the HANSE VISION 14.5 km/h.

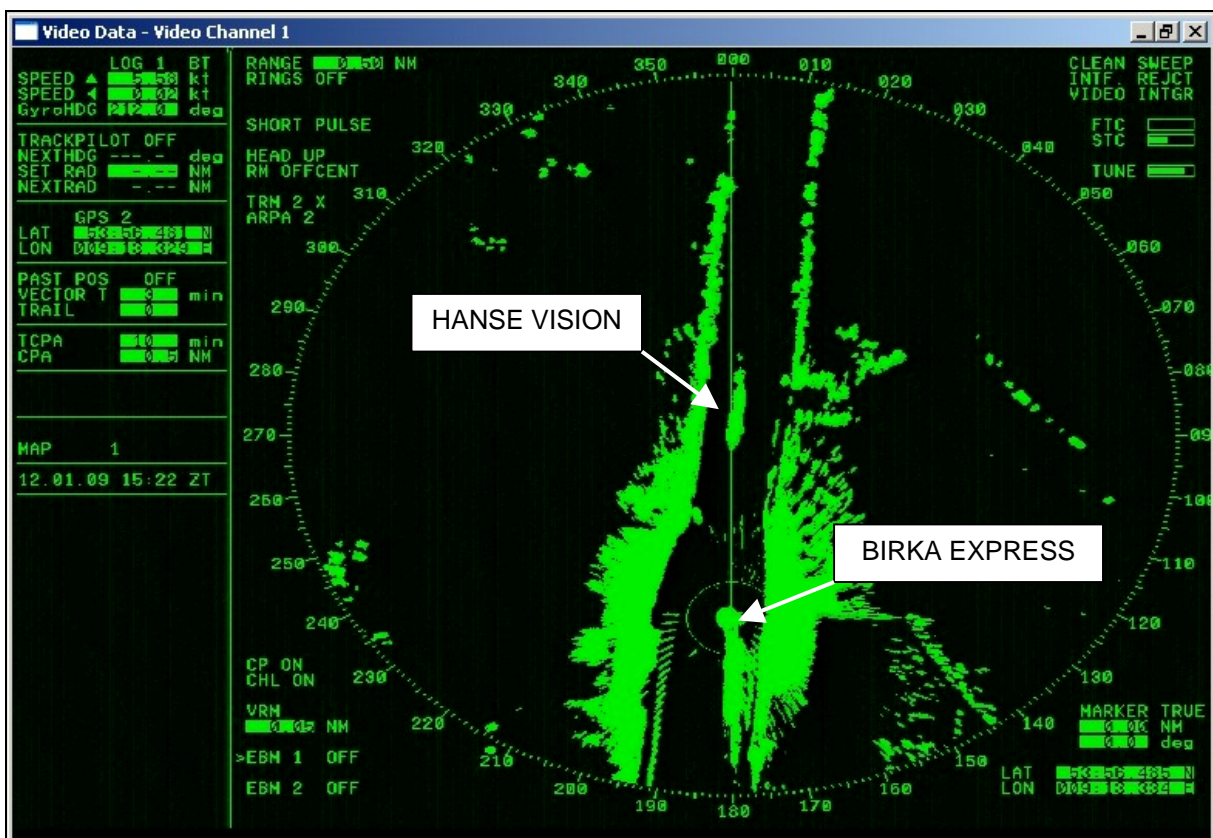
Figure 15: Radar image of the BIRKA EXPRESS at 1422

The AIS representation of the VDR is omitted here because it was not underlaid with a nautical chart; therefore, reference is made to the records of the VTS under para. 6.3. The following radar images further illustrate the course of the accident. Figure 15 shows the initial situation of each vessel at about 1422. In the figure below we see how the BIRKA EXPRESS reaches the siding area boundary at the end of the row of dolphins and begins to turn to port while the HANSE VISION approaches her.
