## Investigation Report

C1/2010M

# **M/S LINDA (FIN), falling overboard of four containers into the Baltic Sea, south of Gotland, on 6 February 2010**

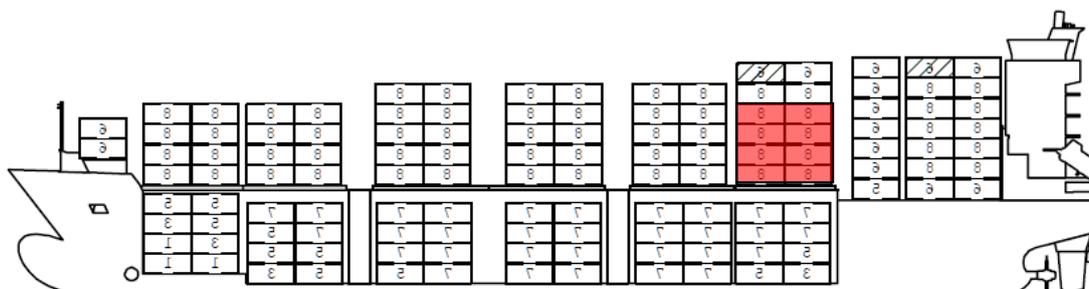
Figure 2. A layout drawing of the cargo spaces on M/S LINDA. The red rectangle indicates the location of the fallen container stack on the outermost bay on the port side of the vessel. (© Oy Langh Ship Ab)

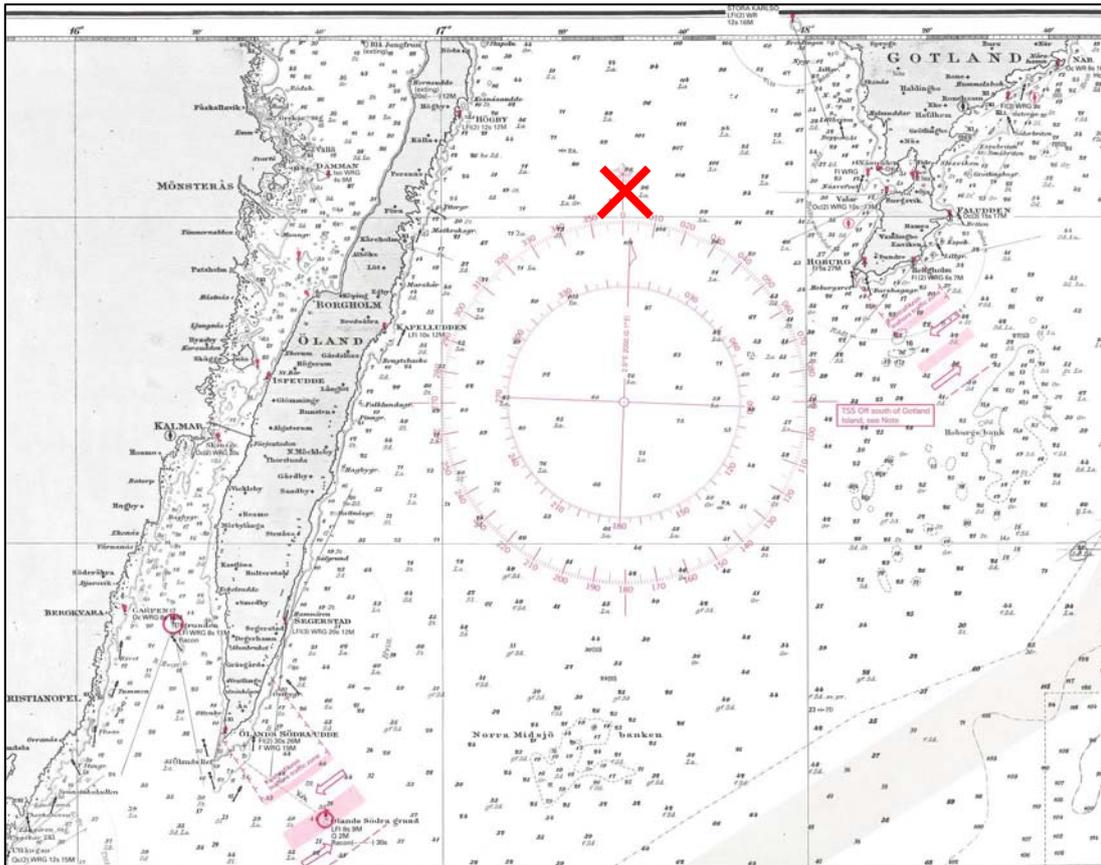
The exact time for the falling, 07.56 vessel's time, was obtained later from the registration of the vessel's CCTV camera located in the superstructure. According to the LINDA's log, the vessel position at 08.00 was lat 57°00.6N and long 017°34.2E.

Figure 4. The scene of the incident has been marked in the figure with a red cross. (© Swedish Maritime Administration 2012)

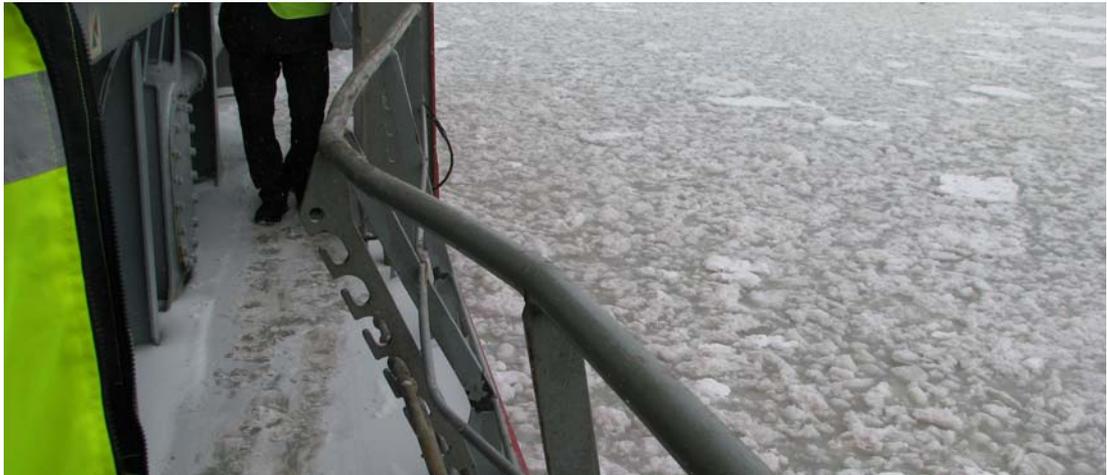
When falling overboard, the containers damaged the vessel's port side railing at a length of approx. 4 metres (Figure 5). The vessel did not suffer any other damages.

Figure 5. The railing damaged by the fallen container stack on the port side of the vessel.

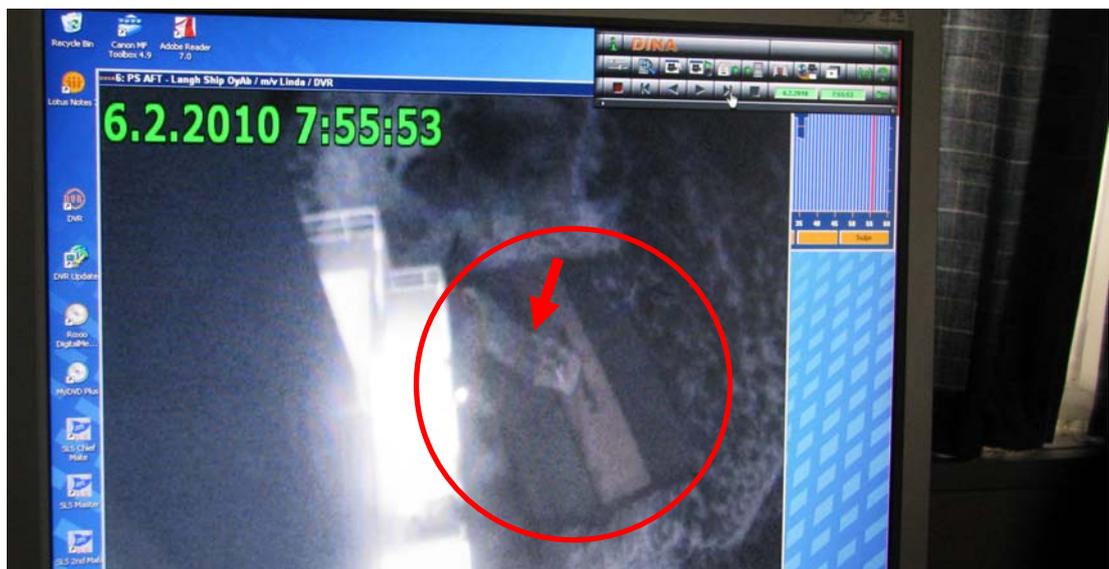
The vessel has CCTV cameras on the boat deck on both sides of the accommodation spaces. The port side camera recorded the containers in the sea after they had fallen overboard. The containers which contained cargo were attached to each other as one block. For example the roof of the broken reefer was also attached to this block.

Figure 6. A picture recorded by the vessel's CCTV camera photographed by a camera from a display on the vessel. The block formed by the three containers attached to each other can be seen in the picture (the red circle). The roof of the broken reefer container is on this block (the red arrow). The wall of the reefer container drifts somewhat behind the block.
