Investigation Report

B1/2011M

M/S ANDANTE (GIB), accident leading to death and a close-call in cargo hold on 30.9.2011

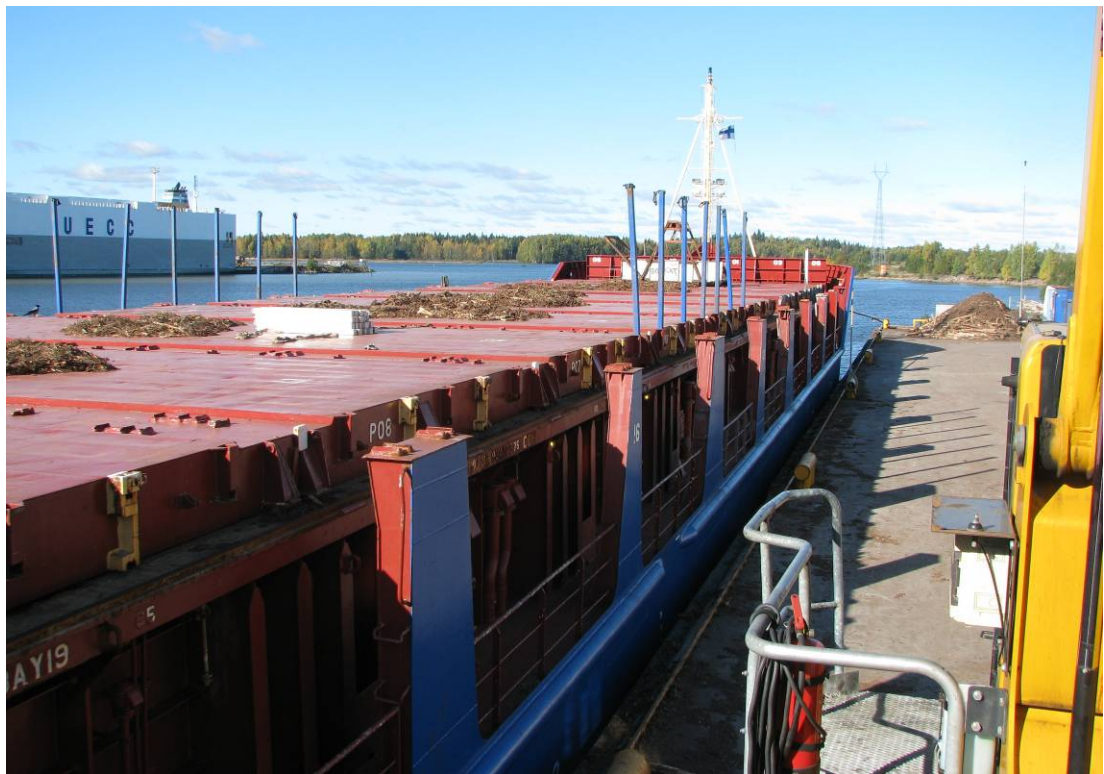
Figure 2. The situation after the deck cargo stowed on the foredeck had been discharged.

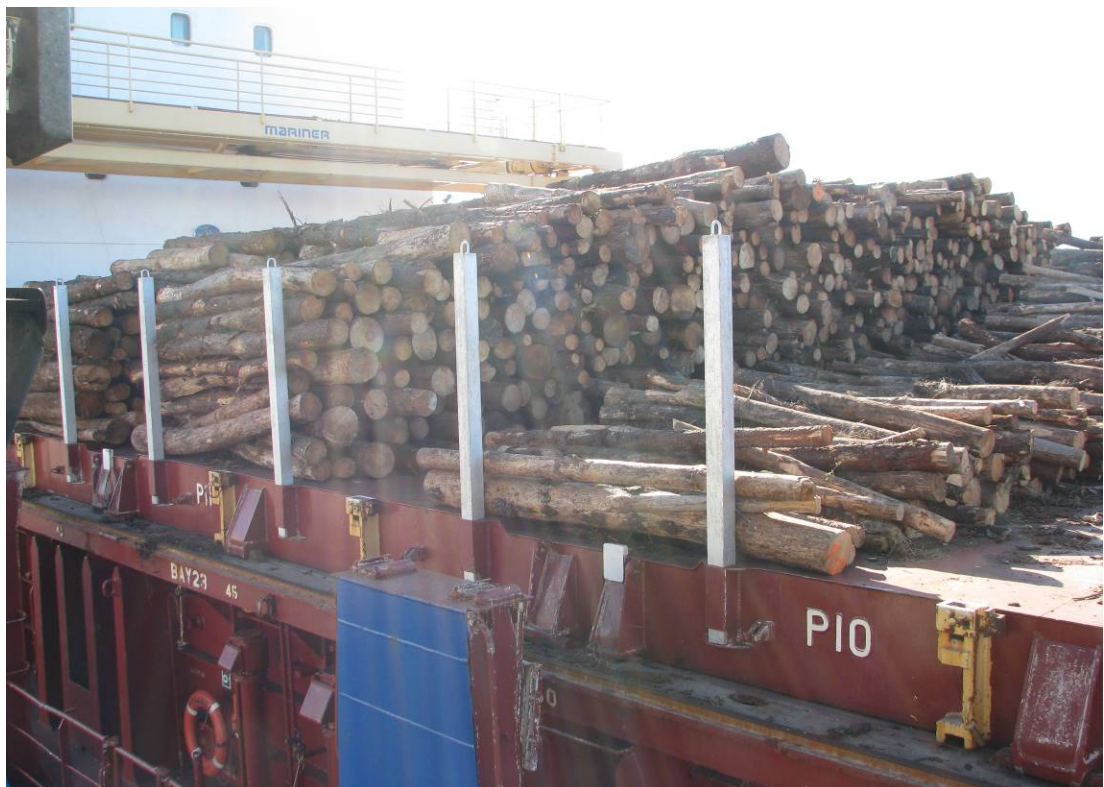
Figure 3. Deck cargo at the aft part of cargo hold 2.

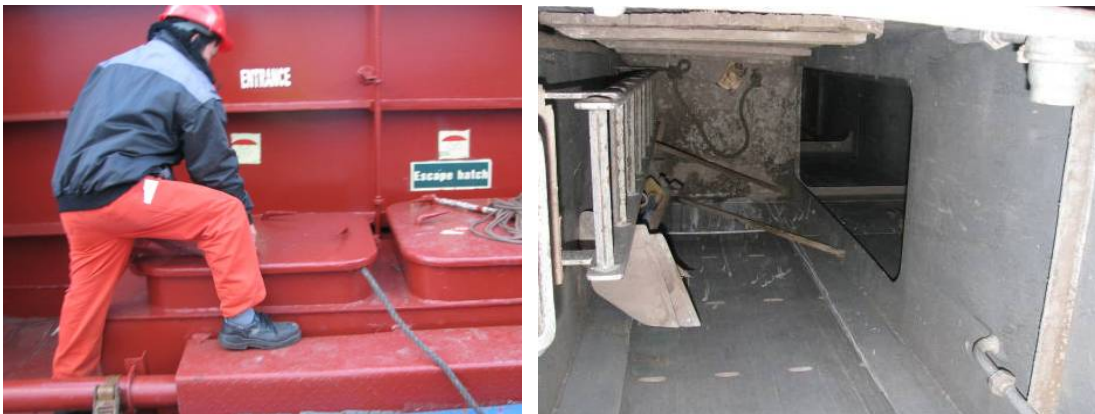
Figure 4. The manhole of the cargo hold to the left. The ladder leading to the hold and the landing, photo taken towards the bow.

There was no kind of warning against the dangers in the cargo hold or a prohibitory sign in the manhole (Figure 4 to the left). The hatch to the right is the emergency exit of the engine room. The landing which can be seen to the right in Figure 4 is the place where the OS died from the lack of oxygen.

In consequence of the accident, the shipping company sent to its vessels a circular letter (N 90) on 5th October 2011 in which it was emphasized that if the vessels carry cargo which causes oxygen depletion, the entries to the cargo hold must be locked and supplied with appropriate warnings.

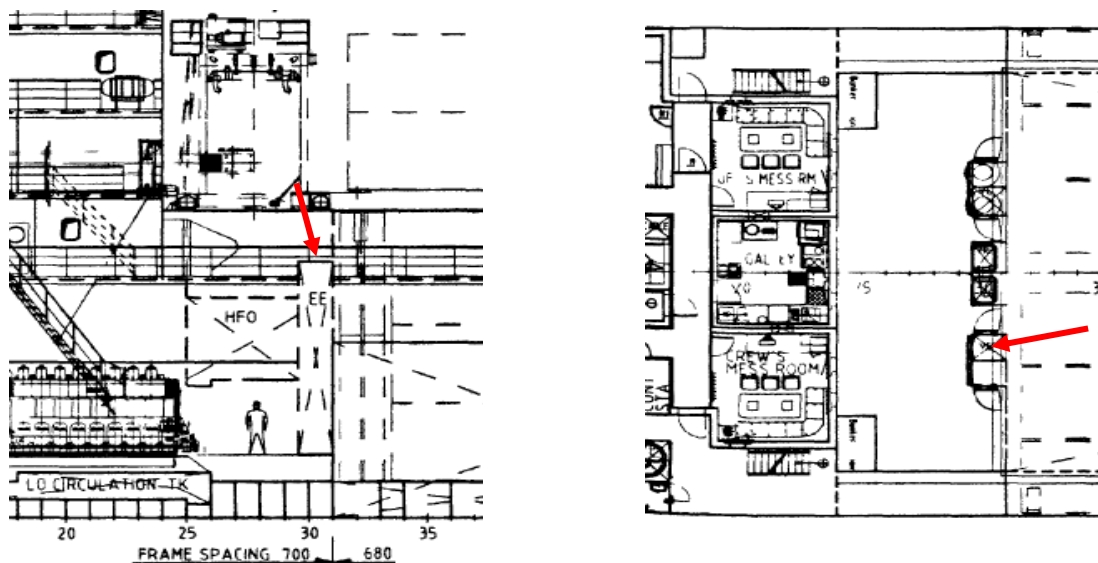
Figure 5. The red arrows point to cargo hold No 2 and indicate the location of the manhole. The arrow to the right points to the emergency exit of the engine room as the drawing is from the starboard side of the vessel. It gives, however, an idea of the depth of the passages in question.

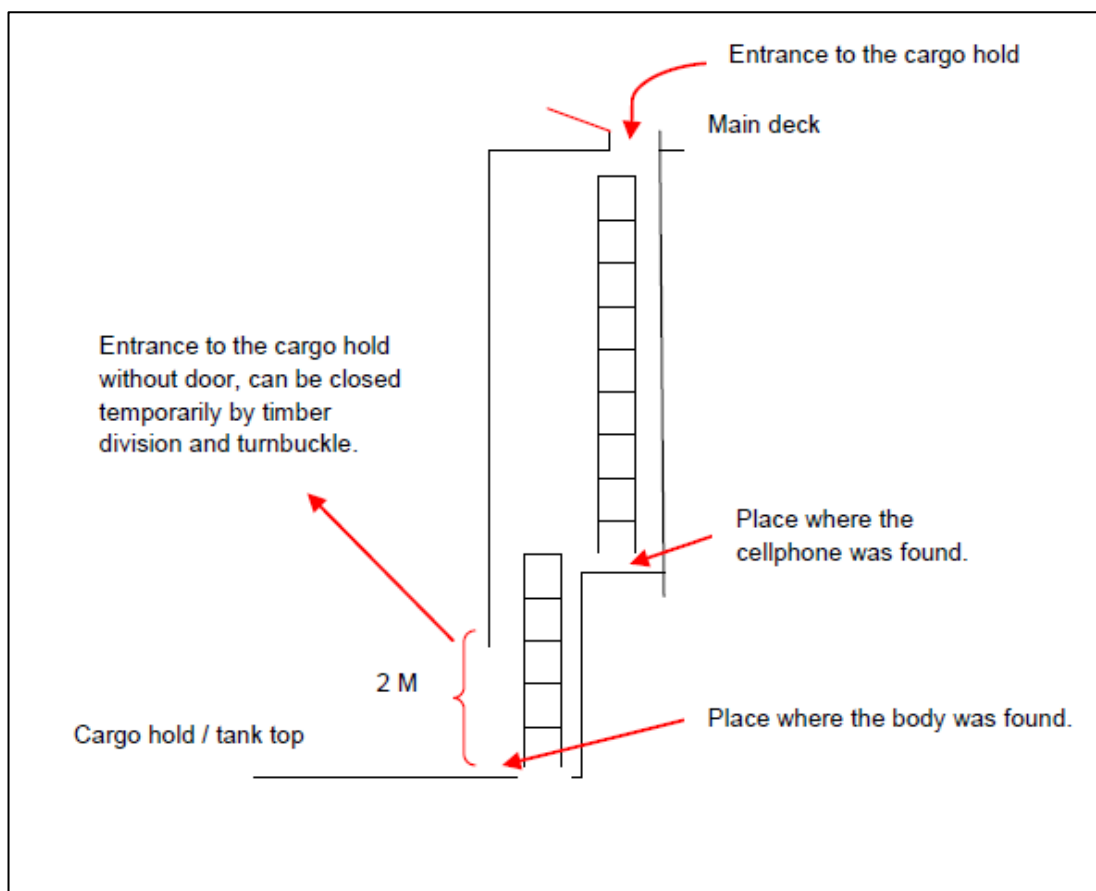
Figure 6. Drawing of the scene of the accident.
