L2021-E1 The return of an airliner to the Helsinki Airport due to a technical reason on 21 February 2021

Report on the preliminary investigation
L2021-E1

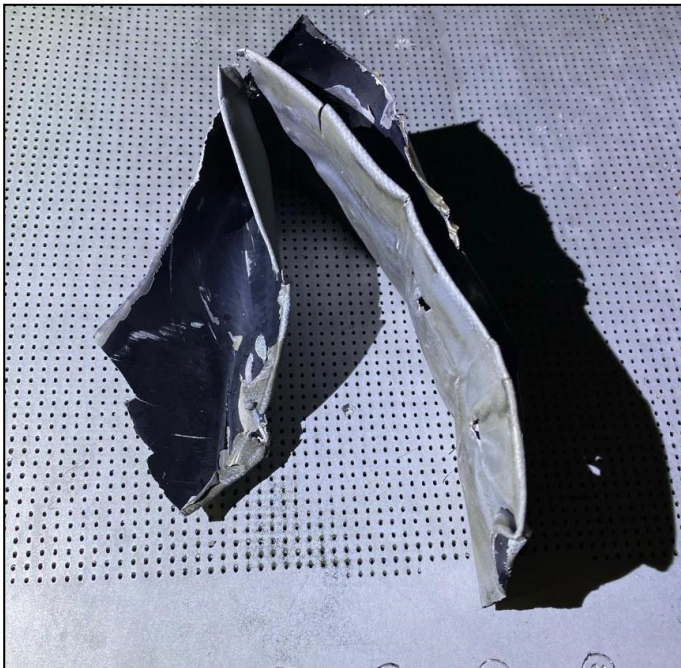
The incident did not cause any personal damage or other rescue activities. In the technical inspection after landing, it was discovered that a piece of the plating had chipped off the engine fan blade (Figure 1), and it was found in the bypass duct, bent and stuck to the fan's first stage stator blade¹. The assessment of the engine's airworthiness, occurrence reports, investigating the cause of the chipping and possible repairs were carried out by the maintenance organisation of Japan Airlines in accordance with the approved methods and standards.

Figure 1. Metal strip fallen off the fan, size: approx. 5 x 20 cm (Photo: SIA).

2. A piece of the plating came loose from the fan blade. This caused an imbalance in the engine, which was detected by the vibration sensors.
