Runway Excursion during Touch-and-go on Instructional Flight at Lahti-Vesivehmaa Aerodrome on February 7, 2021

L2021-01

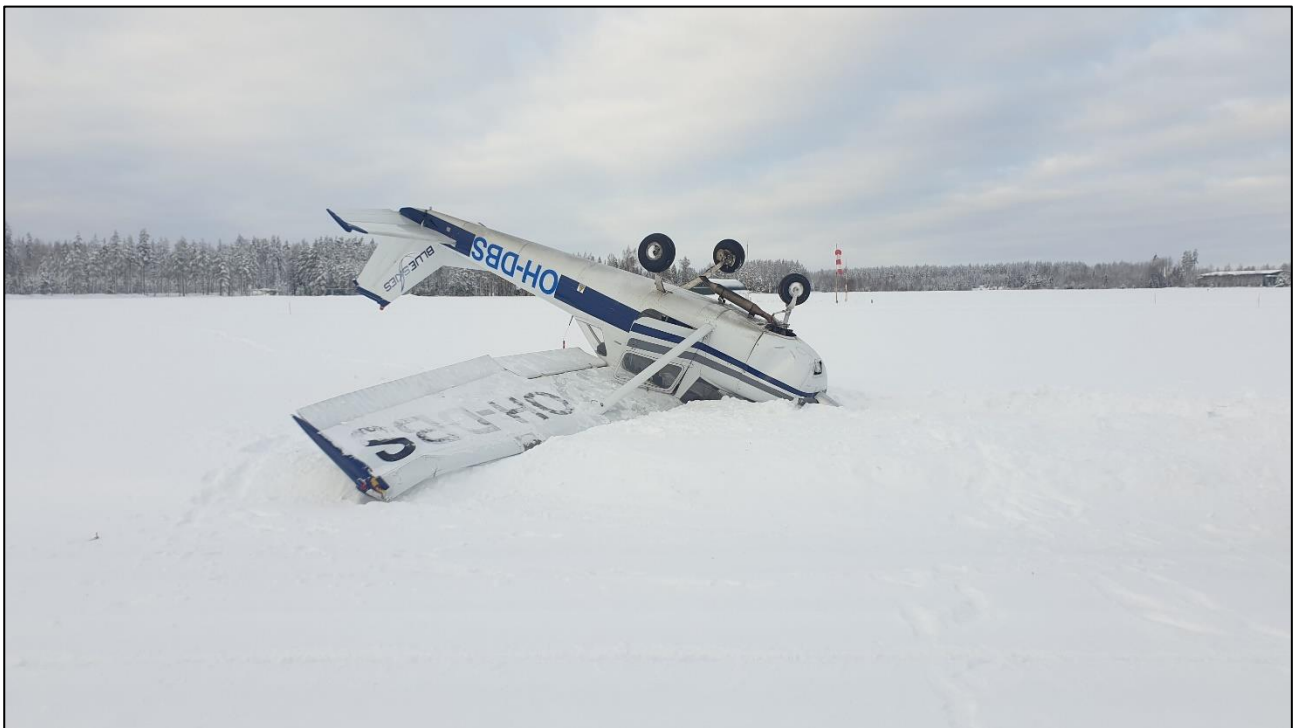
The right mainwheel ran into soft snow; the airplane yawed right, hit the snowbank and exited the runway. It pivoted about the nose and the left wingtip and came to rest in the snow inverted with the nose facing the direction of arrival. The student and the instructor remained suspended from their seat belts. The instructor told the student to switch off electrical power. They unbuckled the seat belts and vacated the cockpit via their respective doors.

Figure 1. The airplane at 1520 h soon after the accident. (Photo: Blue Skies Aviation)

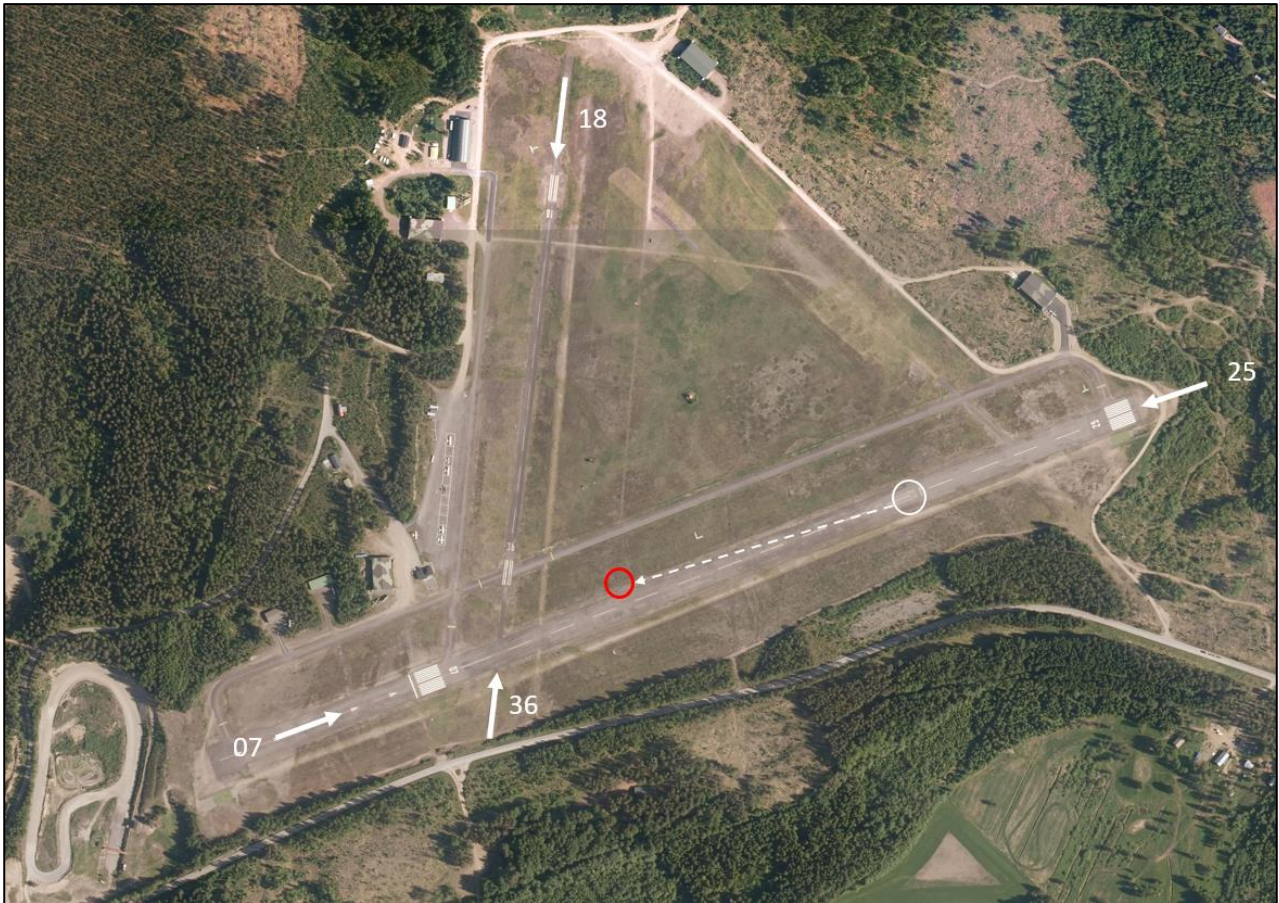
Figure 2. Lahti-Vesivehmaa aerodrome. The white arrows and numbers indicate the runways. The white circle indicates the touchdown point of the accident airplane, and the red circle indicates the point where airplane flipped over. The white dashed line shows the airplane's track. (Photo: Orthoimage ©National Land Survey of Finland. Overlays: SIAF)

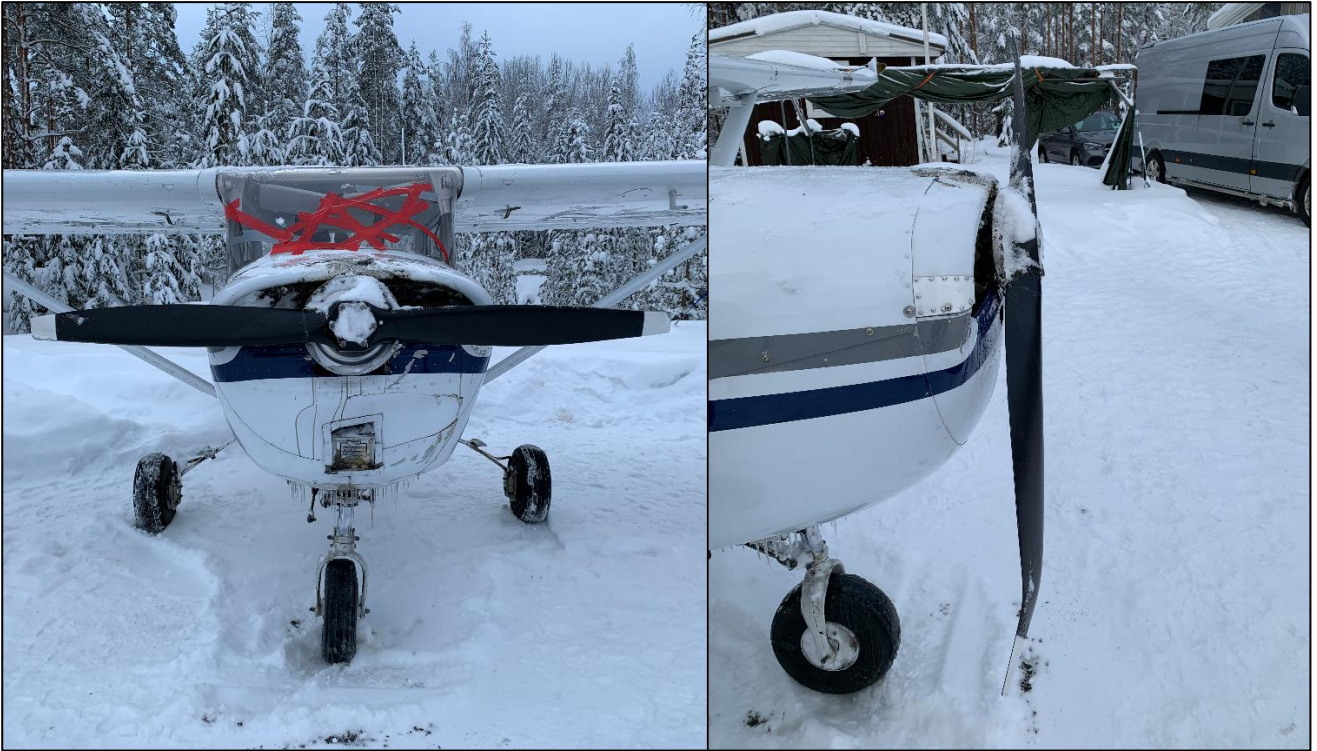
The examination of the airplane showed torn metal in the left wing tip and damage to the vertical stabilizer. The windshield was extensively cracked. The nose landing gear and the engine mount exhibited deformation. Damage to the propeller and the torsional bending of the blade tips were consistent with the engine running at low power on impact. Damage to the airplane is shown in figures 3, 4 and 5.

Figure 3. The windshield was cracked, and the propeller sustained damage. The red tapes were applied to the windshield after the accident. (Photos: SIAF)

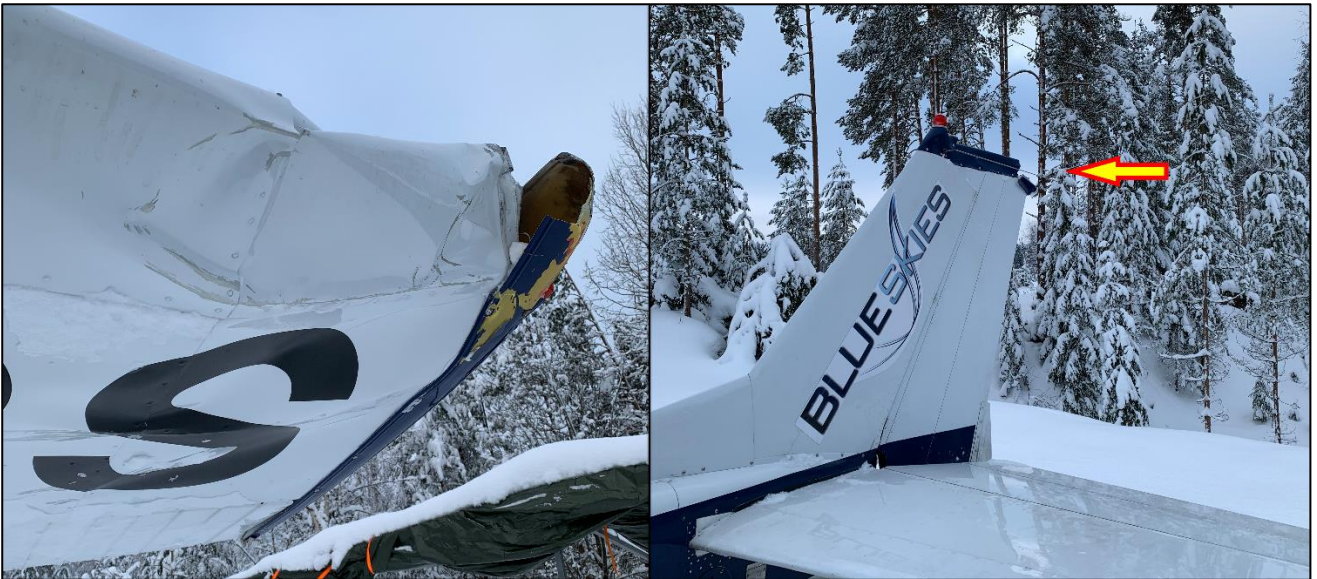
Figure 4. The left wing tip exhibited skin tear and deformation. The tip of the vertical stabilizer was damaged. (Photos: SIAF)

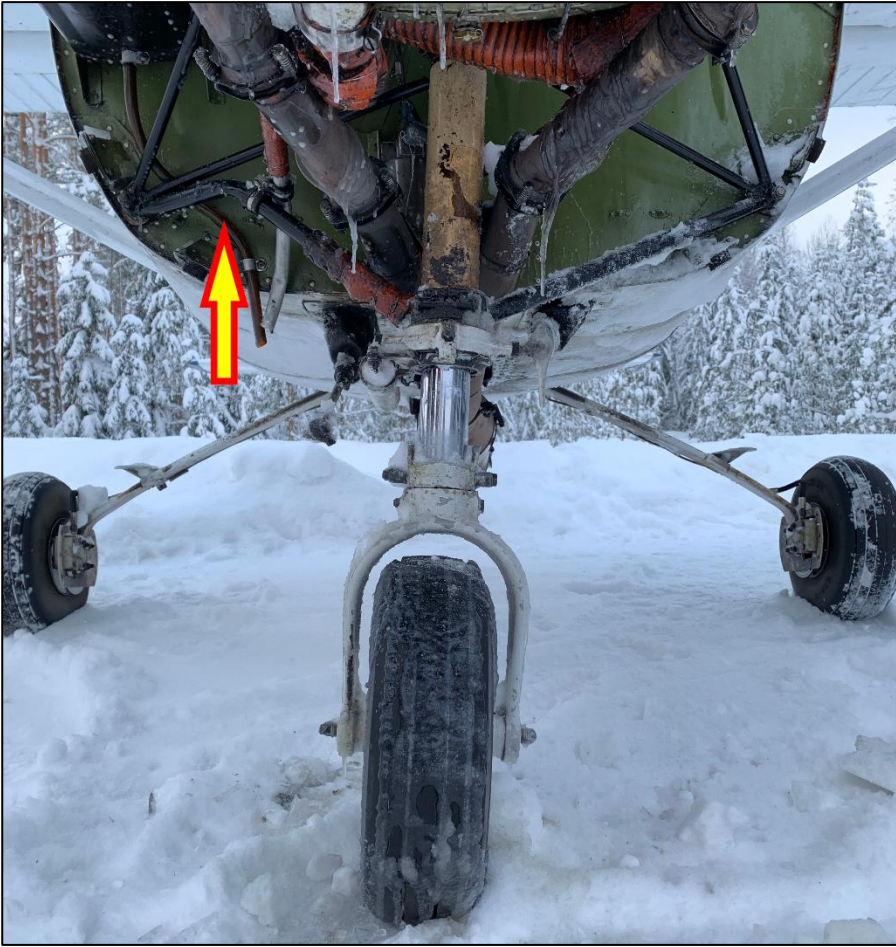
Figure 5. The nose landing gear and the engine mount (arrow) were damaged. (Photo: SIAF)

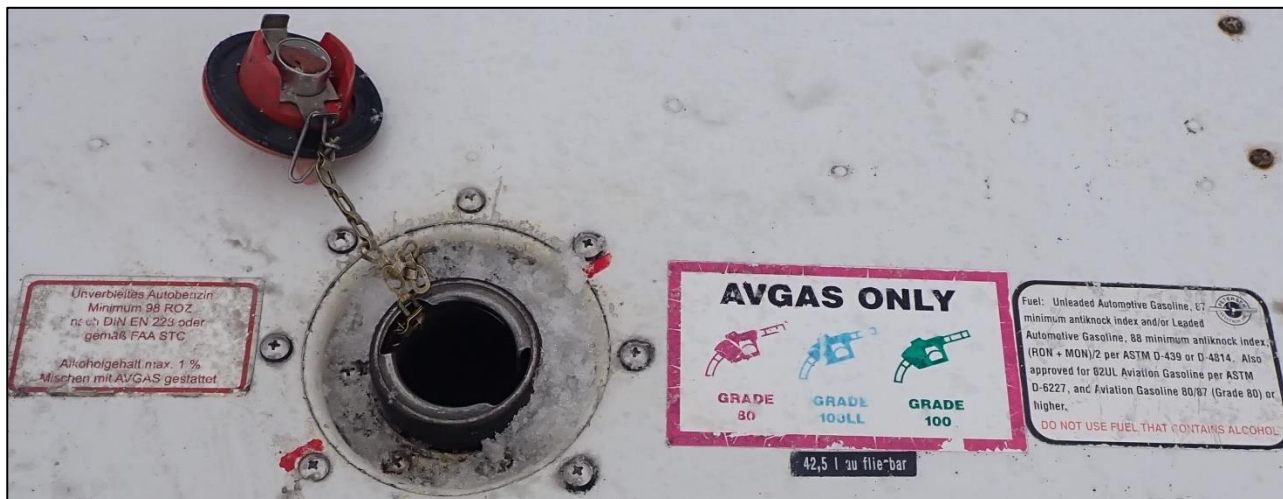
No STC was in effect for the airframe and the replacement engine fitted on July 11, 2019, and none had ever been obtained. However, a metal collar bearing markings associated with an STC²³ was found around the engine oil filler tube, and placards referring to an STC were in place adjacent to the fuel filler ports. It was therefore apparent that parts and markings applicable to the STC issued for the removed engine had not been removed from the aircraft.

Figure 6. Placards on top of a wing adjacent to a fuel filler port. (Photo: SIAF)

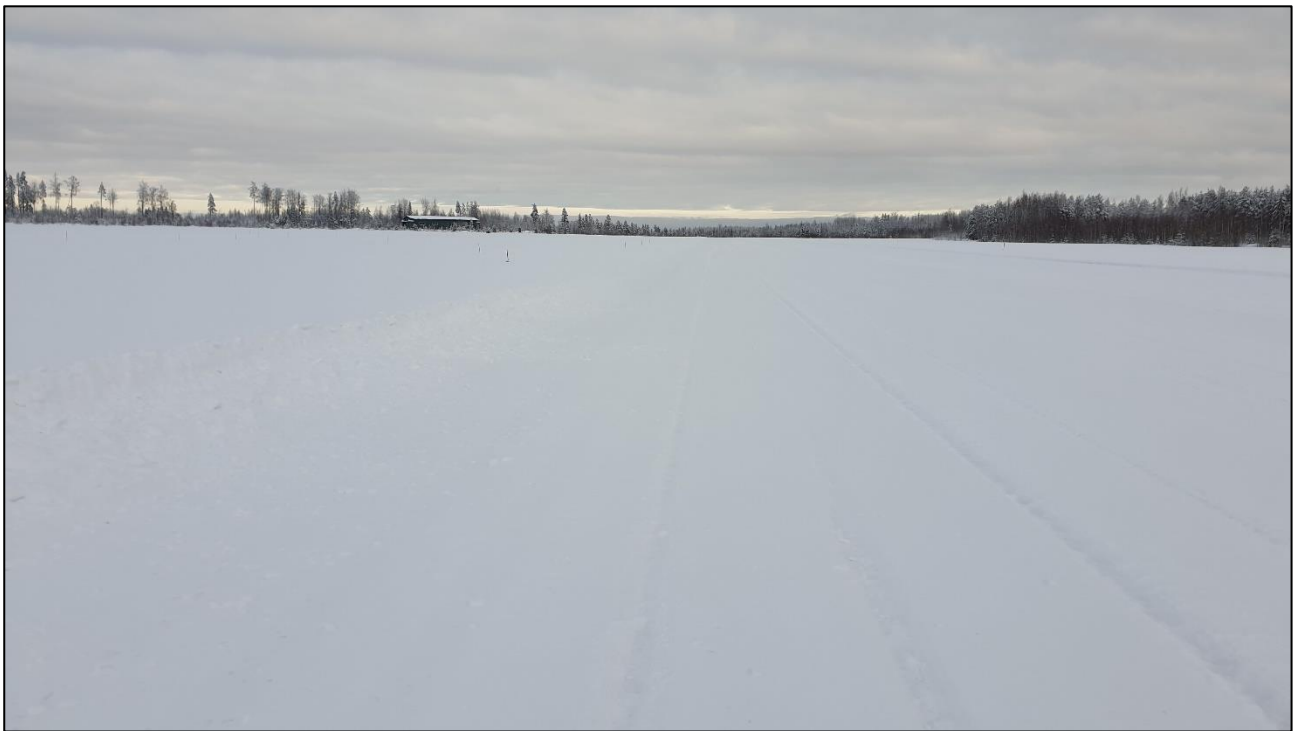
The runway at Lahti-Vesivehmaa is not cleared of snow deposits to expose the pavement, and a few centimeters of dry snow was therefore present on the runway on the day of the accident. Orange-colored snowplow marker stakes indicated the location of the snow-covered runway edge lights, and the approximately 25 m wide cleared area extended to within a few meters of these stakes. Wind and blowing snow constantly reshaped the edges of the cleared area.

Also, cloudy weather and the snowy environment made it hard to distinguish the runway. Sunrise was at 0820 h. Sunset was at 1644 h. Figure 7 shows the conditions prevailing at the time of the accident.

Figure 7. A view along the runway soon after the accident. (Photo: Blue Skies Aviation)

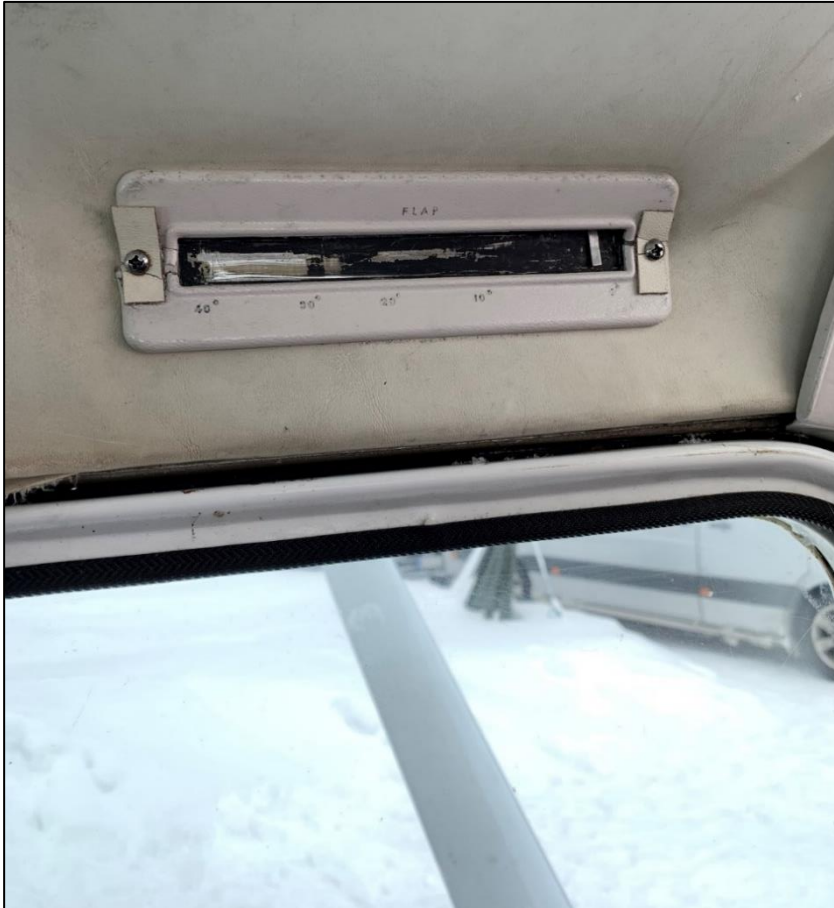
Cockpit Ergonomics The student occupied the left seat. To see the flap position indicator located above the left door (figure 8), the pilot needs to turn his head approximately 90° left from the aircraft's direction of travel and he is therefore unable to simultaneously scan the

environment ahead of the aircraft. He also needs to focus on the flap selector switch. The switch toggle is spring-loaded to center and must be held in the selected position until the flaps reach the desired position. When the switch is released, it returns to center, and flap movement stops. The electrically operated flaps travel from the 40° landing position to the 0° takeoff position in approximately 8 s.

Figure 8. The flap position indicator above the left door. (Photo: SIAF)

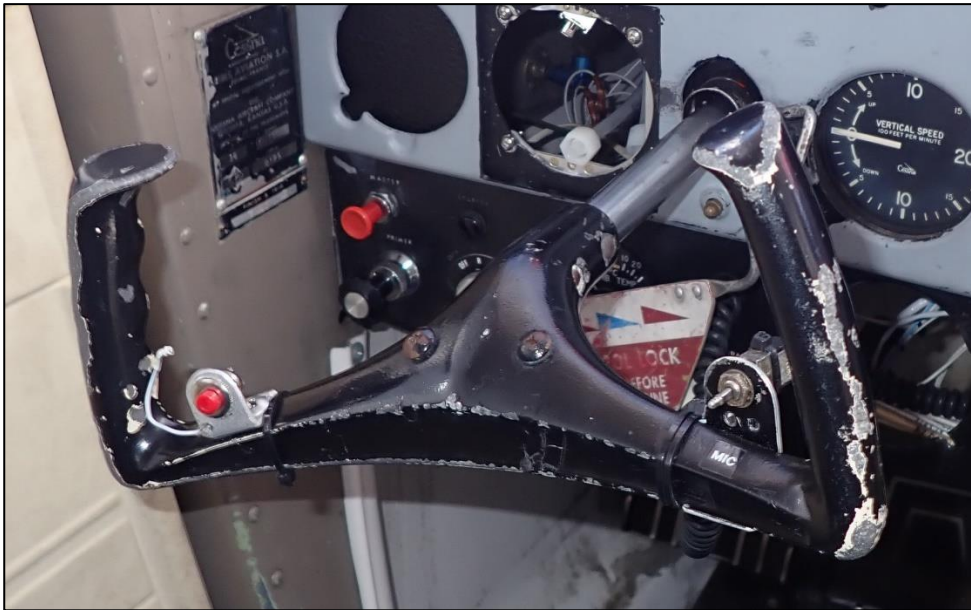
Two push-to-talk²⁸ switches are mounted on the left yoke. The left switch is normally connected to the communication system, but was inoperable in the accident airplane, and therefore the right switch needed to be operated to transmit on the radio (figure 9).

Figure 9. The left yoke. (Photo: SIAF)
