# En-route Engine Malfunction on Airliner on October 15, 2021

Report on Preliminary Investigation L2021-E3

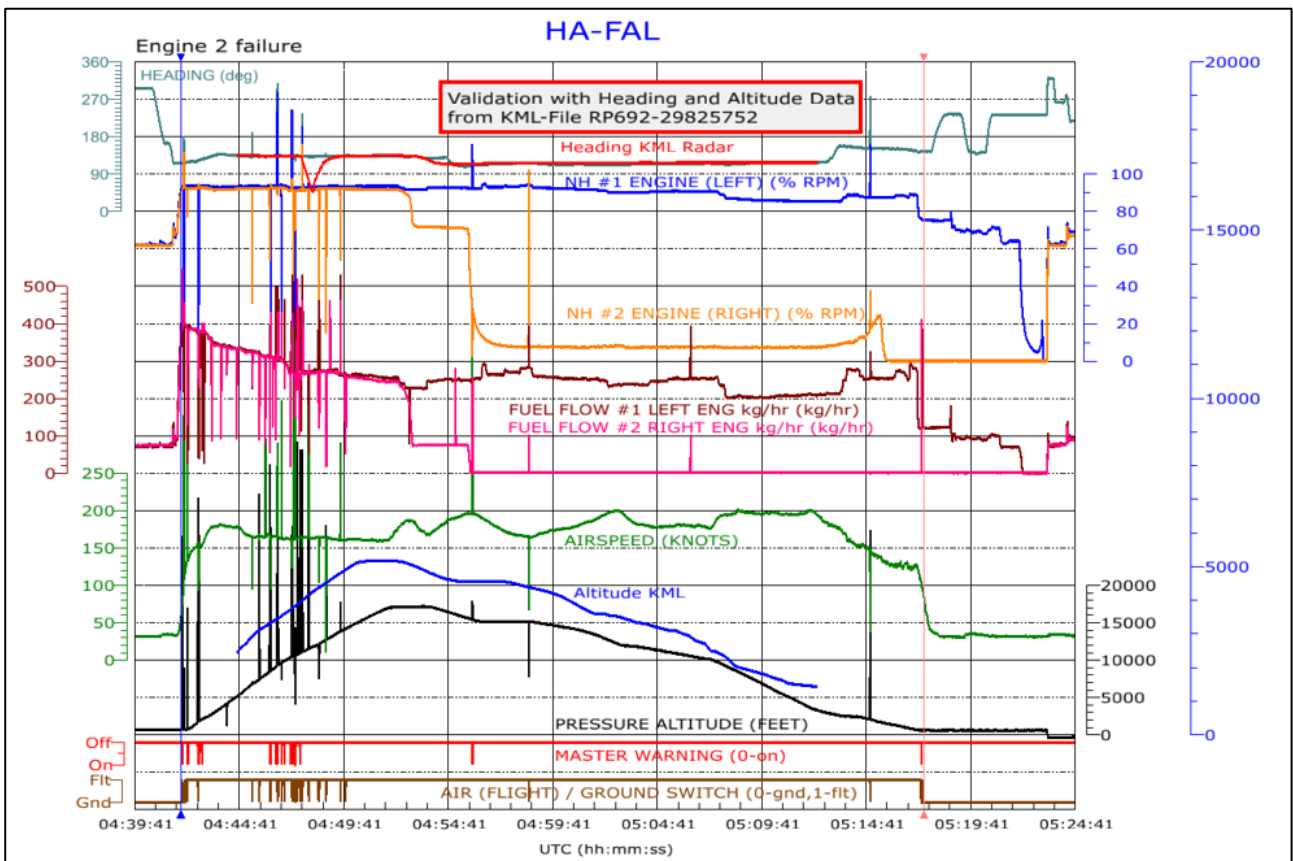
The captain retarded both power levers to reduce engine power and begin descent. While monitoring the engine instruments during power lever movement, the captain noted that right engine torque and fuel flow had dropped below their normal values with the torque indicator reading nearly zero and fuel flow reduced from 230 kg/h to 70 kg/h. The captain advanced both power levers to increase right engine power, but the engine did not respond to power lever movements.

An HMU<sup>6</sup> mounted on each engine establishes the minimum and maximum limits of fuel flow to the engine as a function of P3<sup>7</sup> and the power lever position. The HMU uses P3 as the primary parameter to establish fuel flow limits. Due to a P3 line failure on the incident flight, the HMU scheduled fuel flow to the right engine to the minimum, and as a result engine power decayed close to idle, but no warning indication was received in the cockpit. After the P3 line failure, movements of the right power lever had no effect on fuel flow to, and the power output of, the right engine.

Figure 1. Digital flight data recorder graphs (photo: SIAF)

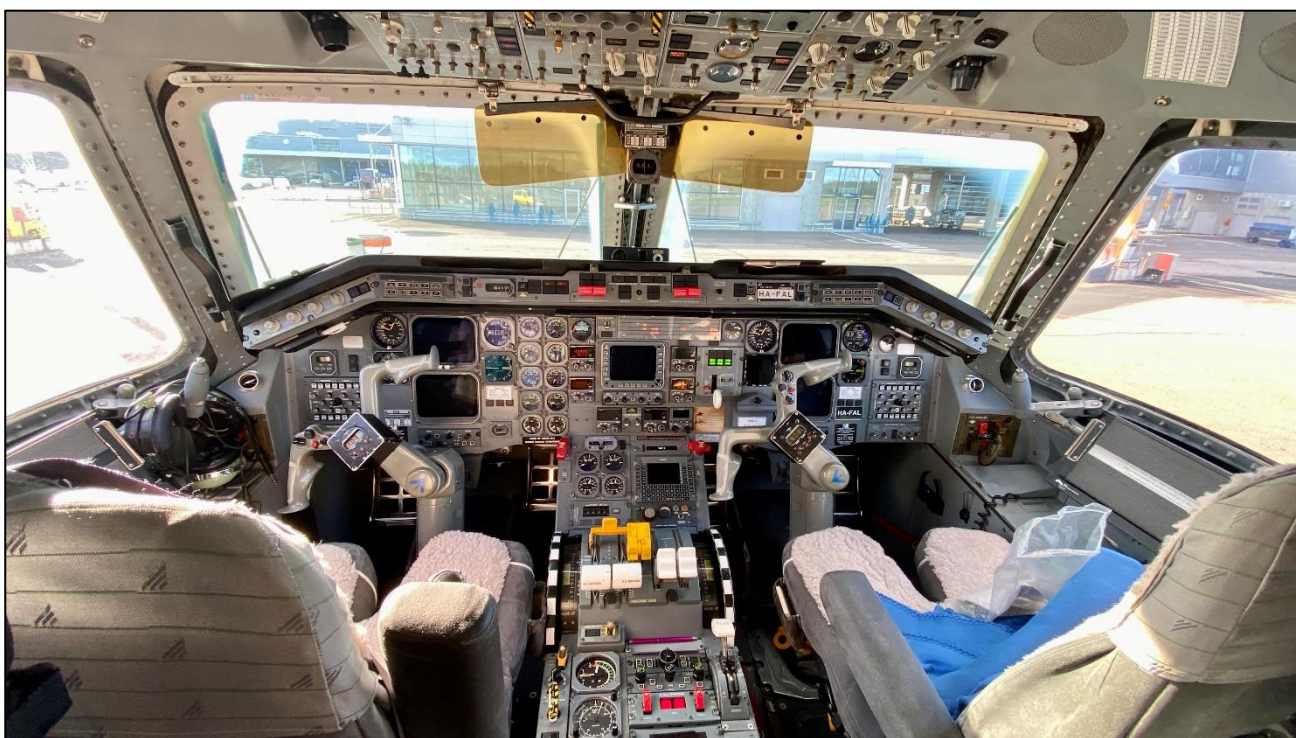
Figure 2. Cockpit of EMB-120ER involved in incident. (Photo: SIAF)
