# Grounding of M/V Timca (NL) off Rauma on 16 February 2021

M2021-01

Investigation ID: M2021-01  
Investigation report 1/2022  
ISBN: 978-951-836-614-3(PDF)

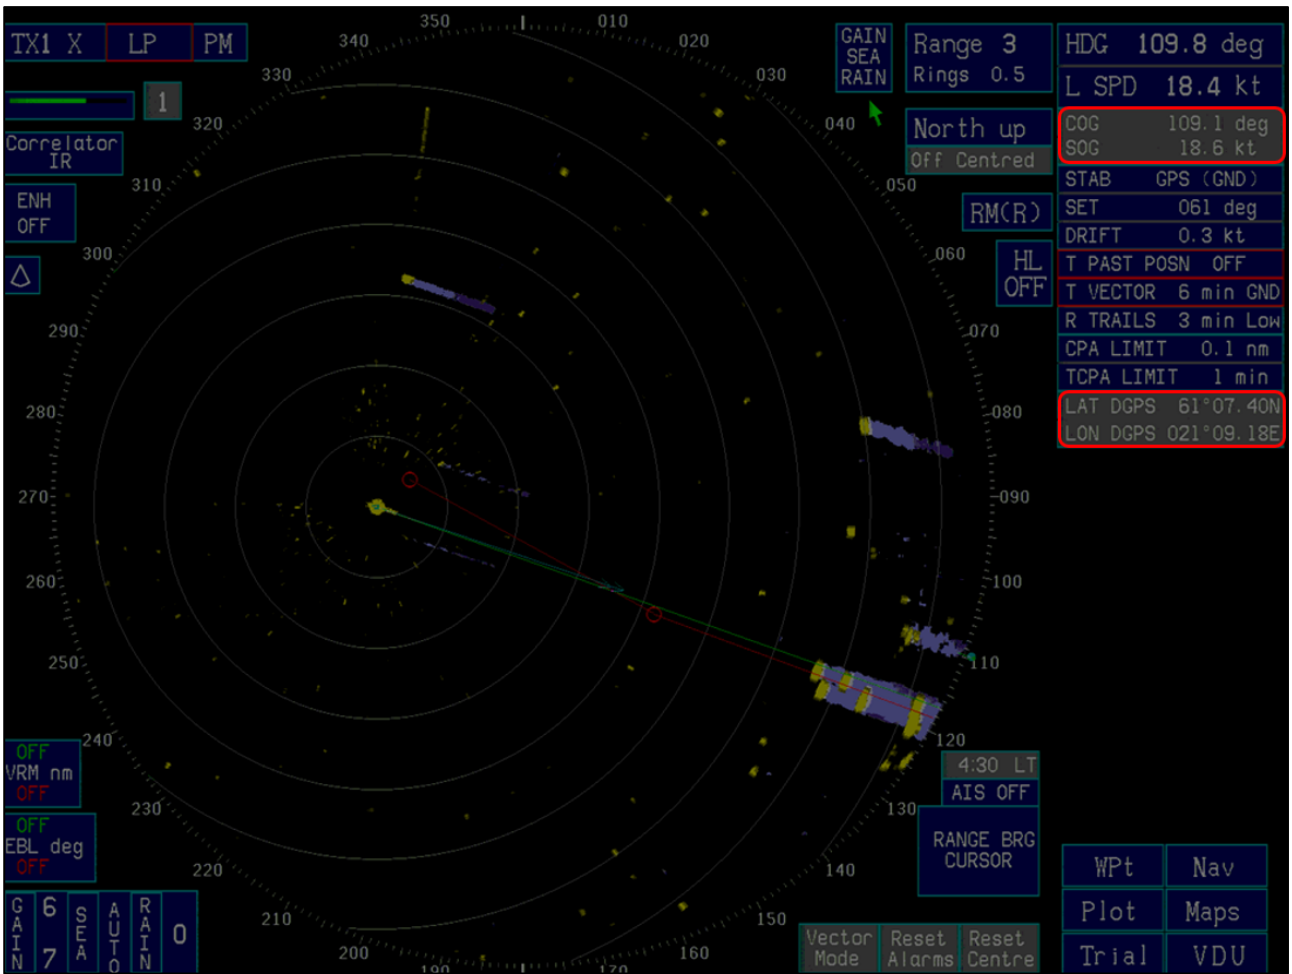
**Picture 1.** Quality of the radar image on the starboard manoeuvring station display when approaching the pilot boarding area at approximately 05:30. A trail caused by the Trail mode function can be seen in the image. No echoes caused by an ice field can be seen in the image. (Source: VDR recording, notes: SIA).

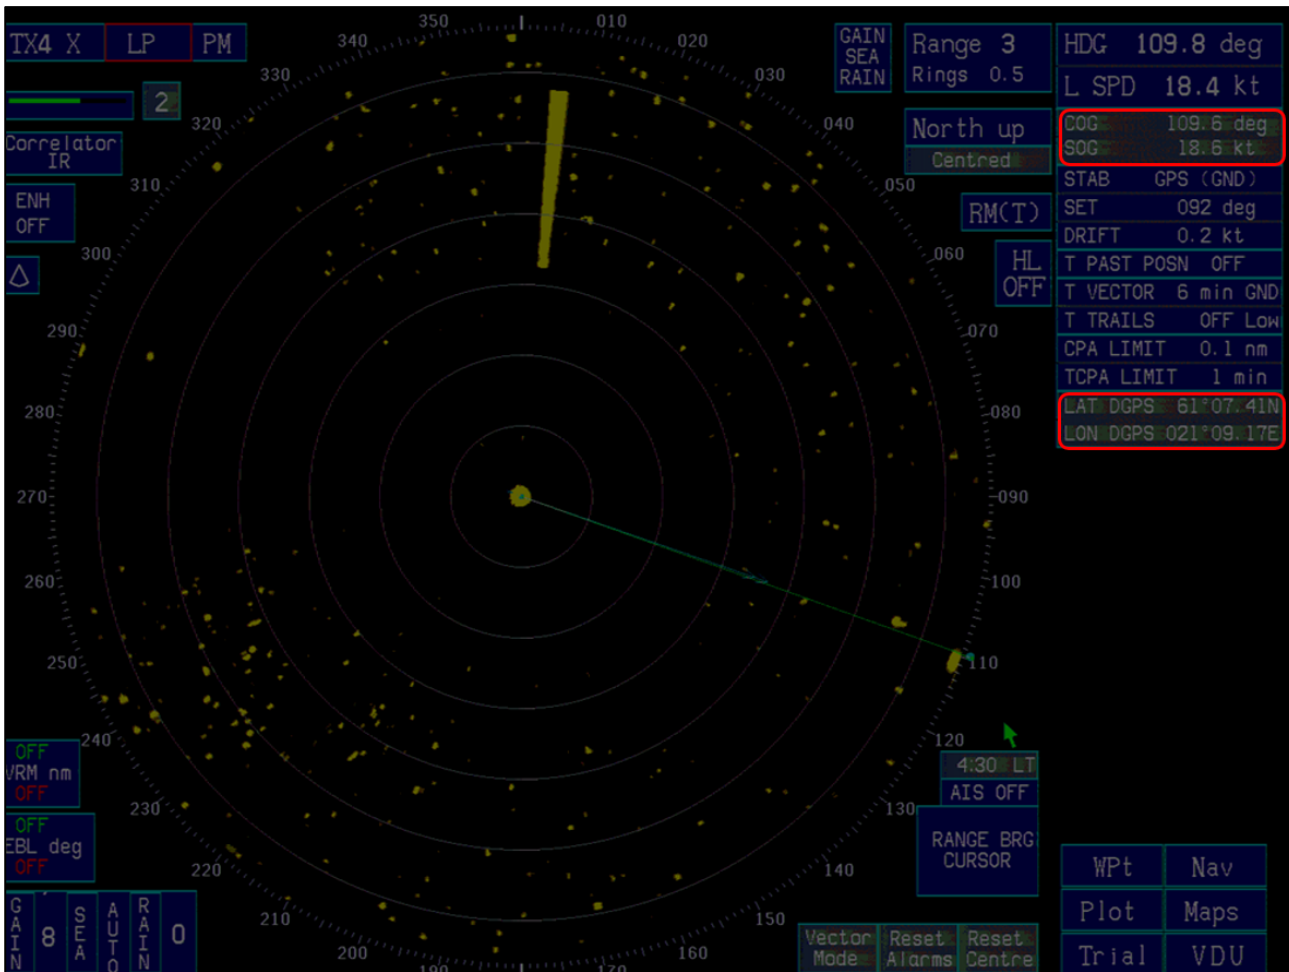
**Picture 2.** Radar image on the port side manoeuvring station display when approaching the pilot boarding area at approximately 05:30. There is no trail caused by the Trail mode function in the image. (Source: VDR recording, notes: SIA).

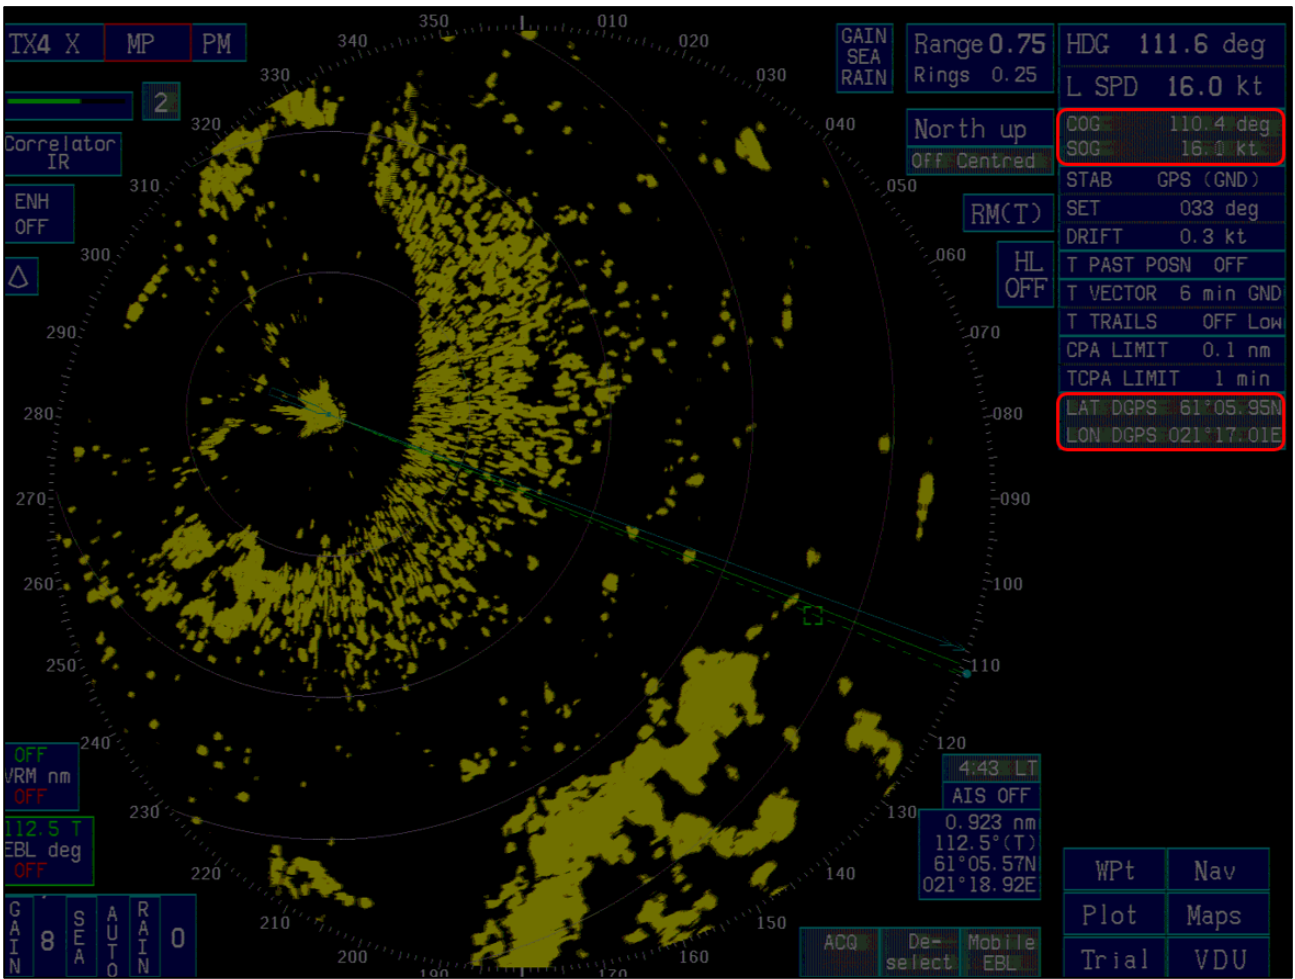
Image 3 below shows the port side manoeuvring station radar display while approaching the edge of the ice north of Rihtniemi.

**Picture 3.** Radar image on the port side manoeuvring station display when arriving at the edge of the ice at 05:43:58. The image shows that the echoes from the surrounding area are extremely strong due to the display settings (gain). (Source: VDR recording, notes: SIA).

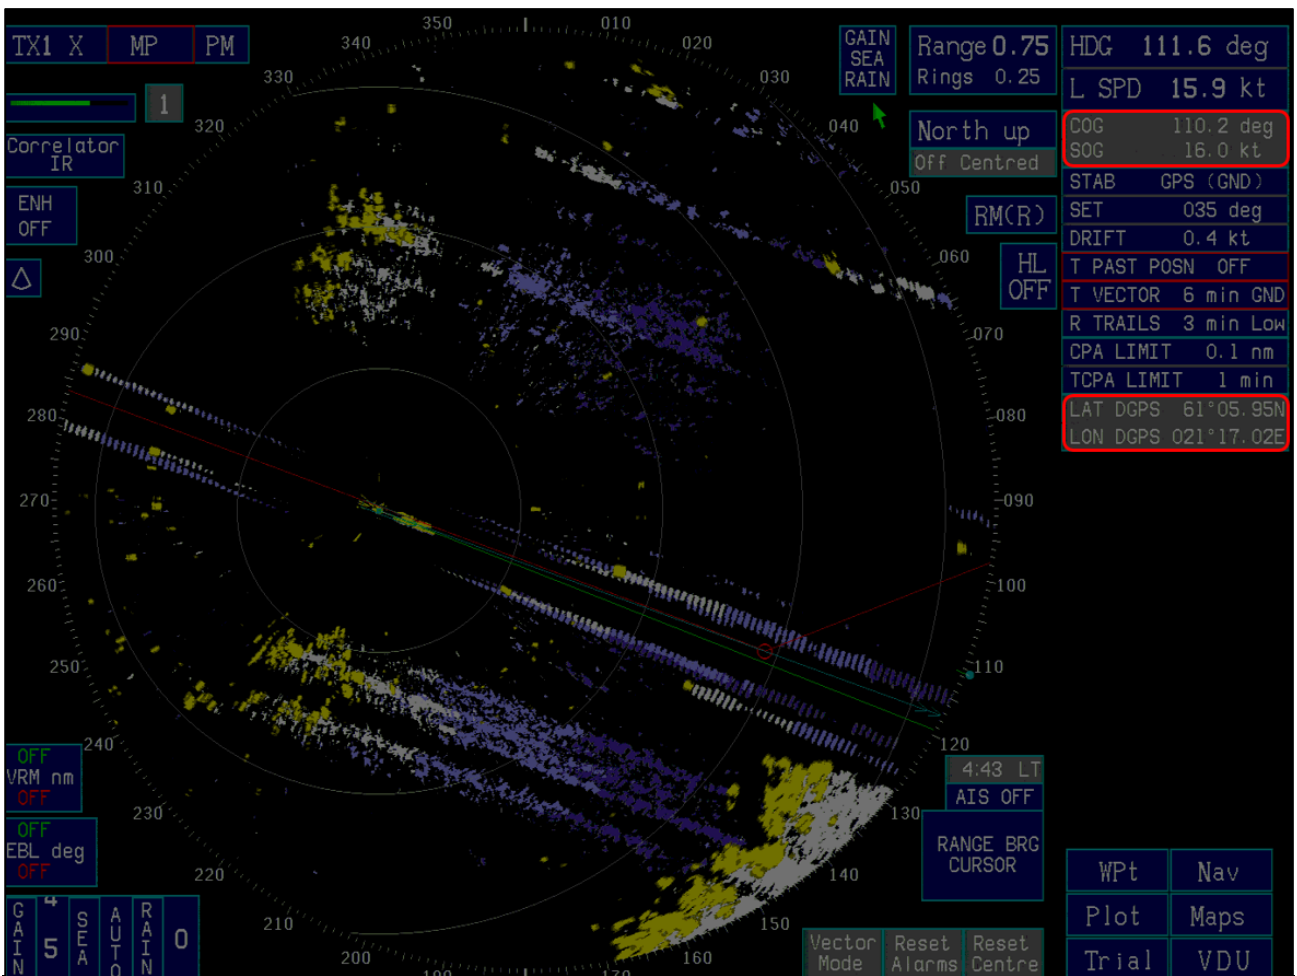
**Picture 4.** Quality of the radar image on the starboard manoeuvring station display, operated by the 2nd officer, when the vessel arrived at the edge of the ice at 05:43:58. The image shows a large amount of trail caused by the Trail mode function on, which was interpreted as a disturbance. (Source: VDR recording, notes: SIA).

According to the master, navigating with the radar became impossible while approaching the edge of the ice, meaning that in practice, it was not possible to use radar to monitor the route and position of the vessel exactly (see Image 4.). Because the visibility was good, the master continued navigating by optical means. Based on the VDR recordings, no significant disturbances caused by the ice field, nor sea state can be detected in the vessel's radar image.

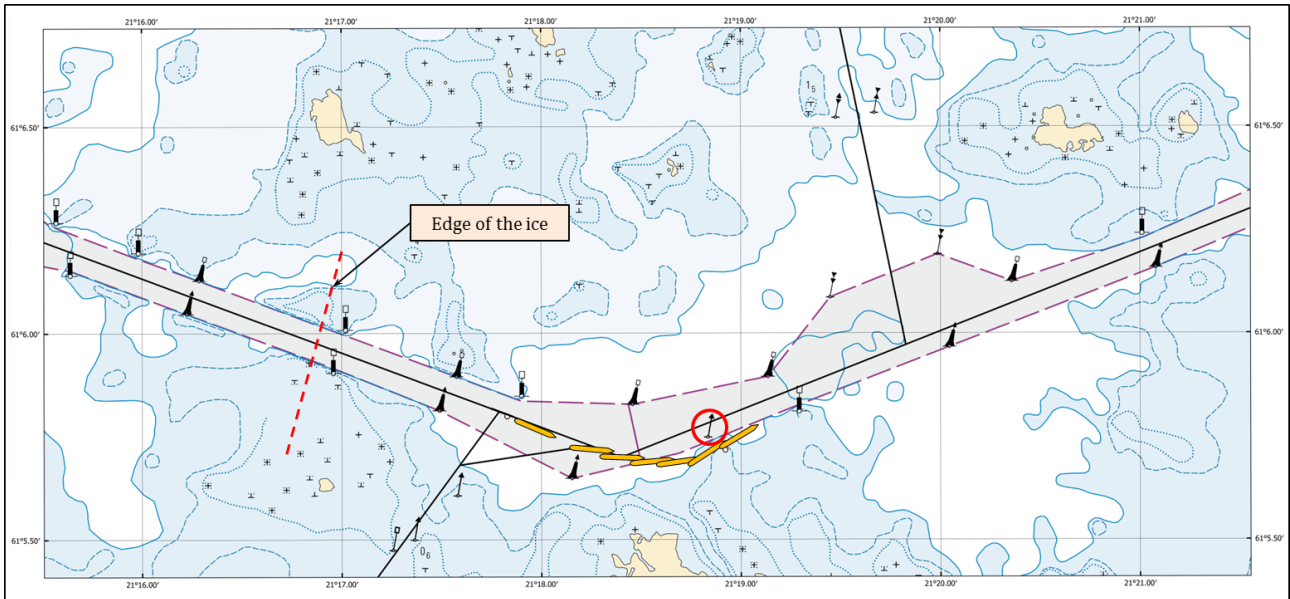
**Picture 5.** Passage of the vessel away from the fairway area towards the shallows shown on the map image, with the edge of the ice field marked with a red dashed line. The temporary "TIMCA" buoy in the red circle was established after the accident. (Map: Traficom, notes: SIA)

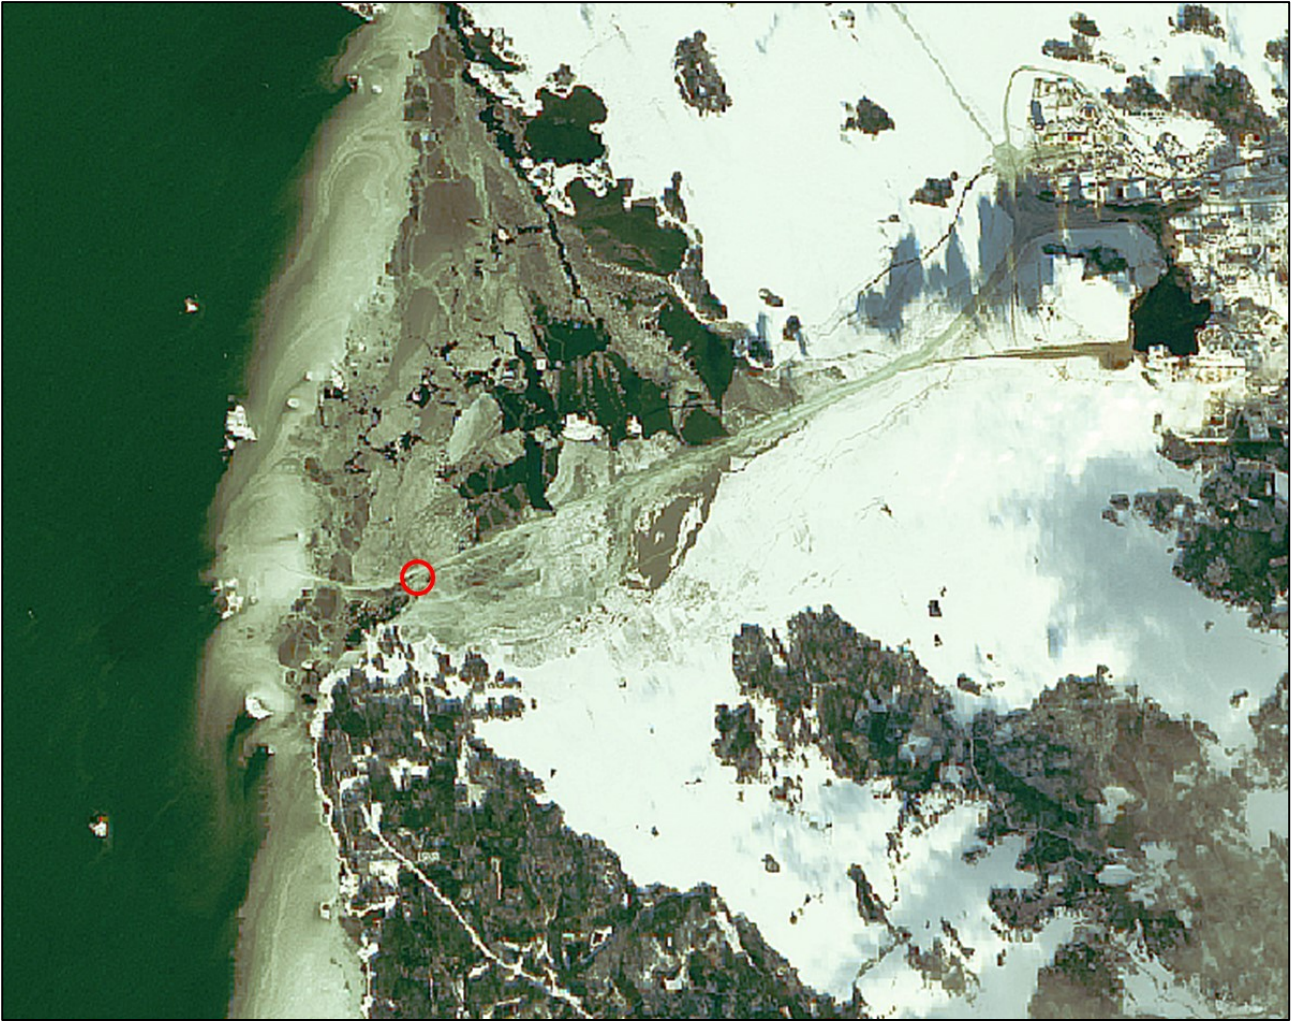
**Picture 13.** Ice situation off Rauma after the accident on 16 February 2021. The area of the accident is marked with a red circle. (Image: TARKKA service by the Finnish Environment Institute (SYKE), notes: SIA)

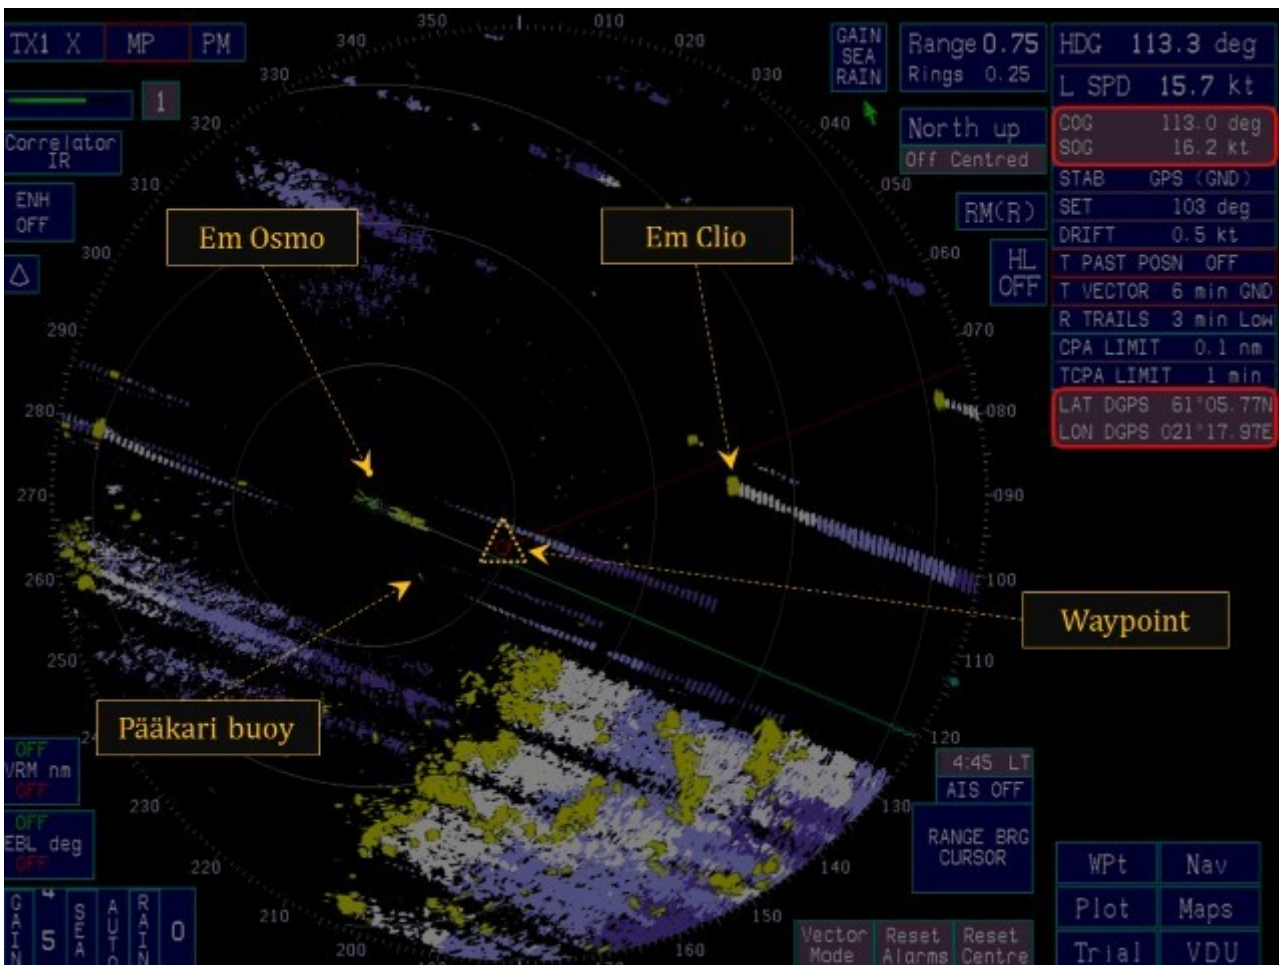
**Picture 14.** Quality of the radar image on the starboard manoeuvring station before the turn towards the direction 069° at 05:45:57. A strong radar echo trail caused by the Trail function can be seen in the image. The Osmo edge mark was in a blind spot on the left side of the vessel, which is continuing in the direction of 113 degrees at the speed of 16.2 knots (approximately 30 km/h). (Source: VDR recording, notes: SIA).

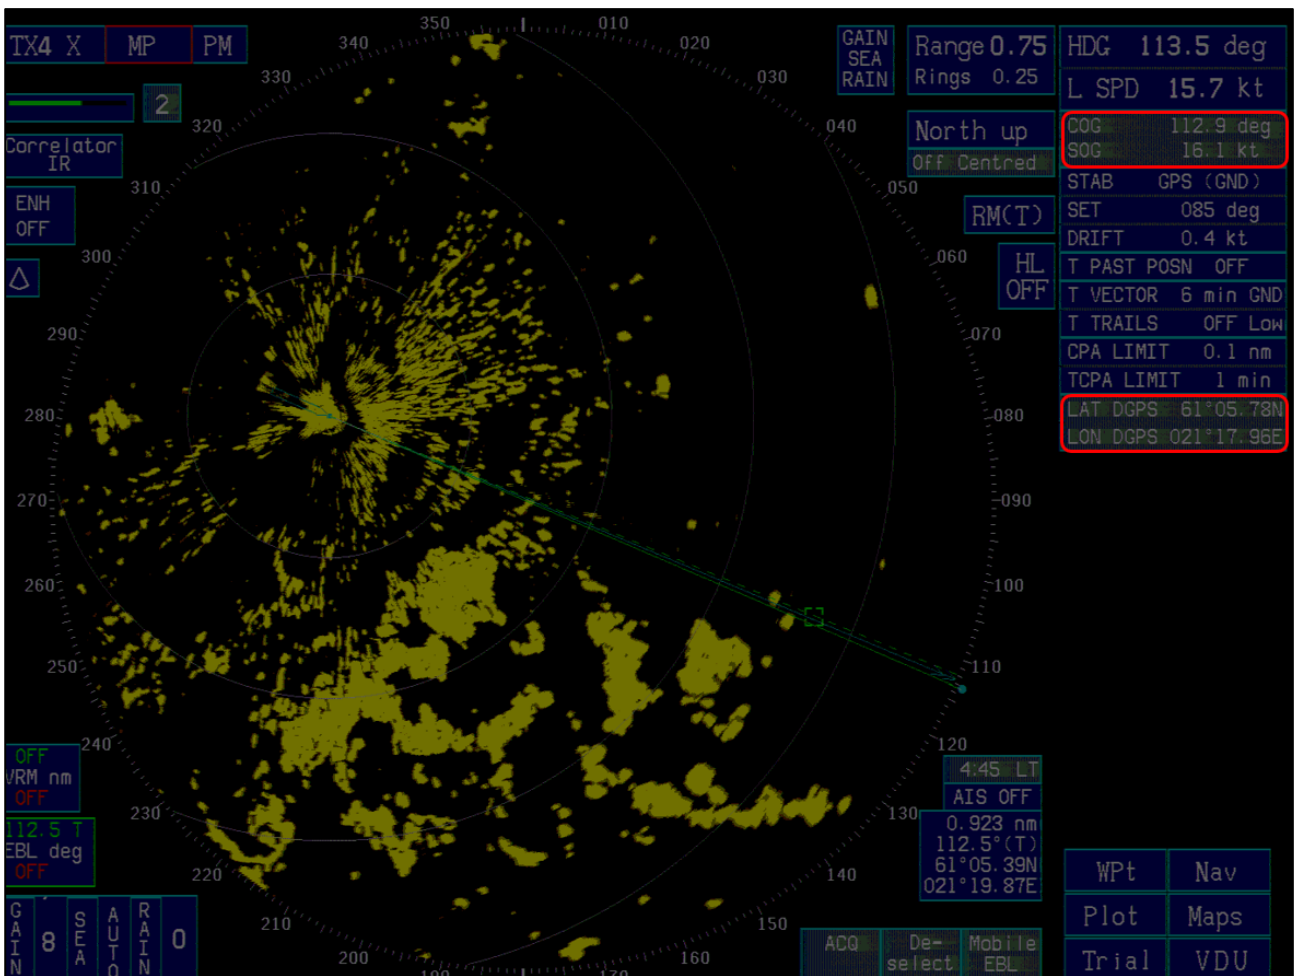
**Picture 15.** Quality of the radar image on the port side manoeuvring station before the turn towards the direction 069° at approximately 05:46:00. The radar image shows strong radar echo gains. (Source: VDR recording, notes: SIA).
