# Amateur-built Aircraft Accident at Hyvinkää Aerodrome on September 27, 2021

L2021-03

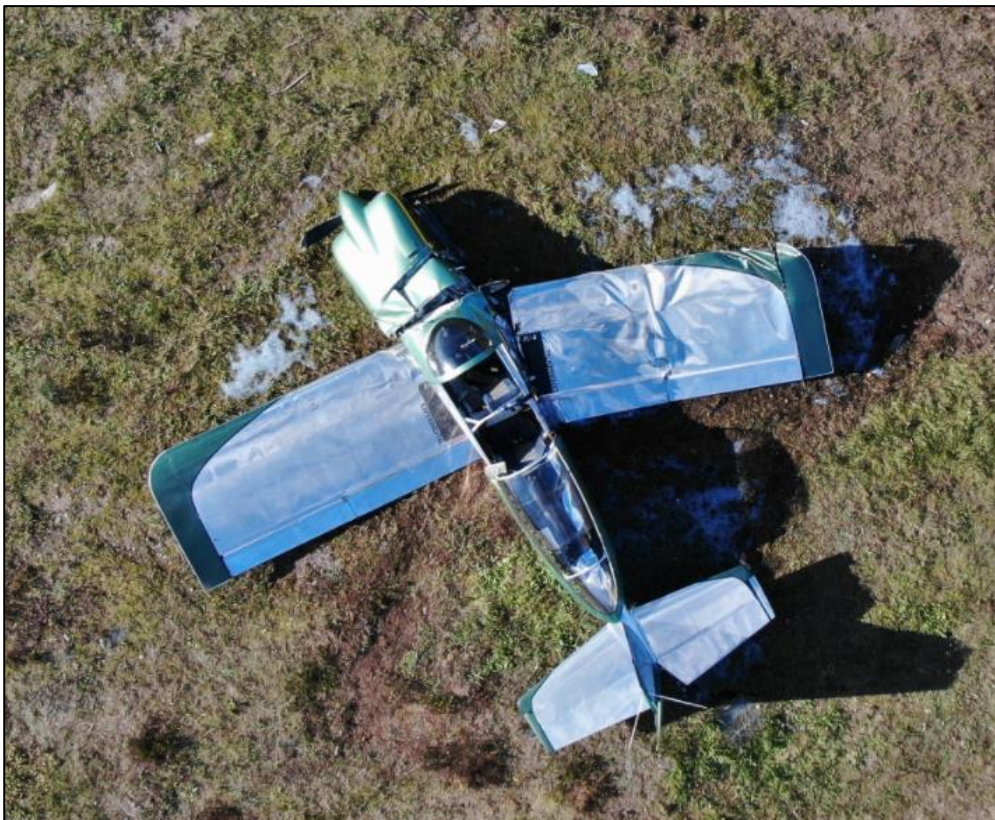
The wings remained attached to the fuselage. The right wing had canted aft by approximately 20° at the wing-to-fuselage joint creating an approximately 15 cm long gap at the leading edge, and bent up by approximately 15° at mid-span. The leading edge had minor abrasions forward of the main spar, and a palm-sized hole was evident at a distance of 30 cm from the fuselage. The left wing leading edge showed abrasions, and dents were noted in the lower surface, but the wing structure was intact. Damage to the wings is shown in figure 4.

**Figure 4.** The airplane after the ground impact. The right wing is canted aft, and its leading edge has separated from the fuselage. (Photo: Police)

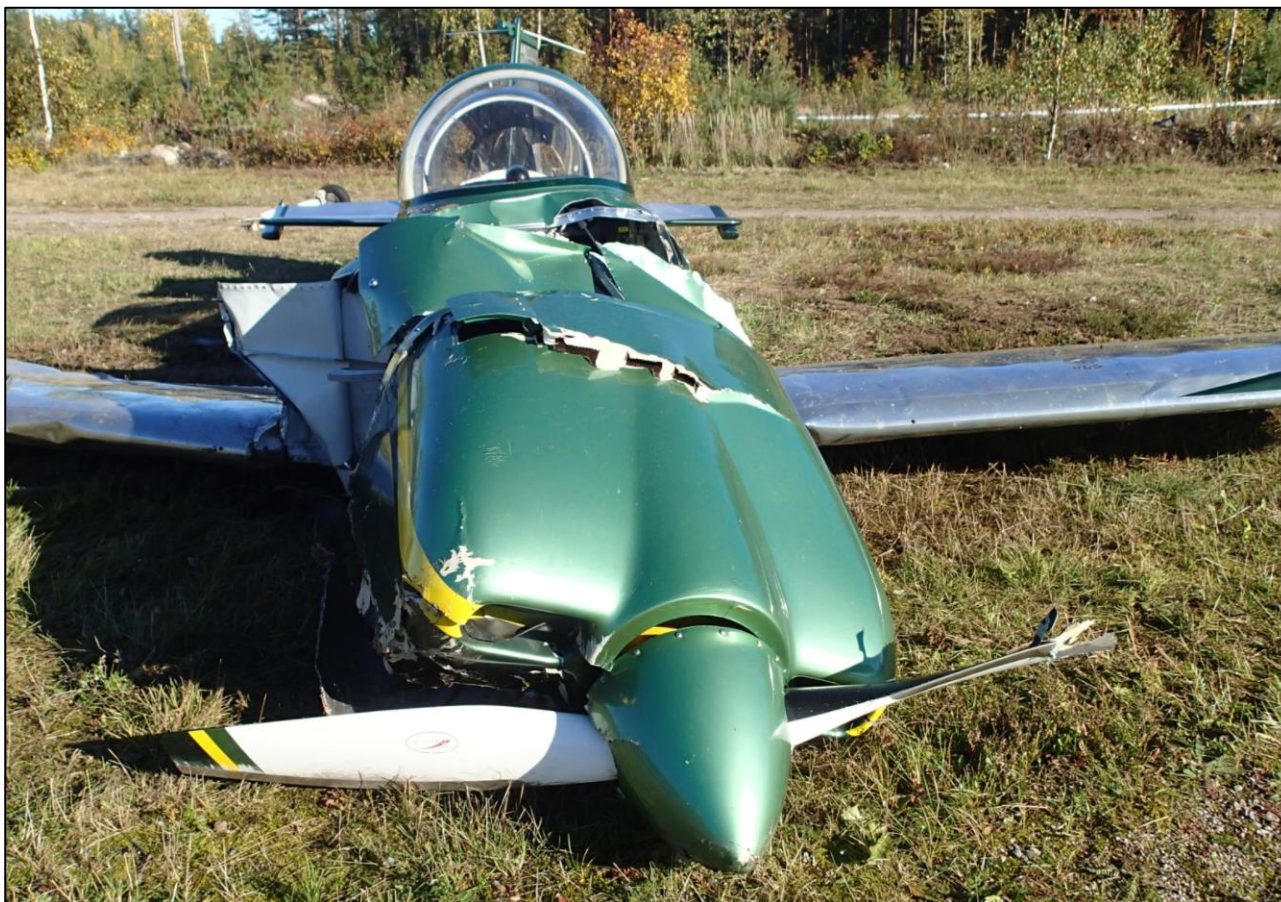
The fuselage exhibited compression damage. The nose section had partially separated forward of the cockpit and twisted about the airplane's longitudinal axis. A deep depression with no signs of impact damage was noted on the right-hand side in line with the mid-point of the airplane's registration. The right-hand landing gear was torn off the mounting bracket.

The left-hand landing gear remained attached to the mounting bracket but had folded beneath the fuselage. The tailwheel mount was bent to the right when viewed from the direction of travel. Damage to the fuselage is shown in figure 5.

**Figure 5.** Fuselage damage and the partial separation and twisting of the nose section are apparent. (Photo: SIAF)

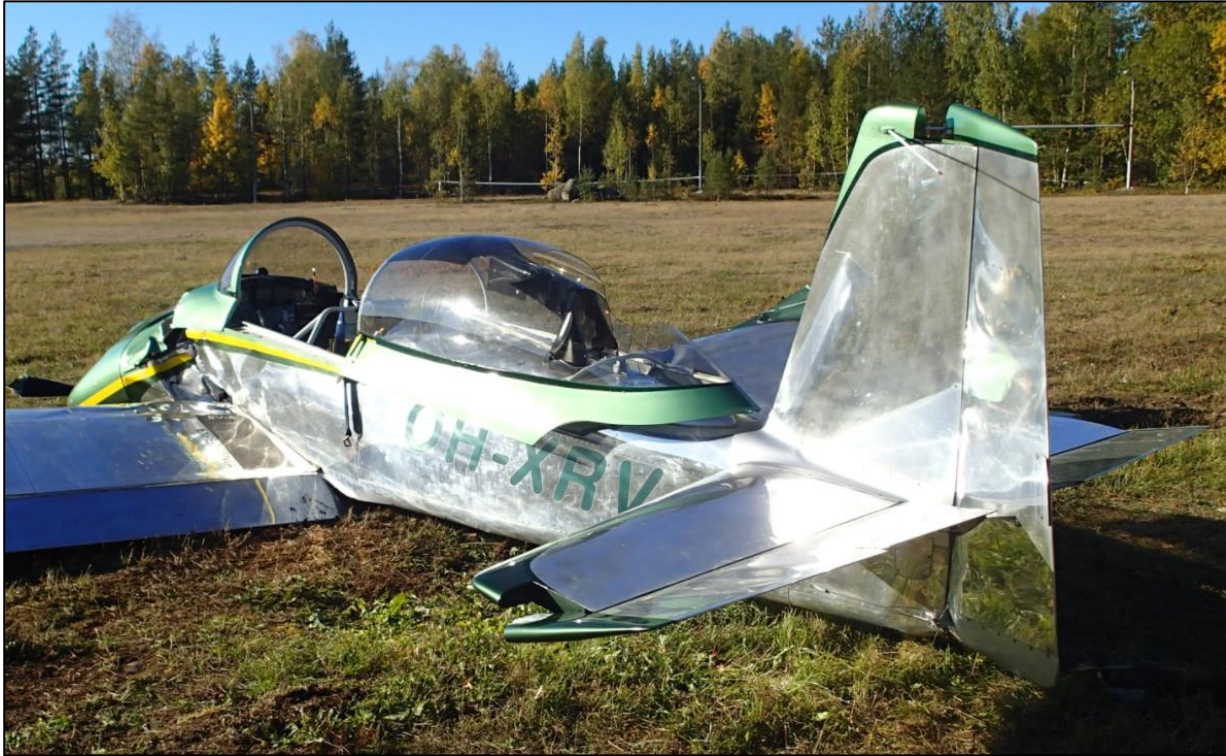
The windshield and the canopy remained attached. Higher-than-normal force was needed to move the canopy due to the distortion of the side rails. An approximately 40 x 40 cm hole was found in the rear of the canopy behind the seatback. Figure 6 shows damage to the canopy.

**Figure 6.** The side rails were distorted. An approximately 40 cm diameter hole is evident in the rear of the canopy. (Photo: SIAF)

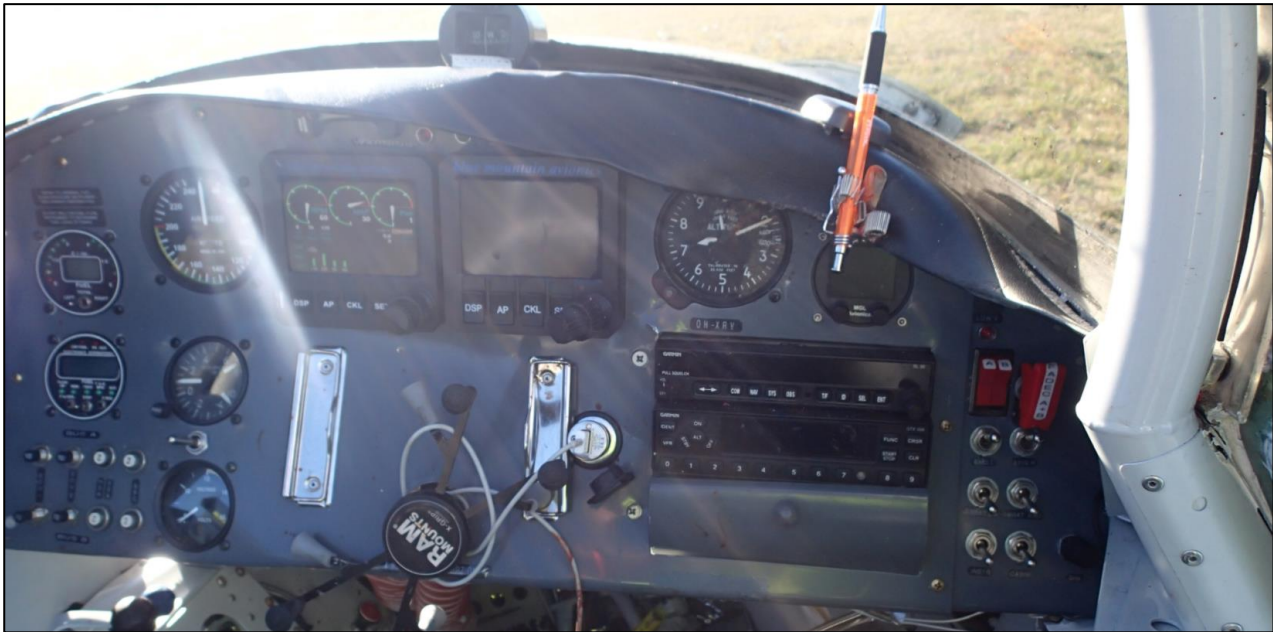
The instrument panel was bent but otherwise undamaged. The right-hand side of the glareshield exhibited deformation. The forward portion of the cockpit section was displaced to the left when viewed to the direction of travel. The footwell structure of the forward cockpit had partially disintegrated with tear-type damage apparent on the right-hand side, while the left-hand sidewall had been forced inward. Downward bending was noted near the right-hand seat attachments. The seatback was canted to the right at its upper attachments, but the seat belts remained attached to the fuselage and were undamaged. The rudder pedals remained attached to the shaft, and the control cables remained connected to the pedals. The control stick remained attached, and functional connection between the stick and the ailerons was established. Damage to the instrument panel is shown in figure 7.

**Figure 7.** The instrument panel was bent at mid-point. Deformation of the glareshield is also shown. (Photo: SIAF)

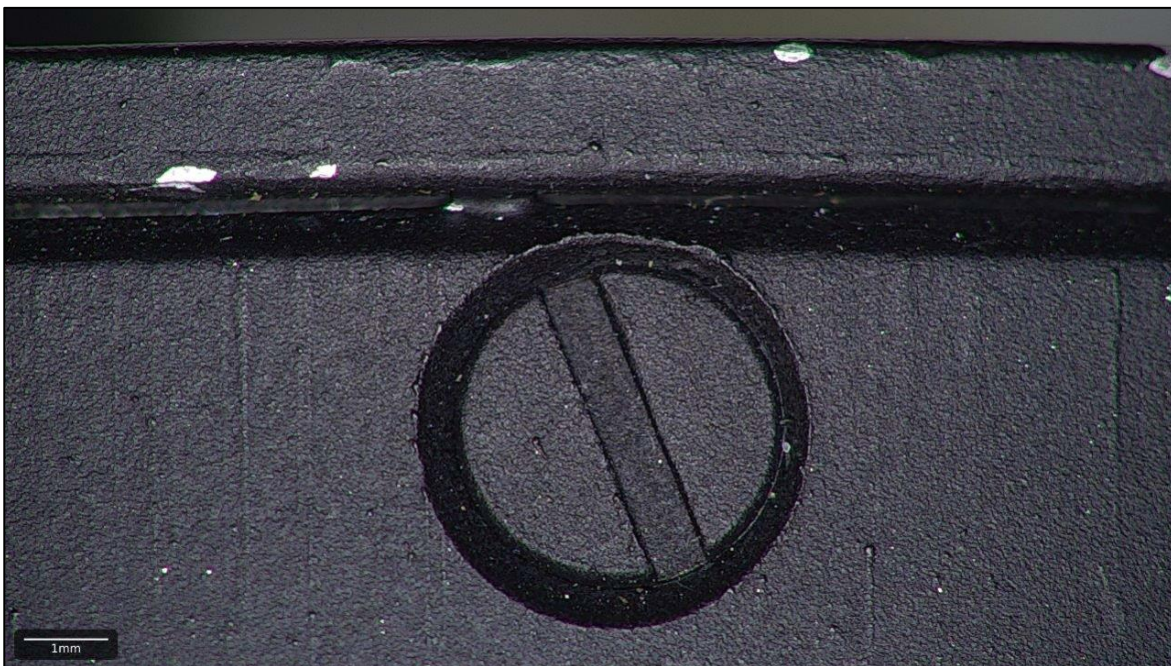
A visual external inspection showed no signs of removal of the case attachment screws. It is probable that the case had not been removed before, or the case and the screws had been repainted after removal and subsequent reinstallation. The instrument exhibited no significant external damage sustained before or during the accident.

**Figure 13.** An airspeed indicator case attachment screw and surface finish. (Photo: Insta ILS, usage rights: SIAF)

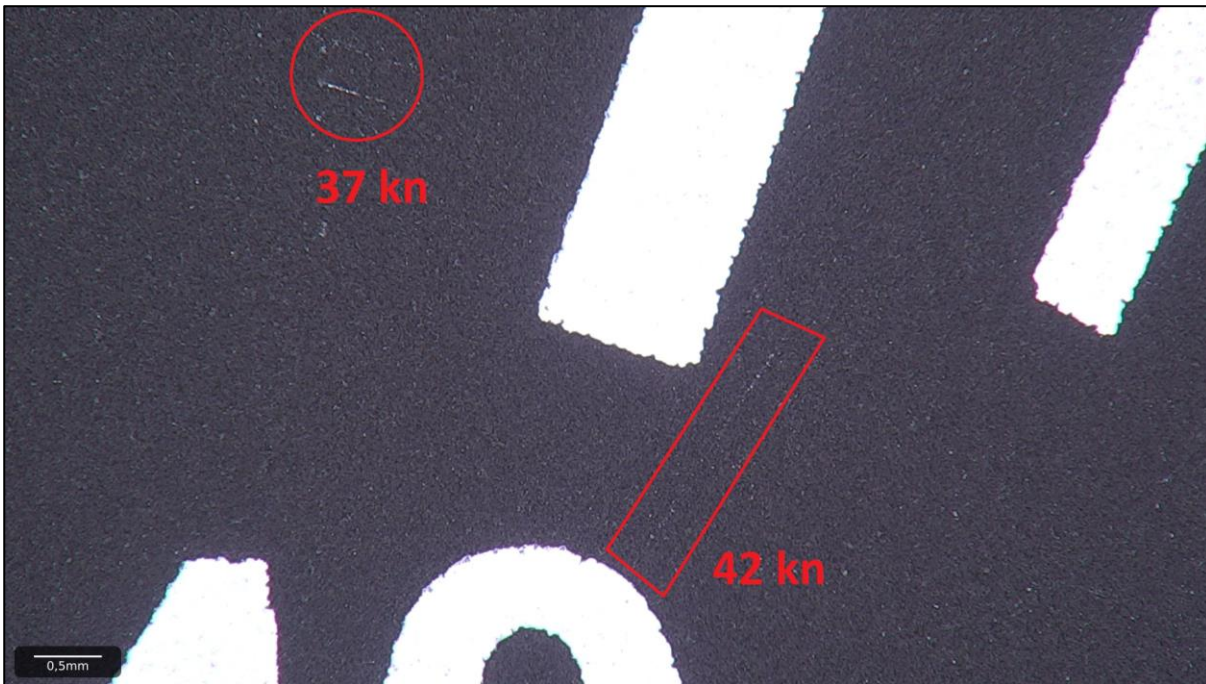
scratch. The impact marks were at 37 and 68 kt, and the scratch at 42 kt position. These imprints are shown in figures 14 and 15.

**Figure 14.** Impact mark and scratch on the airspeed indicator face. (Photo: Insta ILS, usage rights: SIAF)

Examination showed that the surface finish of the instrument face is prone to damage, and it is easily damaged by pointer contact. When an impact occurs, the pointer bends toward the face and its tip makes an initial contact. Therefore, the imprints at the pointer tip location were possibly impact-related, while the scratch had probably been produced earlier. The

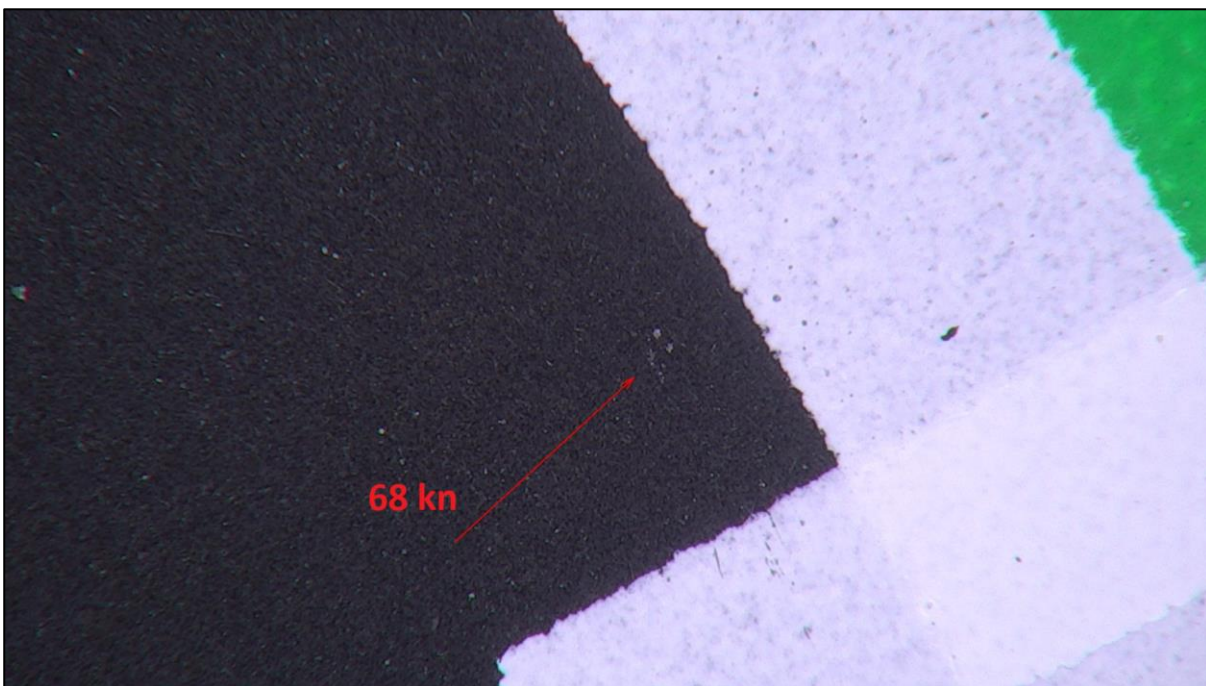
**Figure 15.** Impact mark on the airspeed indicator face. (Photo: Insta ILS, usage rights: SIAF)

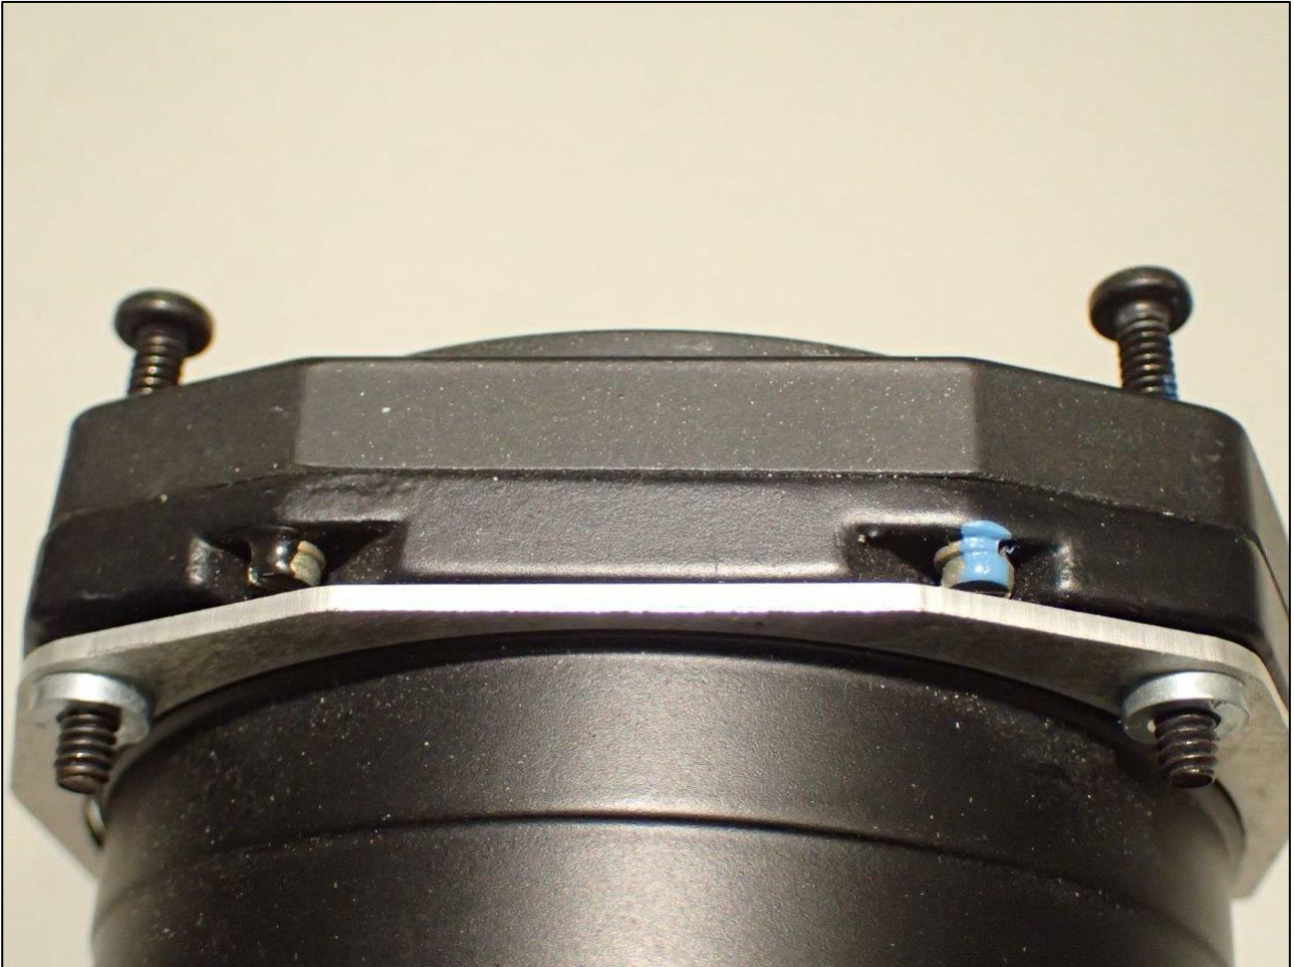
Hard sealing paint on the heads of the altimeter case lockscrews was intact. A visual inspection indicated that no maintenance had been carried out on the instrument while installed, or if any maintenance action had been performed, the screw heads had been repainted. Immediately after the impact, the altimeter indicated -2,820 ft at the pressure setting of 1,028 hPa, which indicated damage to the instrument.

**Figure 16.** Altimeter case lockscrews. The left-hand and right-hand screws are sealed with black and blue paint, respectively. (Photo: Insta ILS, usage rights: SIAF)

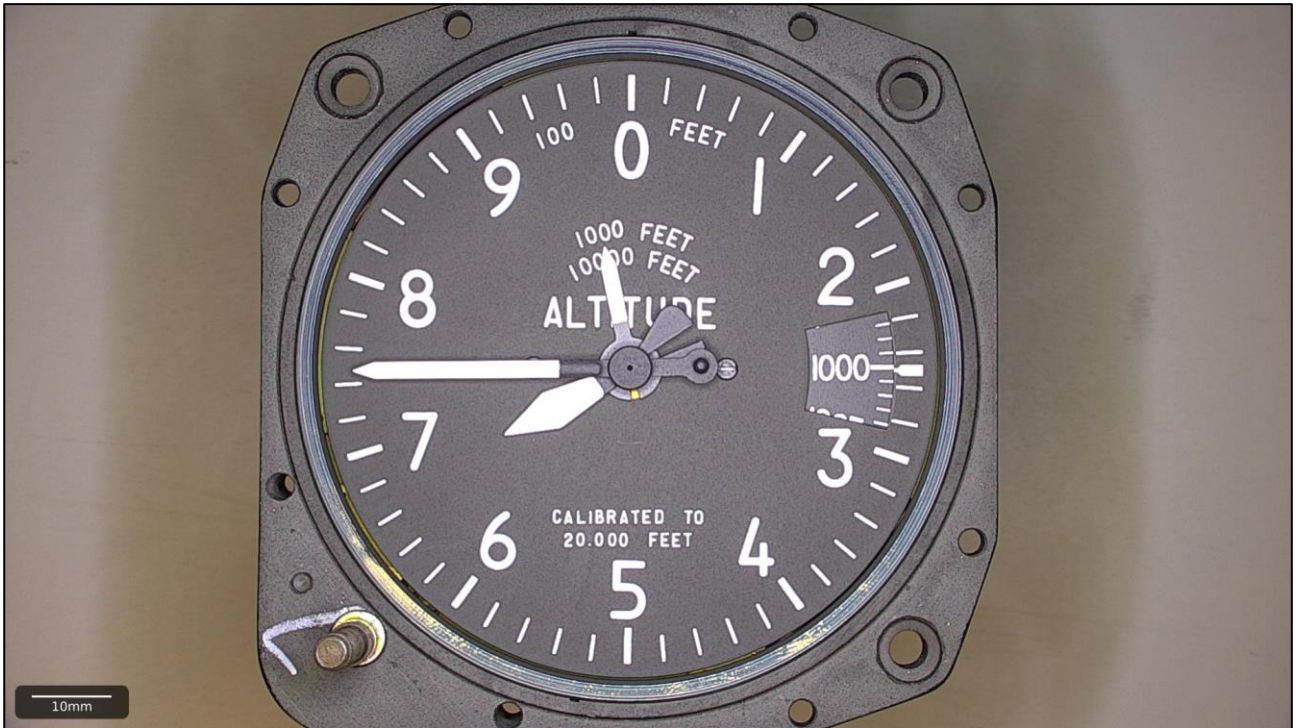
The instrument face was subjected to microscope examination using the same technique as for the airspeed indicator, and no impact marks were found. When the barometric setting was adjusted to the prevailing pressure, the instrument indicated -3,255 ft.

**Figure 17.** Altimeter indication after barometric pressure reset. (Photo: Insta ILS, usage rights: SIAF)

Examination revealed damage to the sector gear. The damage supports an assumption that the gear had slipped several teeth of the handstaff pinion, which had resulted in the incorrect indication. When the mechanism was rotated by hand to a position where the damaged section of the gear engaged the pinion, the pointers moved to indicate a value approximately 2,500 ft higher.
