Corporate Aircraft Collision with Lamp Post during Warm-up Run at Kemi-Tornio Airport on December 5, 2021

L2021-05

Investigation designator: L2021-05
Investigation report 9/2022
ISBN: 978-951-836-640-2 (PDF)

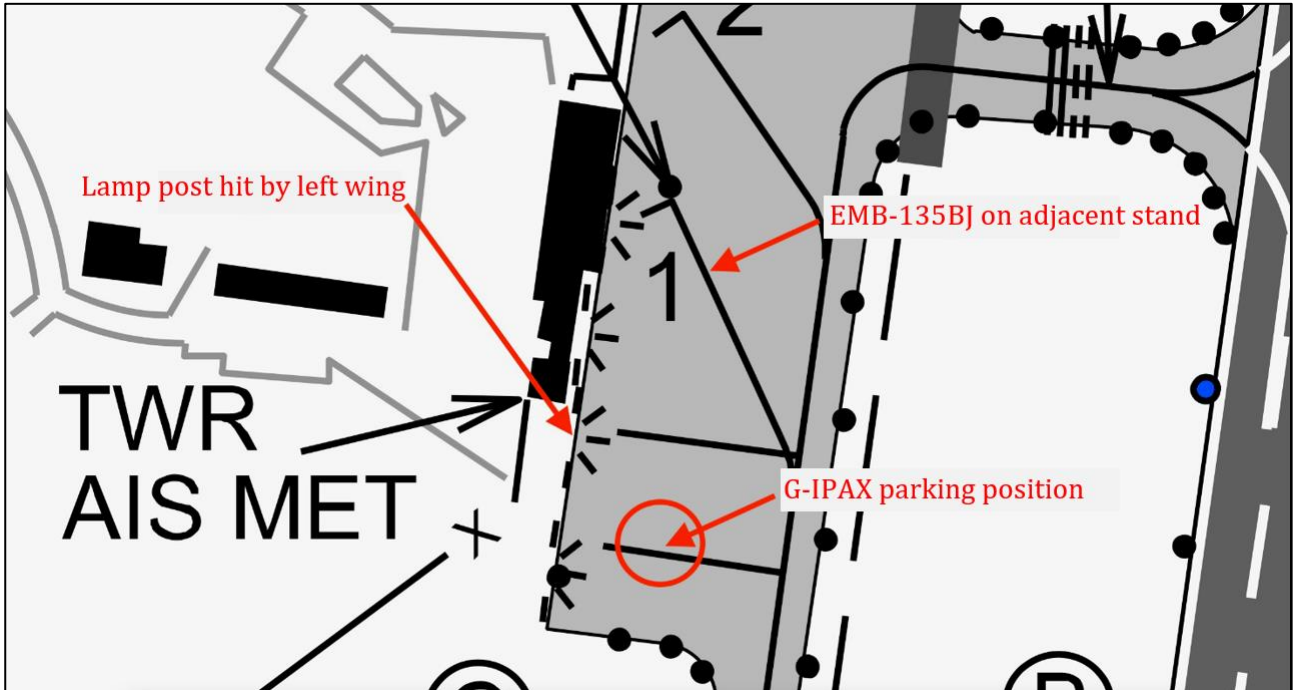
Figure 1 The apron chart of Kemi-Tornio aerodrome with arrows pointing at aircraft locations before the accident. G-IPAX is the accident aircraft. G-SUGR is another company aircraft. The map also shows lamp posts and aerodrome buildings. (Photo: Fintraffic ANS. Annotations: SIAF)

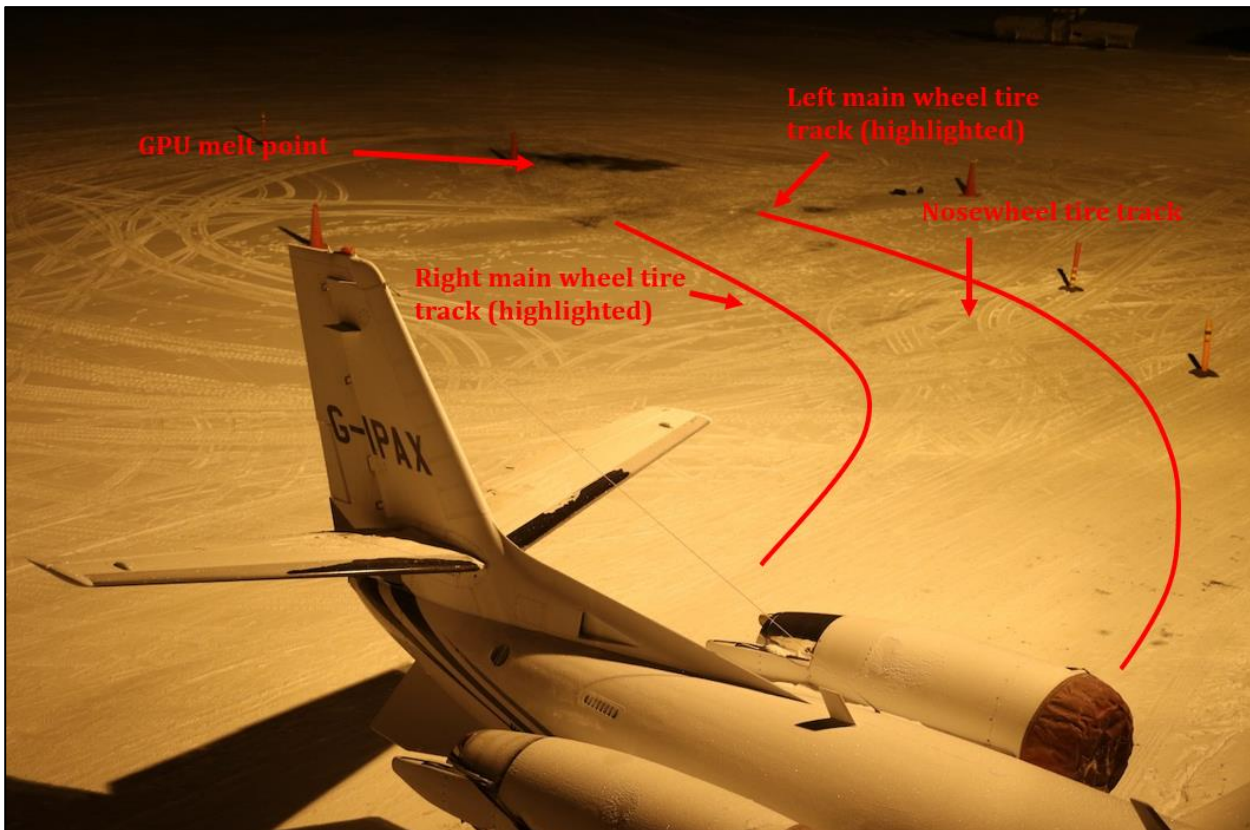
As a result, the aircraft moved forward unexpectedly. The nosewheel pushed the front chock over a thin layer of compacted snow for a short distance until the chock slid aside, off the wheel's track. The captain applied brakes to stop the aircraft, to no effect. He simultaneously reduced power on the engines to idle and used nosewheel steering to maneuver the aircraft to the right, away from the terminal building (**Figure 2**). However, the left wing leading edge struck a metal lamp post at the edge of the apron at approximately 1238 h. The aircraft rotated approximately 90° to the left relative to the direction of travel and came to a halt with the nosewheel in snow at the edge of the apron. The captain cut off fuel supply to the engines soon after the impact. The distance that the aircraft traveled was approximately 20 m.

Figure 2 The red lines indicate the tire tracks created during aircraft movement. The photo was taken in the evening of December 5 before the aircraft was moved from the accident location. The wheel chocks on the background are not in their original positions, and the GPU has been removed. (Photo: SIAF)

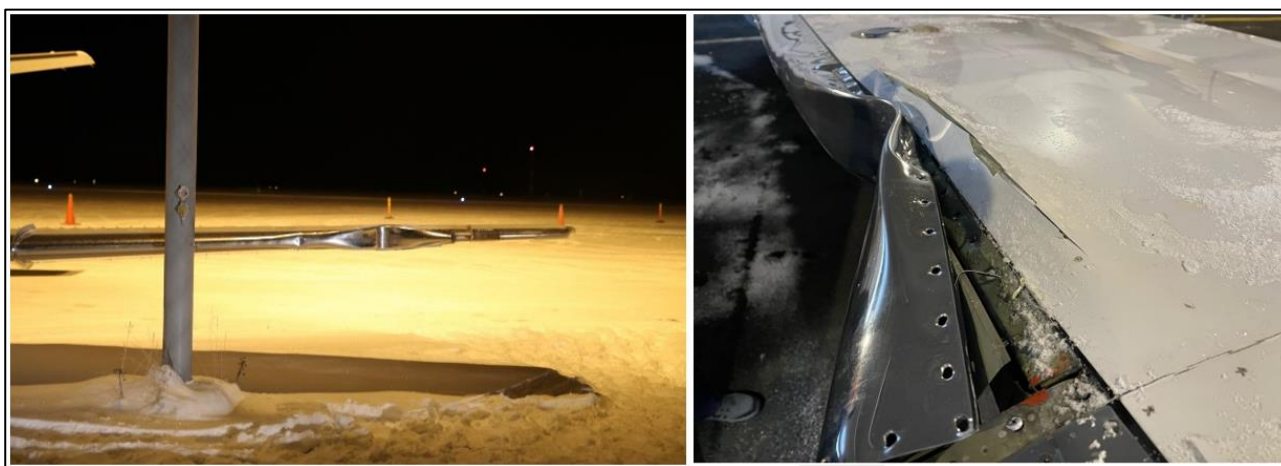
The impact created a dent in the wing leading edge that extended all the way to the wing spar (**Figure 4**). The cable from a ground power unit (GPU) had been connected to the aircraft. Bending force imparted by the cable plug on the fuselage-mounted receptacle caused deformation of the receptacle. The accident did not result in injuries.

SIAF investigators examined the aircraft in the evening of December 5 before the aircraft was moved from the apron. Examination showed that the impact had caused substantial damage to the left wing leading edge and the wing spar, which is a structural member of the wing (**Figure 4**). It was also found that the GPU receptacle and adjacent rear fuselage structure had been damaged when the GPU output cable was pulled tight as the aircraft moved forward and imparted a bending force on the receptacle. The receptacle and damaged structure were located aft of the rear pressure bulkhead and therefore were not part of the pressure hull.

Figure 4 The dent in the left wing leading edge extends all the way to the wing spar. (Photos: SIAF)

The aircraft operator's maintenance organization subsequently carried out damage assessment and repairs in a hangar at the aerodrome. SIAF representatives visited the site twice to observe damage assessment and the progress of the repairs and to gather technical information for the investigation. A representative of the aircraft manufacturer also visited the site to provide guidance on the repairs.

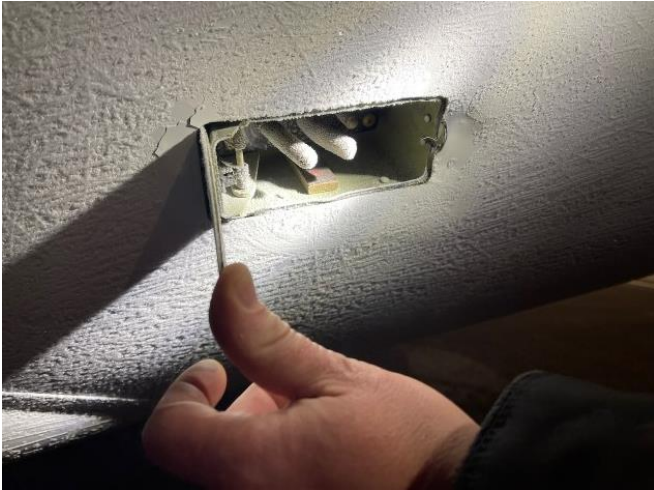
The cable from a mobile GPU was connected to a receptacle located in the aft fuselage. Aircraft movement pulled the cable tight, which in turn imparted a bending force on the receptacle causing deformation of the receptacle and a depression in the fuselage. The cable separated from the aircraft soon afterwards. No damage to the GPU was reported.

Figure 5 The GPU receptacle pins exhibited bending, and the fuselage skin around the receptacle was deformed under cable tension. (Photo: SIAF)

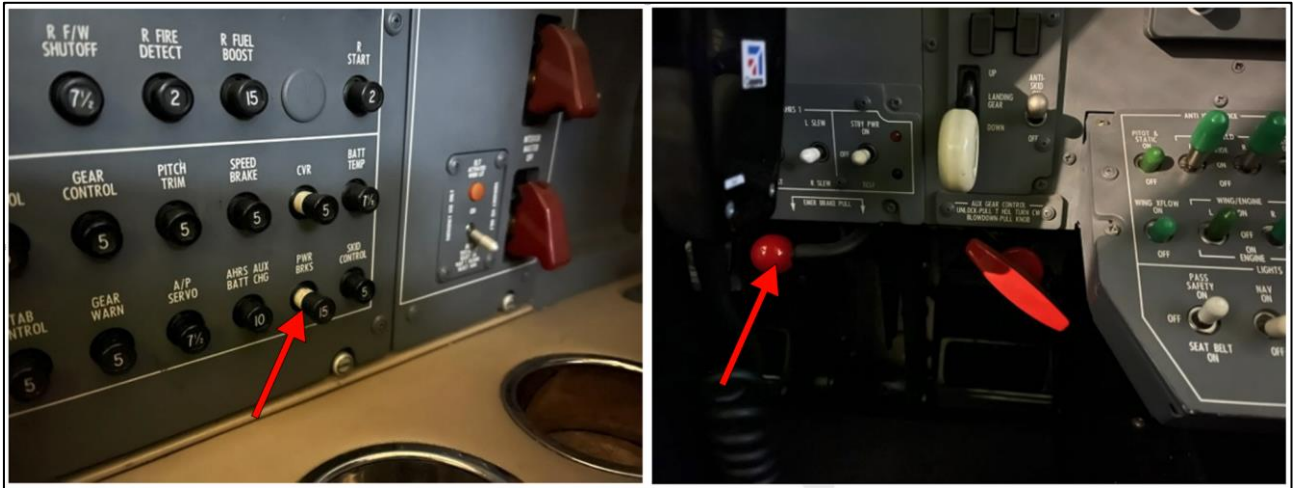
The on-site investigation on December 5 showed that the brake system circuit breaker was tripped. The 15 A circuit breaker is in a panel next to the left cockpit seat (**Figure 6**).

Figure 6 Left: The circuit breaker panel next to the left seat. The arrow points at the tripped brake system circuit breaker (PWR BRKS), which would not reset during the functional test on December 8. Right: The arrow points at the emergency brake handle forward of the left seat. The location behind the control column - which is partially visible in the photo - may cause difficulty in handle operation. (Photo: SIAF)

The operator's mechanics performed a brake system functional test three days after the accident on December 8. When the brake system circuit breaker was reset with aircraft systems powered-up, the circuit breaker tripped immediately, and the hydraulic pump - which would have been audible in the cockpit - did not operate. The circuit breaker was replaced. A subsequent functional test revealed that the circuit breaker would remain in the reset position initially, but when the systems were powered-up, it would trip immediately. In the test, the pump started and ran for a very short period of time until the circuit breaker tripped and the pump was de-energized. The circuit breaker is an on-condition item⁹.

The aircraft was repaired at the aerodrome during summer 2022. Although the brake system circuit breaker was replaced, the hydraulic pump did not operate and was replaced. The company sent the defective pump for examination, but no inspection report has reached the investigation team so far.

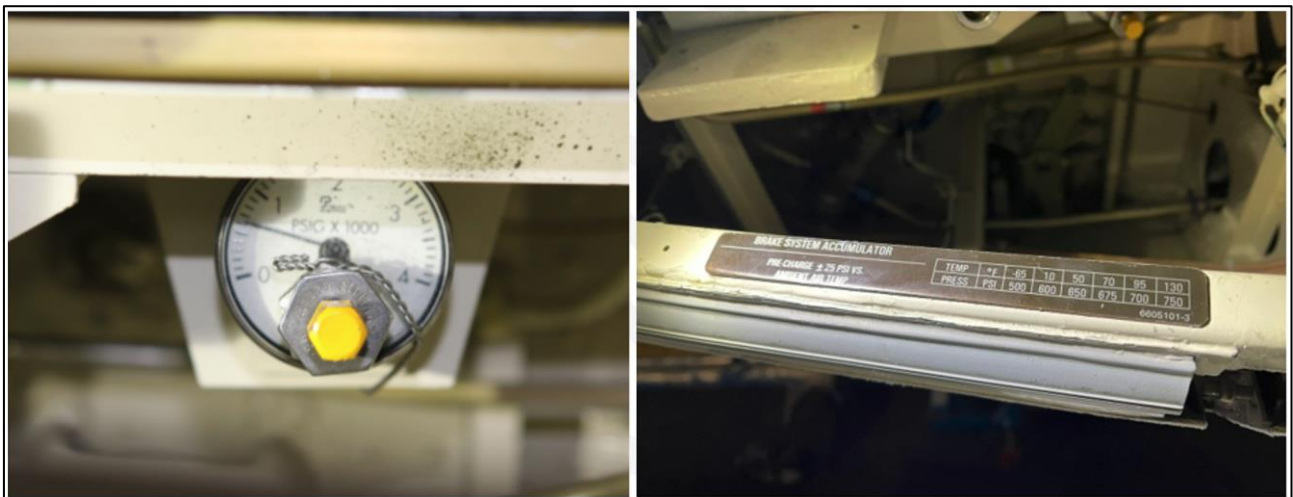
Kuva 7 The brake system accumulator pressure gage read approximately 650 psi three days after the accident on December 8. According to the adjacent placard, this was sufficient in the prevailing temperature. Temperature of -10 °C equals 14 °F. (Photo: SIAF)

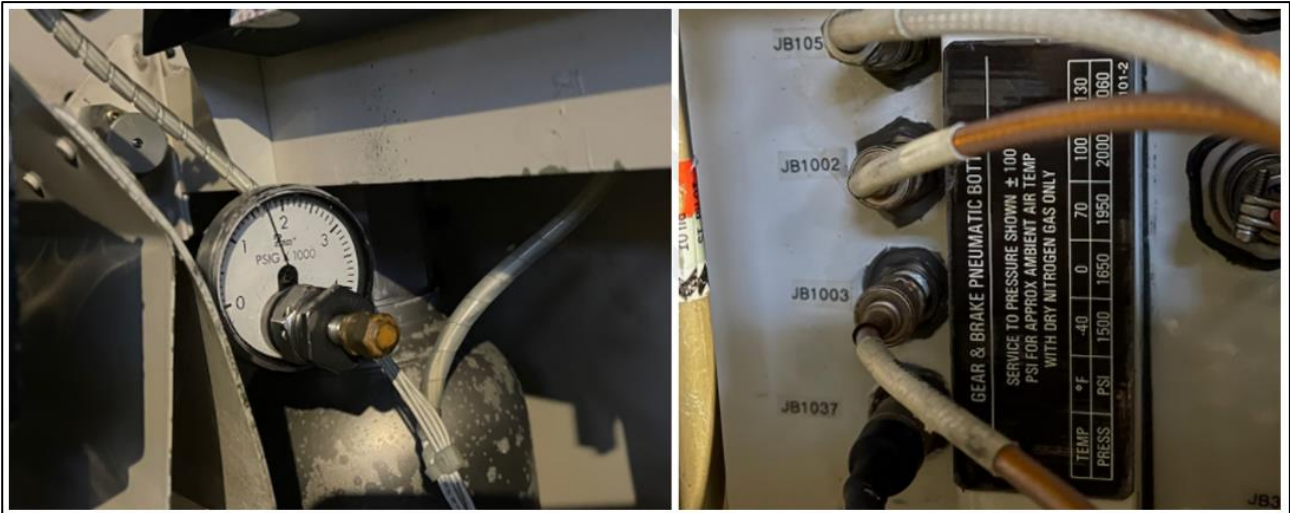
Kuva 8 The emergency brake system pressure gage read approximately 1,720 psi on December 8. According to the placard, this was sufficient in the prevailing temperature. (Photo: SIAF)
