## Amateur-built Aircraft Accident in Tikkakoski on April 17, 2022

L2022-02

Investigation designator: L2022-02  
Investigation report 5/2023  
ISBN: 978-951-836-649-5 (PDF)

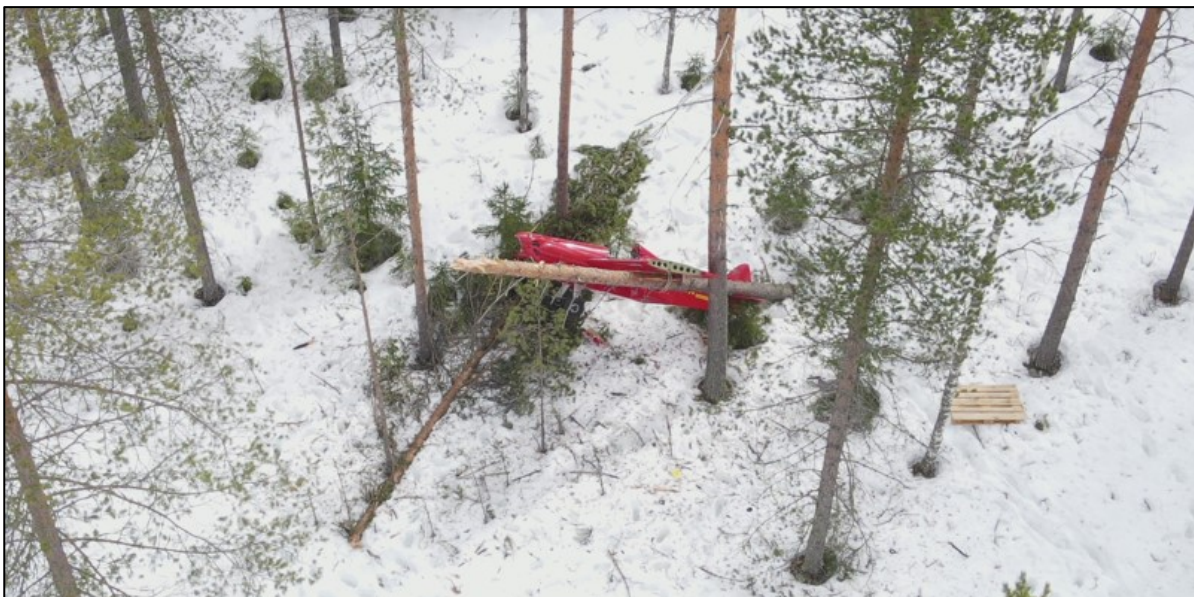
A birch tree broken near the top was located at the edge of a parking lot approximately 50 m from the accident site. Flakes of red paint from the accident airplane were found at the same location. The top of the tree, less than 2 m long and a few centimeters in diameter, was located approximately 10 m beyond the point of the initial tree impact. The airplane had then struck a pine tree, severing it about 10 m above the ground. It also impacted another pine tree, on which the pilot's headset was found at about 7 m above the ground. The airplane came to rest in a right wing low attitude, supported by the severed tree.

**Figure 6.** The impact severed the pine tree on which the airplane came to rest. The pallet was brought to the site after the accident. (Photo: Police)

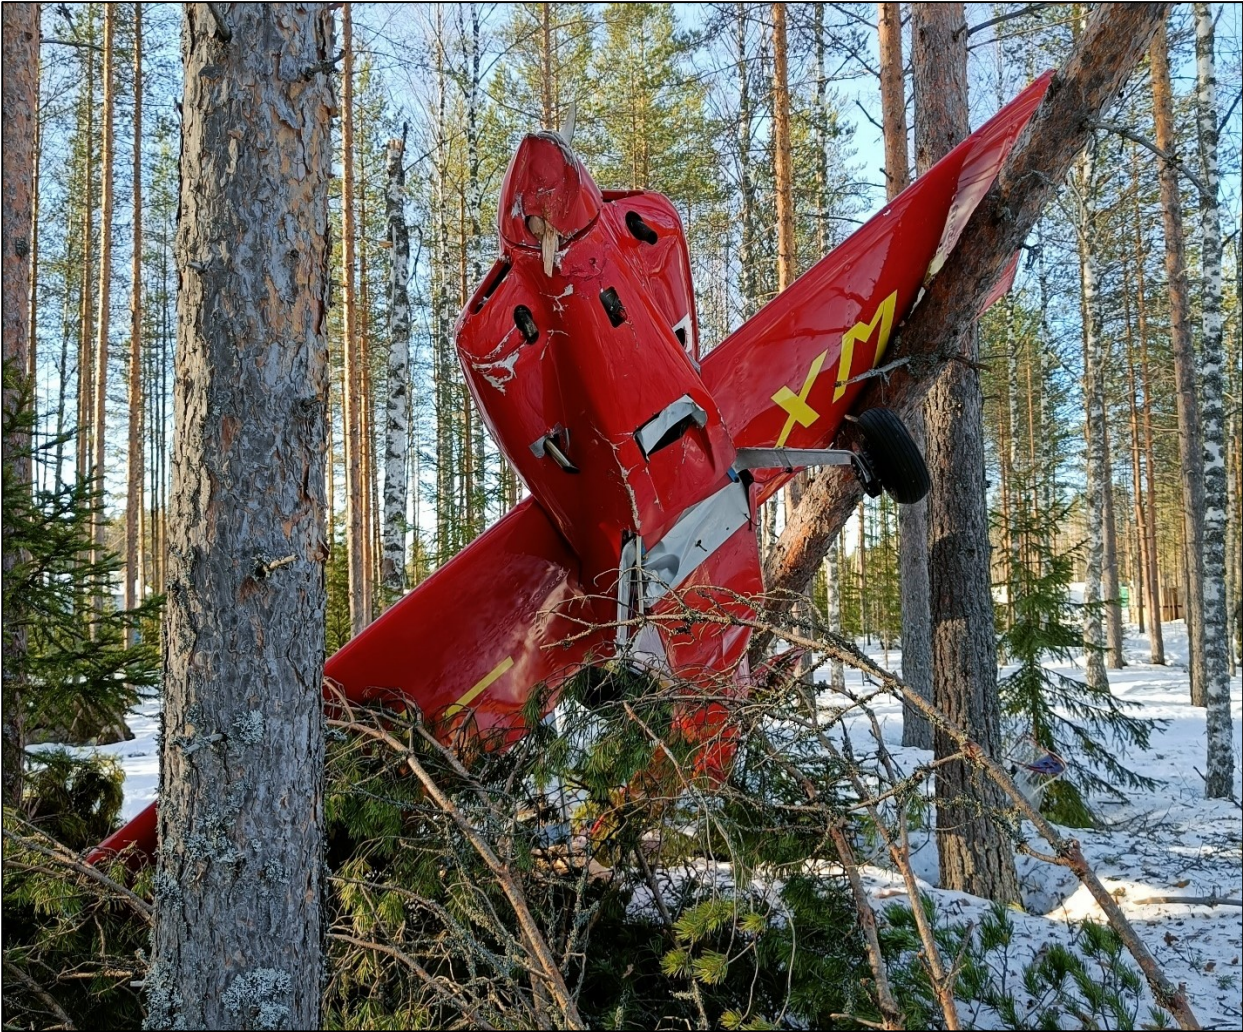
**Figure 7.** The airplane came to rest supported by a severed tree. The propeller blades broke off near the root, and the spinner exhibited denting. The cowling was impact-damaged. The forward right-hand exhaust was bent. (Photo: SIAF)

The propeller was broken into several sections at the root and the fracture surfaces exhibited grainwise separation. The separated sections were located at the accident site. The tips and leading edges of the blades displayed no signs consistent with a tree strike. The damage suggested that the propeller had not been rotating during tree impact. The propeller hub remained attached to the engine.

The upper cowling showed abrasion that extended all the way to the cockpit, while the underside of the lower cowling was split to the right of the fuselage centerline. The engine air intakes and their fairings were fragmented. The operating cable of the inlet air preheat system had fracture-separated from its housing in the lower cowling.

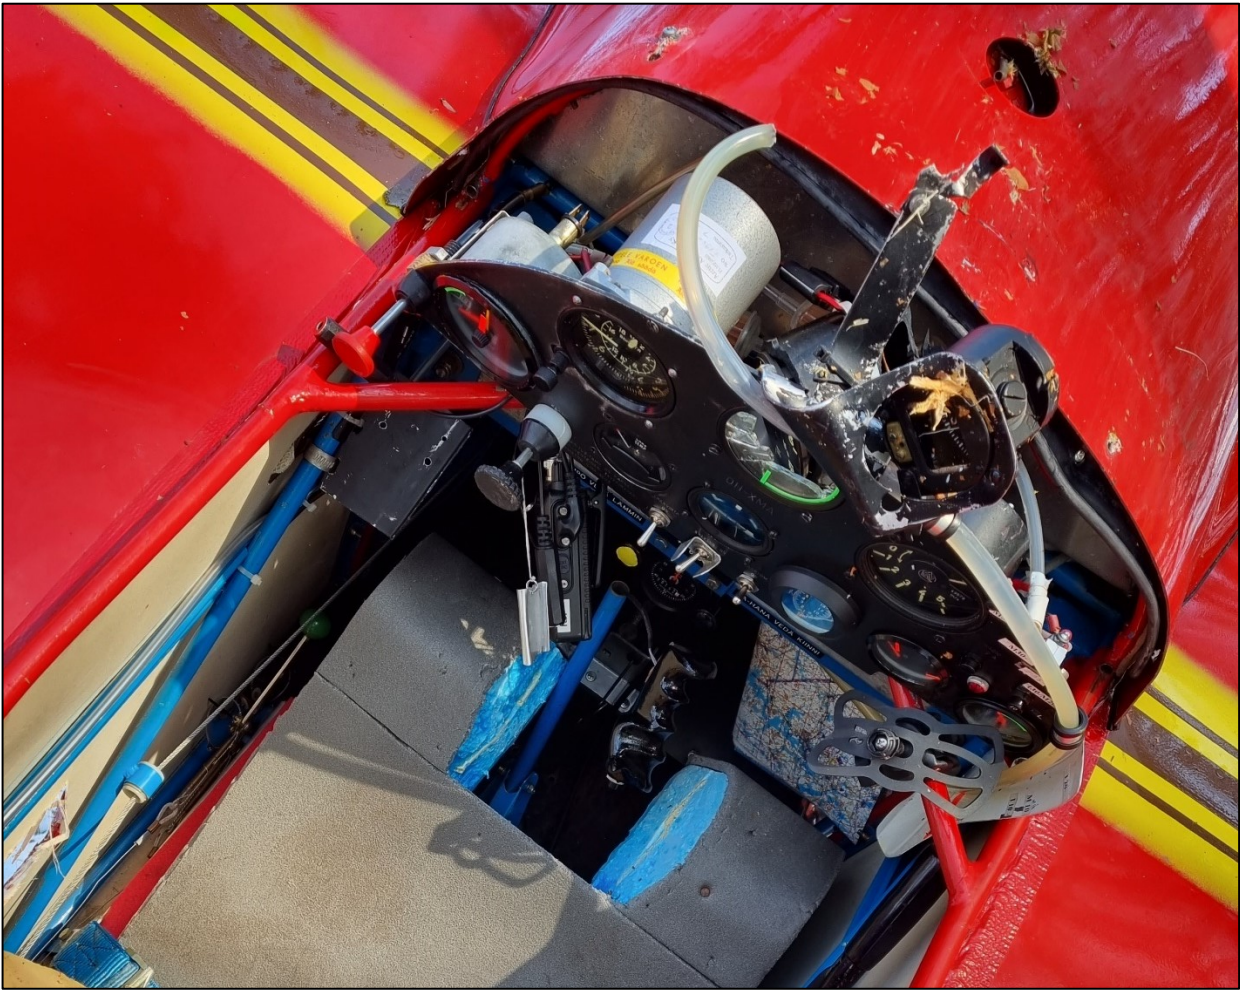
Fragments of the shattered canopy were located across the accident site. The instrument panel had displaced aft, and the upper part of the fuel tank was breached. The control column grip had separated. The main switch and the ignition switch were set to OFF. The throttle was in a position that broadly corresponded to a cruise power setting. Inlet air preheat was deselected, and the fuel shut-off valve was open. However, the exact pre-impact positions of the controls remained undetermined due to the damage.

**Figure 8.** The cockpit. The instrument panel is displaced aft. The control stick grip has separated. The airspeed indicator and the compass have dislodged. (Photo: SIAF)

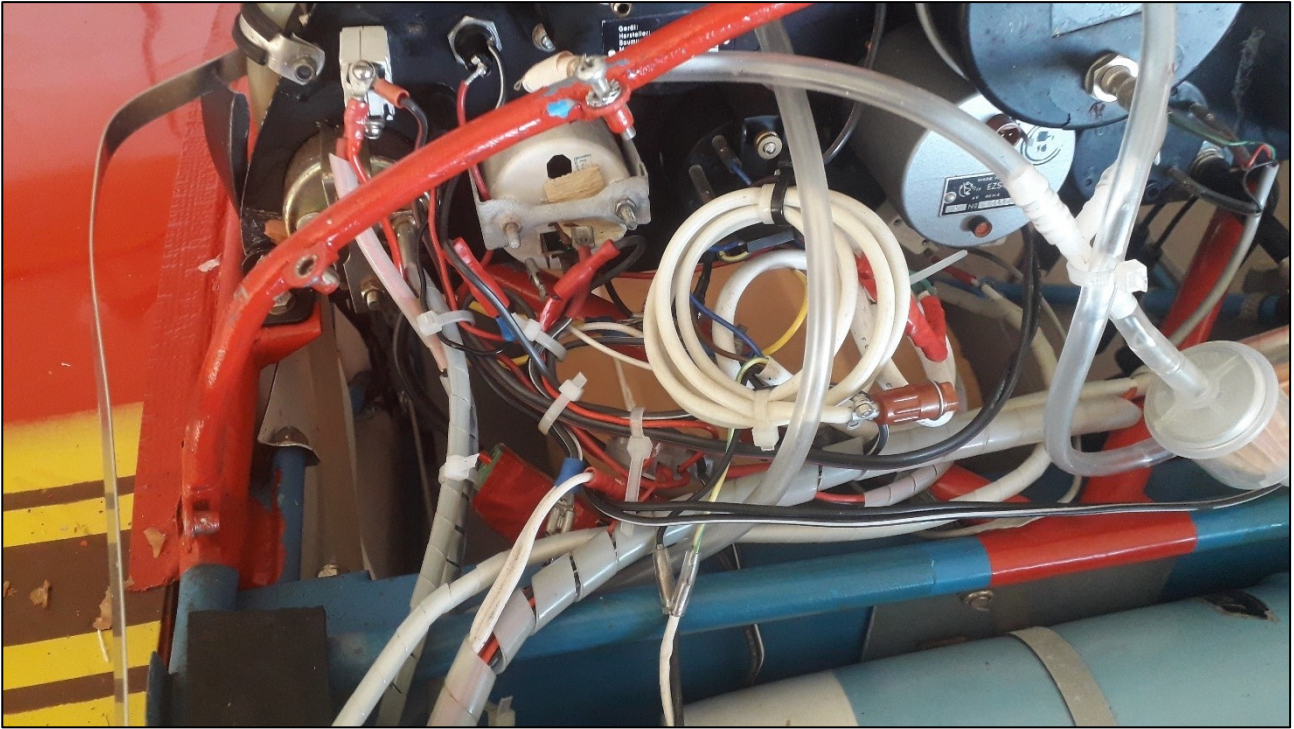
The tachometer received an engine speed signal from the magneto via a wire connected to the ground terminal on the capacitor. Therefore, a tachometer fault could have resulted in magneto grounding and engine cut-out.

Wires of various types and of inconsistent quality were found in the electrical installation. A wide variety of connectors had been used for the splicing and connecting of wires. Some of these connectors were unshielded and unsuitable for aircraft use. Wires were routed and attached in such a way that allowed pinching and chafing against aircraft structure and between wires.

**Figure 9.** Electrical connections to the instrument panel. (Photo: SIAF)

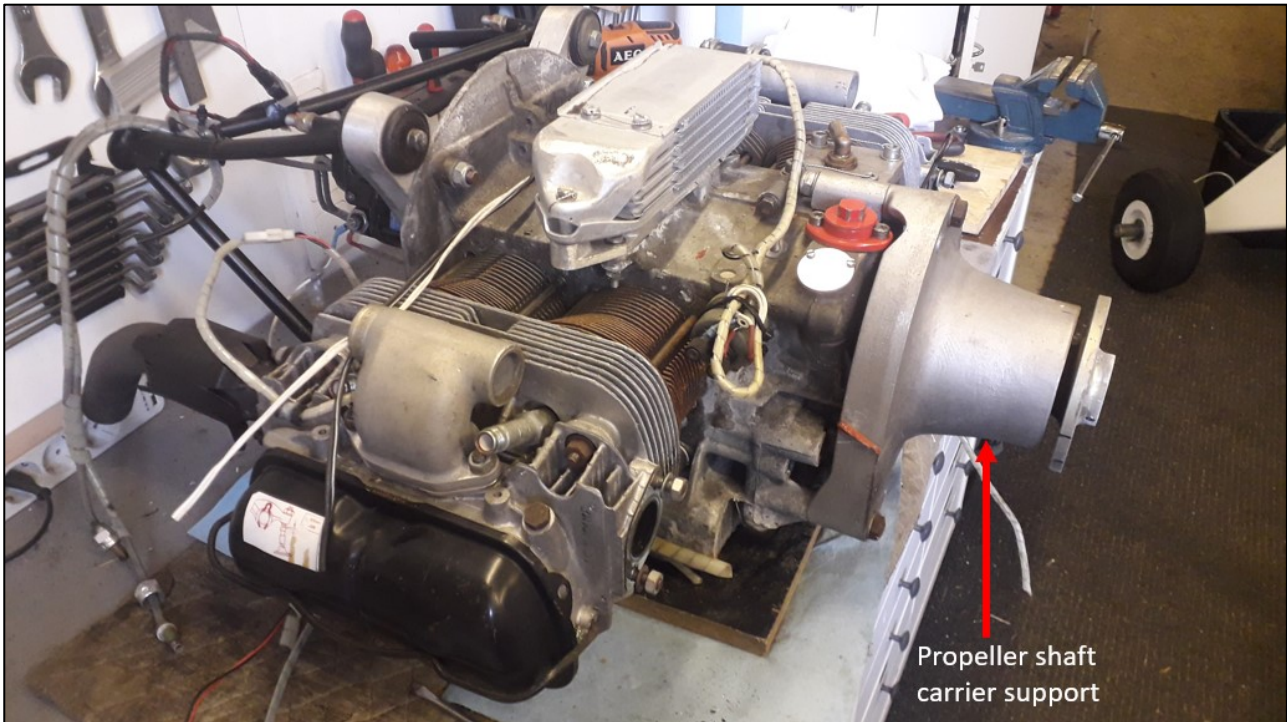
**Figure 10.** The engine of the accident airplane. The red arrow points at the propeller shaft carrier support. (Photo: SIAF)

Considerable resistance to rotation was evident when the engine was rotated by hand before disassembly. The cause of this resistance was traced to the propeller shaft and its carrier support. After the attachment of the support to the engine was loosened, resistance was no longer evident. It is likely that the support had moved slightly on impact. No deformation was found in the crankshaft or the propeller shaft. Dust corrosion was noted around the mating surface of the support bearing and the propeller shaft, and surface roughness was evident on the shaft where it had been in contact with the bearing. Detailed examination revealed that the shaft had moved relative to the bearing, and as a result material had worn off from the bearing inner diameter and the shaft surface. No other anomalies were found in the bearing. The depth of abrasion wear on the shaft was 0.13 mm. It was found that the movement of the shaft relative to the bearing was caused by excessive end float of the crankshaft. The lengthwise movement of the crankshaft had imparted similar movement to the propeller shaft. Additional wear could have resulted in the loss of propeller shaft support, in which case the rotation force of the propeller could have led to the breakdown of the connection between the propeller shaft and the crankshaft.

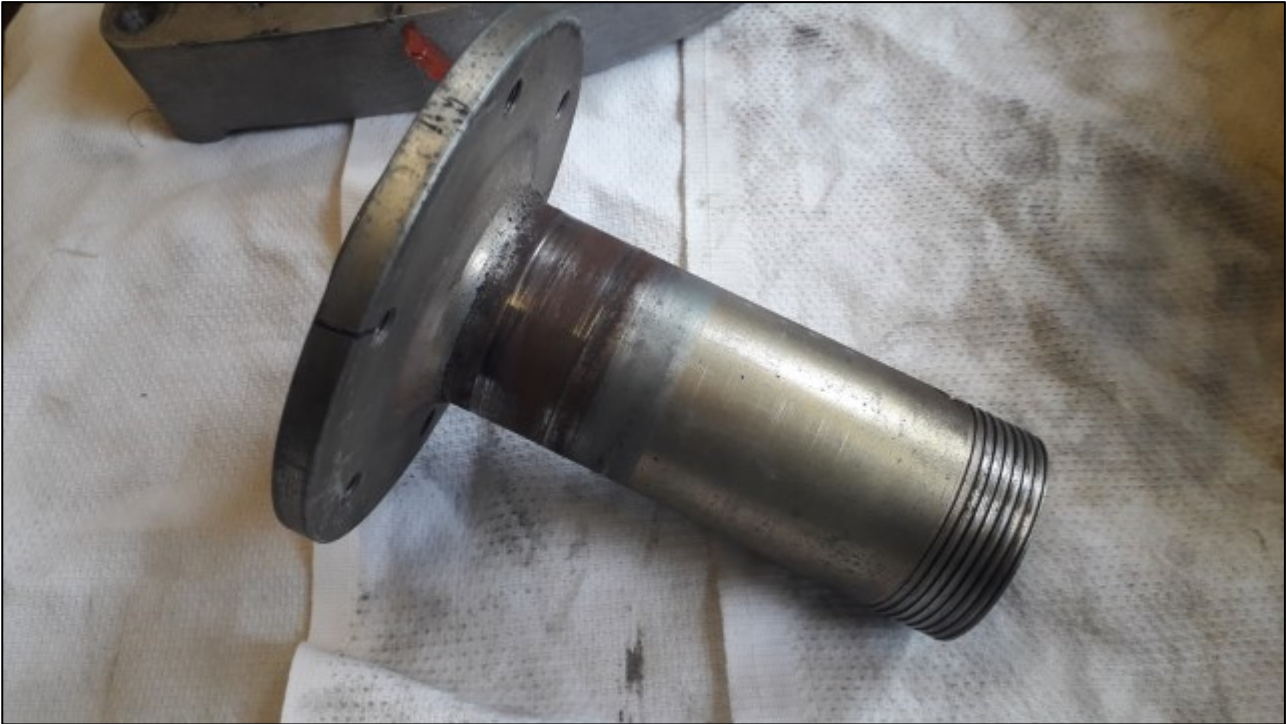
The airplane's maintenance records contained no entries regarding the bearing or its maintenance requirements. Although self-lubricating bearings are generally maintenance-free, it should be noted that in this case the lubricant was approximately 30 years old. Maintenance records contained no remarks concerning play between the bearing and the propeller shaft.

**Figure 11.** The propeller shaft and propeller mounting flange. Abrasion caused by the contact with the bearing and dust corrosion are apparent around the left-hand end of the shaft. (Photo: SIAF)

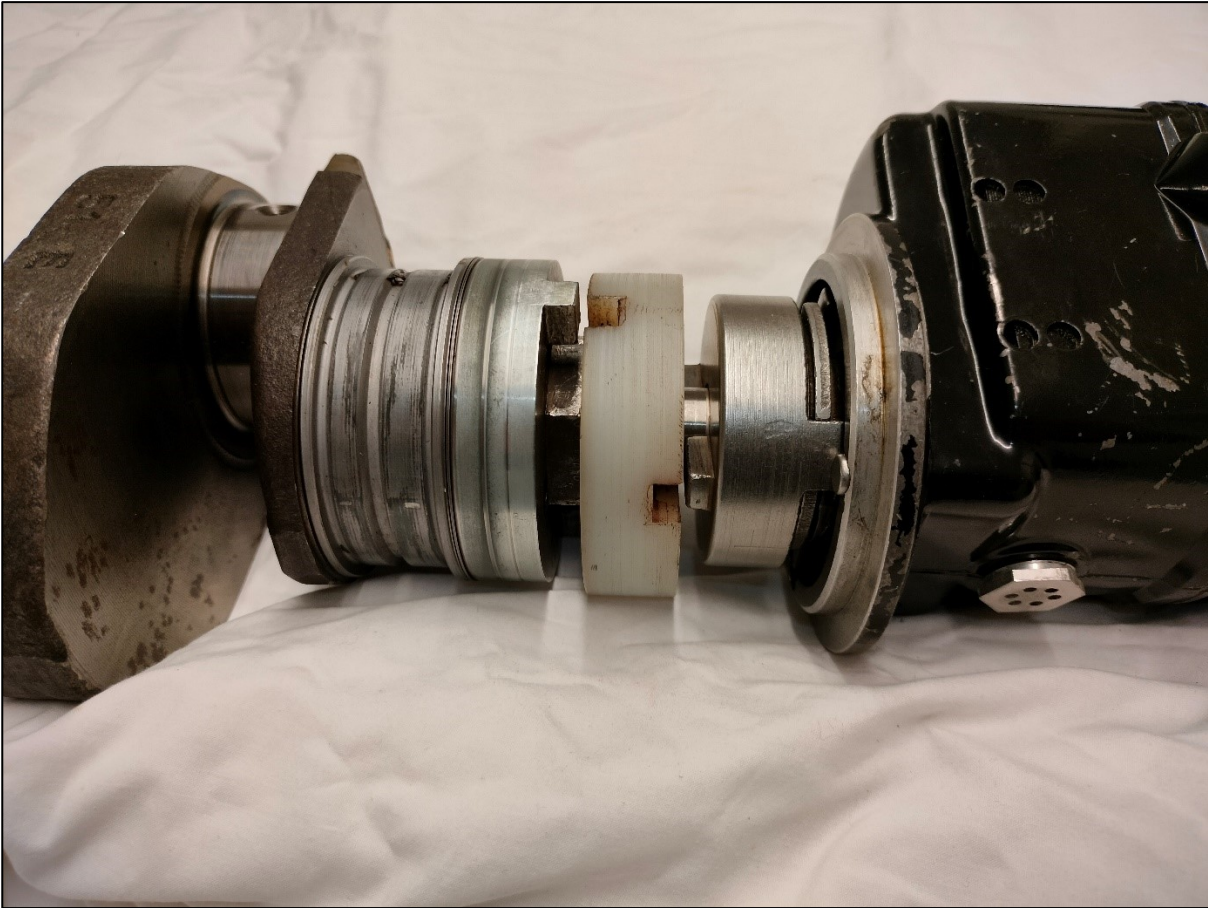
**Figure 12.** The rear end of the crankshaft, the magneto, and the magneto drive coupling. (Photo: SIAF)

The nuts of the heavy-duty crankcase pass-through studs were found under-torqued. However, no stretching or pull-out from the threads in the other crankcase half was noted. The fit of the crankcase halves was inspected with the crank mechanism not installed. The crankshaft bearing journals were in good condition and showed only minor local polishing. An inspection of the camshaft showed that the bearing surfaces and cam contact surfaces were in good condition. Even though the valve tappets were generally in good condition, some had signs of incipient pitting corrosion. The tappet assemblies moved freely in the bores machined in the crankcase. The camshaft and crankshaft bearing inserts fitted in the crankcase halves were in adequate condition considering the running time of the engine, and no signs of insert movement was noted. The camshaft inserts displayed polishing of varying degree and uneven wear of metal. Some inserts had scratches and localized craters caused by contaminants in lubricating oil. No signs of seizing were found.

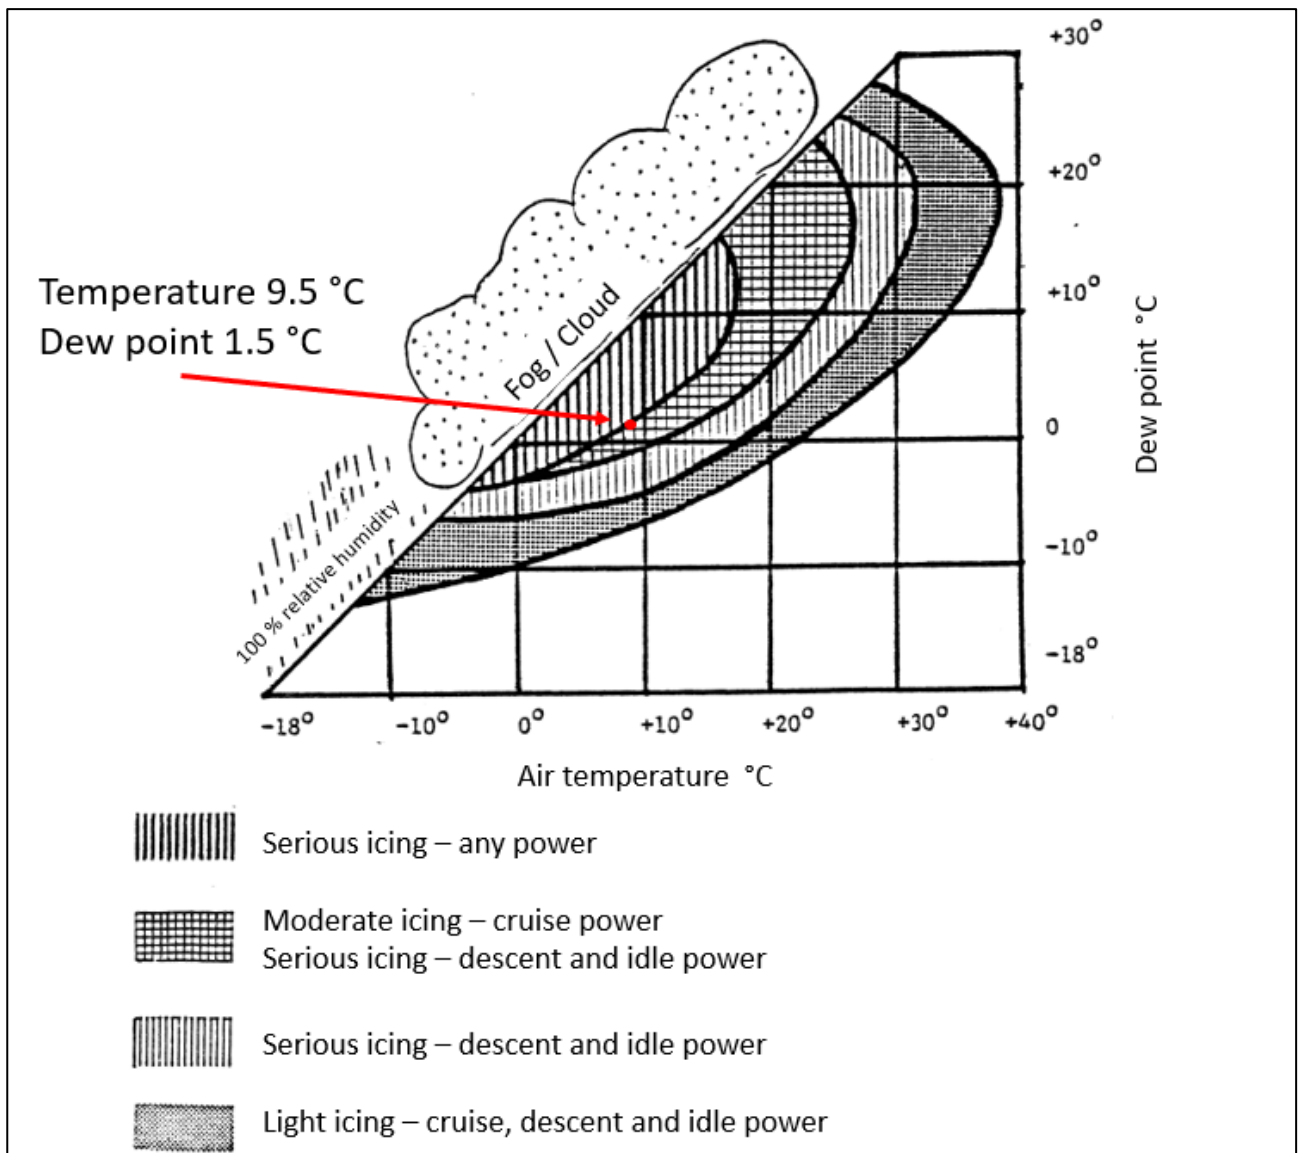
Figure 14 shows susceptibility to icing as a function of temperature, dew point and power setting. The MEPS model indicated that at the time of the accident temperature at landing circuit height was +9.5 °C and dew point was +1.5 °C. This point is shown in the figure. Susceptibility to icing was moderate at cruise power and serious at descend or idle power, or serious at any power setting.

**Figure 14.** Susceptibility to carburetor icing as a function of temperature, dew point and power setting. The red arrow and dot indicate the prevailing conditions at landing circuit height at the time of the accident. (Photo: Aeronautical information publication OPS T1-18, October 22, 1984, canceled in 2003, annotated in red by SIAF)
