Apartment fire causing the death of five people in Vantaa on 8 October 2023

Y2023-02

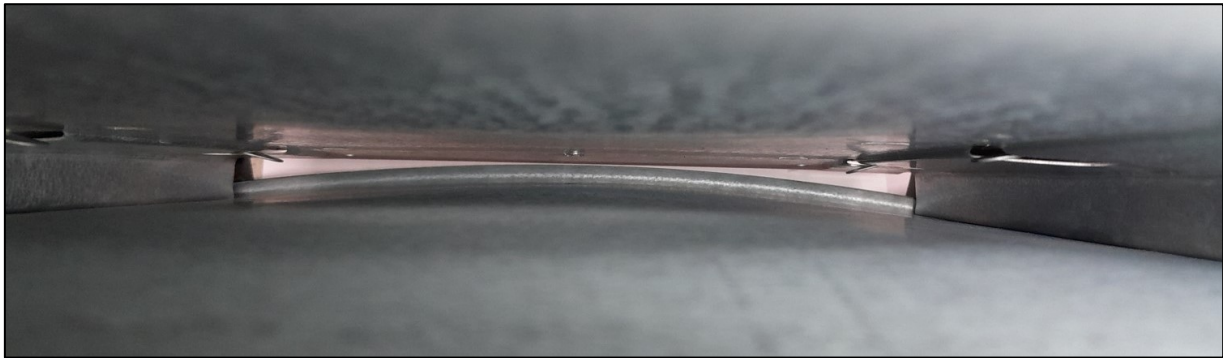
the back of the heater in the middle. In the corresponding spot at the bottom part of the heater, the gap is more than 20 mm wide.

Figure 4. The photo shows the gap between the stone space and the heater frame. The plate-like back of the frame on top of the photo and the curved stone space on the bottom. There is a bent collar at the top of the metal casing of the stone space, which reduces the free opening. (Photo: Safety Investigation Authority, Finland)

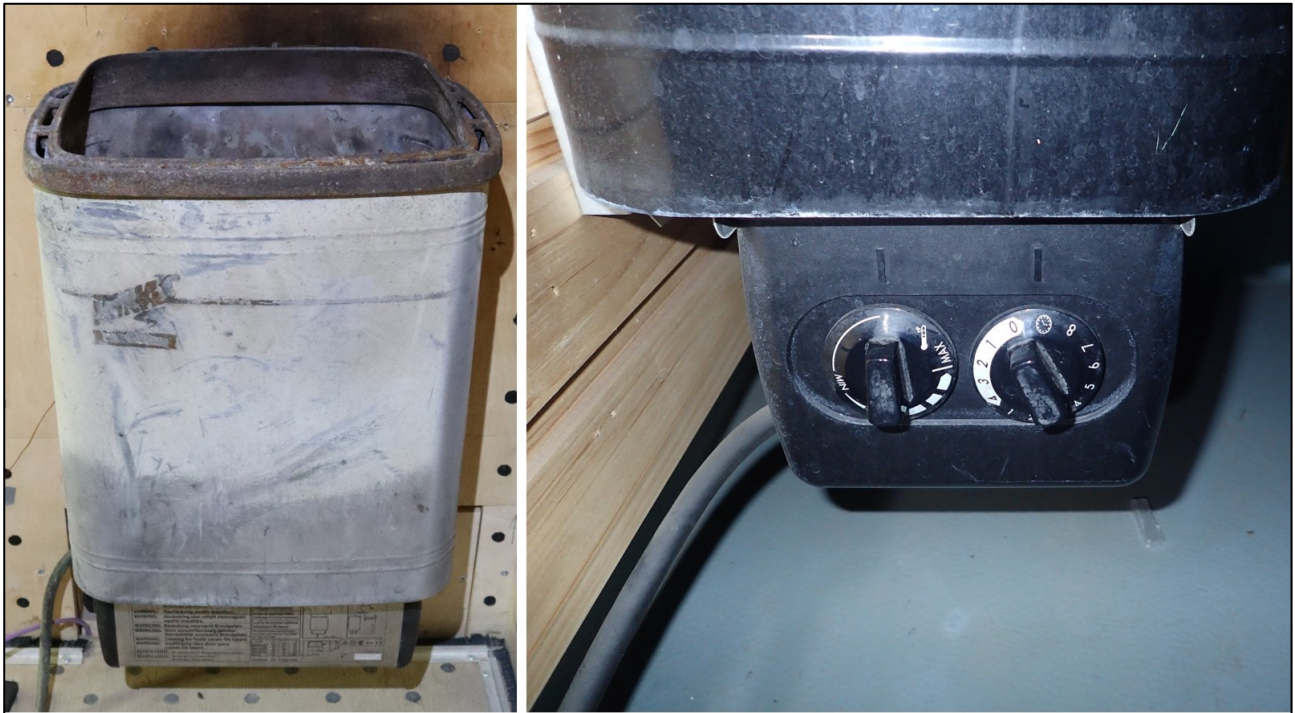
Around the top edge of the sauna heater, there was a cast iron collar, the air flow spoiler. The visual examination of the heater revealed deformations in the casing of the heater's stone space, so that the casing had outward dents.

Figure 6. In the photo on the left, the burnt heater after it was re-electrified and on the right the controls of another heater of the same age. The heater in the photo on the right is in the sauna of another apartment in the same building. (Photo: Safety Investigation Authority, Finland)

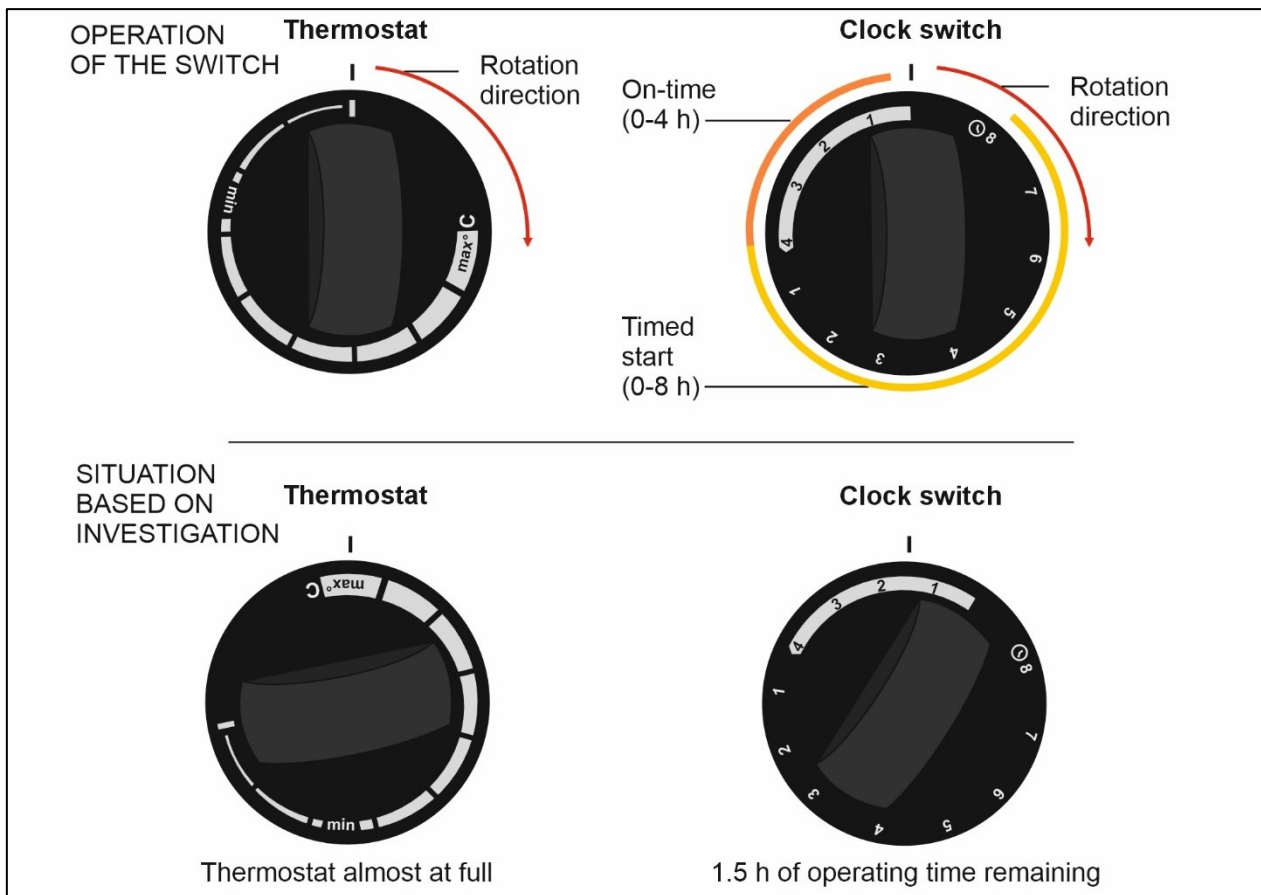
The positions of **the controls of the burned heater** could be verified with sufficient certainty by means of reference pieces and X-ray examination.¹⁵ At the time of the fire, the thermostat switch was nearly in the maximum position. The time remaining on the timer control for the heater to remain active was approximately an hour and a half. The timer had stopped after the power supply was cut off due to the fire. The overheat protector had not gone off.

Figure 7. The image shows the basic functions of the controls and the positions of the controls at the time the power was cut off based on the investigation. (Image: Safety Investigation Authority, Finland)

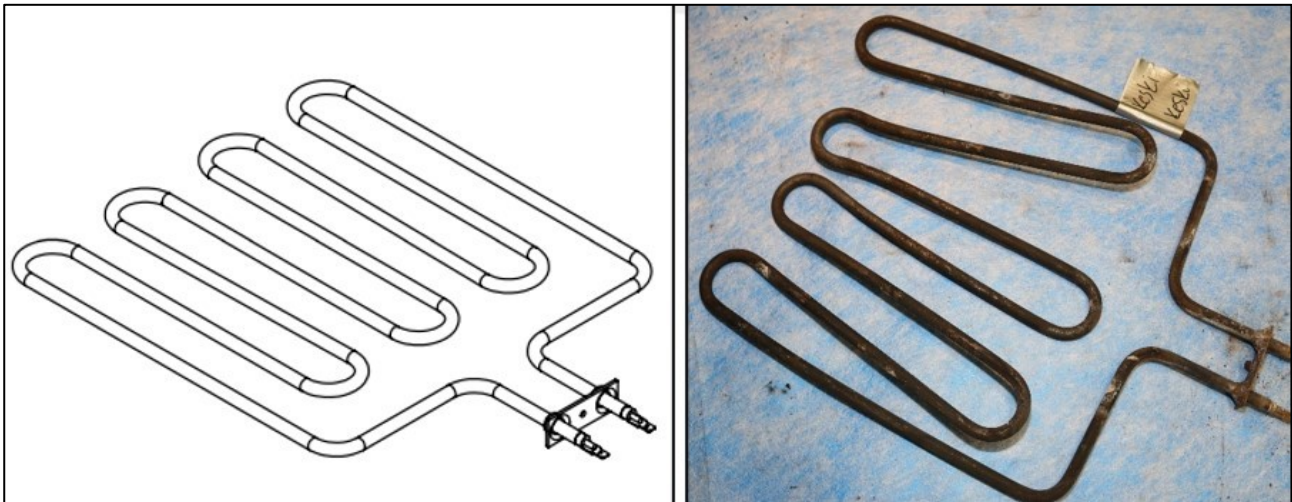
Figure 9. On the left, a technical drawing of the heating element of the heater and, on the right, the middle heating element of the heater involved in the accident (Image on the left: Harvia, photo on the right: Safety Investigation Authority, Finland)

extent. At least at one point, the heating element had been bent so that it touched the bottom of the stone space. No melting of the steel shell was detected.

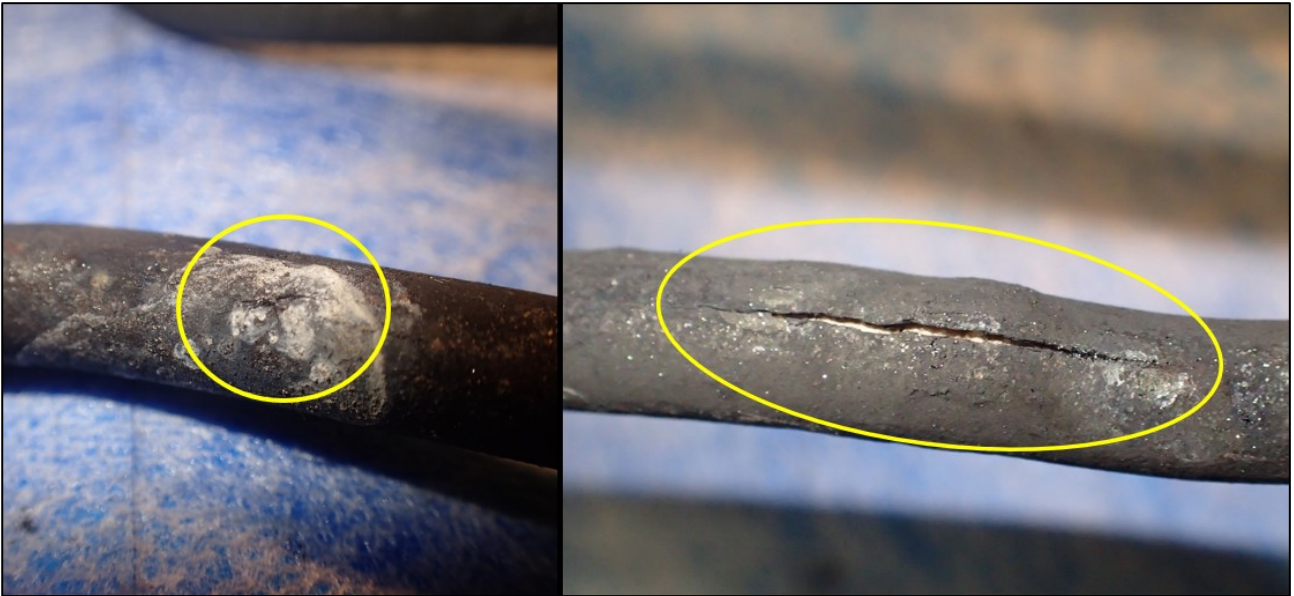
Figure 10. Hair cracks in the steel shells of the heating elements of the heater.

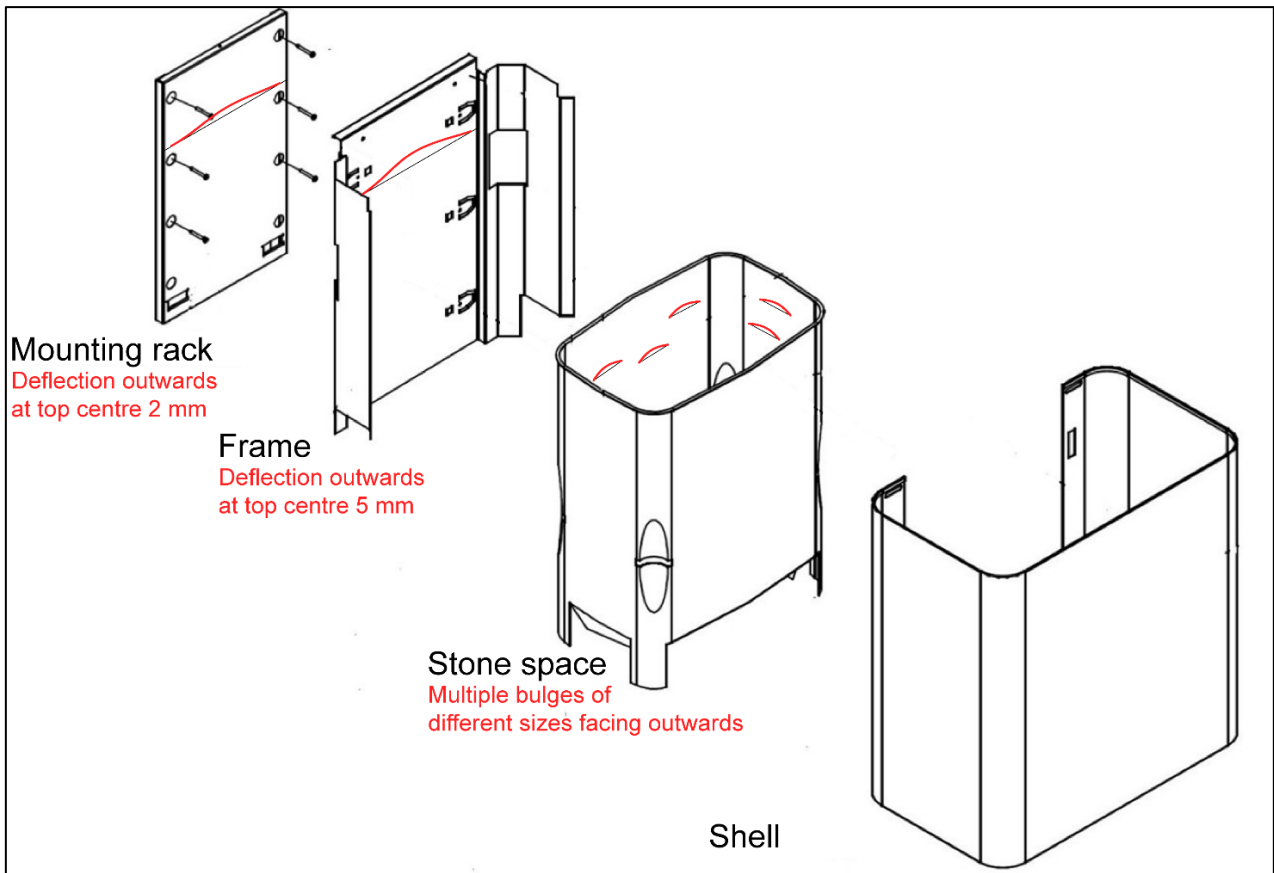
There were bulges of different sizes throughout the heater's stone space casing. At the top of the heater, the mid-section of the heater frame had been bent outwards by approximately 5 mm and the mounting rack by 2 mm, correspondingly. The frame and the mounting rack had a visible heat pattern at this point.

Figure 11. The structure of the heater and deformations observed in the investigation. (Photo: Harvia, edited by Safety Investigation Authority, Finland)

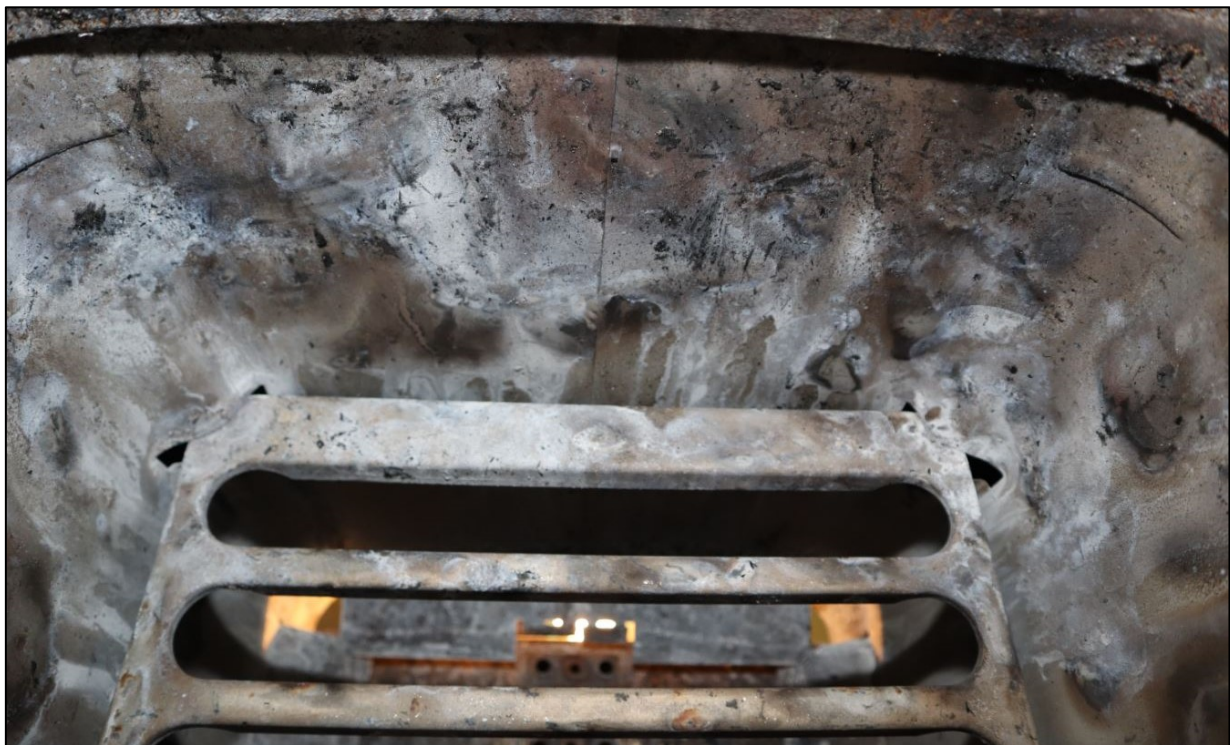
Figure 12. There were bulges of different sizes throughout the heater's stone space casing. The heating elements were not in place when the photos were taken.

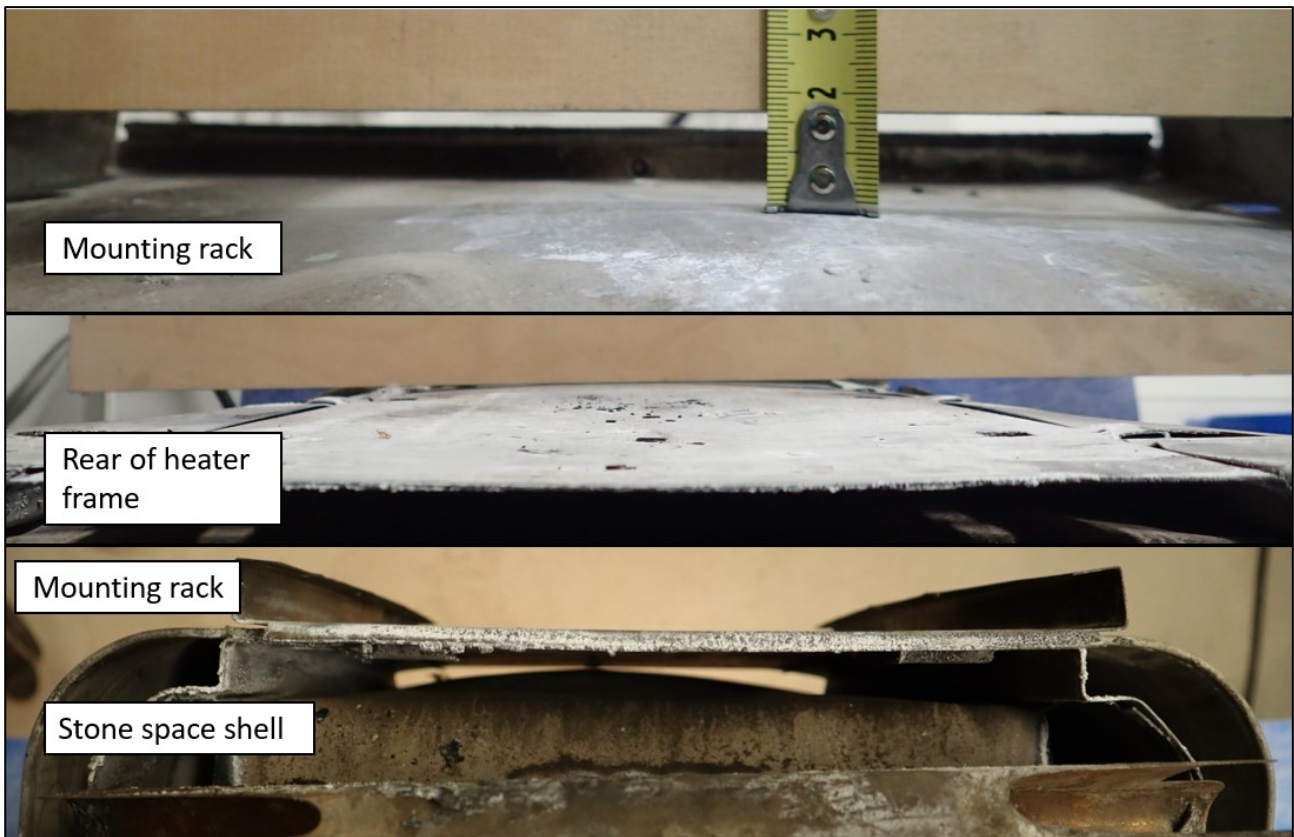
Figure 13. The photo on top shows the mounting rack with a sheet of plywood placed on top of it to measure the bend. The frame of the rack is bent from the top of the heater towards the panel wall by a few millimetres. The photo in the middle shows the rear part of the heater frame, where a bend of approximately 5 mm can be seen at the corresponding point. The rear of the frame had been in contact with the mounting rack plate at the point of the bend. At the bottom, the rear part of the heater photographed from bottom up. In the picture, the mounting rack is in contact with the heater, and the curved shape of the stone space casing can be seen well. (Photo: Safety Investigation Authority, Finland)

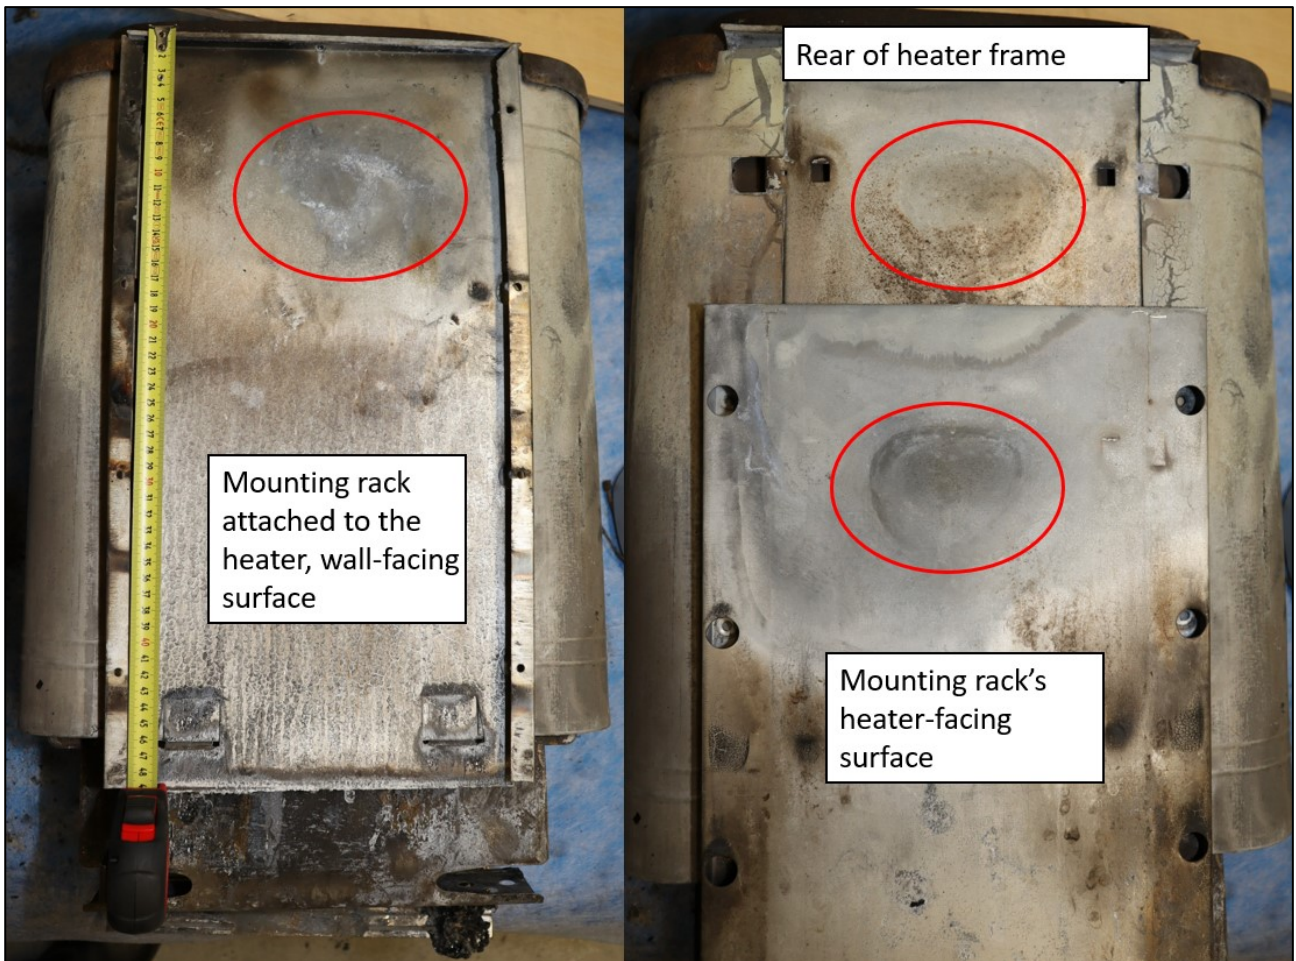
Figure 14. Heat patterns were visible in the middle of the top part of the heater and the mounting rack. On the left, the surface of the mounting rack that faced the wall, and, on the right, the surface of the mounting rack that faced the heater at the bottom and the back wall of the heater frame on top. (Photo: Safety Investigation Authority, Finland)

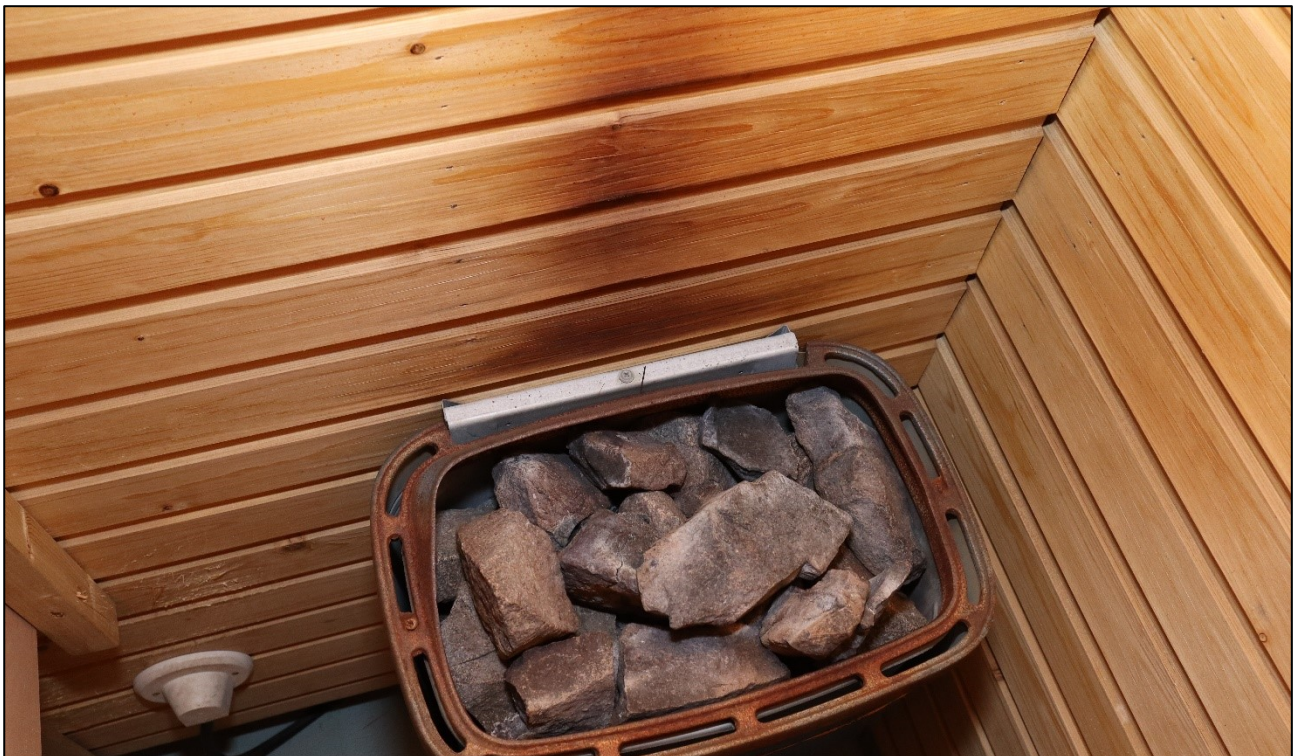
During the investigation, it was found out that the panel wall above the sauna heater had darkened in another apartment in the building where the accident happened. No deformations or other deficiencies were observed in this sauna heater.

Figure 15. The sauna heater in another apartment in the building where the accident happened. The panel wall above the heater has darkened significantly. Some of the topmost stones on the heater were quite large. (Photo: Safety Investigation Authority, Finland)

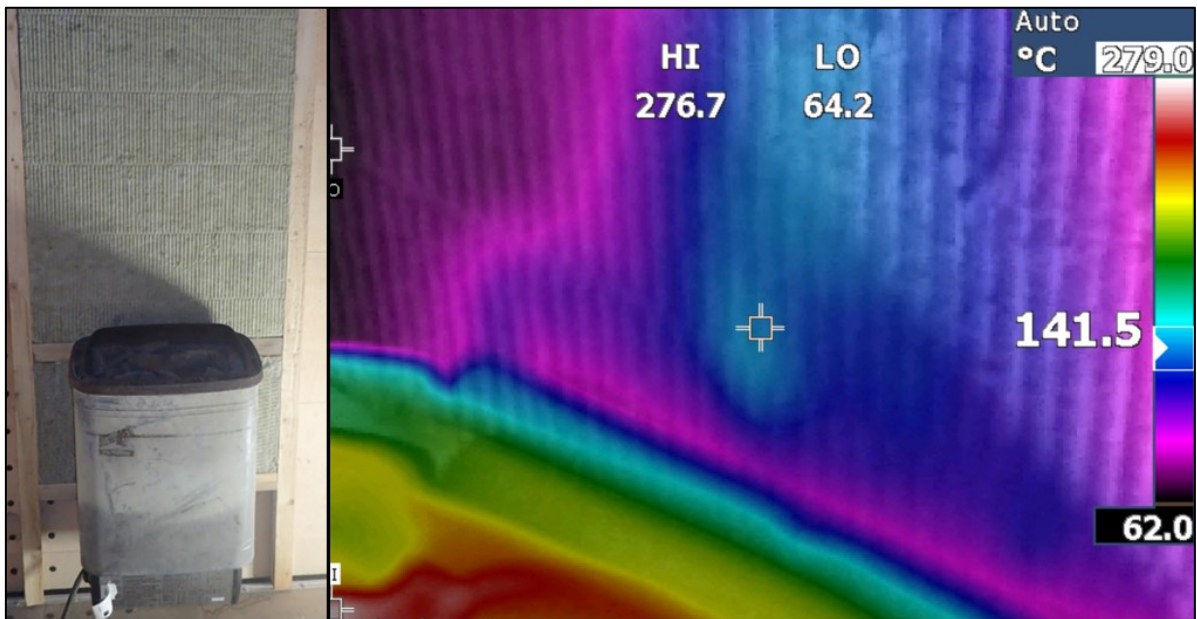
temperature measured during the test was slightly above 140 °C at the spot above the collar of the heater along its centre line. The shapes displayed in the image acquired using an infrared camera correspond well with the darkened area on the wall.

Figure 16. On the left, the heater involved in the accident is attached to a wall lined with insulating wool. On the right, an infrared camera image in which, in the spot indicated by the cursor in the middle, the temperature was slightly above 140 °C. In the lower left corner of the image, the highest temperature above the sauna stones was 276 °C. (Image: Safety Investigation Authority Finland,)

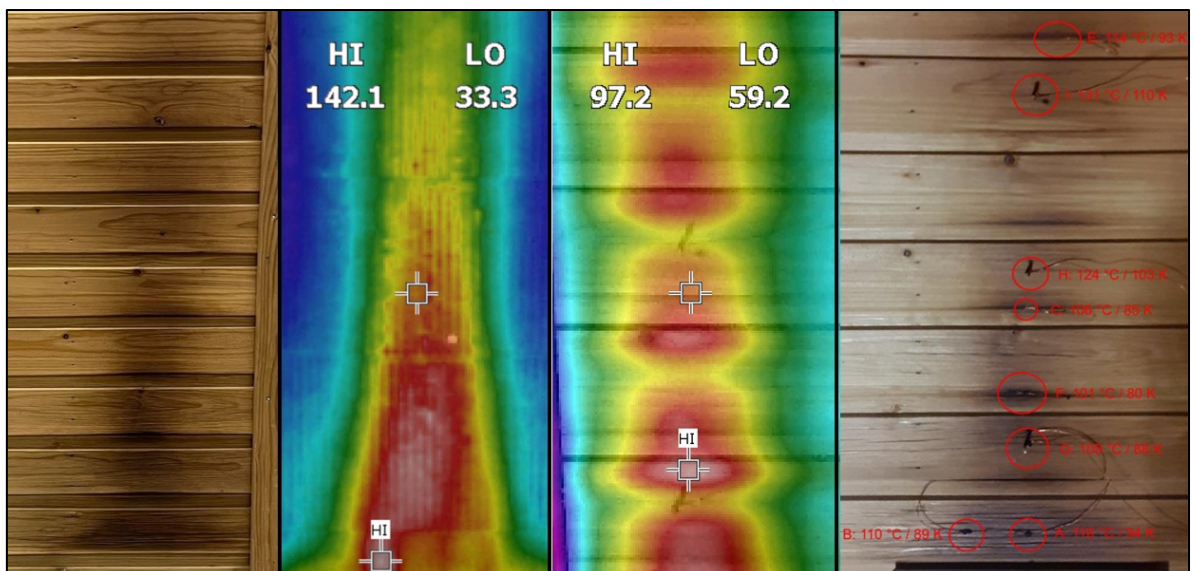
Figure 17. On the left, the darkened wall of another apartment. The second image shows an infrared image of the wall lined with insulating wool taken at the corresponding spot above the heater. At the spot indicated by the cursor in the middle, the temperature was slightly above 140°C. The warm area corresponds well with the darkened wall. The third image shows an infrared image of the panel wall above the heater. The temperature is highest at the seam of the panel. On the right, temperatures observed at different measuring points in the test. The highest temperature measured was 131 °C. (Figure: Safety Investigation Authority, Finland)

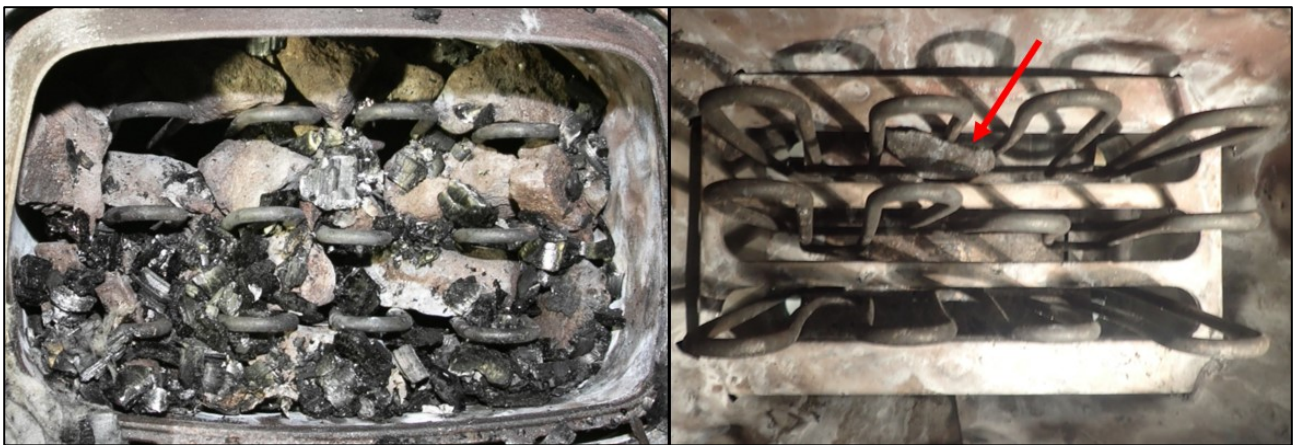
The amount of sauna stones in the heater involved in the accident was normal. The stones were tightly placed in the stone space of the heater and some of them were wedged between the inner casing and the heating elements. Because the heating elements are not supported separately, the stones pressed on them so that they were bent. At least at one point, because of the stones, the heating element had been pressed tightly against the bottom of the stone space. Some of the stones showed discolouration.

Figure 18. On the left, a photo taken during the site investigation, in which about two layers of stones had already been removed from the heater. The stones were in a tight contact both with each other and with the electrical heating elements and the casing of the stone space. The charred pieces of wood had fallen on top of the heater during the fire. On the right, the photo taken after the stones were removed shows one tightly wedged stone that had pressed the heating element against the heater's metal structure. (Photo on the left: the police; Photo on the right: Safety Investigation Authority, Finland)

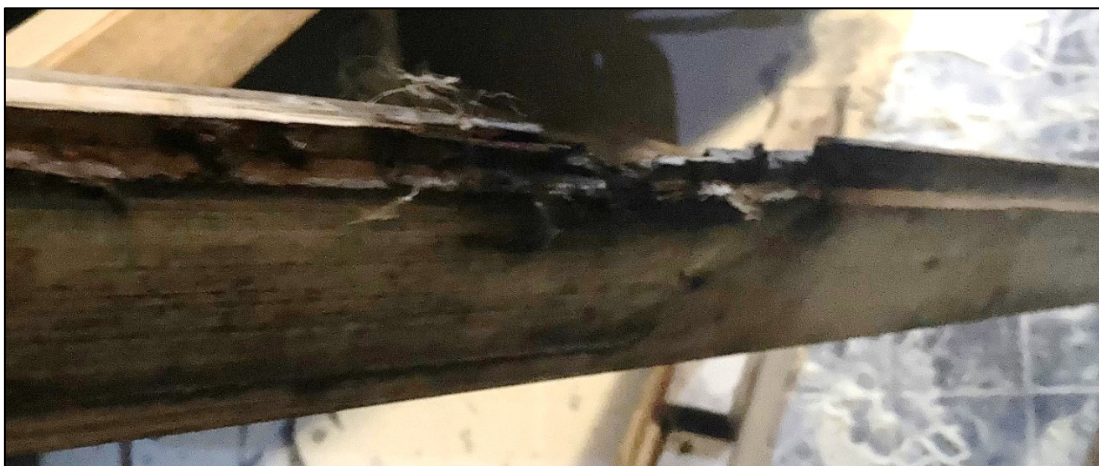
When the site of fire was cleared, the panel behind the upper part of the heater was found to be significantly charred. The most badly charred section was at the middle of the heater.

Figure 20. In the Päijät-Häme fire, the wall panel behind the sauna heater was significantly charred. (Photo: Päijät-Häme Rescue Department)

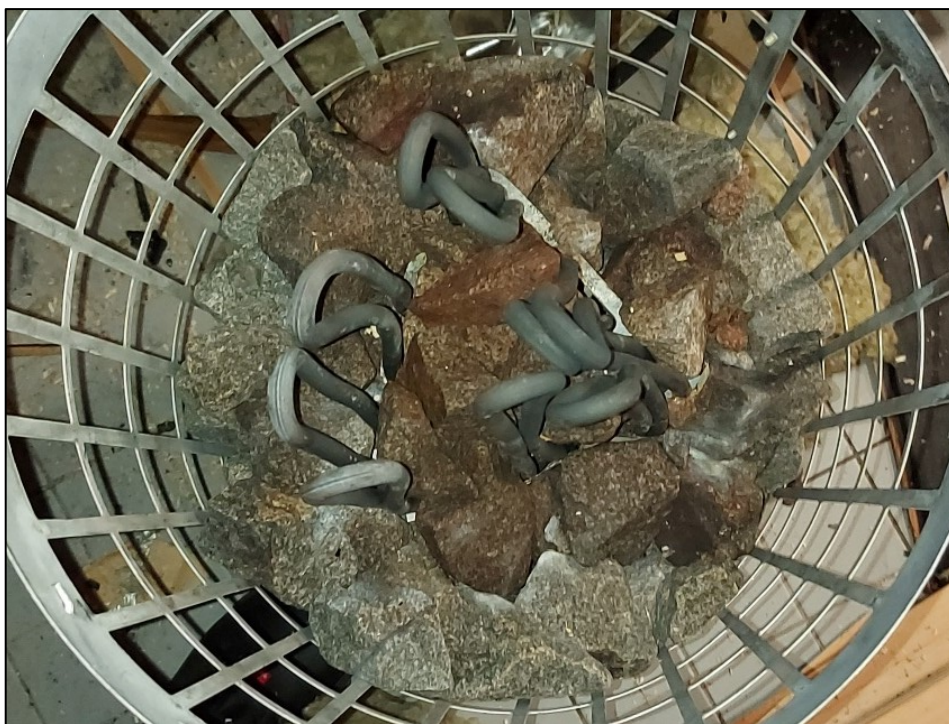
Figure 21. When stones were removed from the heater involved in the fire in Kanta-Häme, it was found out that they were compacted to a significant degree. Heating elements of the heater were bent so that some of them were touching one another. The stones in the middle of the heater were discoloured. (Photo: Kanta-Häme Rescue Department)

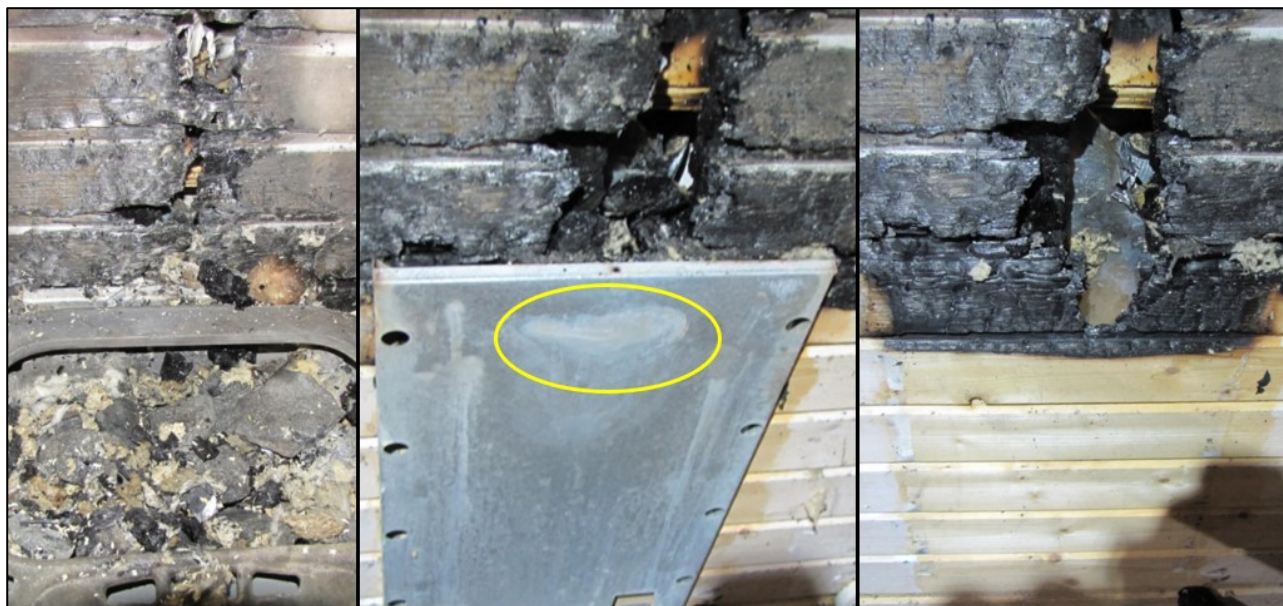
Figure 22. In the fire in North Savo, the fire started at the same point as in the fire under investigation. In the photo on the left, the heater is in place. In the photo in the middle, the heater has been removed and the pattern left by heat is visible on the mounting rack at the same location as in the fire under investigation. Judging by the image on the right, it seems that the panel wall ignited at exactly the same spot where the heat pattern can be seen. (Photo: North Savo Rescue Department)
