Separation of Passenger Door on Instructional Flight East of Pori on August 19, 2022

L2022-03

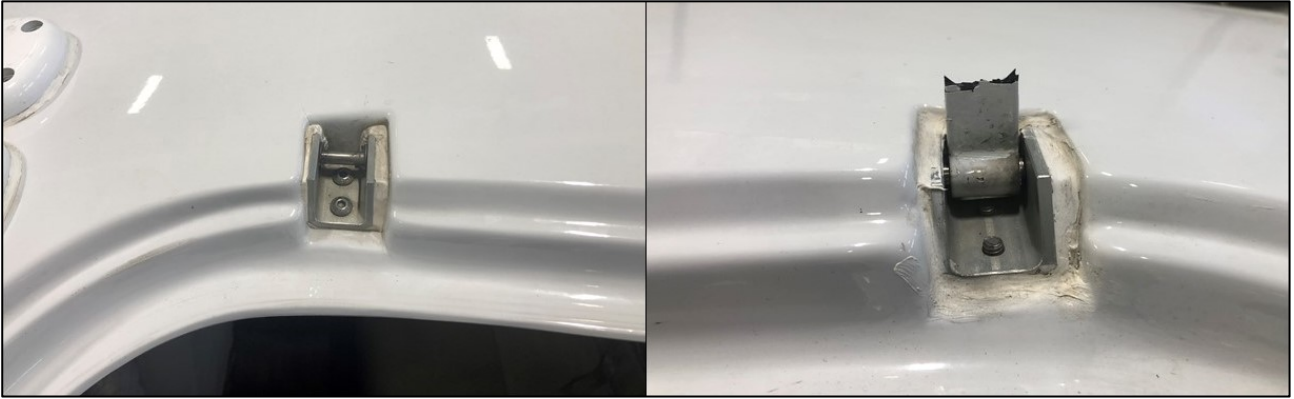
The passenger door was torn off from its hinges and separated from the airplane, taking with it the gas spring strut that assists in door opening and supports the door in open position. The entire forward hinge arm had detached, but the emergency door release pin remained in place in the hinge bracket. The aft hinge arm had fractured, leaving the lower part attached to the

hinge bracket. The airplane sustained no additional damage, and the airframe showed no signs of door impact. The separated door was not recovered. The operation of the door warning system could not be tested during the on-site examination because the airplane could not be powered-up. However, the structure, operation and locking mechanism of the door could be examined using the internal and external controls on another DA42 that was parked in the FINAA's hangar.

Figure 2. Damaged door hinge assemblies. (Photos: SIAF)

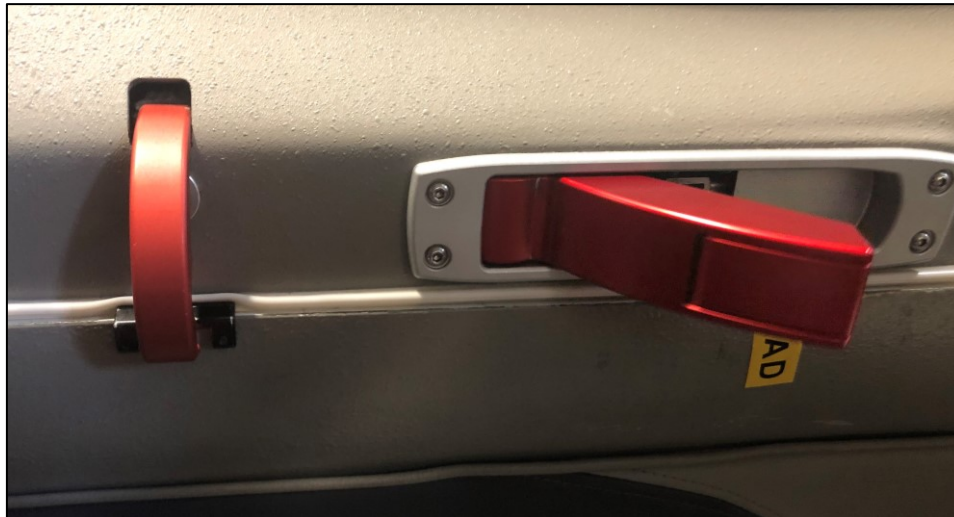
Figure 7. The internal door handle (right) in a partially open position and the safety catch (left). (Photo: SIAF)

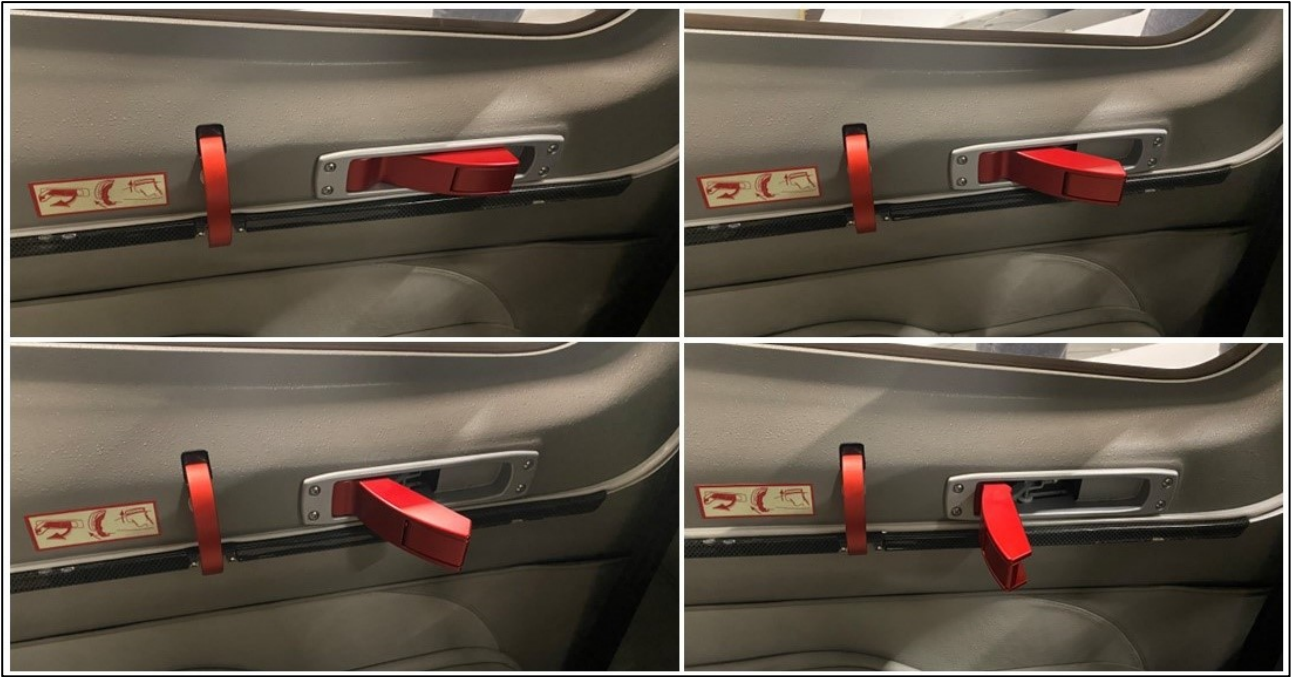
Examination of the internal door handle disclosed that in both airplanes the microswitch indicated a locked condition although the handle was not pressed fully locked. Measurements showed that the handle could be pulled out to approximately 30° angle until an unlocked condition was indicated. Therefore, it is very easy to close the door and leave the door handle not fully locked, without this being sensed by the warning system. Neither does the mechanism snap the handle into the fully locked position, and therefore the handle needs to be pushed into the end position. The locking pins disengaged from the guide plate holes when the handle was pulled out to approximately 50° angle, which allows the door to open to a position where it is held only by the safety catch. When the handle is moved toward open position and the locking pins disengage from the guide plates, the compression gas spring snaps it into the end position, and the door becomes fully unlocked.

Figure 10. The internal door handle in four different positions. Top left: the handle is in the fully locked position. Top right: the handle is at approximately 30° angle; an unlocked condition is indicated. Bottom left: the handle is at approximately 50° angle, locking pins have disengaged from the guide plate holes, and the safety catch holds the door in near closed position. Bottom right: the handle is in the fully unlocked position. (Photos: SIAF)

Diamond Aircraft Industries modifies the door locking mechanism to allow operators to achieve and verify the fully locked condition without undue difficulty. The warning system should also alert the crew members if the door is not fully locked. [2023-S23]

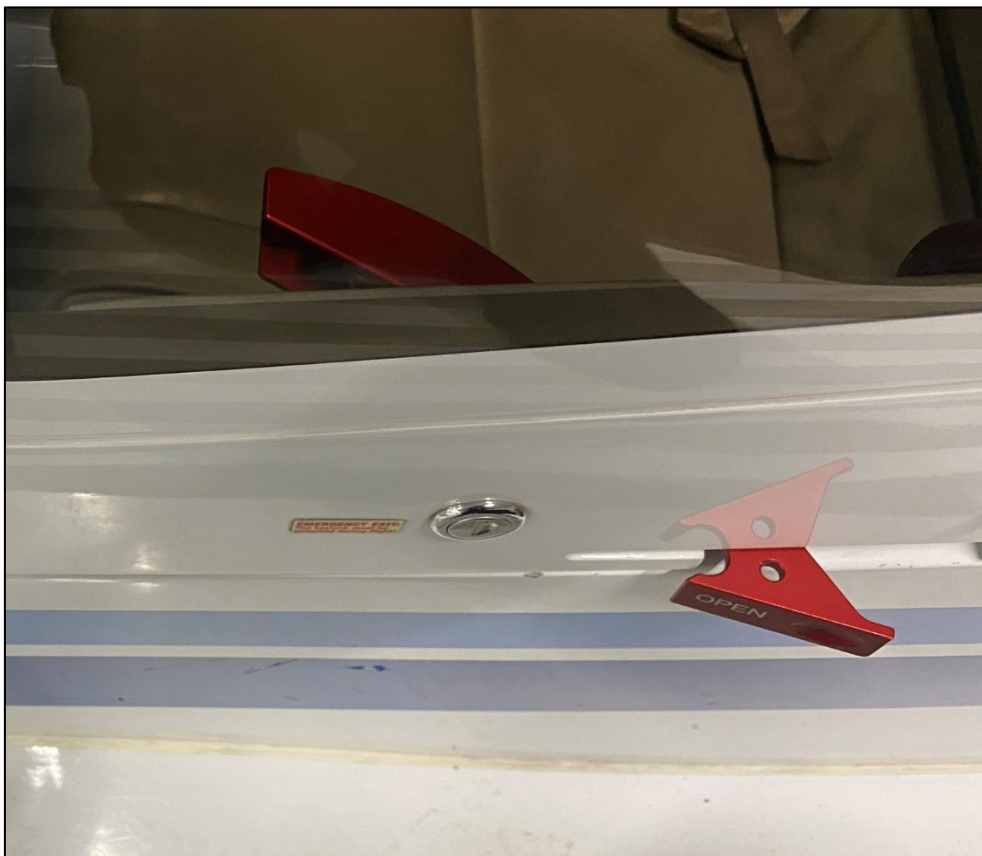
Figure 11. The external and internal door handle in the position that triggers the door warning. (Photo: SIAF)

When the door is held by the safety catch and is in near closed position, the locking pins are not aligned with the guide plate holes and the door cannot be locked solely by pushing the handle but should be simultaneously pulled towards closed position for locking.

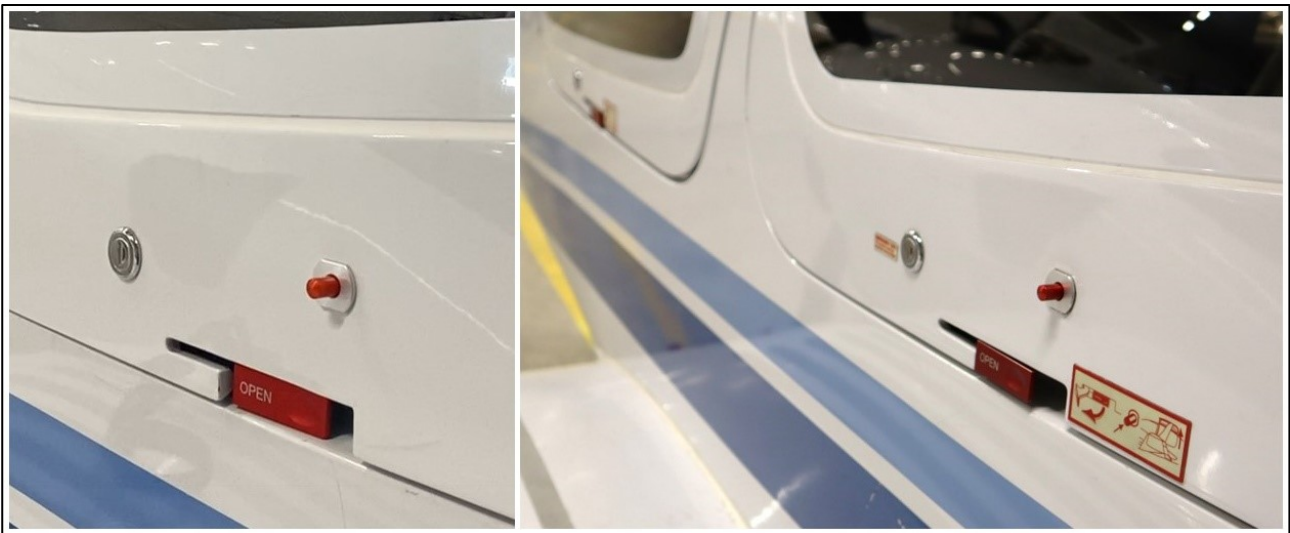
The external door handle is mechanically connected to the internal handle and follows its movements. Examination of the two airplanes disclosed differences between handle positions with the handle in the fully locked position. In one airplane, the handle was visibly recessed in the door frame, while in the other, it was slightly proud of the frame surface. Depending on the airplane, to achieve full locking from the outside, it may be required to apply pressure on the handle until it becomes recessed in the door frame. On the other hand, in some airplanes the handle will not necessarily be in the fully locked position although it is flush with the frame.

Figure 12. The fully locked position of the external handle appeared different in the two airplanes. Left (OH-DAN with a new door): the handle is recessed by approximately 8 mm. Right (OH-DAM): the handle is slightly proud of the door frame. (Photos: SIAF)

The minor differences found between external handle positions have no significant effect on locking pin position, and the door is fully locked regardless. Furthermore, when the pins leave the fully engaged position, the pilots can clearly identify a “not closed” condition from the internal handle position.

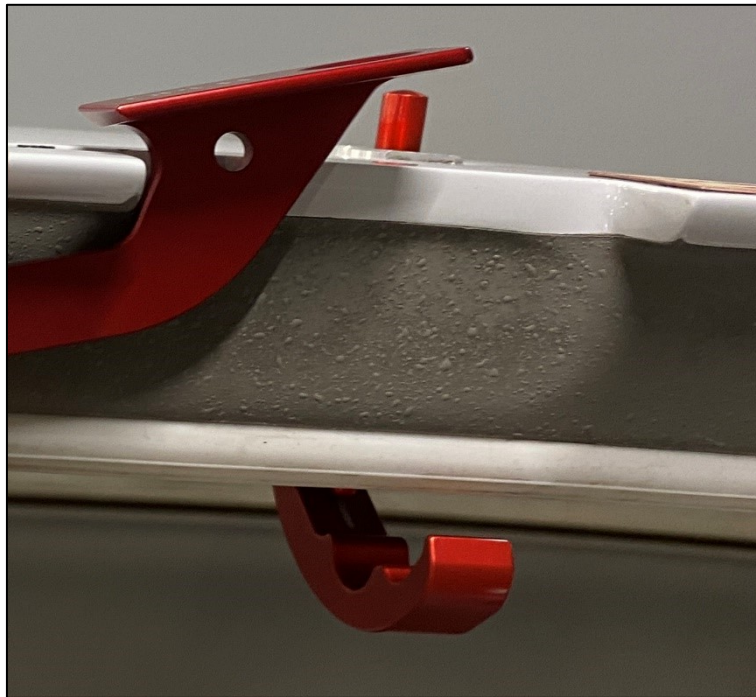
Figure 14. The external door handle in the position where the compression gas spring snaps the handle into the fully locked position. (Photo: SIAF)

handle until it is recessed in the door frame; from this follows that the flush position will not necessarily indicate a fully locked condition. Both handles should always be pushed into the end position because the compression gas spring alone cannot snap the handle into the fully locked position. The stiffness of the locking mechanism varies between airplanes and depending on the history of door operation.

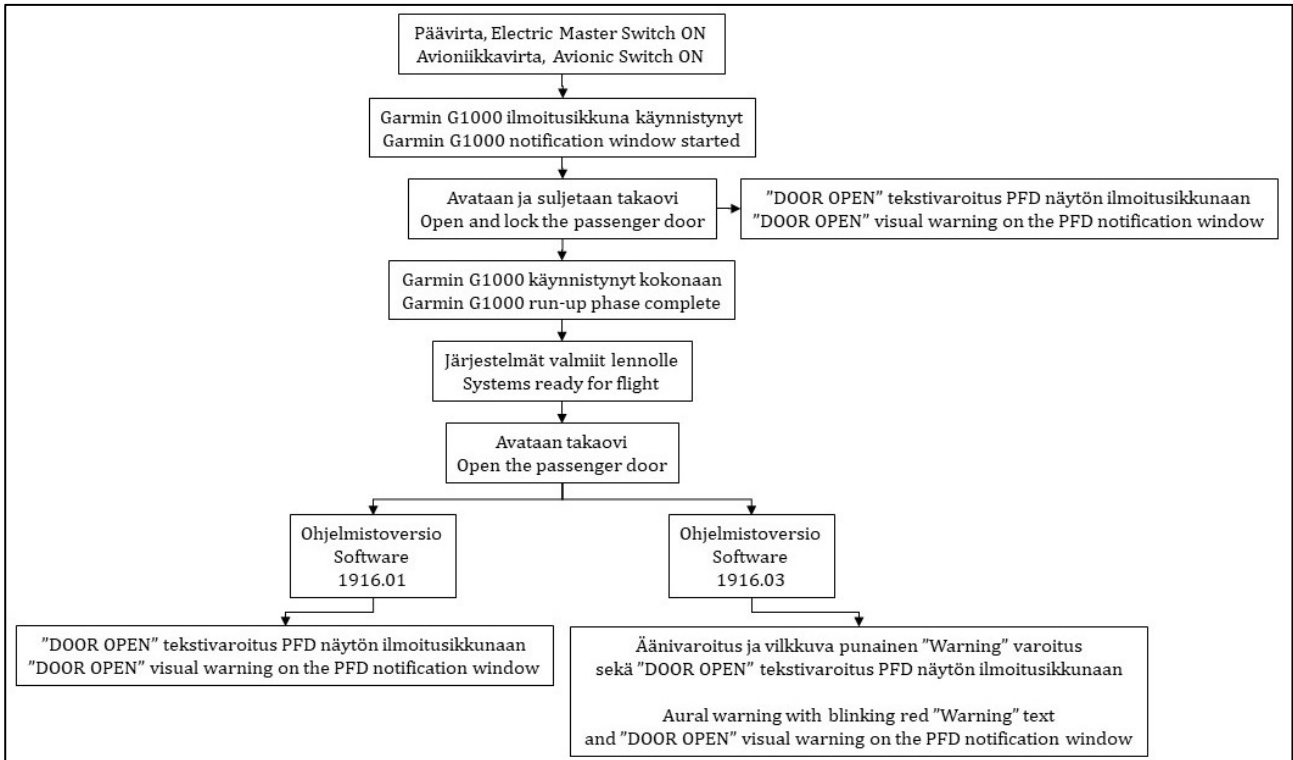
The tests revealed that with the software (1916.01) installed in the incident airplane at the time of the occurrence, a condition where door opening did not trigger the aural warning could be replicated. In this condition, the electric master switch was set to ON and G1000 run-up was in progress. The baggage doors, the canopy and the passenger door had been closed and locked. The passenger door was opened and locked after the PFD notification window

appeared but before G1000 run-up was complete. When the systems were ready for flight, the door was opened, which caused a red “Door open” warning in the notification window, but the aural warning did not sound and the blinking “Warning” text did not appear in the bottom right corner of the PFD. When the door was then locked and opened a second time, all alerts operated normally. The test sequence was repeated in the other airplane, that was fitted with updated software (1916.03). In this case, the warning system operated normally regardless the phase of G1000 run-up, and both aural and visual warnings were received.

Figure 15. The door warning system test sequence and findings. The older software (1916.01) did not trigger the aural warning on door opening. (Diagram: SIAF)

Two cases where the warning did not sound were observed during tests with the software installed in the incident airplane. One of these matched the system description in that the passenger door remained unlocked and the "Door open" warning appeared on the PFD. In the other case, the door was opened and then locked after the notification window had appeared but before G1000 run-up was complete. In this case, the aural warning did not sound on the next opening of the door. When test was repeated with the new software installed, the warning sounded. It is possible that a similar situation occurred on the incident flight. The crew members noted the "Door open" warning only after door separation, but the aural warning did not sound. Operators are generally unfamiliar with the conditions required for door warning system energizing.
