INTERIM REPORT

Safety Investigation Authority Finland, July 10, 2025

AVIATION ACCIDENT NEAR EURA AERODROME ON MAY 17, 2025

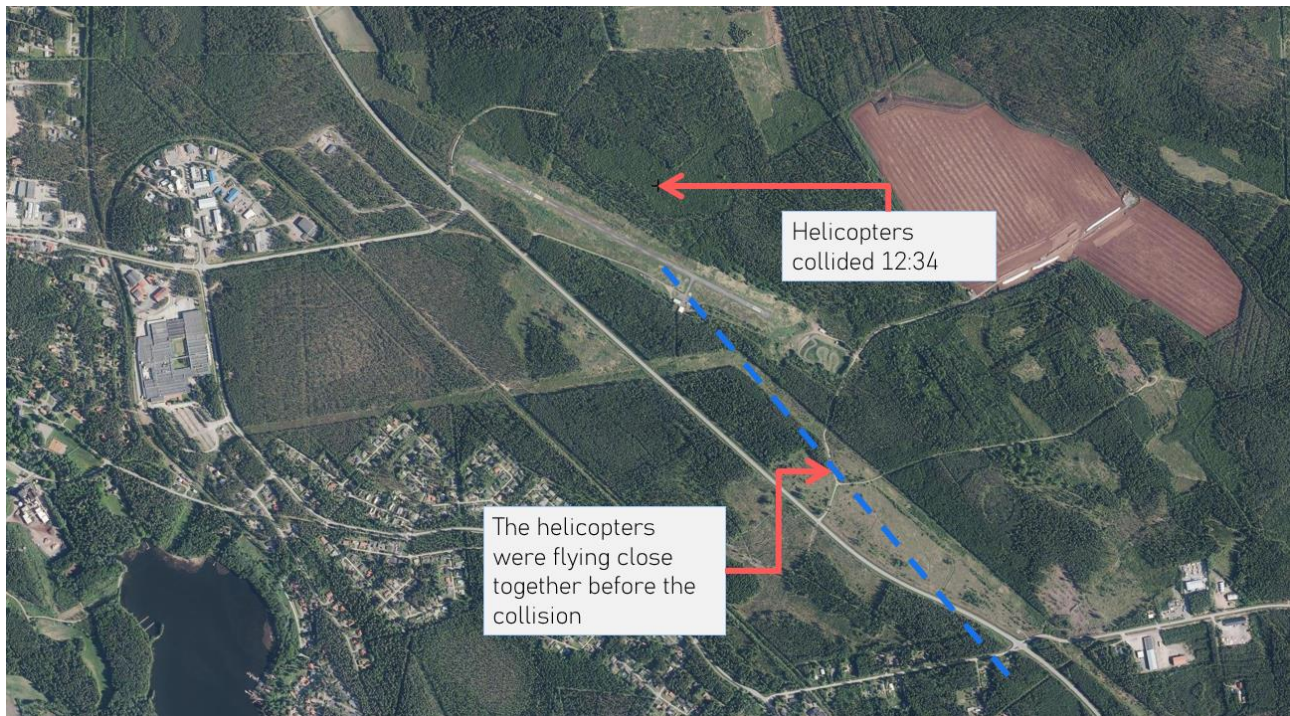
The collision occurred at 1234 local time to the northeast of the runway at approximately 200 m above ground level. The tail boom of each helicopter separated on impact, and the main rotor systems disintegrated. Debris scattered over a large area in forested terrain north of the aerodrome. Post-crash fire consumed the fuselage of ES-ETR.

Figure 1. Aerial view of the accident location with the helicopters' track marked in blue. The red arrow indicates the collision point. (Aerial view: National Land Survey of Finland, annotations by SIAF)

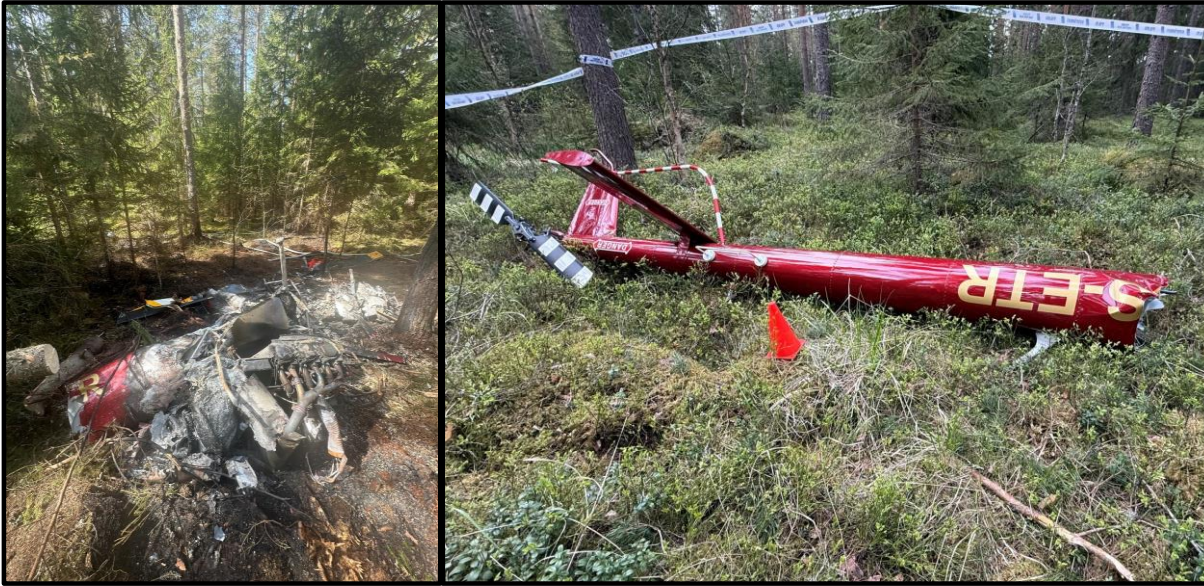
Figure 2. Wreckage of ES-ETR. The fuselage with a section of the main rotor system (left), and the tail boom (right). The marking cone was placed by investigators. (Photo: SIAF)

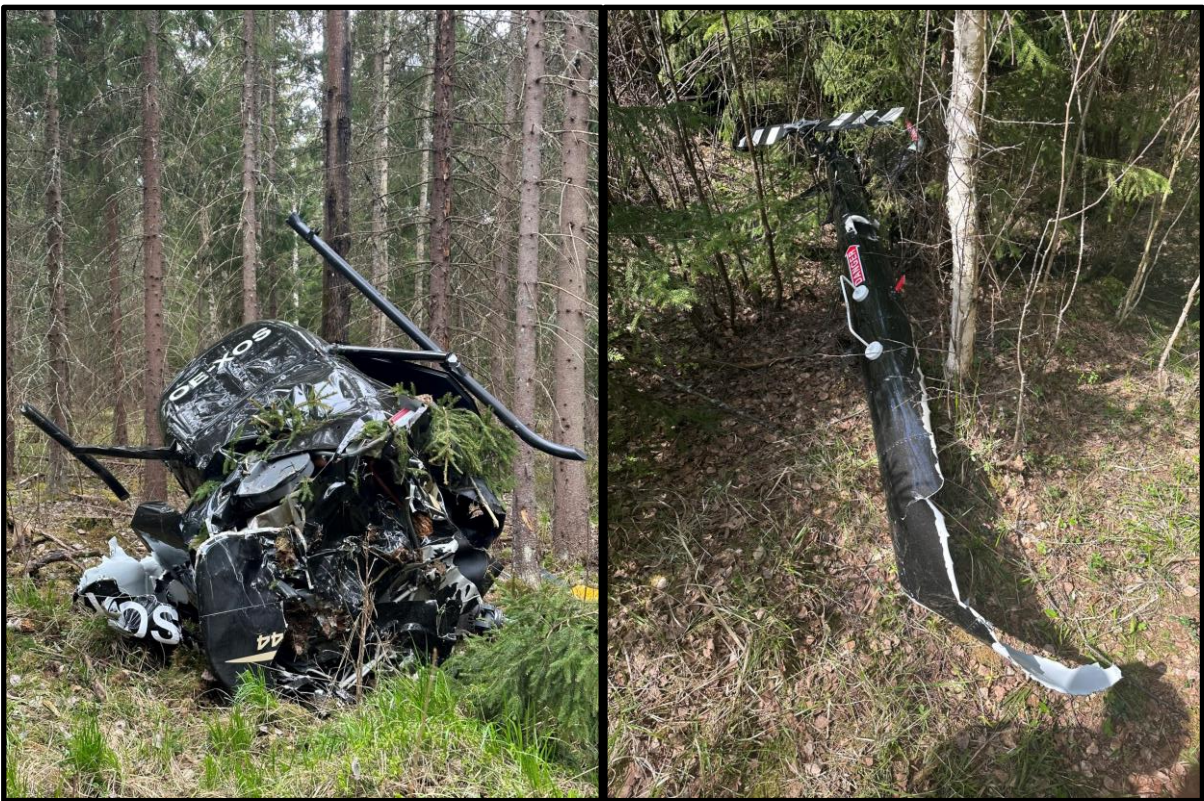
Figure 3. Wreckage of OE-XOS. The fuselage (left), and the tail boom (right). (Photo: SIAF)
