Investigation report

C5/2009M

M/V EMSRUNNER, grounding off Kalajoki on 11.12.2009

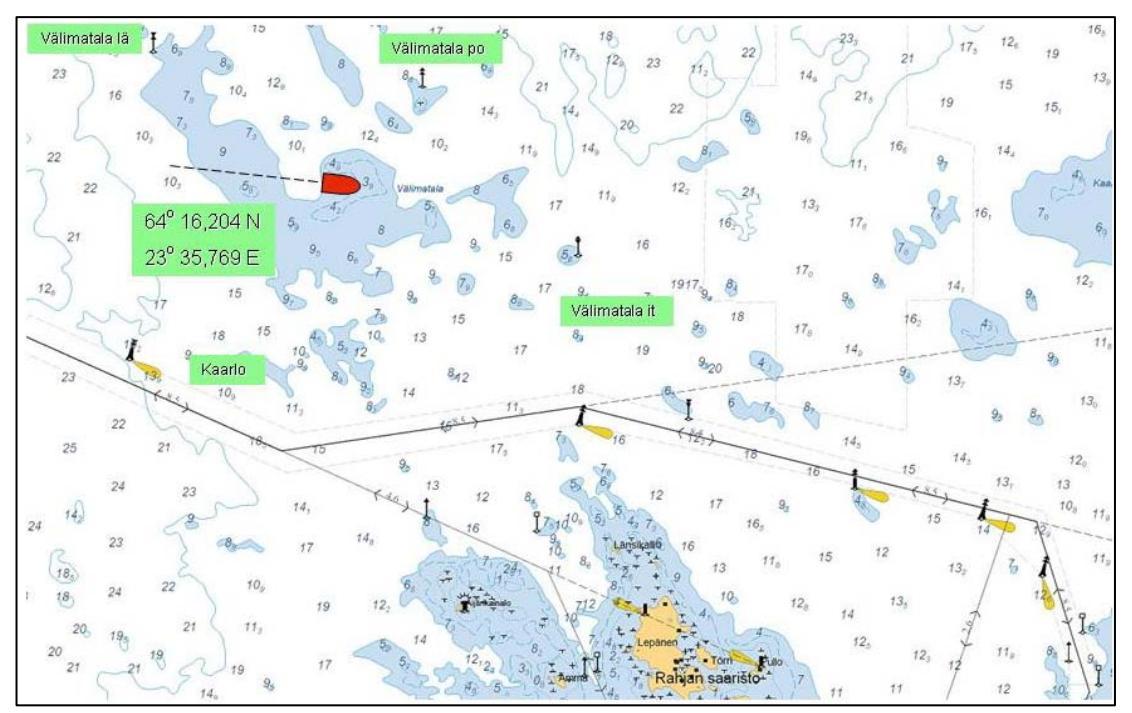
The ship grounded on the Välimatala shoal to the north of the fairway¹. The shoal is marked with three spar buoys. According to the map, the depth in the middle of the shoal is 3.9 metres.

Picture 5. The location and area of the accident.

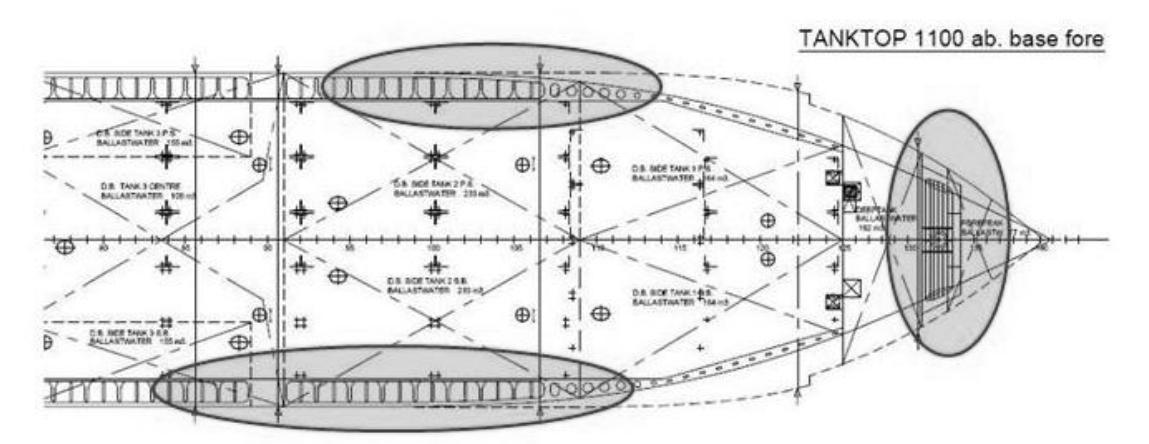
The vessel got tears to the bow ballast tank to her port side, dents to the fore peak area, tears to the bilge keel and some dents to bottom plates on starboard side. Furthermore there were some damages in the bow thruster room. There were no leakages or environmental damages.

On the day after the accident, inspections performed and photographs taken by divers noted that the ship was dented in the fore peak area on the Port side, and torn on the left ballast tank area between frames 120–125. Other damage included dents on the SB side between frames 85–109, a tear in the bilge keel on frame 87, and dents around the bottom. In addition, two propeller blades were damaged.

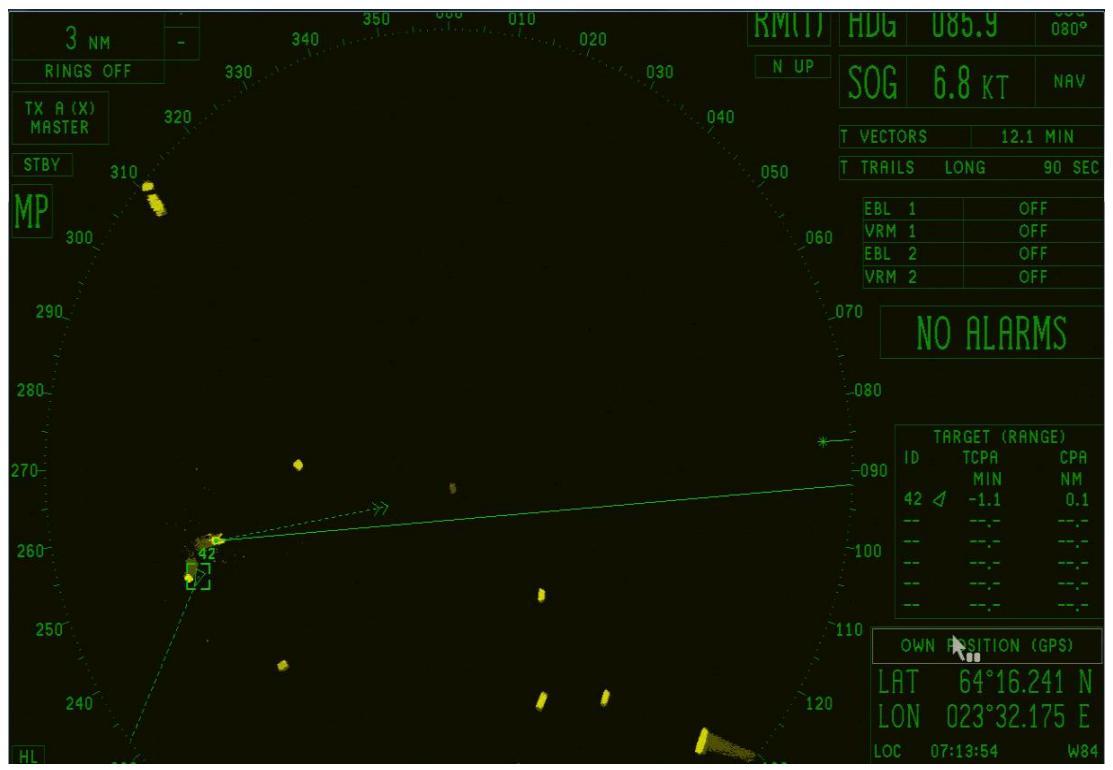
Picture 8. At 8.14.35 the heading of the ship has changed from 080 to 086 without separate orders. The pilot cutter departs for the harbour.

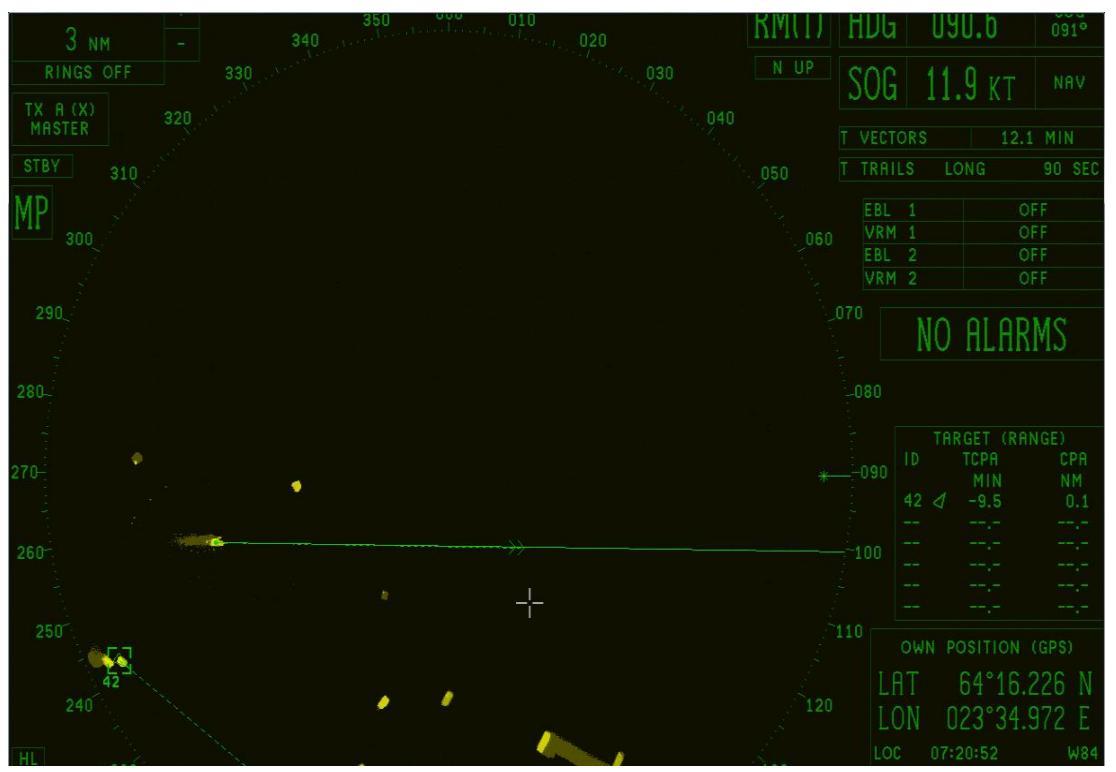
Picture 13. At 8.21.10 the pilot discusses the situation with the cutter operator. The true location of the ship is revealed, and he states that he will turn the ship to the south as suggested by the cutter operator. At 8.21.40 The pilot requests the Master to temporarily decrease the speed to half.

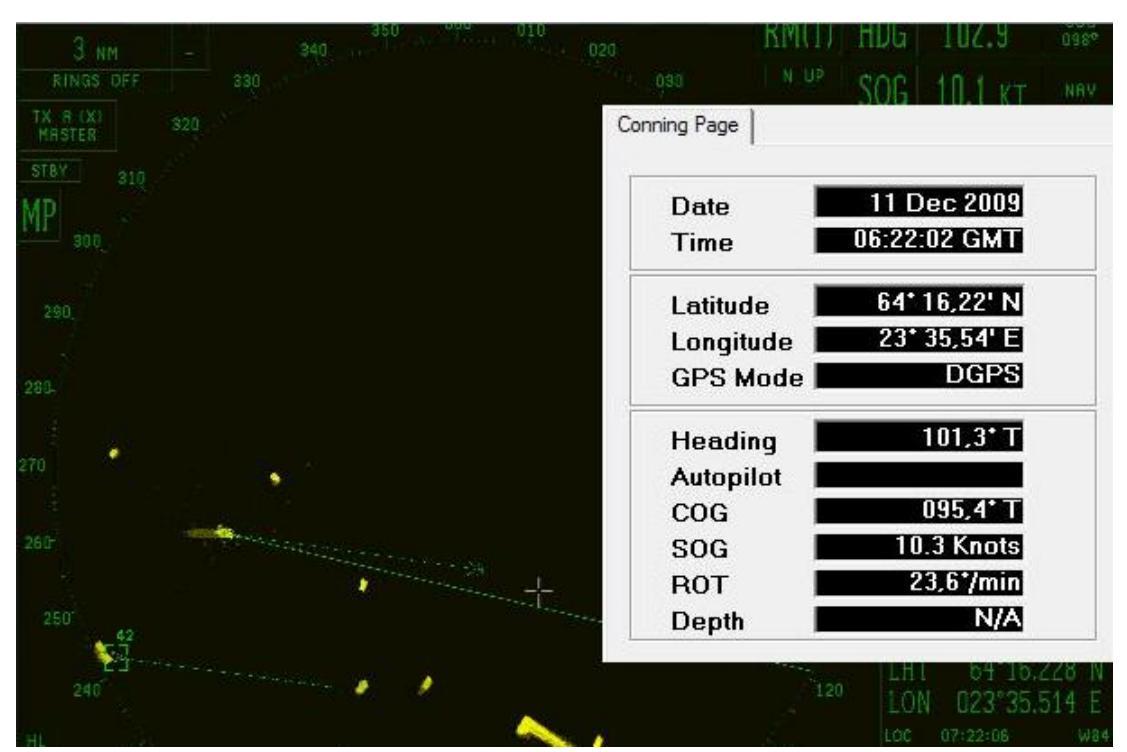
Picture 14. At 8.22.02 the first bottom contact takes place. Speed: 10.3 knots, heading: 101.3°, bearing: 095.4°, rate of turn: 23.6°/min. The cutter remains by the Kaarlo ice buoy.

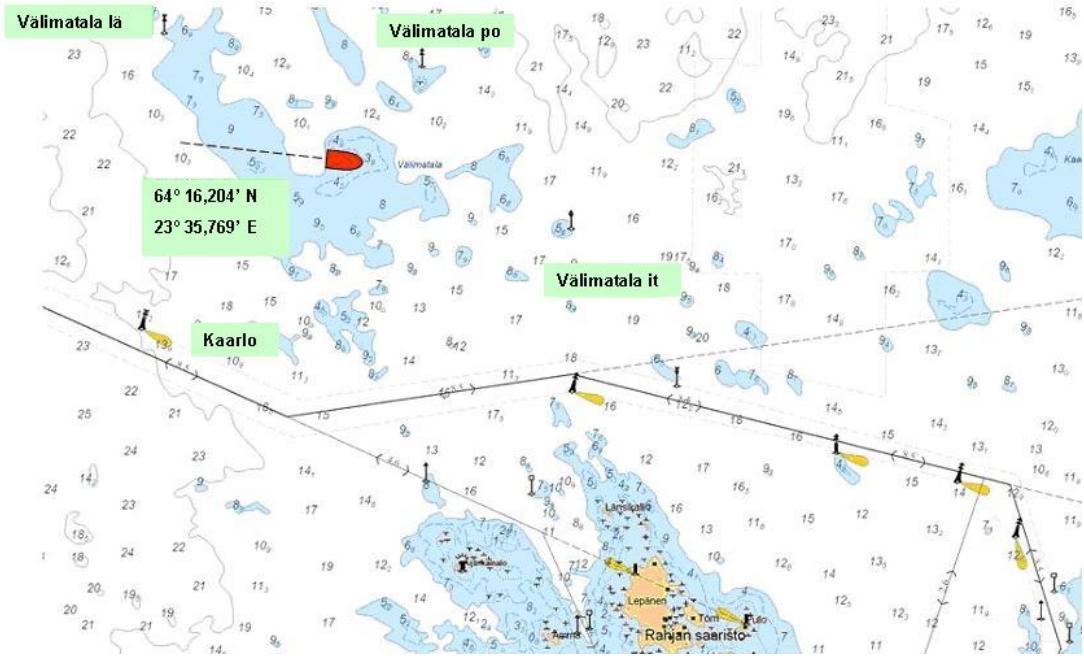
Picture 16. The ship continued on her course, making more bottom contacts, until it stopped within approximately one minute.
