### Investigation report

M2012-02

### M/S PHOENIX J (ATG) grounding off Rauma 18.4.2012

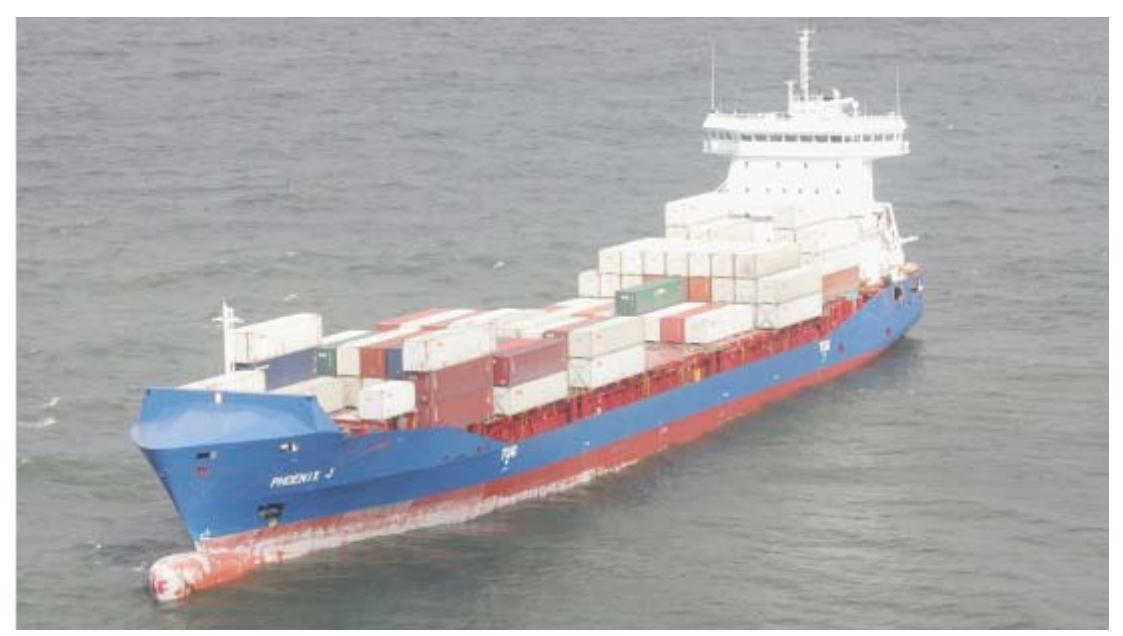
Figure 1. M/S PHOENIX J aground. Photo: the Finnish Border Guard.

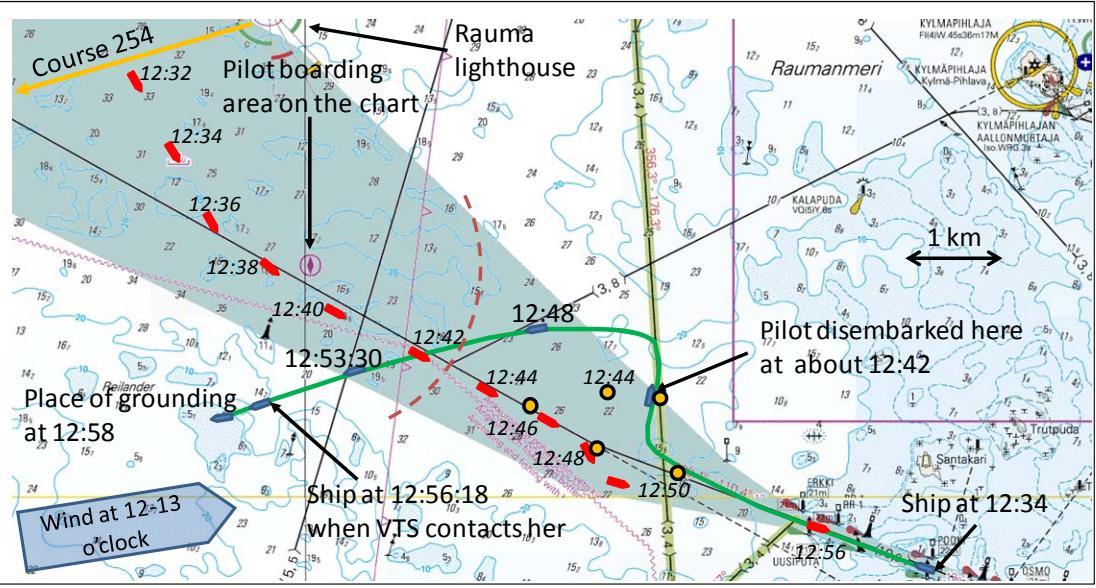
Figure 7. The accident area. The route of the PHOENIX J is indicated in green colour and it is based on the AIS data recording (VTS). Red colour has been used to indicate the position of the HARBOUR FOUNTAIN with the interval of two minutes, times in italics. The orange/black circle has been used to indicate the position of the pilot boat while it moved from one vessel to the other. The brown broken curve is in the distance of 1 Nm from the pilot boarding area. After the disembarkation of the pilot the PHOENIX J turned too early to the course leading to Gävle from the Rauma lighthouse (254 degrees).

The pilot boarding place has been marked clearly on the chart (violet diamond inside a circle). The pilot left the vessel before the pilot boarding area marked on the chart. This practice is usual in Rauma when there are strong westerly winds.

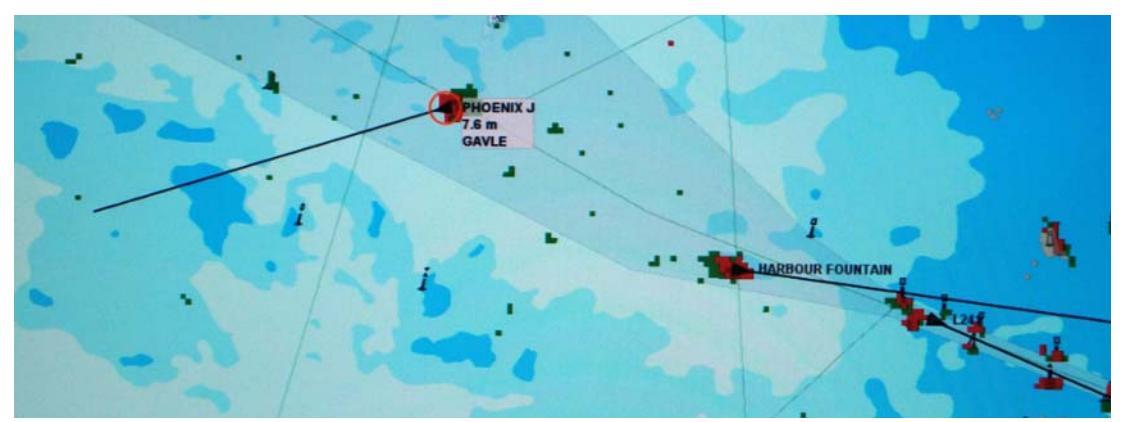
The West Coast VTS monitored the movements of the outbound PHOENIX J and the inbound HARBOUR FOUNTAIN. The VTS operator<sup>14</sup> monitored more closely the latter one, because the embarkation of the Pilot took place on the southern edge of the fairway area and in addition close to an edge mark, Figure 8a.

Figure 8a. The positions of the vessels and the pilot boat at approx. 12.52.

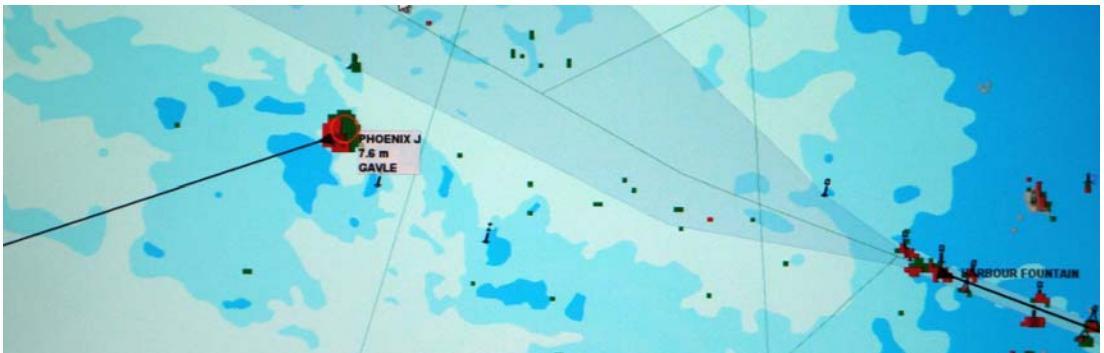
The pilot boat left the side of the HARBOUR FOUNTAIN at 12.48.20 (Appendix 1) and the Pilot informed at 12.51.32 that he was onboard the HARBOUR FOUNTAIN. The VTS operator had zoomed the display to monitor the HARBOUR FOUNTAIN, which was in the narrowing part of the fairway and approaching a narrow, dredged fairway section. The PHOENIX J could not be seen on the display. After this the VTS operator zoomed out the display outlook, which then for some time became dark. When the display was functioning again, the PHOENIX J had passed the edge of the fairway area, but it had not turned on the line leading out. The vessel was close to position from which a 5.5-metre deep fairway leads southwards, Figure 8b.

Figure 8b. The vessels' positions at approx. 12.56.

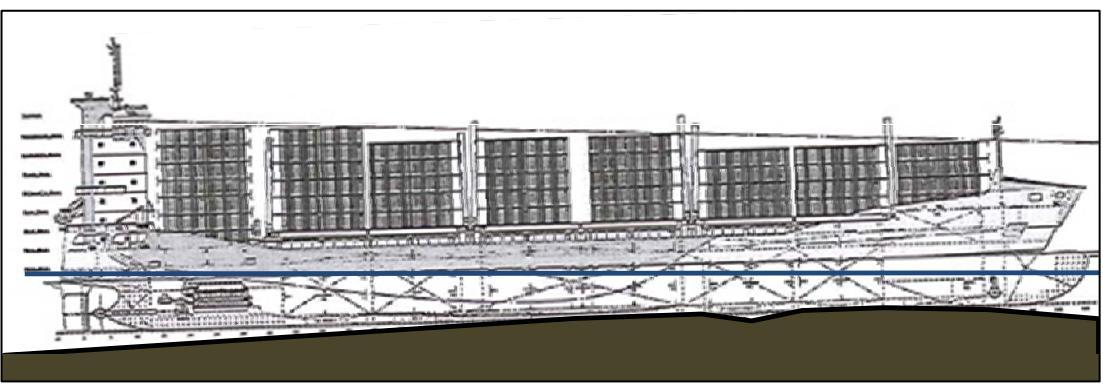
Figure 9. PHOENIX J aground. The number of containers shown in the figure is a theoretical maximum (source: the shipping company webpage). Figure 1 shows the number and location of containers at the time of the accident.

According to the diver's report<sup>17</sup> the vessel was aground from midships towards the bow (between the frames 90–118 and 138–153), Figure 9. Her forward draught was approx. 5 m and the aft draught was approx. 8.7 m, and she had a starboard list of approx. 2.5 degrees<sup>18</sup>.

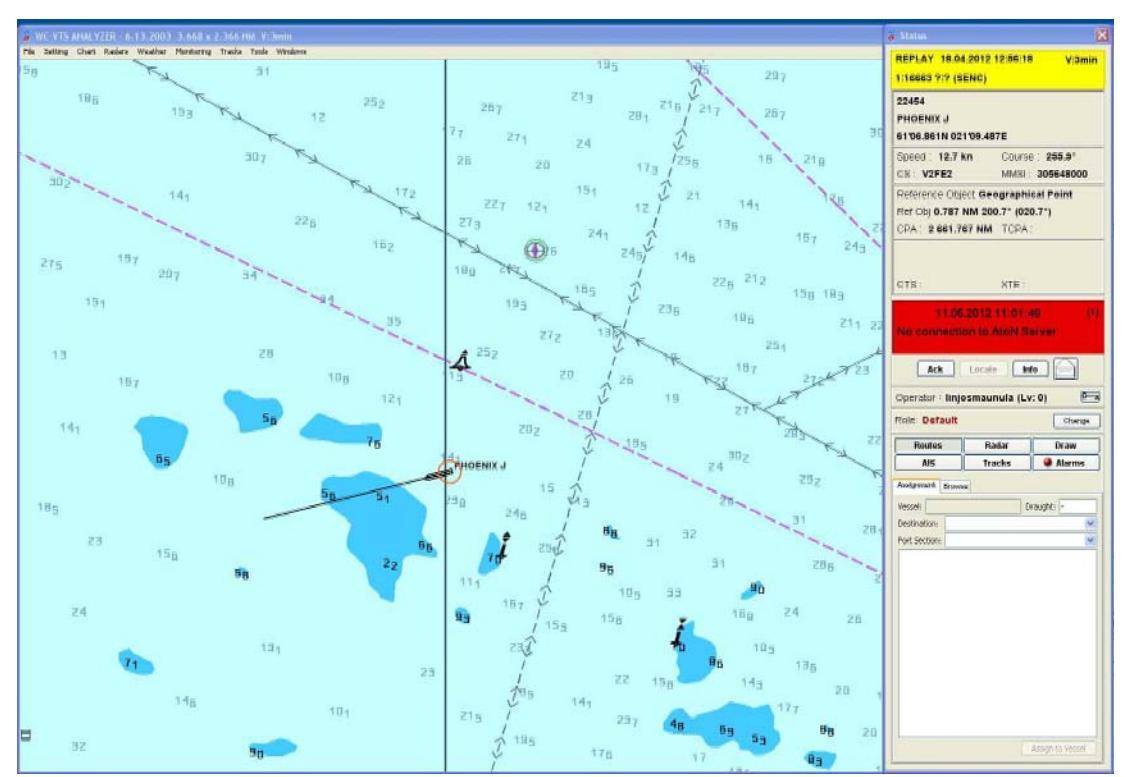
Figure 10a. The position of the PHOENIX J when the VTS started the approx. 20second-long communication at 12.56.18. Print screen from the VTS recording.

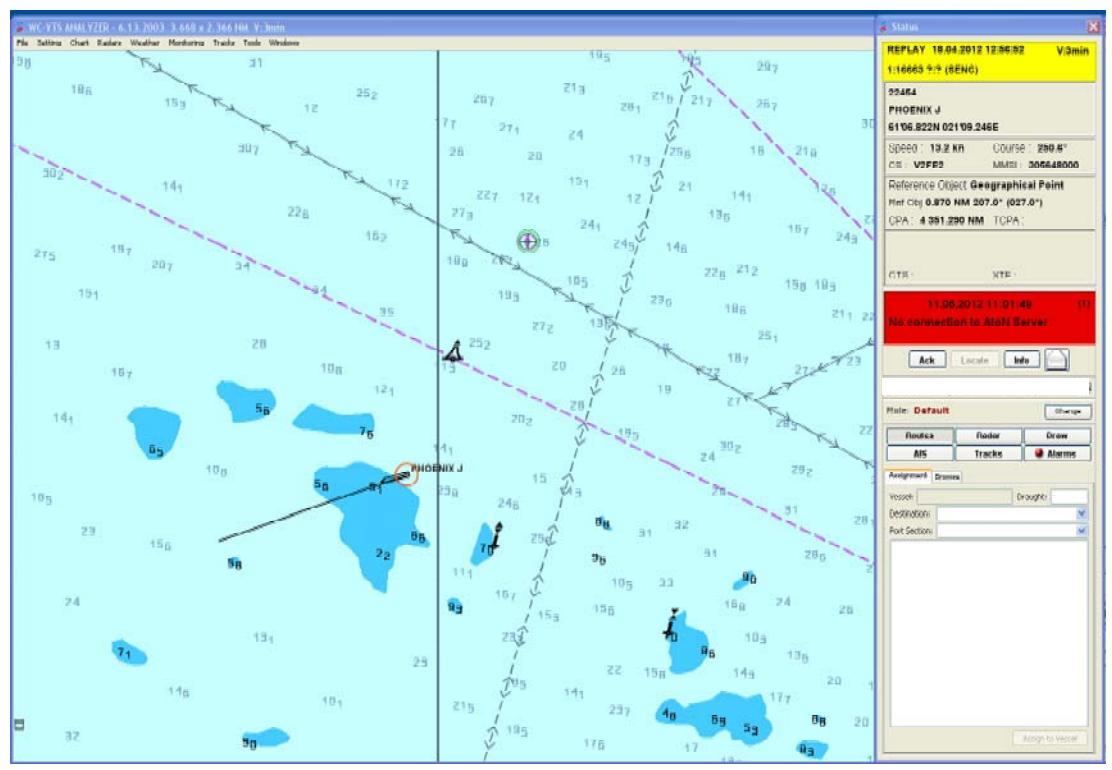
Figure 10b. The PHOENIX J about to run aground with the speed of 13.2 knots at 12.56.52. Print screen from the VTS recording.

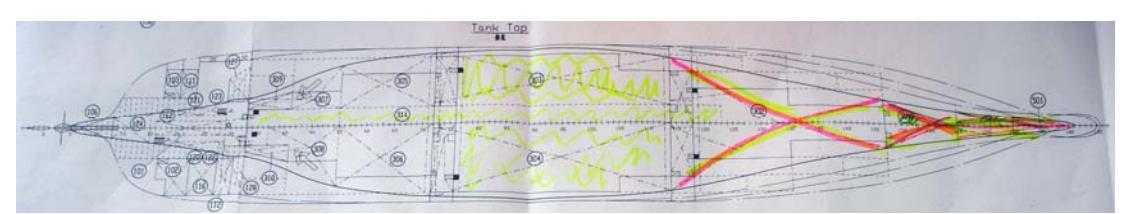
It was concluded in the inspections that there was water in the aft part of cargo hold number 1 as well as in the pipe tunnel.

Figure 11. The extent of the leakages. Drawing Germanischer Lloyd.

The even part of the vessel's bottom from midships towards the bow, extending between frames 90 and 183, had been damaged. There were fractures and dents in the bottom plates. In addition to the pipe tunnel, there were leakages in the following ballast tanks: forepeak, double-bottom tanks 1 and 2 in the middle and 3 on the starboard side. There was a leakage in cargo hold number 1. The water level in the cargo hold remained at 15 cm with the help of the vessel's own pumps. The bottom of the hold had risen somewhat up on a large area and split at frames 122–124, next to the longitudinal bulkhead. Several cracks, which were as long as 600 mm and as deep as 400 mm, were detected in the area of the even bottom between the frames 95 and 183, to port from midships (Figure 13). The bulkhead of the starboard side heavy fuel oil tank on frame 118 had buckled just above the bottom of the hold. No leakages were detected in the heavy fuel oil tanks (Figures 11, 12a and 12b).

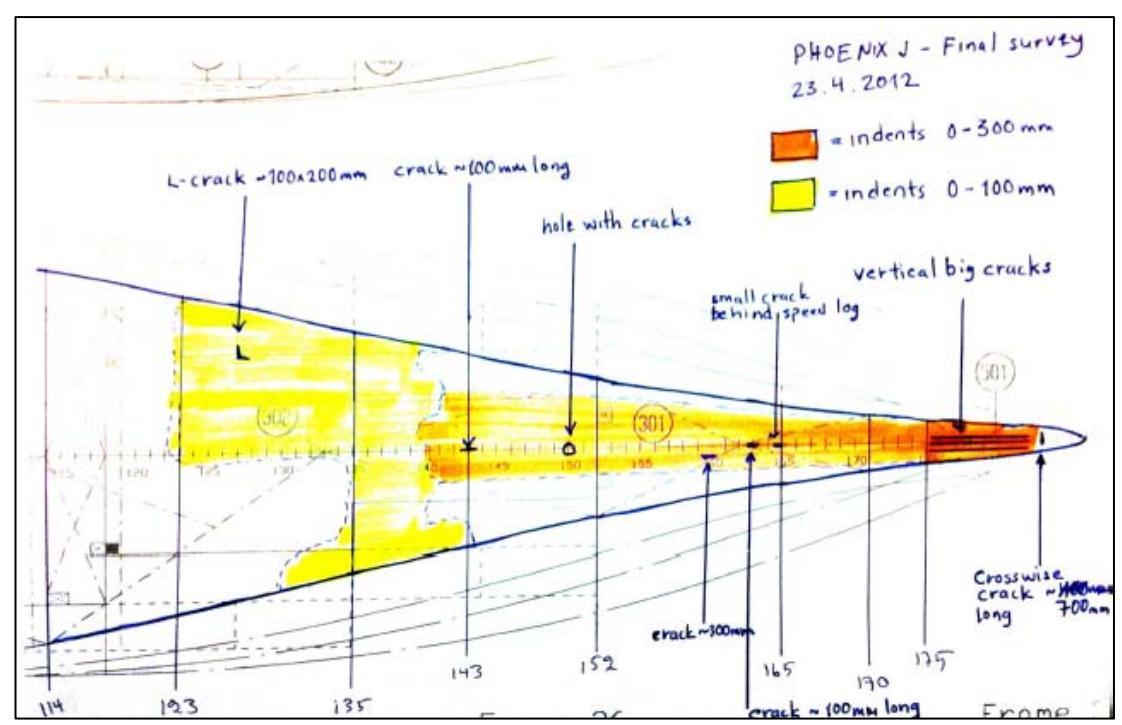
Figure 12a. A graph by the classification society on the damages to the bow. Drawing Germanischer Lloyd.

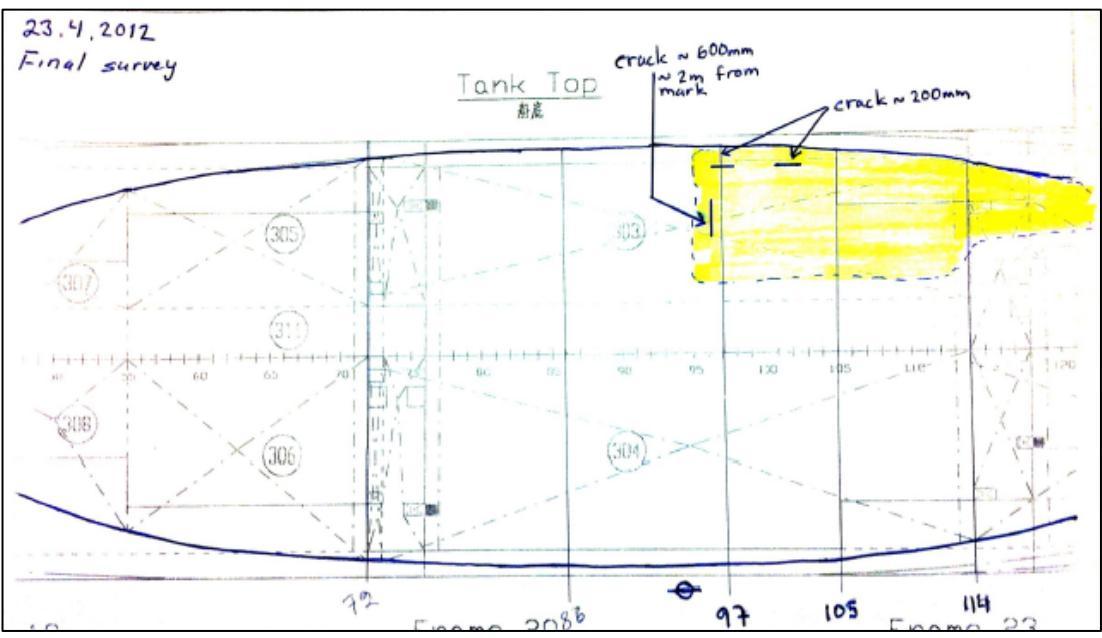
Figure 12b. A graph by the classification society on the damages more aftwards. Drawing Germanisher Lloyd.

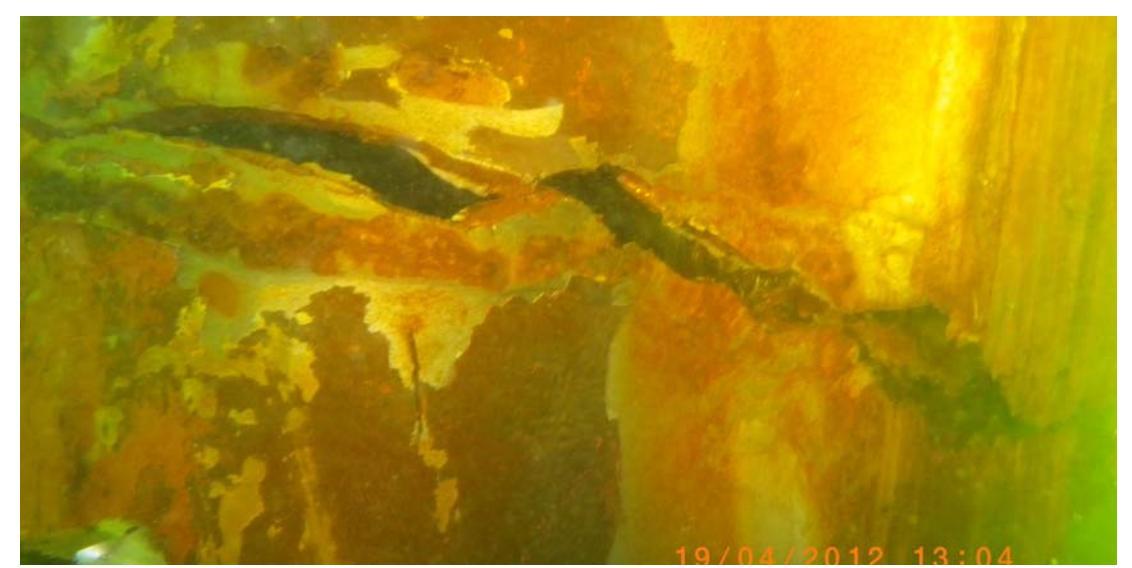
Figure 13. Crack at the bow on frame 182. Photo taken by the diver.

On the request made by the Finnish Transport Safety Agency the vessel's cargo was unloaded. After getting a written permission, the vessel left for a dockyard in Germany without assistance. The classification inspection of the repairs to the vessel was carried out in Bremerhaven on 1.8.2012. Altogether 13 new double bottom sections were installed.

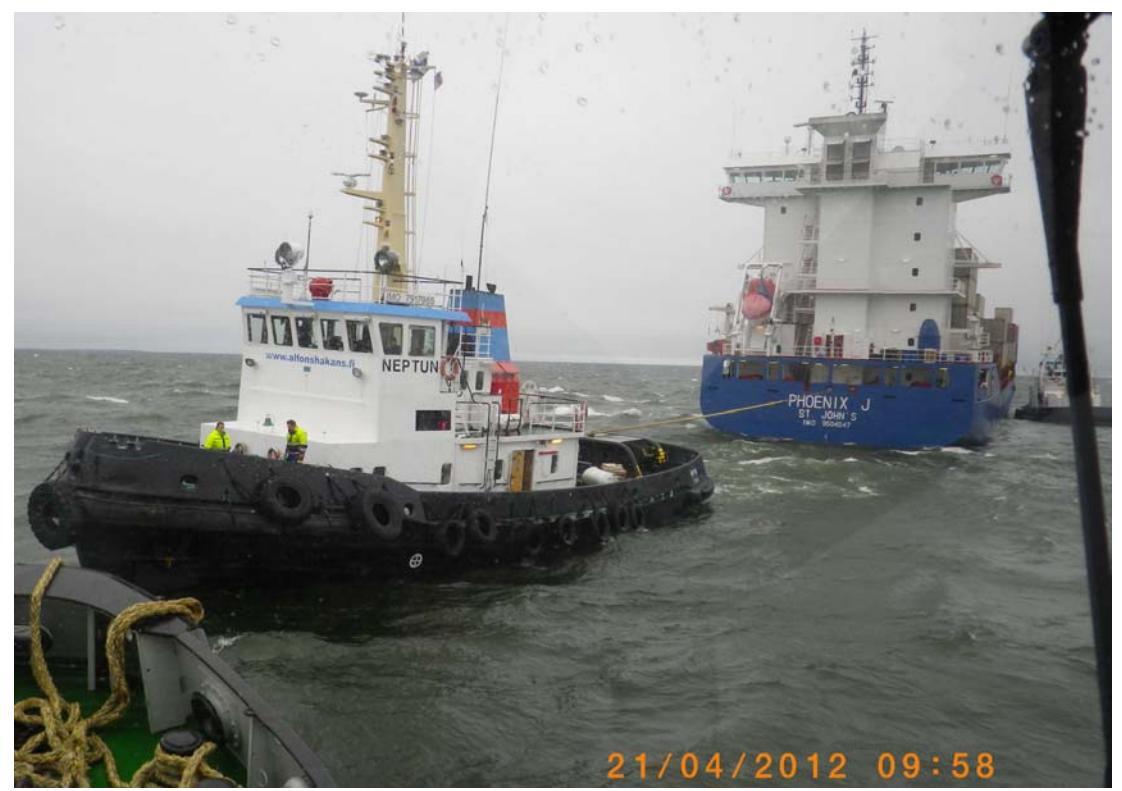
Figure 16. Attempt to refloat the vessel on 21.4.2012. Photo by the diving company.
