Investigation Report

B1/2008M

M/S TALI, grounding in Jössingfjord, Norway, on 29.1.2008

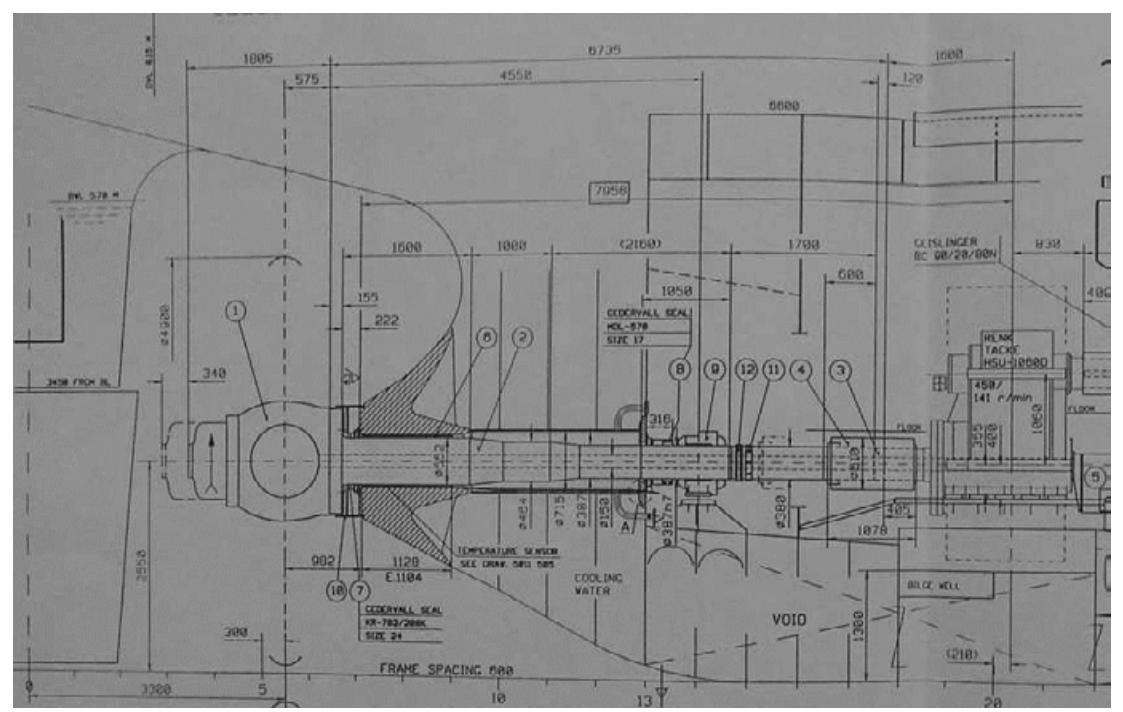
Figure 4. The propeller shaft line. Position 4 is the SKF coupling. The propeller shaft gets thinner about 1,820 mm from the orifice of the opening.

When designing vessels, it would be advisable to reflect on which point in the propeller shaft line should be the weakest against an outwards-pulling force. Should the propeller come loose in a corresponding situation before the shaft comes loose, in which case there is no leakage and the rudder may remain functional? In the case of the M/S TALI, the propeller withstood the outward-pulling force in such a way that the propeller shaft moved out and water could freely flood into the engine room.

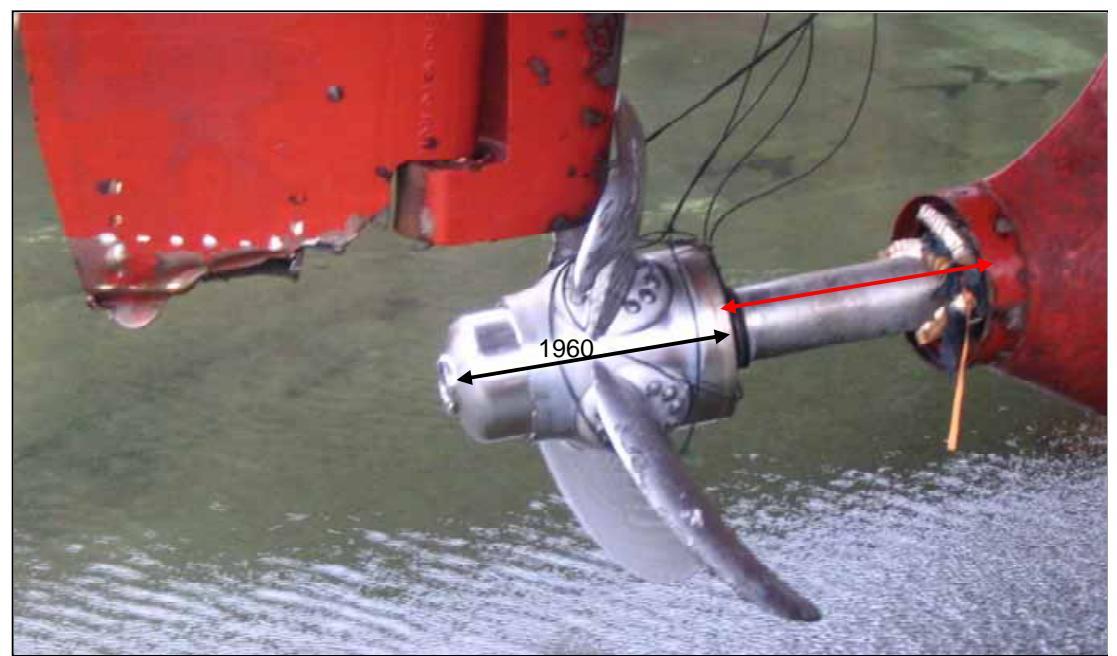
The vessel's propeller and the propeller shaft and its bearings as well as the rudder were damaged. In addition to this, the aft part of the vessel's hull got a clear dent (Figures 13 and 14). After the propeller hit the bottom rock, it pulled out the propeller shaft while the vessel was moving forwards. The shaft came off from the thrust bearings, and its inner part, which was narrower in diameter, remained loose in the opening of the shaft tube. Water started to flow into the engine room through the shaft tube. The thrust bearings broke the cooling water pipes and the cooling water tank¹⁹ started to empty. The lower part of the rudder blade became first partly loose, and it later fell to the bottom in its entirety²⁰.

Figure 13. The damaged rudder, propeller and propeller shaft. The leakage gap has been filled. The propeller shaft bent and twisted. The propeller shaft had come out to the extent that it was about 90 mm thinner in the opening. (See Figure 19).

First the aft part of the hull and then the propeller hit a rock, and due to the vessel's big mass, the shaft came loose from its thrust bearings and protruded until it stopped when the propeller hit the rudder and the SKF coupling hit the shaft tube. The rudder also hit the bottom and got damaged.

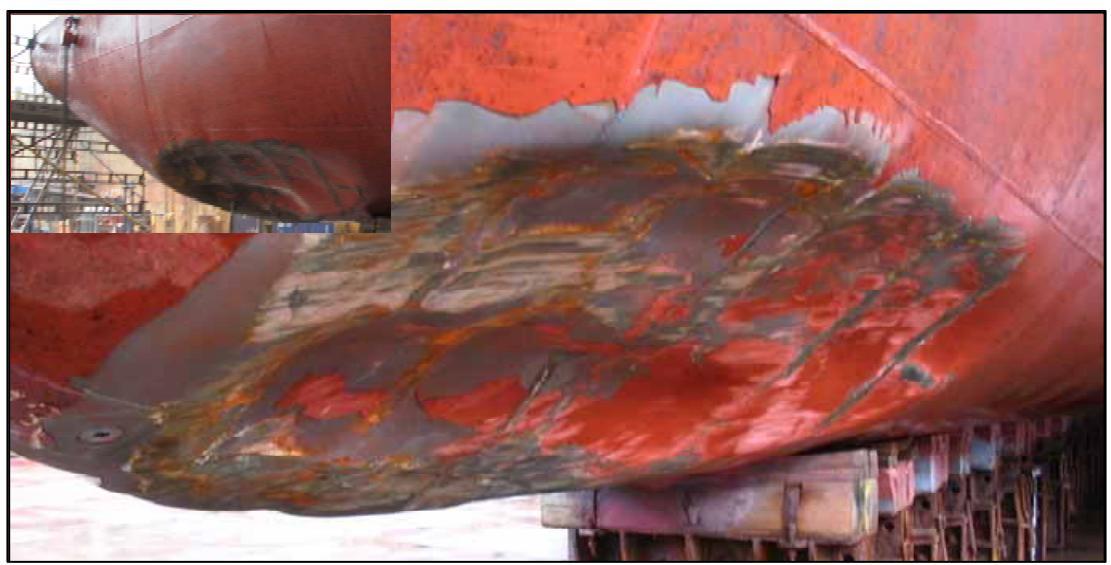
Figure 14. The dent in the M/S TALI's bottom near the propeller and the rudder. There were no damages elsewhere in the bottom of the vessel.

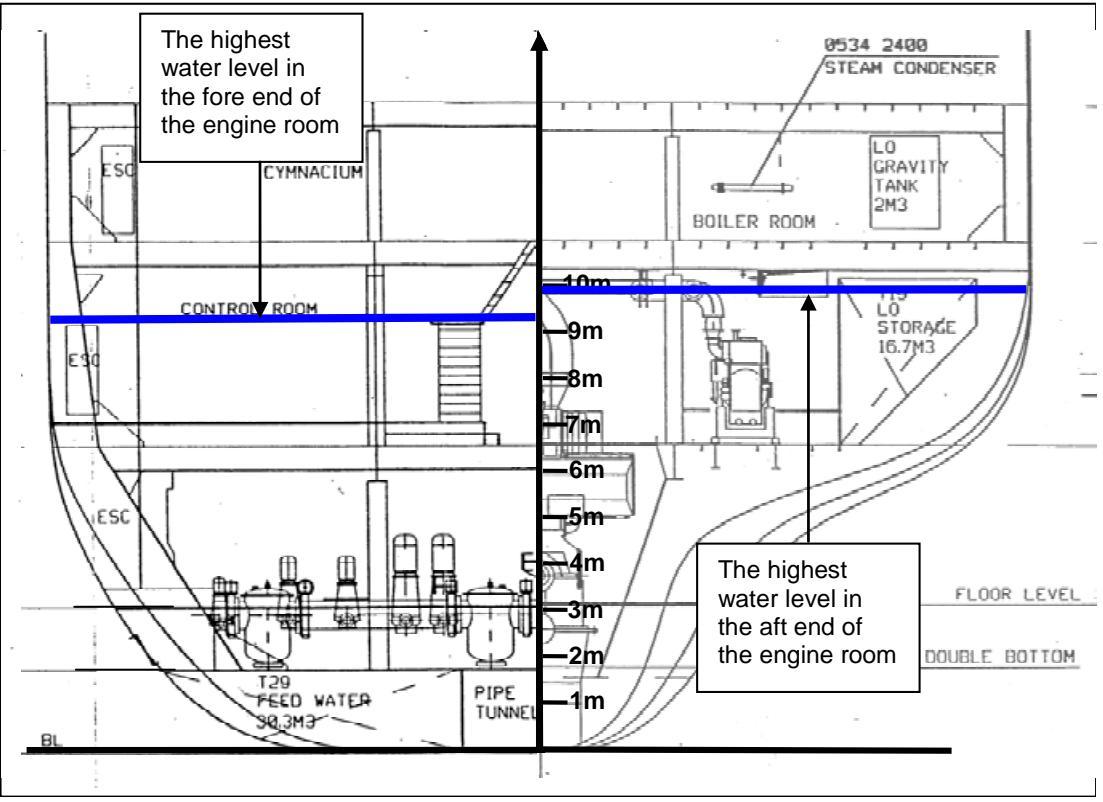
Figure 15. Water level in the aft part of the engine room. The water was about 50 cm lower in the forward part because of the vessel's trim.

The engine room equipment got damaged because of the water which flooded in. For example alarm and other cables had to be changed even in the dry areas because it was not possible to cut and join them. About 45 kilometres' length of different cables were renewed. All the engine room devices were fully overhauled and many of them were replaced by new ones.

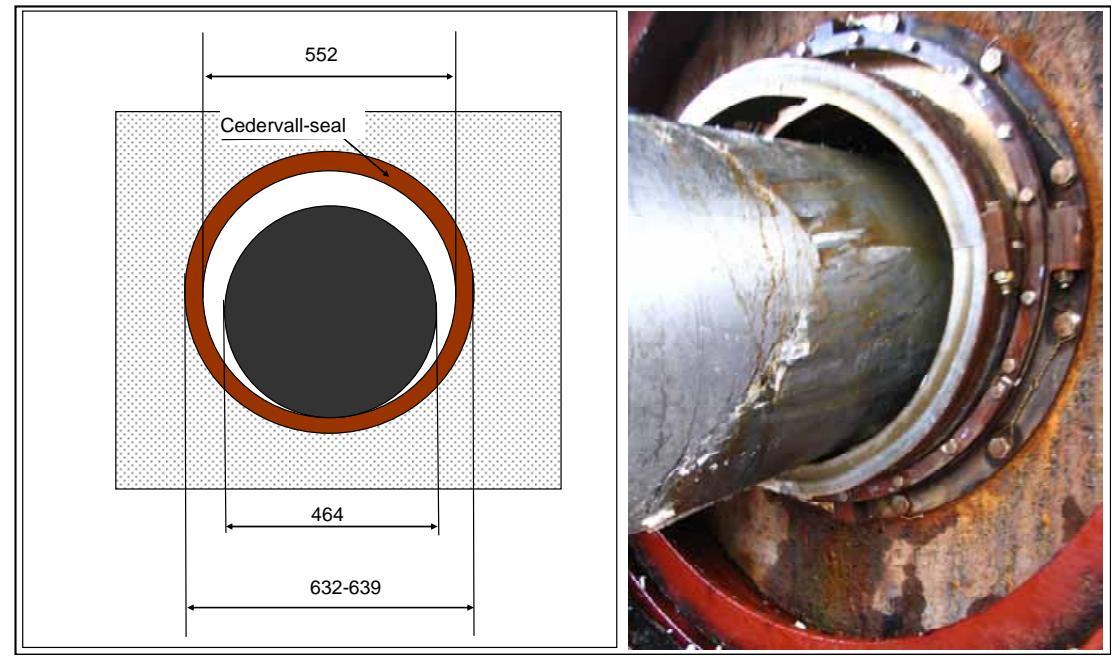
Figure 19. The leakage gap. The measurements are expressed in millimetres. The immediate area next to the opening was cast steel, indicated by grey colour in the picture.

The maximum value of the in-flow speed of water is estimated based on a known formula³²; the flow of water through a small opening with a pressure head h. The water level observations made on M/S TALI set the boundary conditions. The in-flow area of the leakage gap (Figure 19) was approximately 700 cm². The gap developed when the propeller shaft protruded. The outward movement stopped when the propeller hit the rudder and the SKF coupling hit the shaft tube (Figure 4).

In reality the flow has passed through a long tube having a narrow sickle-formed cross section and there have been obstacles in its inner end, e.g. the broken SKF coupling. The calculated maximum volume flow is approximately 44.4 m^3 /min during the first minutes of the leakage. In the investigation approximately 20 m³/min has been estimated to be a realistic value because of the pipe friction and the choking effect of the broken SKF

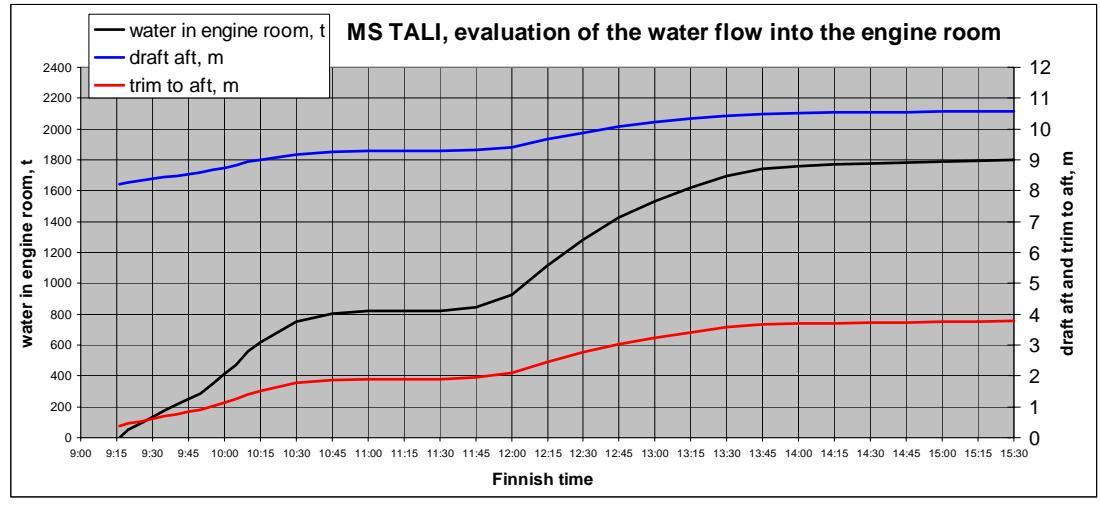
coupling at the bow end of the shaft tube. The results of the calculations have been presented in Figure 20. The point for the decreasing and recommencing of the flow has been somewhat rounded in the calculations.

Figure 20. An estimate on the flooding of the engine room.

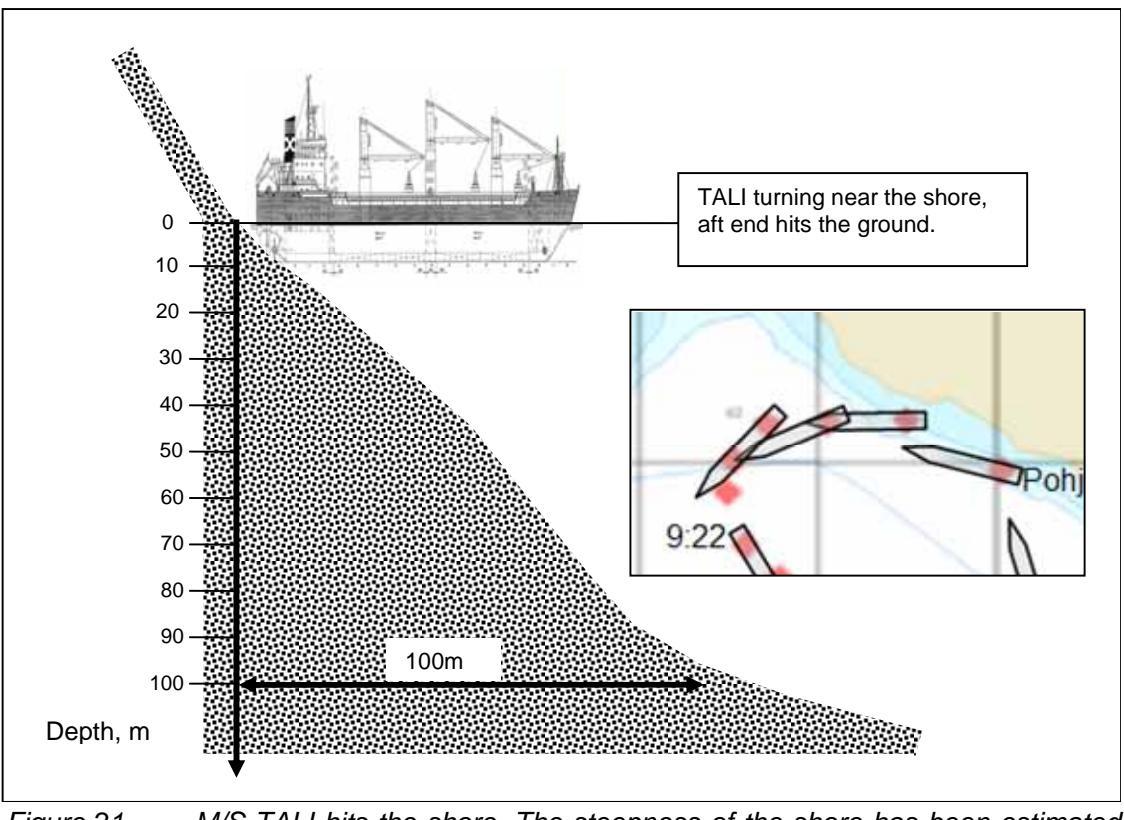
Only the aft of the vessel hit the bottom. If the vessel had stayed only a couple of metres further away from the shore, the grounding could probably have been prevented. On the other hand, if the vessel had been a couple of metres closer to the shore, the shell of the vessel might have been broken and several compartments flooded. The consequences of this would have been the capsizing and sinking of the vessel.

Figure 21. M/S TALI hits the shore. The steepness of the shore has been estimated based on the depth curves in the chart extract; the shallowest is 10 m, the following one 20 m and the third one 100 m.
