Ingerma A. - Strizhak V.: The Strength Studies for the Locking
Devices of the Bow Visor of M/V ESTONIA.

**THE STRENGTH STUDIES FOR THE LOCKING
DEVICES OF THE BOW VISOR OF MV ESTONIA**

AN ANALYSIS OF THE CALCULATION METHODS OF THE LOAD CARRYING CAPACITY OF THE LOCKING DEVICES OF THE BOW VISOR OF MV ESTONIA

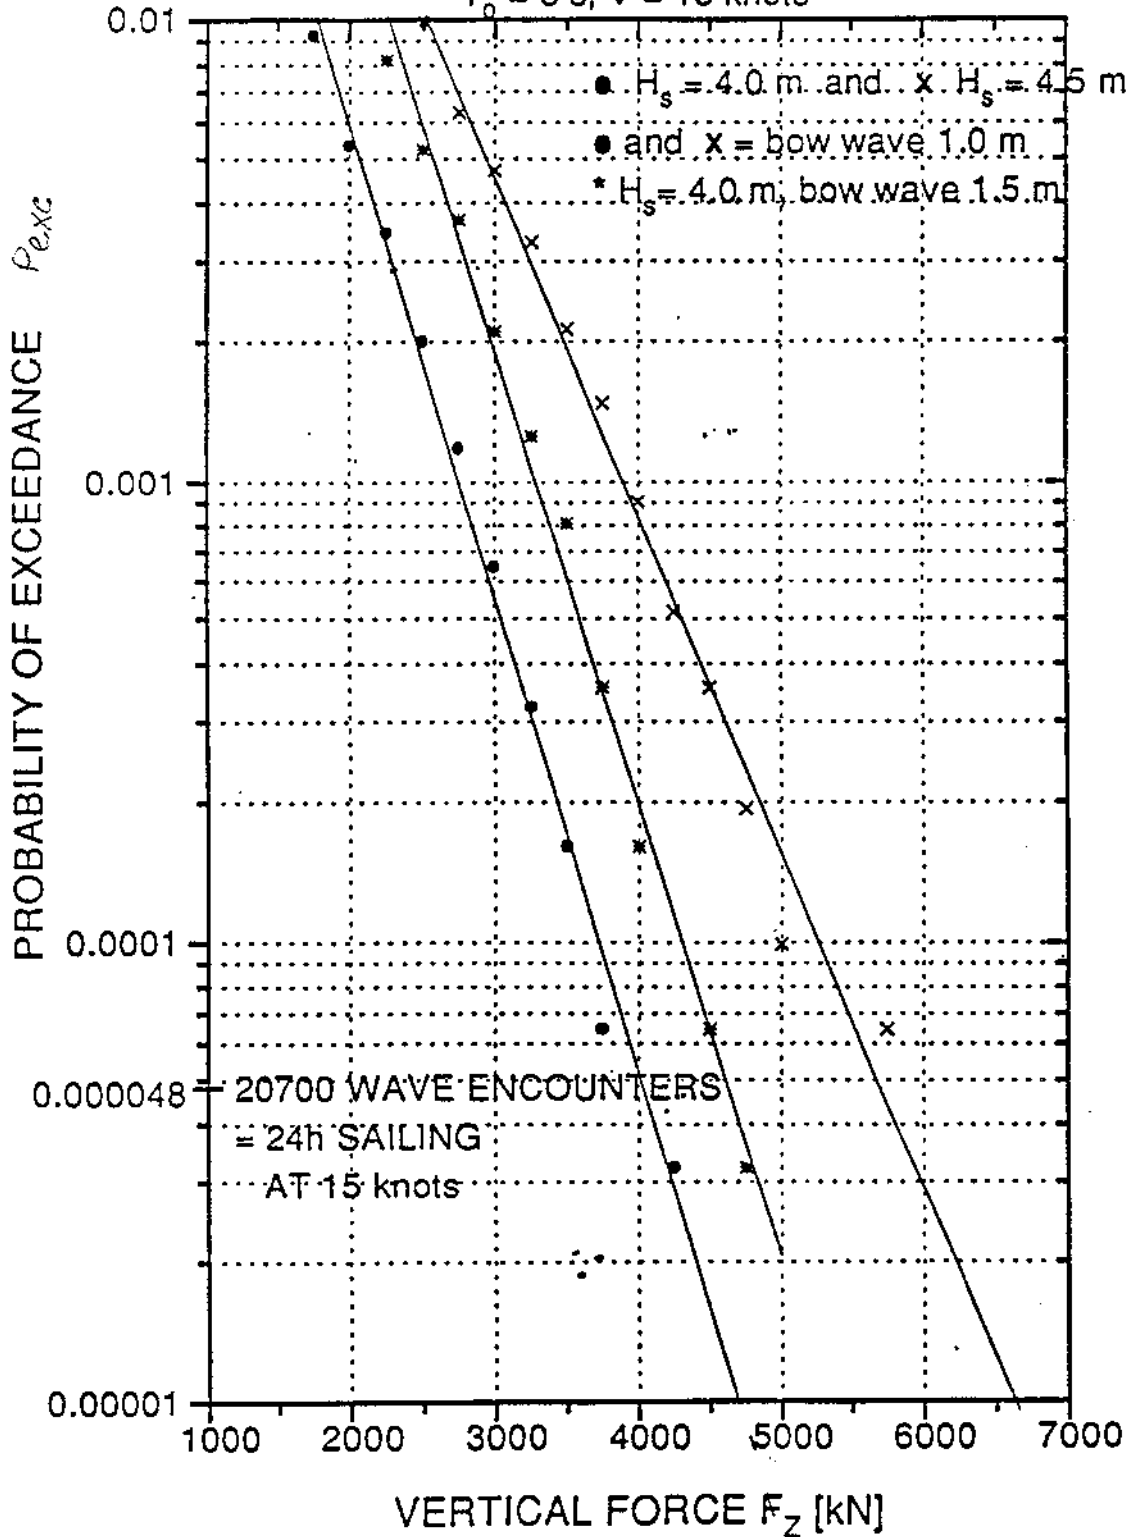
Fig. 5.8 Vertical wave loads on the visor in bow oblique seas with $H_s = 4$ m and 4.5 m.

PROBABILITY OF VERTICAL FORCE
36 HOURS SIMULATIONS
HEADING = 150°

$T_0 = 8$ s, $V = 15$ knots

The significant wave height is 4 and 4.5 m and during the last hour the ship was affected by approximately 1000 waves and the possible occurrence frequency of the greatest vertical force was 1/1000 and the greatest vertical sea force has been estimated to be 5000 kN or less probably 6000 kN, as shown on Fig. 2 [4].

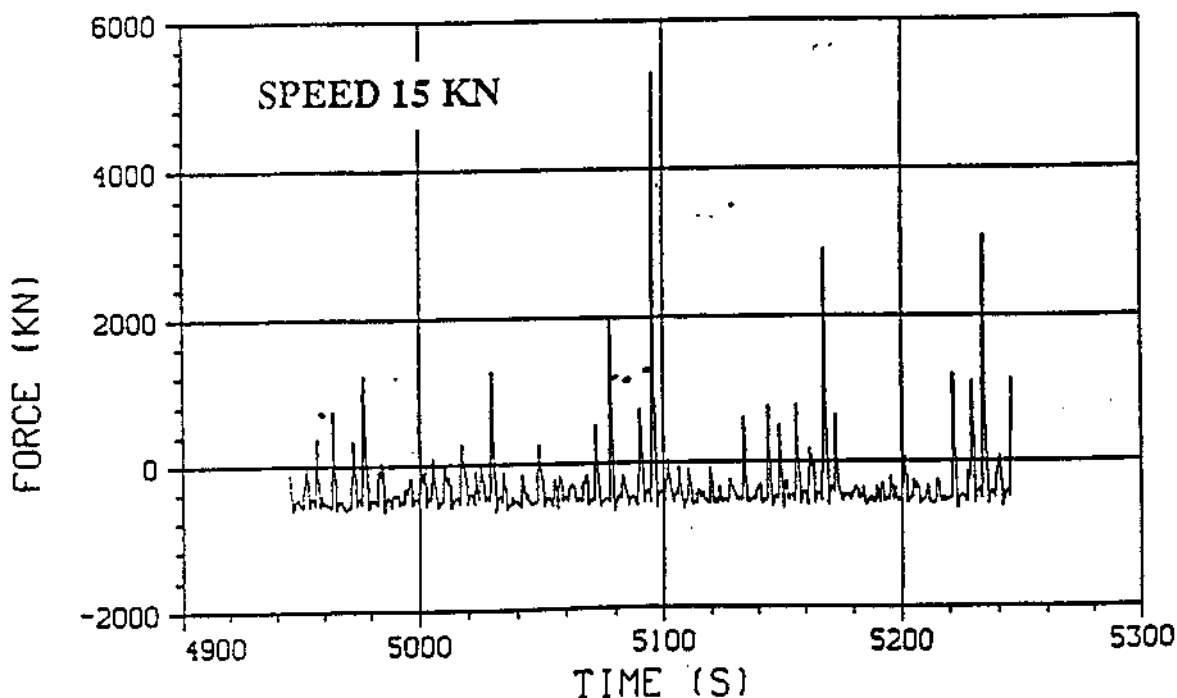
Fig. 5.10 Experimental (SSPA) and simulated records of visor loads in head seas, $H_s = 5.5$.

SSPA MODEL EXPERIMENTS

Vertical visor load F_z

VTT SIMULATIONS

SIGNIFICANT WAVE HEIGHT $H_s = 5.5$ M
TIME HISTORY OF BOW FORCE

The theoretical calculations [4] and model simulations [5] are in agreement and have been presented on Fig. 3 [4].
