MV Estonia. Visor Damage and Visor Attachment Strength
Investigations at VTT.

Report VALB243.

VTT Manufacturing Technology.

Espoo 15.9.1997.

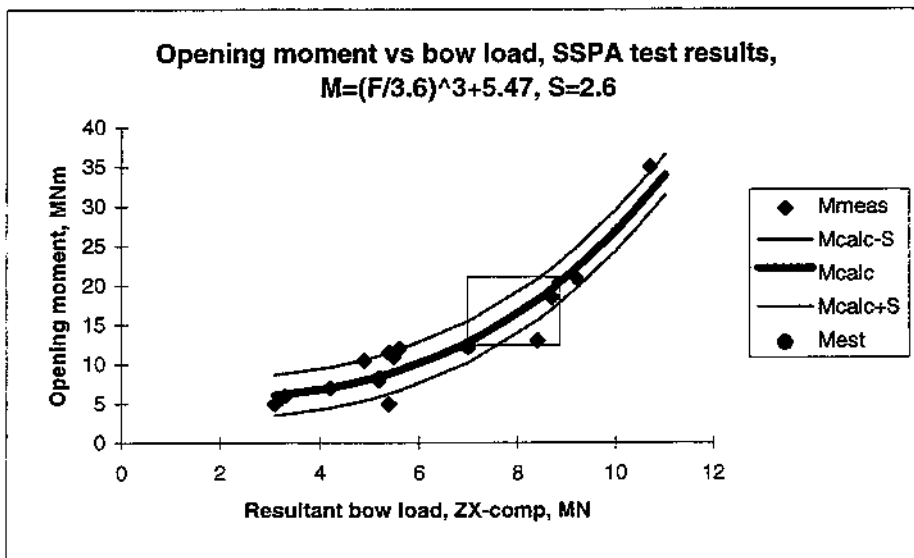
Figure 2. The interrelation of the measured bow force and opening moment. Estimated critical range 7 to 9 MN indicated. Force is component F_{zx} in ship's longitudinal plane, $F_{zx}=F_x*1.414=F_z*1.414$.

Force and moment components obtained from model tests as performed by SSPA (Gothenburg, Sweden) are shown in Figure 2 together with a best estimate equation describing their relationship. Here the force is $F_{zx}=F_x*1.414=F_z*1.414$. The mean trend and its standard deviation are given in the graph. The fitted equation is by the present author for use only within the range of given data.

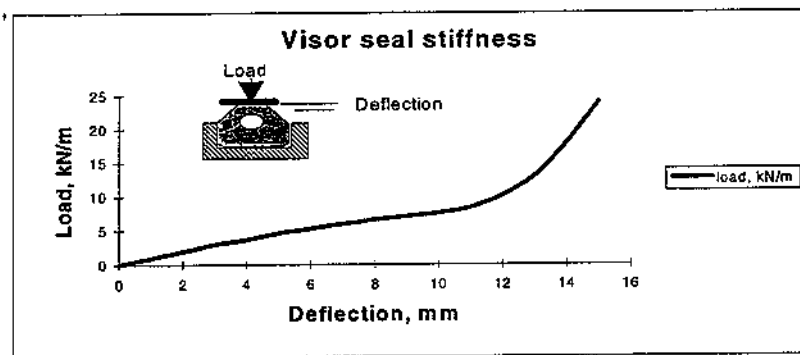
Figure 8. Visor seal stiffness as measured for 1 m length of seal.

The flexibility of the seal was measured in order to facilitate comparison and quantification of reaction of visor support elements to wave-induced forces. The visor seal was found to have progressive stiffness, such that a 10 mm compression was reached with a 10 kN load per metre of seal length and the following 5 mm needed 15 kN more, see Figure 8.

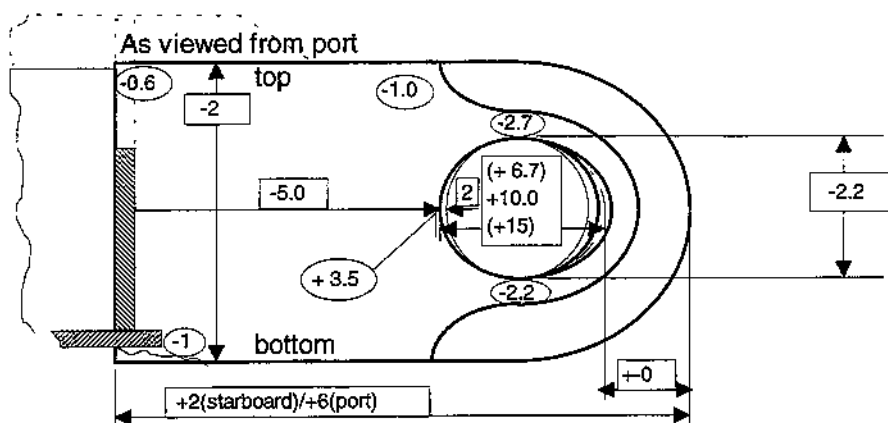
The full length of the eye is about 95 mm at midthickness and 93 mm at $\frac{1}{4}$ thickness from the concave (starboard) side. At the aft end of the hole the side bend is 10 mm or slightly less.

Figure 15. Lug dimensions as differences to nominal as drawn dimensions. Note also reduced thickness of eye ligaments above and below eye, which supports tensile stretch of lug.

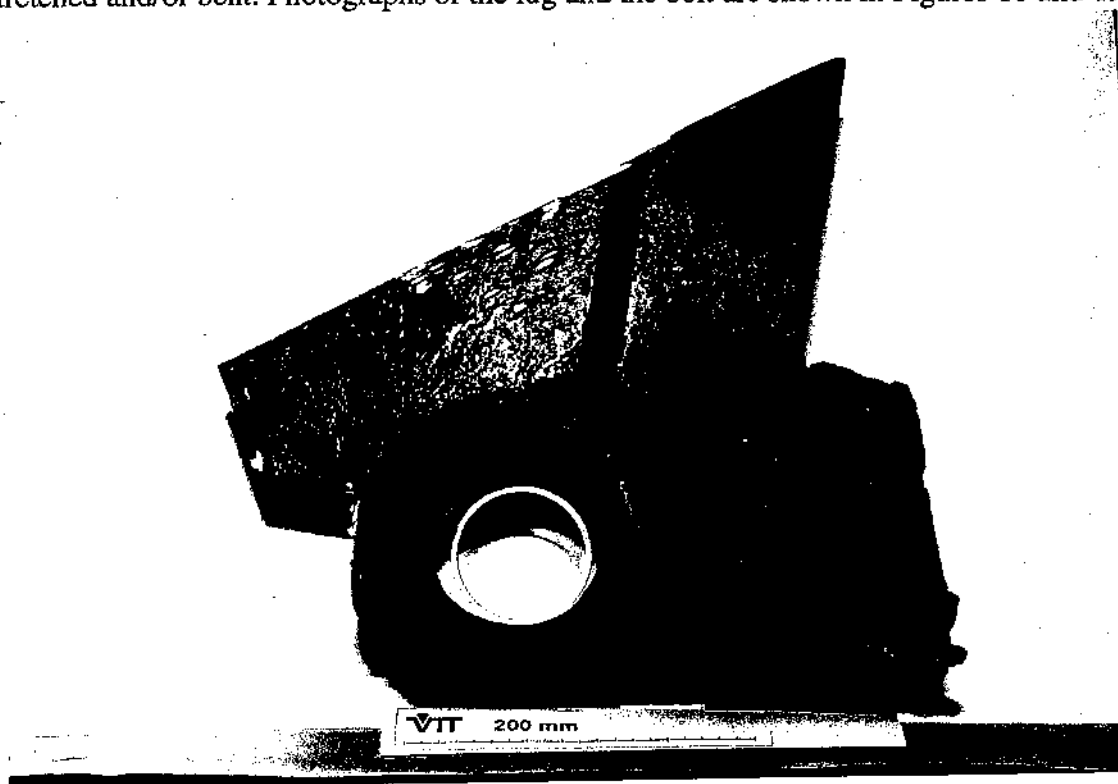
Figure 18. The Atlantic lock visor lug from the MV DIANA II. Part of the added plating surrounding the lug tip has been removed for measurement purposes.

The visor lug and locking bolt of the former MV Diana II were recovered from the ship for purposes of comparing measurements with the ESTONIA-lug. This was necessitated because of earlier observations of this locking mechanism to have significant play (reported to be on the order of 30 mm by Turbotechnic after the January 1993 accident) after the MV Diana II had experienced heavy weather and damage to its visor locking devices in early 1993. It became of interest to find if the locking bolt was unbent or worn and if the visor lug had stretched and/or bent. Photographs of the lug and the bolt are shown in Figures 18 and 19.

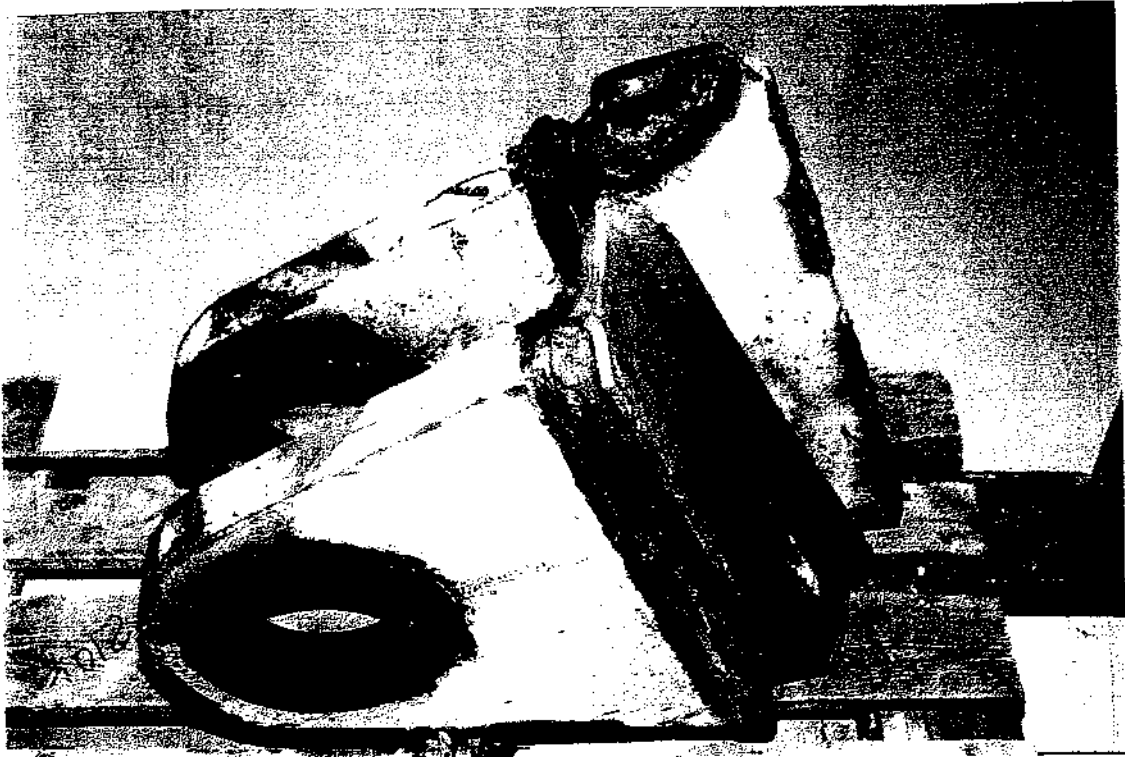
Figure 31 . Port lifting cylinder lower platform as seen from bow centre. Position tilted 120 degrees bow up. Bow end of lower port extreme stringer weld repaired. Centre stringer bent with broken fillet weld, nearest (centremost in ship) fillet weld missing.

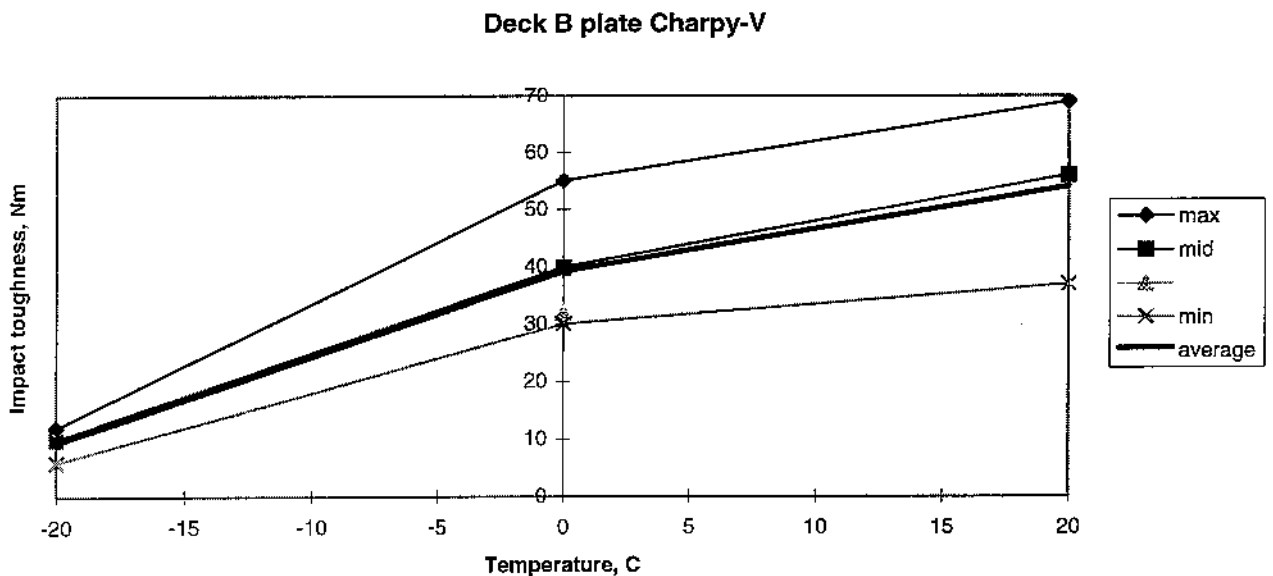
Figure 32. Deck B Charpy-V impact toughness values.
