Investigation report

B 4/1999 L

Landing gear malfunction of a HS 125-700B aircraft and landing at Helsinki-Vantaa airport on 3 September 1999

OH-JET

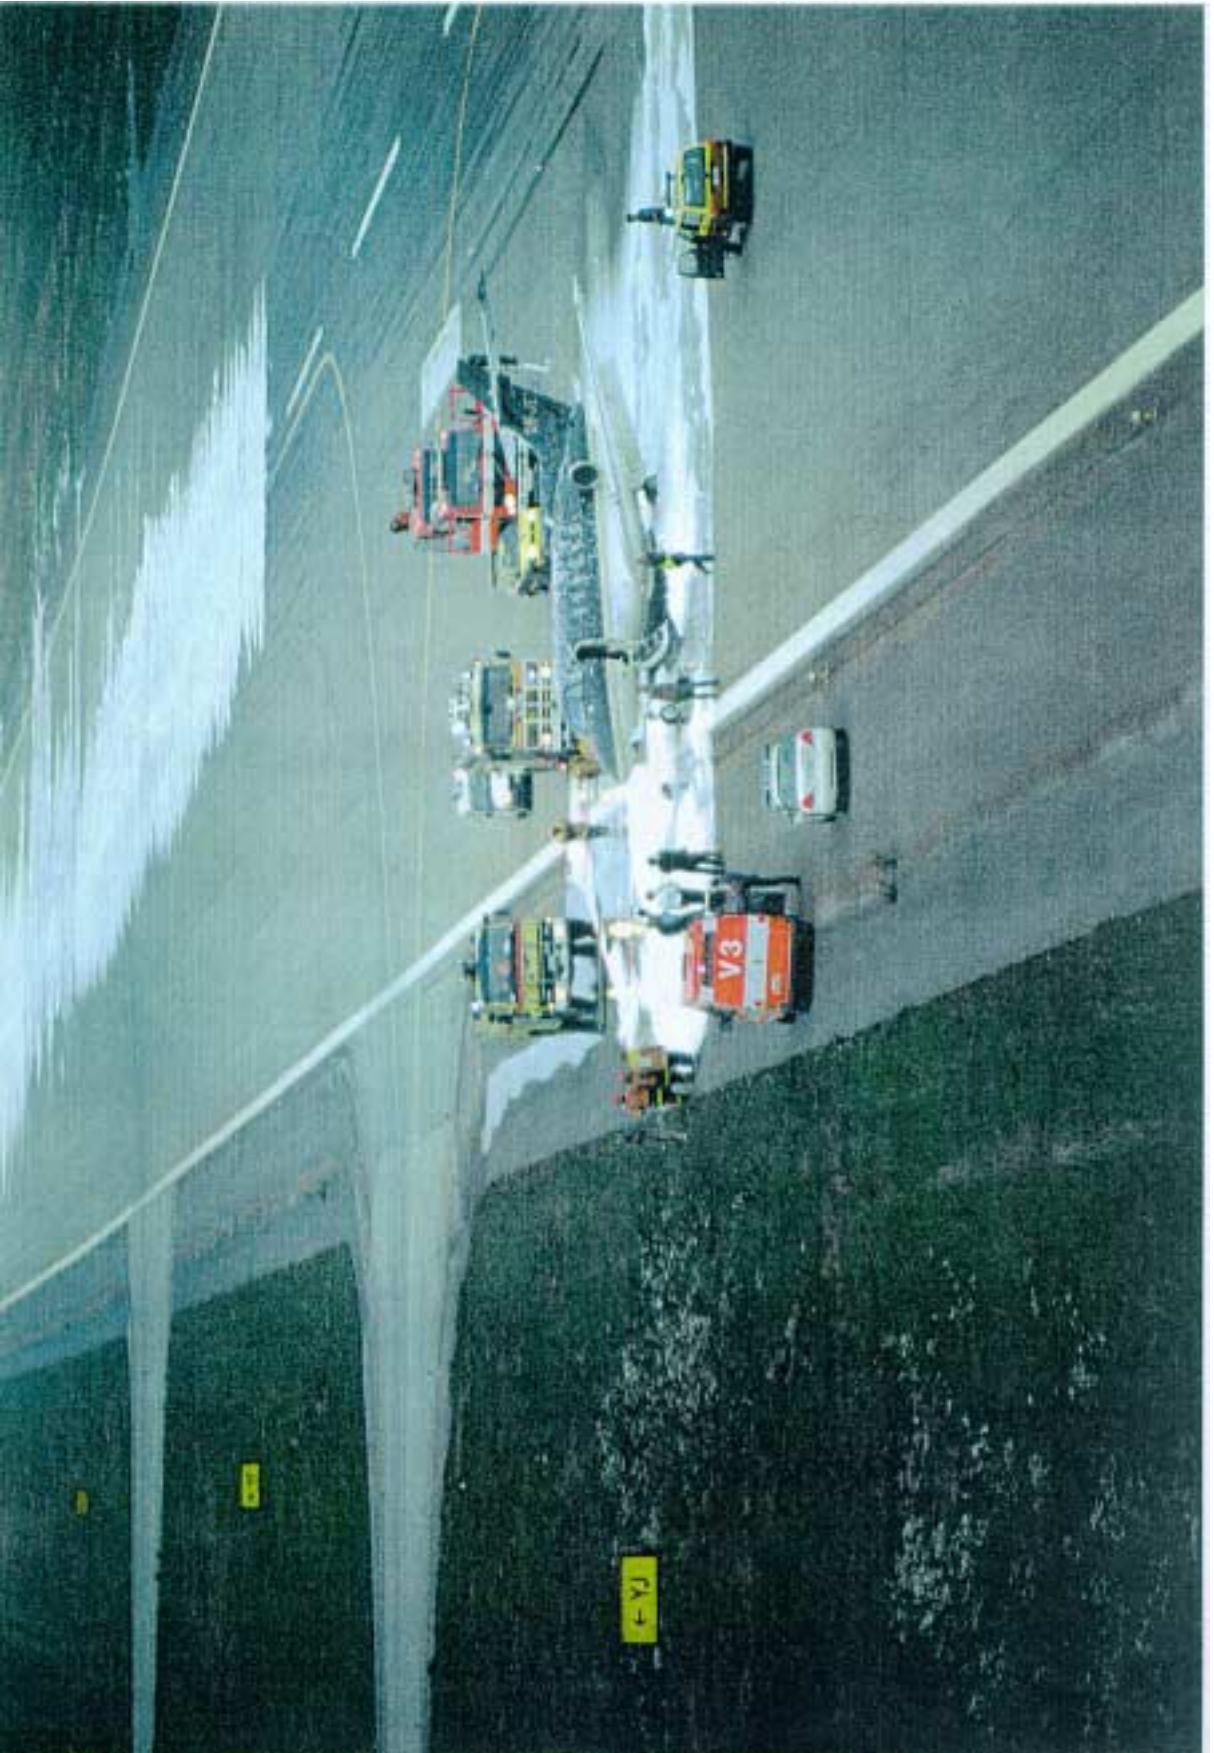
Fracture surface 1b

90% stress corros.
10% ductile fracture

Fracture surface 1a

50% stress corros.

Fracture surface 2a

25% stress corrosion

Fracture surface 2b

Fracture surface 1a.
50% of the fracture is
caused by stress corrosion.

The stress corrosion cracks
emerge from the inner side of
the lugs and move outward.
